# Proposed Gran Central Development

## *Geotechnical and Hydrogeological Investigation Report*

19130799-003-R-Rev0 GHI

17 February 2020

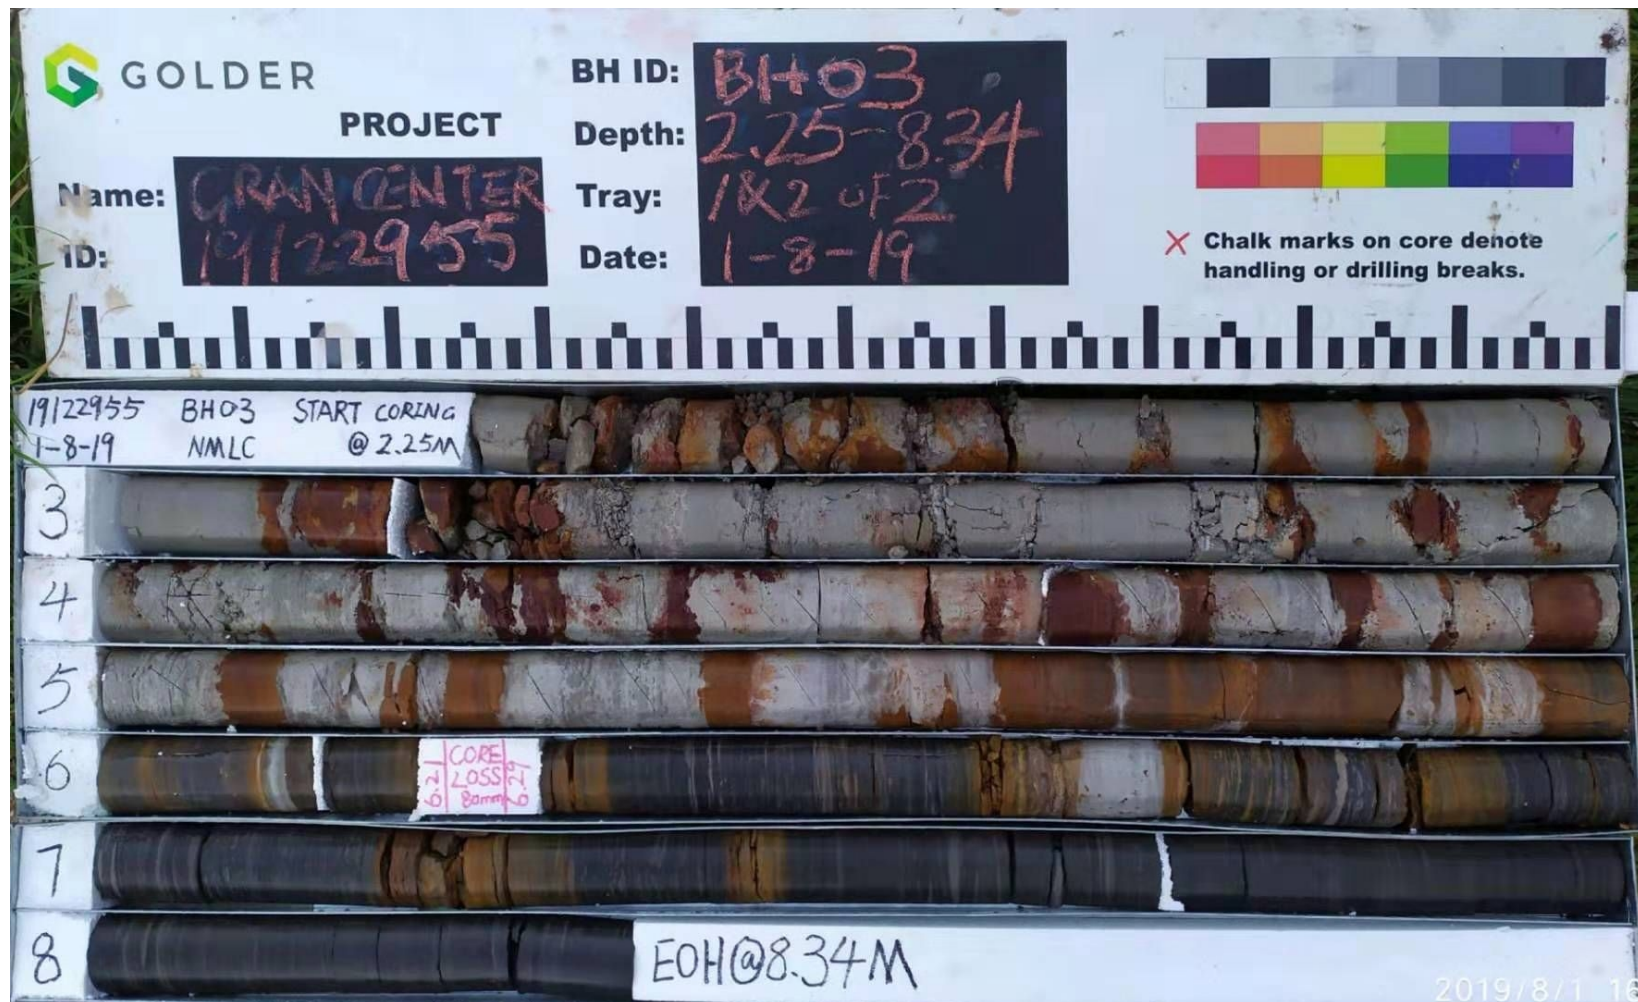
This report of core photographs must be read in conjunction with accompanying notes and abbreviations.

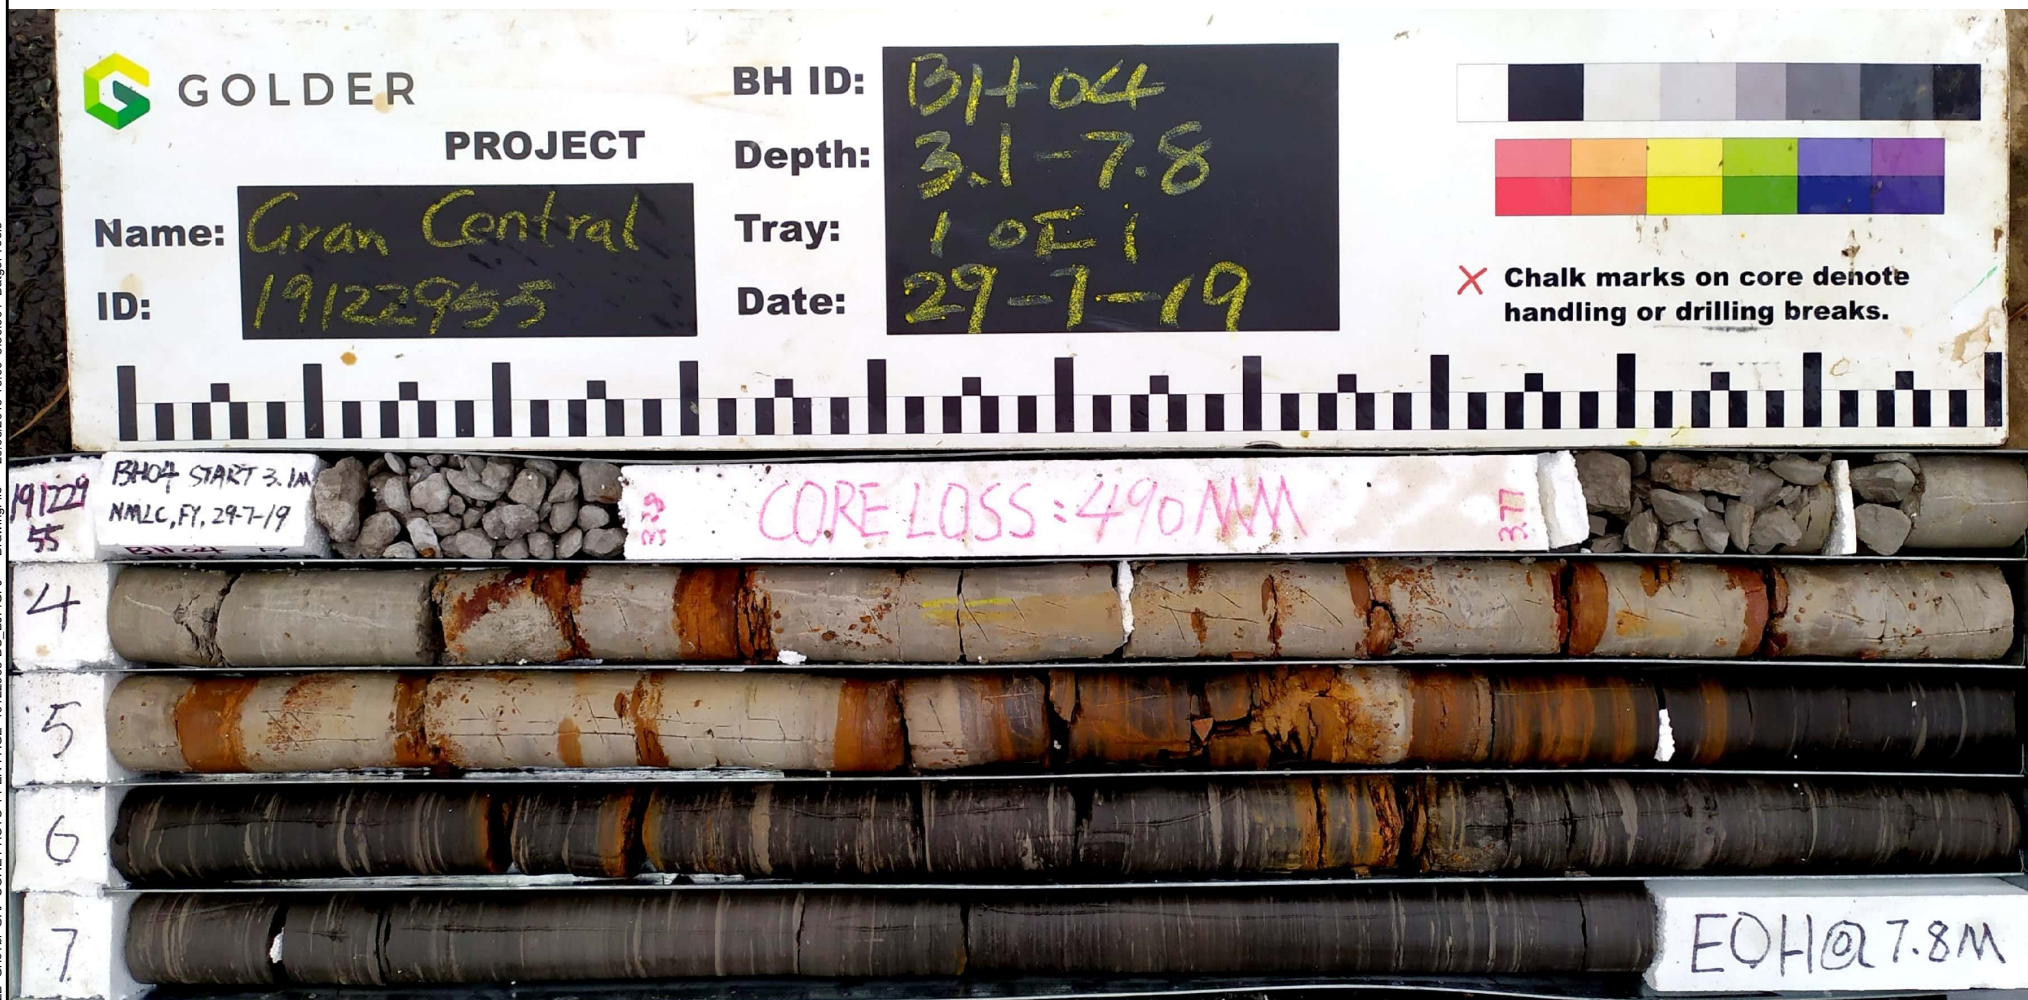
This report of core photographs must be read in conjunction with accompanying notes and abbreviations.

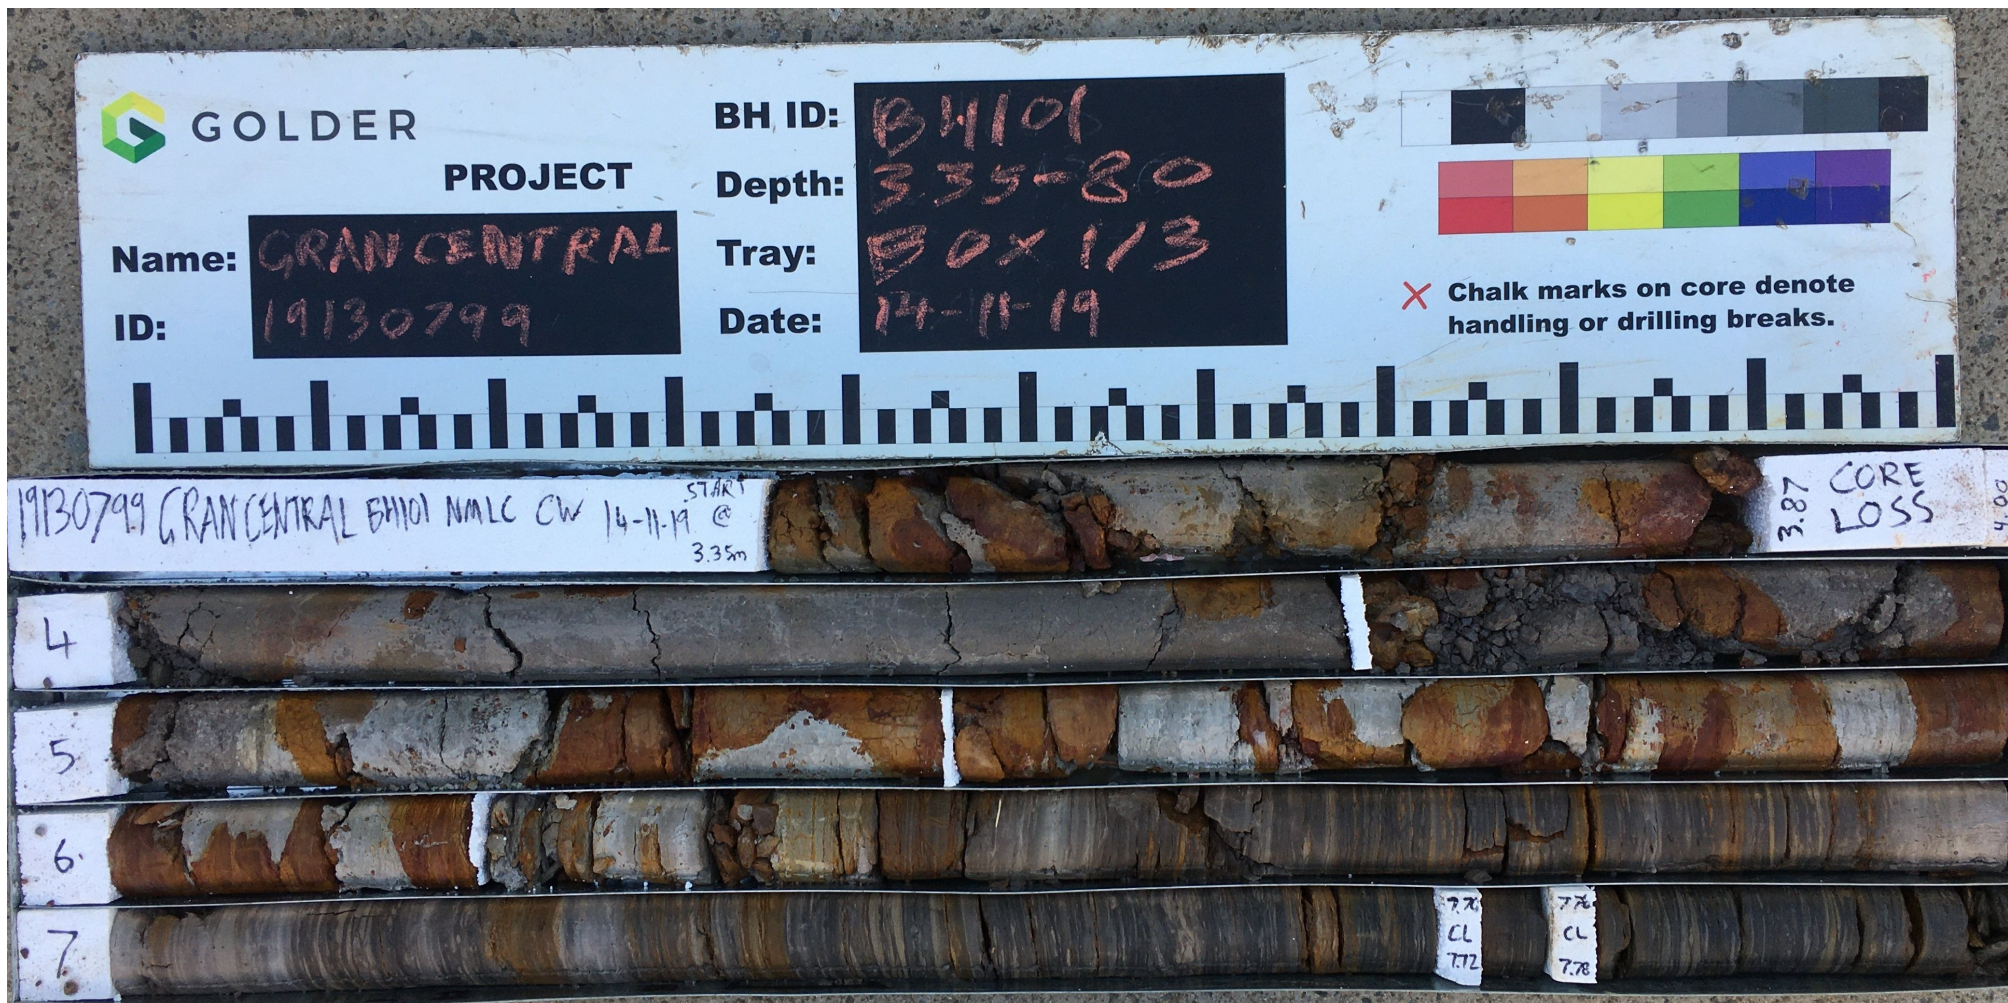
SHEET: 1 OF 3  
 DRILL RIG: Komatsu 05  
 CONTRACTOR: Nealings  
 LOGGED: CW DATE: 15/11/19  
 CHECKED: BC DATE: 18/11/19

This report of core photographs must be read in conjunction with accompanying notes and abbreviations.

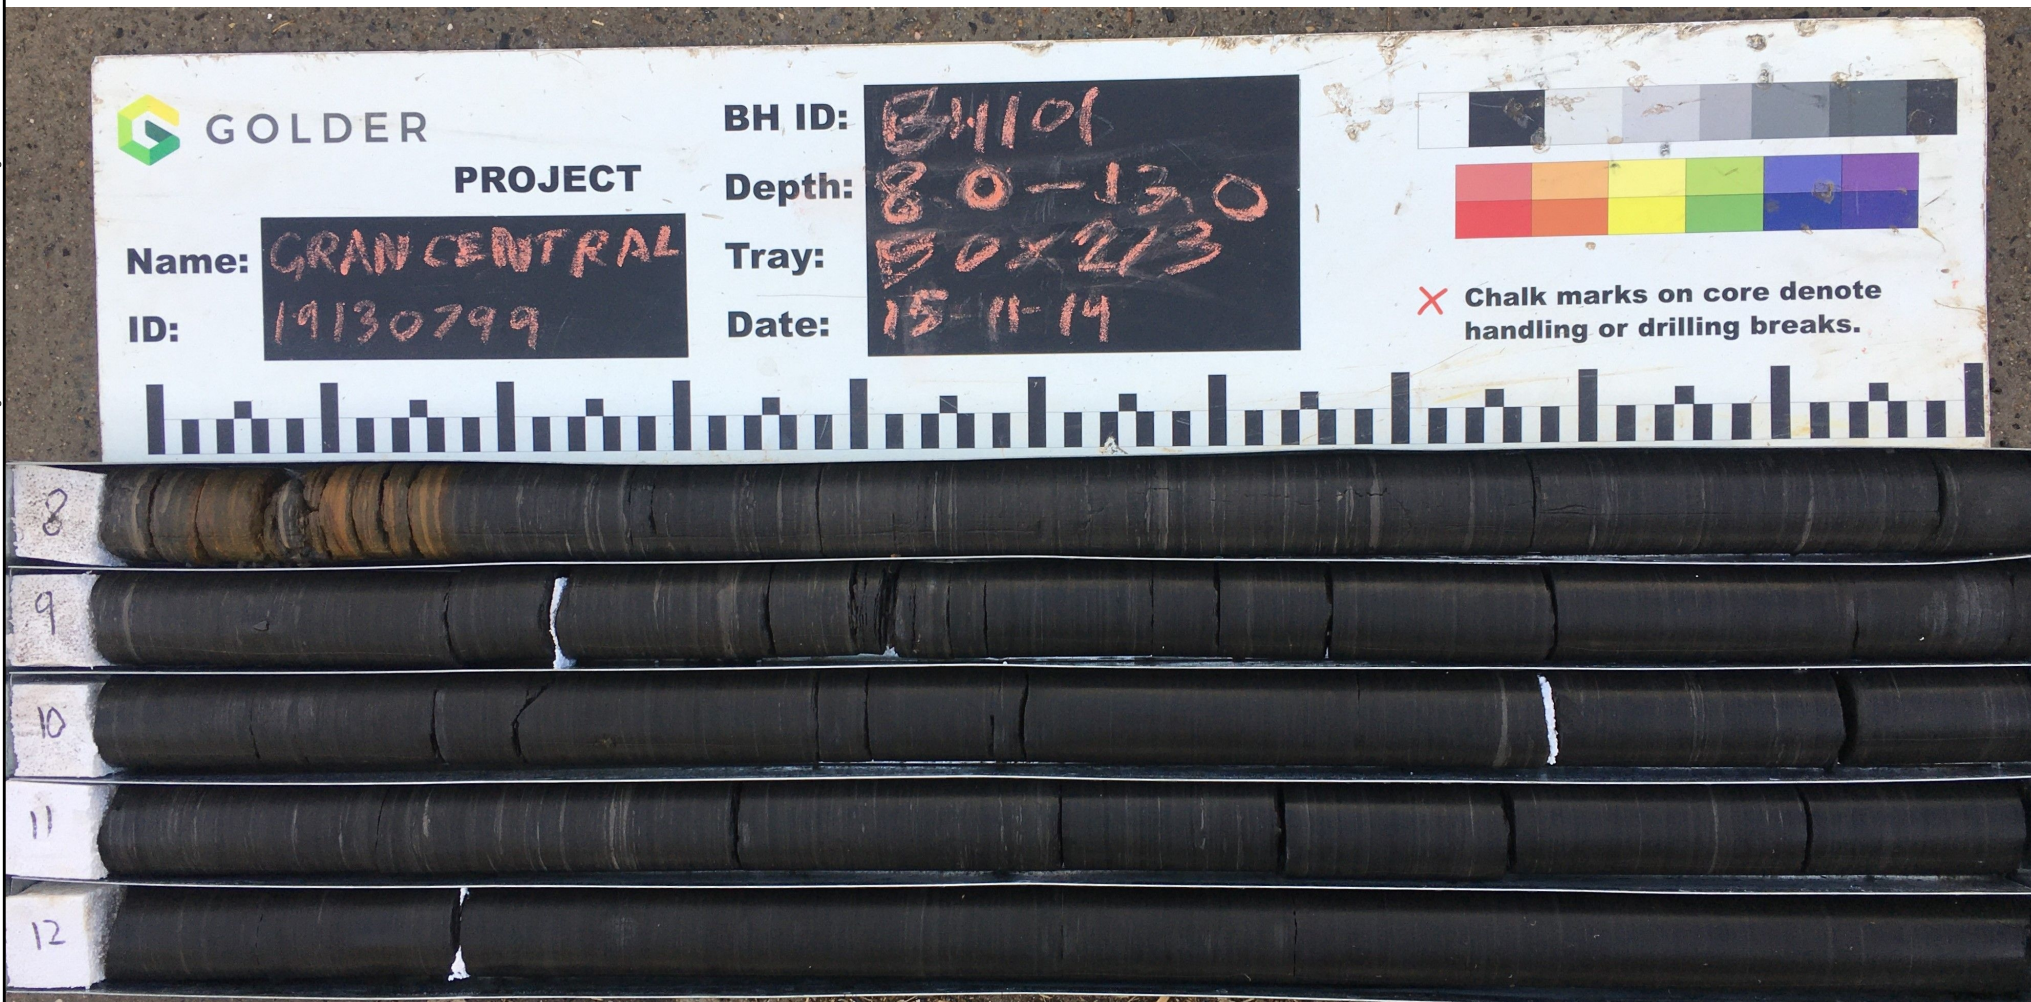
SHEET: 2 OF 3  
 DRILL RIG: Komatsu 05  
 CONTRACTOR: Nealings  
 LOGGED: CW  
 CHECKED: BC

This report of core photographs must be read in conjunction with accompanying notes and abbreviations.

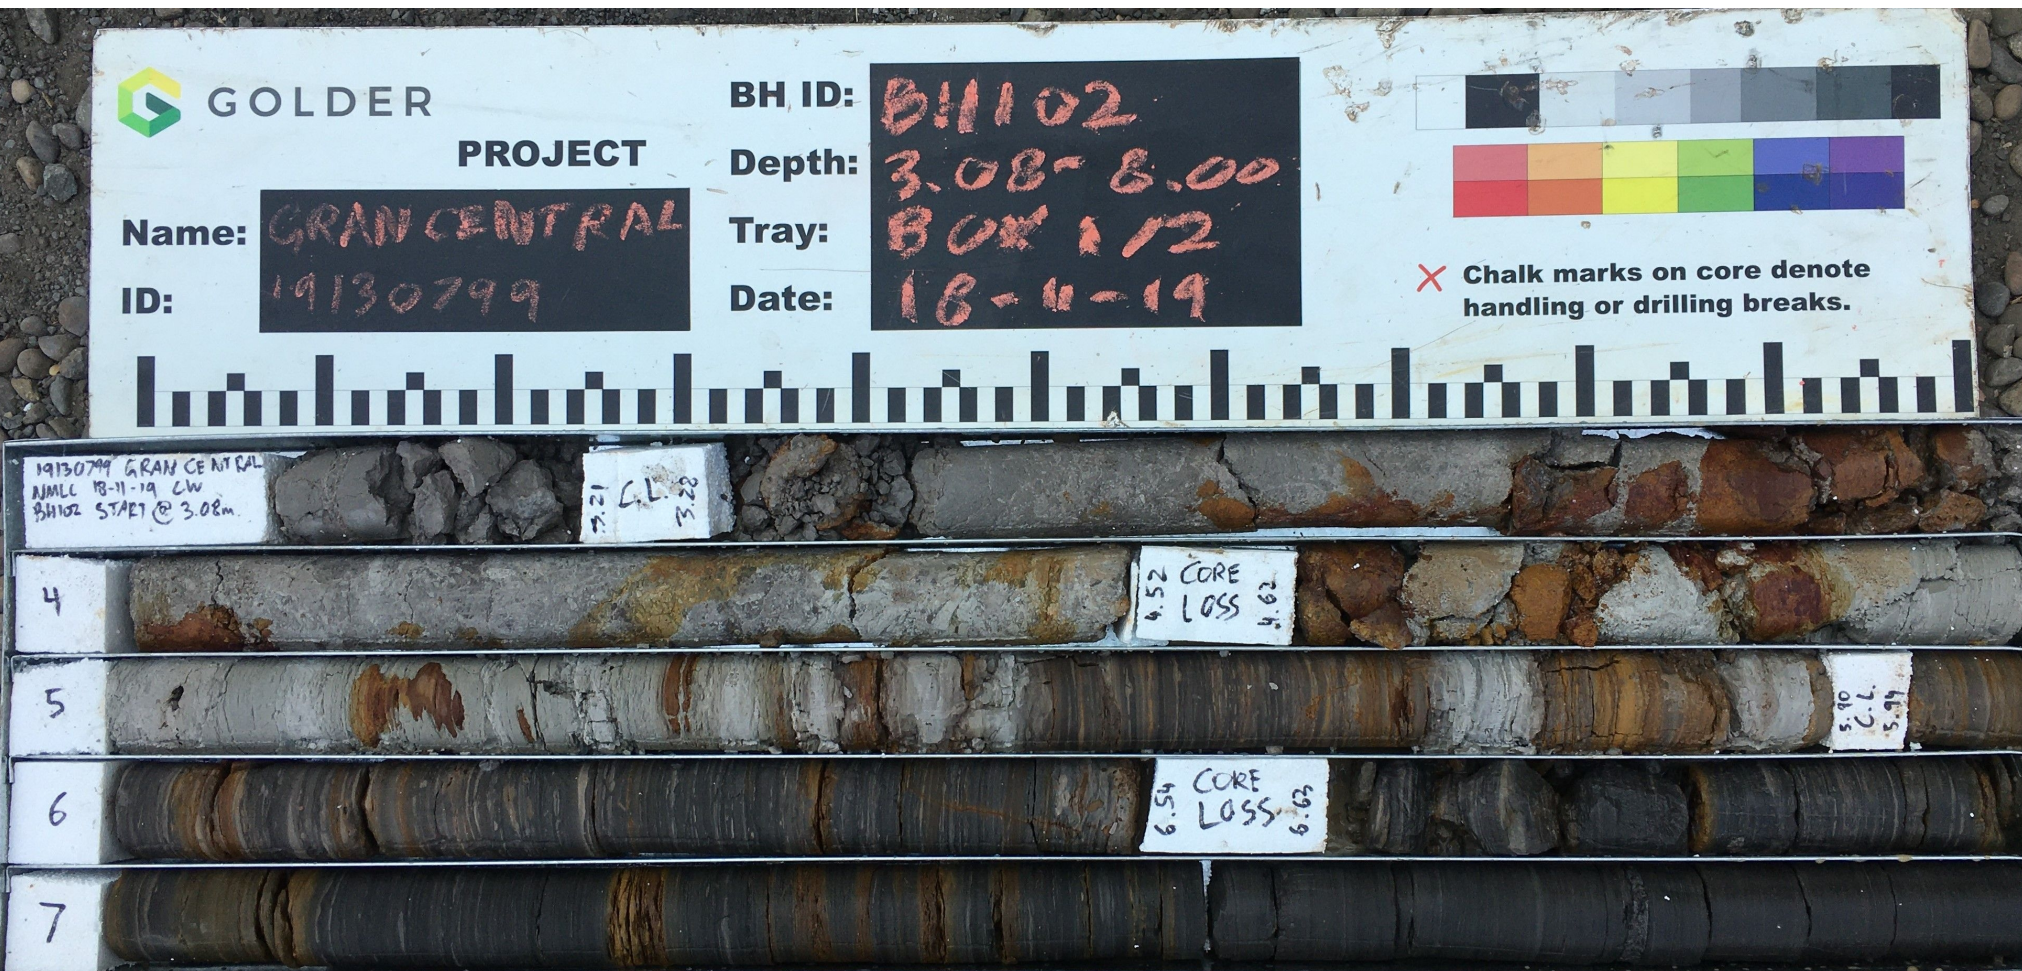
SHEET: 1 OF 2  
 DRILL RIG: Komatsu 05  
 CONTRACTOR: Nealings  
 LOGGED: CW  
 CHECKED: BC

This report of core photographs must be read in conjunction with accompanying notes and abbreviations.

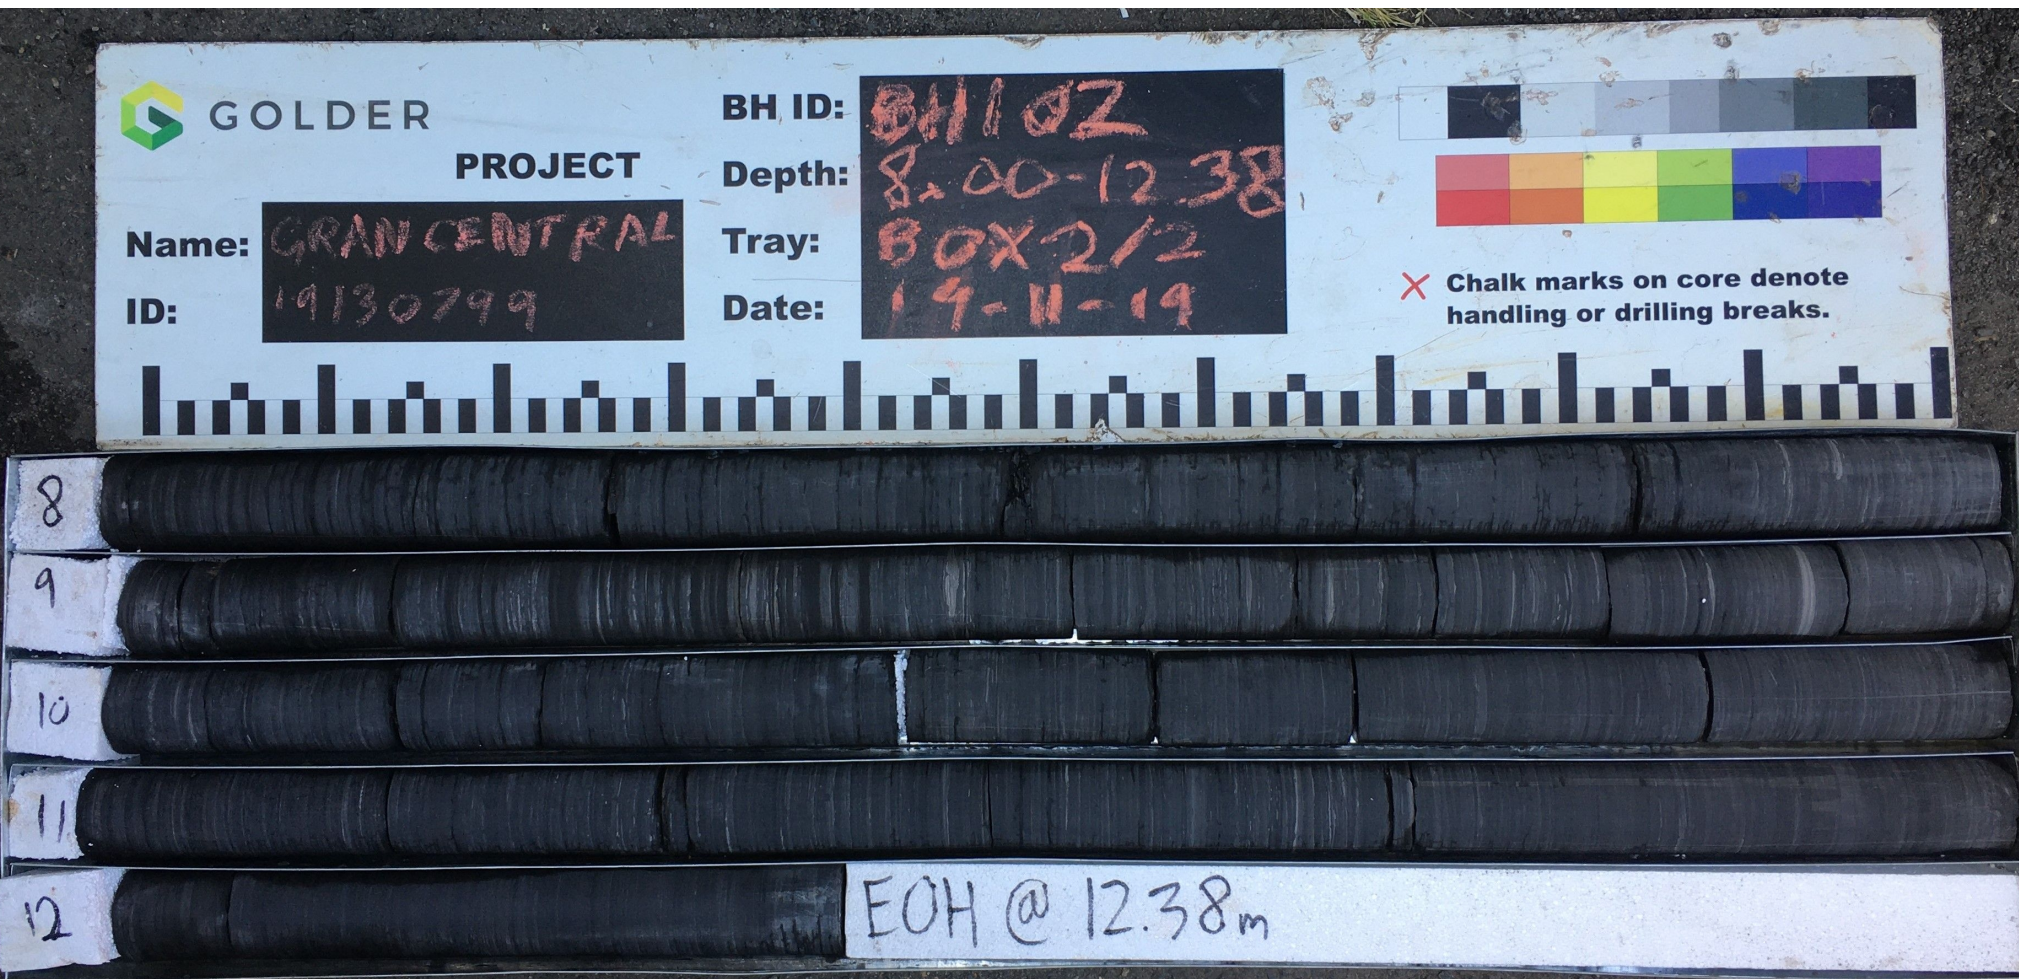
SHEET: 2 OF 2  
 DRILL RIG: Komatsu 05  
 CONTRACTOR: Nealings  
 LOGGED: CW DATE: 19/11/19  
 CHECKED: BC DATE: 29/11/19

This report of core photographs must be read in conjunction with accompanying notes and abbreviations.

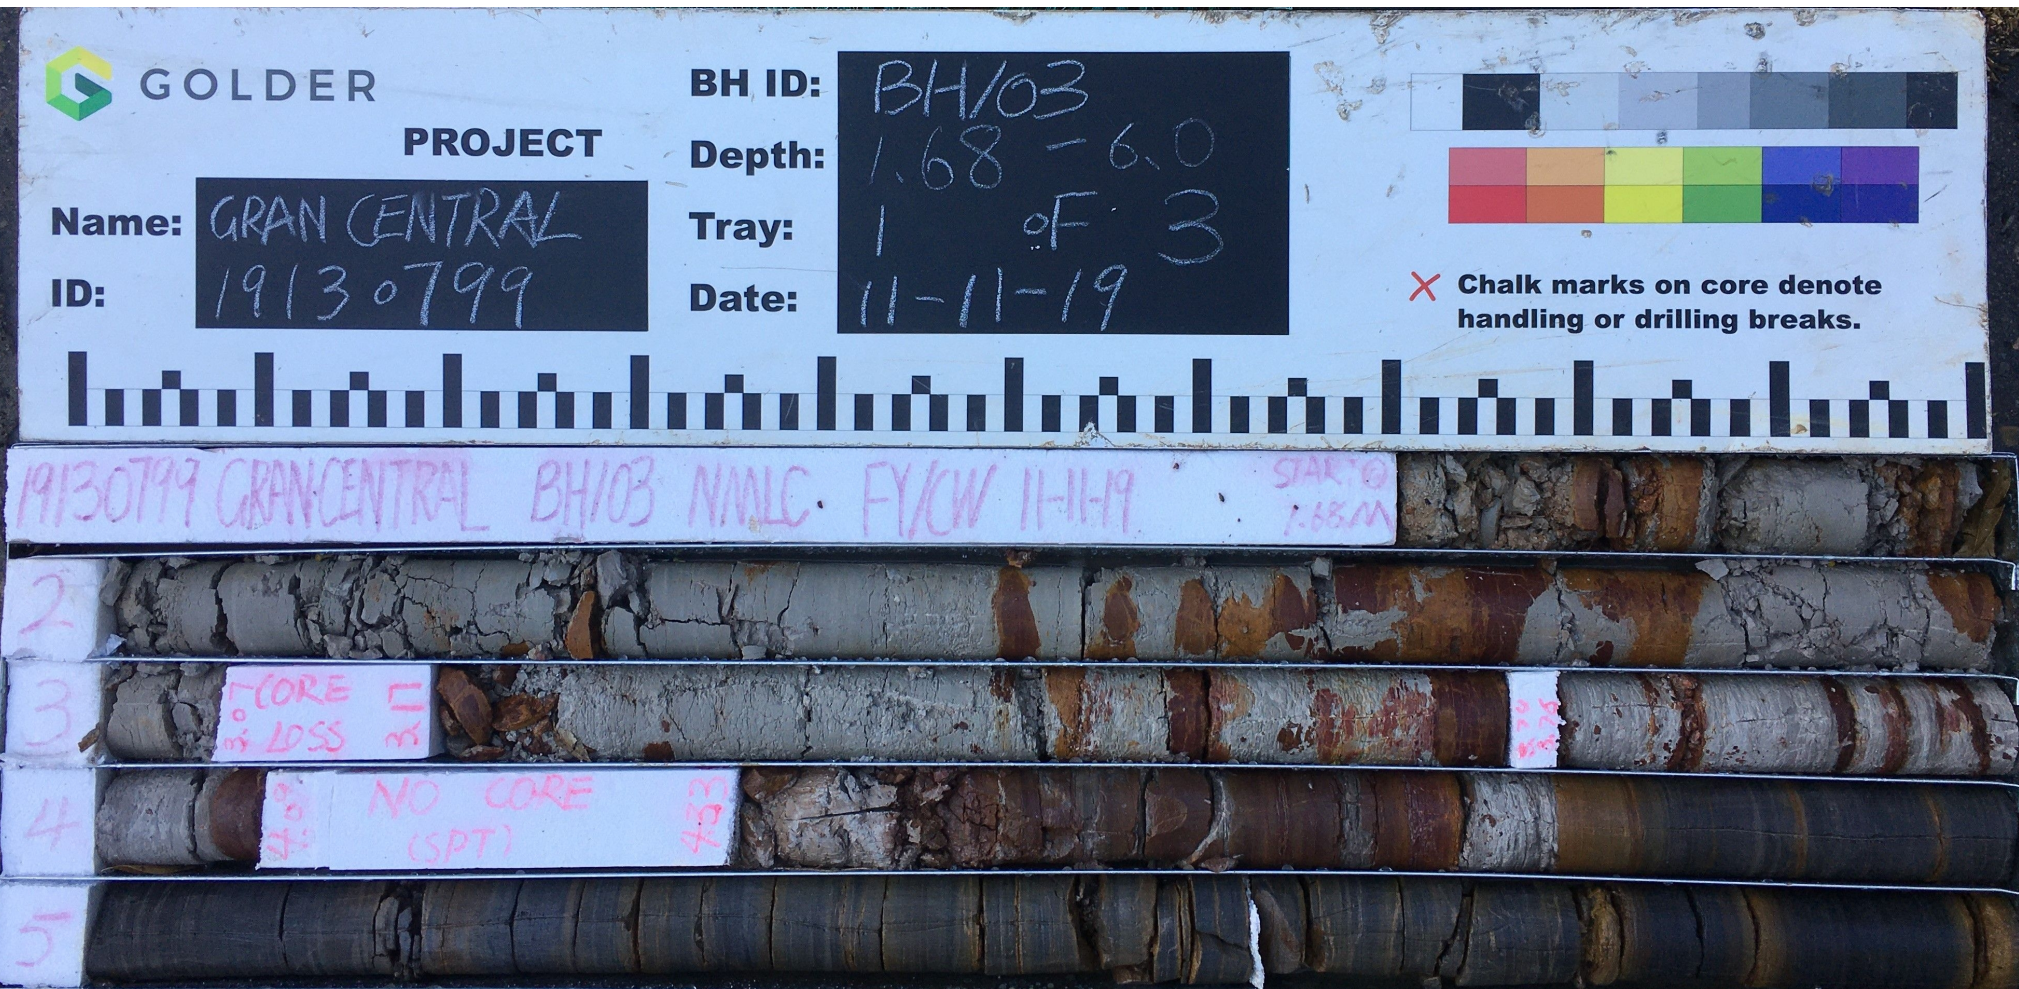
SHEET: 1 OF 3  
 DRILL RIG: Komatsu 05  
 CONTRACTOR: Nealings  
 LOGGED: CW DATE: 12/11/19  
 CHECKED: BC DATE: 18/11/19

This report of core photographs must be read in conjunction with accompanying notes and abbreviations.

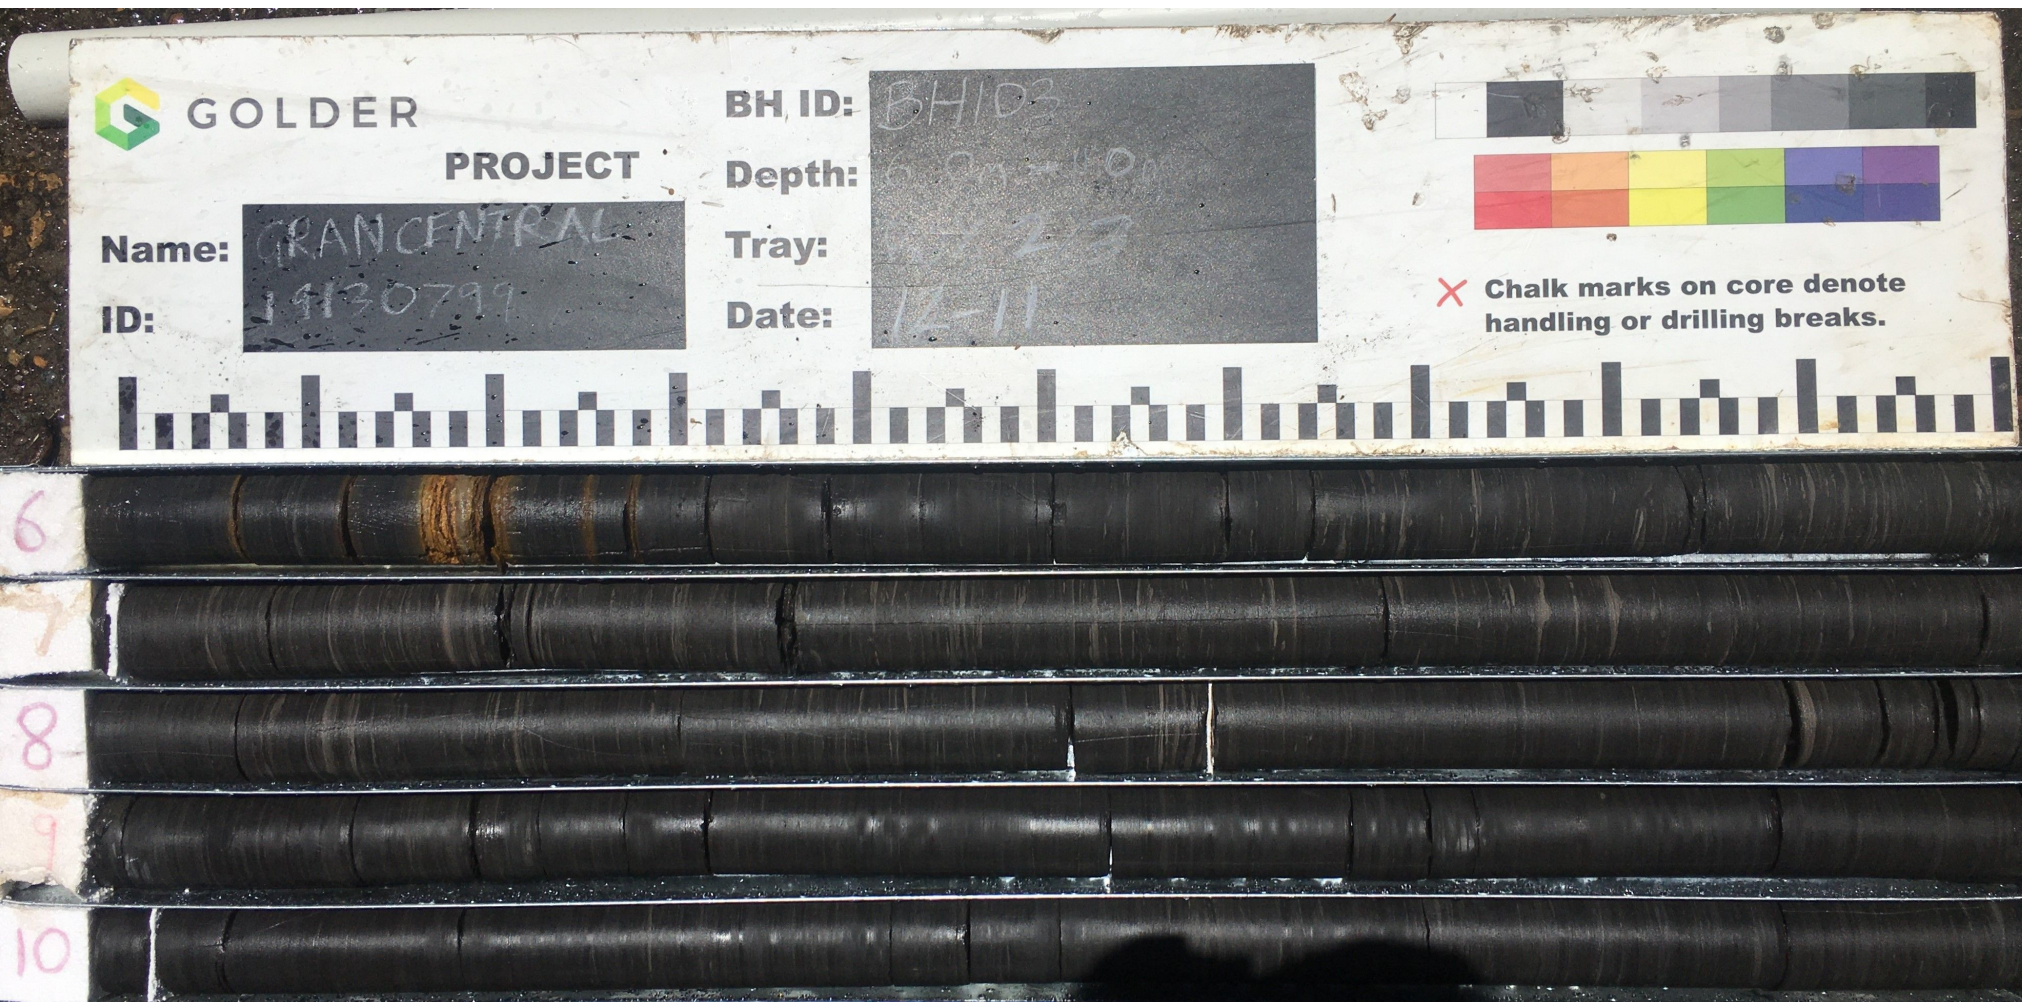
SHEET: 2 OF 3  
DRILL RIG: Komatsu 05  
CONTRACTOR: Nealings  
LOGGED: CW DATE: 12/11/19  
CHECKED: BC DATE: 18/11/19

This report of core photographs must be read in conjunction with accompanying notes and abbreviations.

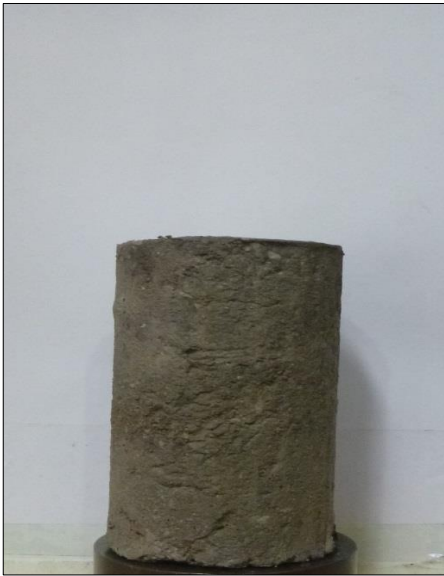
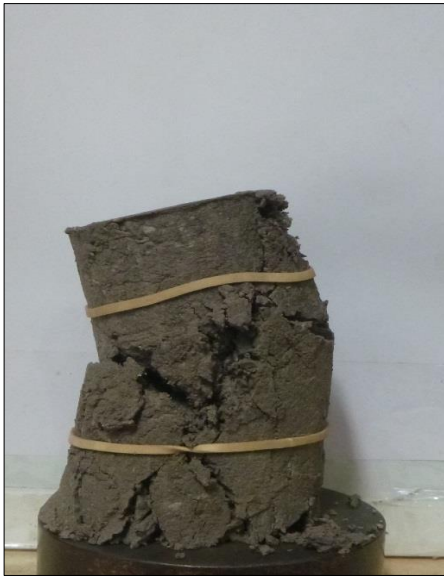
| Uniaxial Compressive Strength | | | |
|---|---|---|---|
| <b>Uniaxial Compressive Strength      0.14      MPa</b> | | | |
| Date Tested: | 2/12/2019 | Moisture Content: | 16.3 % |

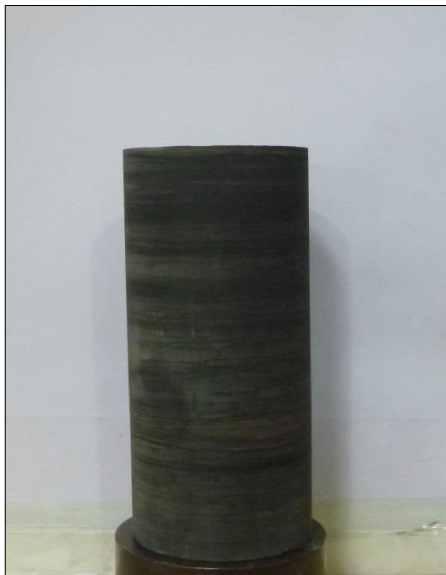
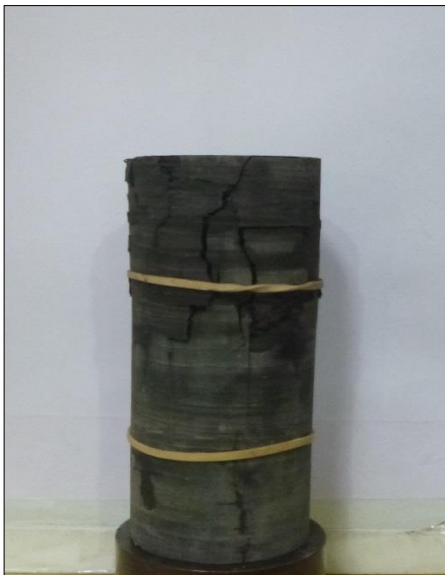
| Uniaxial Compressive Strength | | | |
|---|---|---|---|
| <b>Uniaxial Compressive Strength      9.5      MPa</b> | | | |
| Date Tested: | 2/12/2019 | Moisture Content: | 3.4 % |

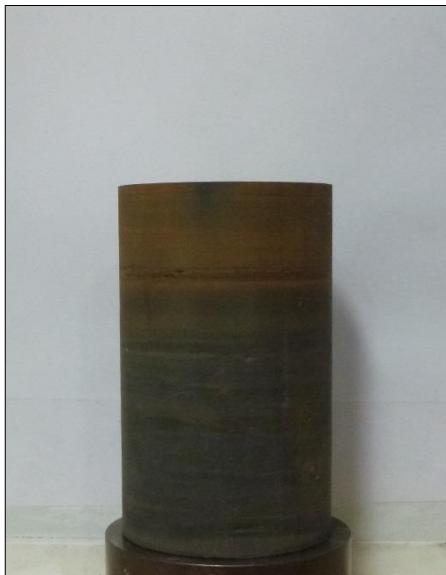
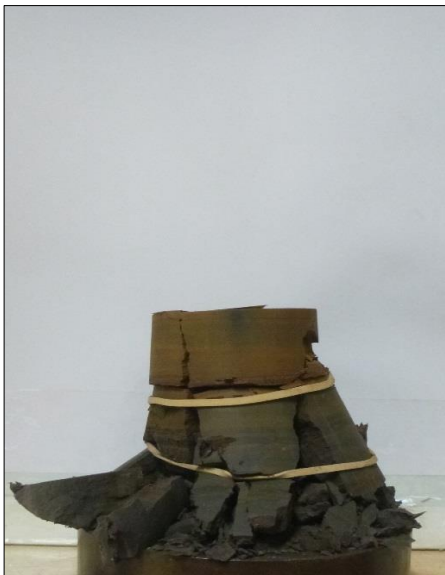
| Uniaxial Compressive Strength | | | |
|---|---|---|---|
| <b>Uniaxial Compressive Strength      0.19      MPa</b> | | | |
| Date Tested: | 2/12/2019 | Moisture Content: | 11.8 % |

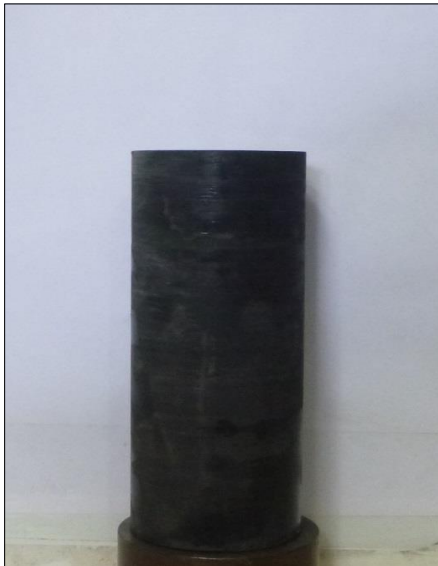
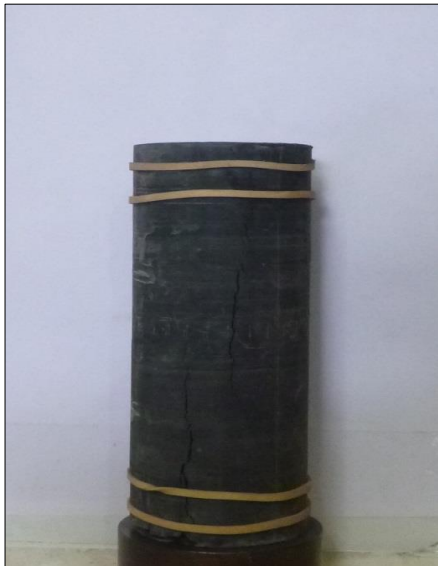
| Deformability of Rock Materials in Uniaxial Compression | | | |
|---|---|---|---|
| <b>Mode of Failure</b> | Tensile dominated | | |
| <b>Uniaxial Compressive Strength</b> | | <b>11</b> | <b>MPa</b> |

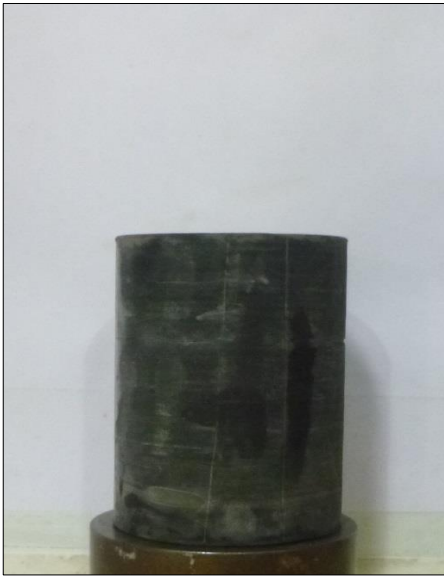
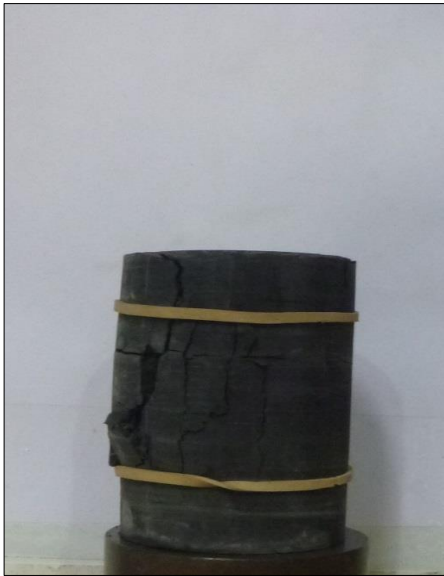
| Uniaxial Compressive Strength | | | |
|---|---|---|---|
| <b>Uniaxial Compressive Strength      13      MPa</b> | | | |

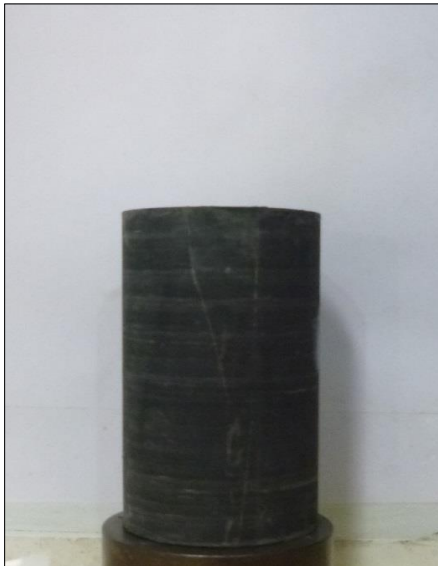
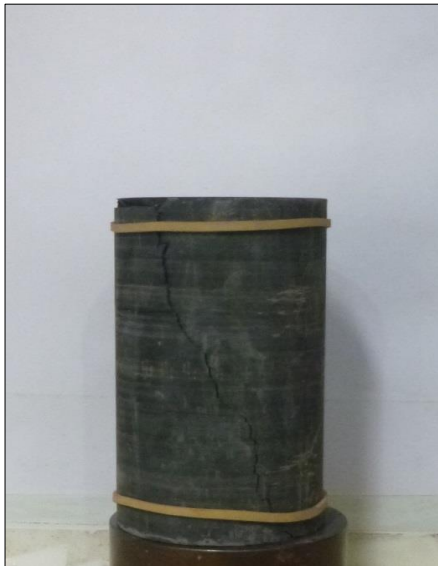
| Deformability of Rock Materials in Uniaxial Compression | | | |
|---|---|---|---|
| Mode of Failure | Tensile dominated | | |
| <div style="display: flex; justify-content: space-around;"> </div> <div style="display: flex; justify-content: space-around; margin-top: 5px;"> <span>Before Test</span> <span>After Test</span> </div> <p style="color: red; margin-top: 10px;">Test specimen length to diameter ratio falls outside of standard limitations of 2.5-3.0.</p> | | | |
| <b>Uniaxial Compressive Strength</b> | | <b>11.0 MPa</b> | |

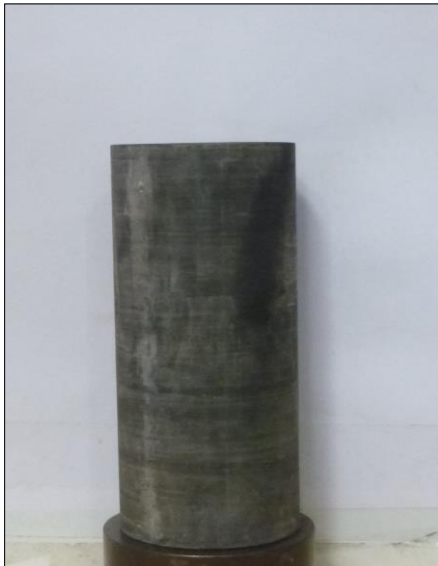
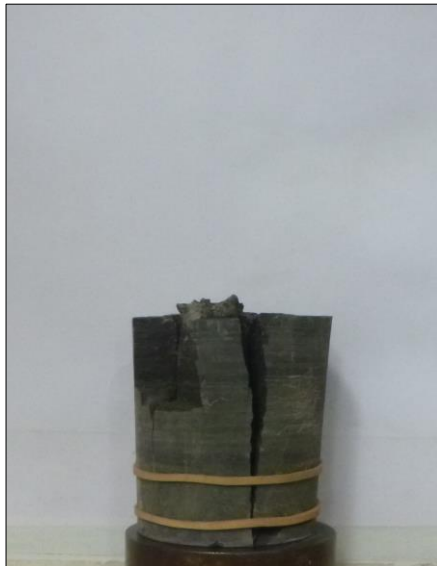
| Deformability of Rock Materials in Uniaxial Compression | | | |
|---|---|---|---|
| <b>Mode of Failure</b> | Tensile dominated | | |
| <div style="display: flex; justify-content: space-around; align-items: center;"> <div style="text-align: center;"> <p>Before Test</p> </div> <div style="text-align: center;"> <p>After Test</p> </div> </div> | | | |
| <b>Uniaxial Compressive Strength</b> | | <b>11</b> | <b>MPa</b> |

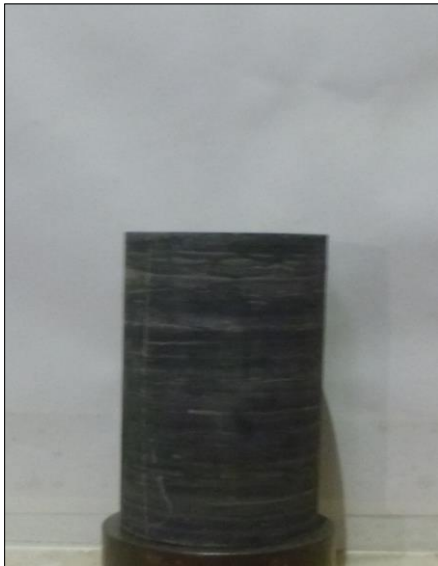
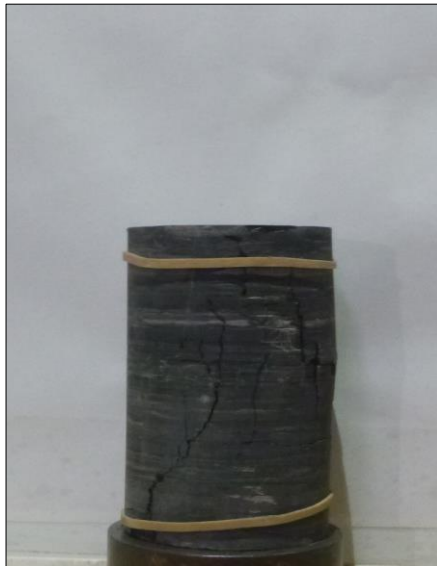
| Deformability of Rock Materials in Uniaxial Compression | | | |
|---|---|---|---|
| <div style="display: flex; justify-content: space-around;"> </div> <div style="display: flex; justify-content: space-around;"> <p>Before Test</p> <p>After Test</p> </div> | | | |
| Test specimen length to diameter ratio falls outside of standard limitations of 2.5-3.0. | | | |
| Uniaxial Compressive Strength | | 21.0 | MPa |
