Report on Geotechnical Investigation

Proposed Mixed-Use Development 2-6 Cavil Avenue, Ashfield

> > Project 99573.00 November 2020

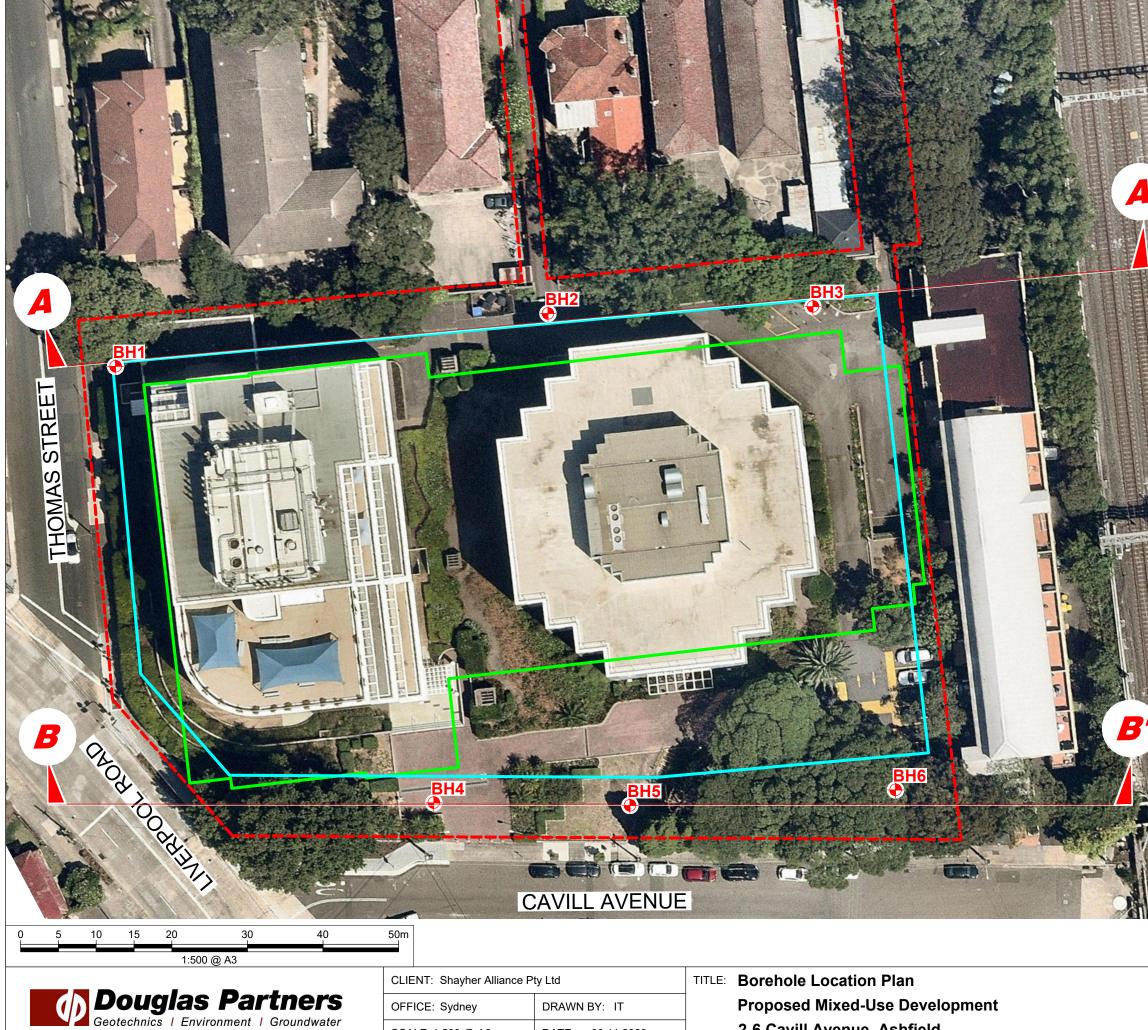
PROJECT No: 99573.00 DRAWING No: 1 **REVISION:** 1

LIENT: Shayher Alliance Pty Ltd							
FFICE: Sydney	DRAWN BY: IT						
CALE: 1:500 @ A3	DATE: 30.11.2020

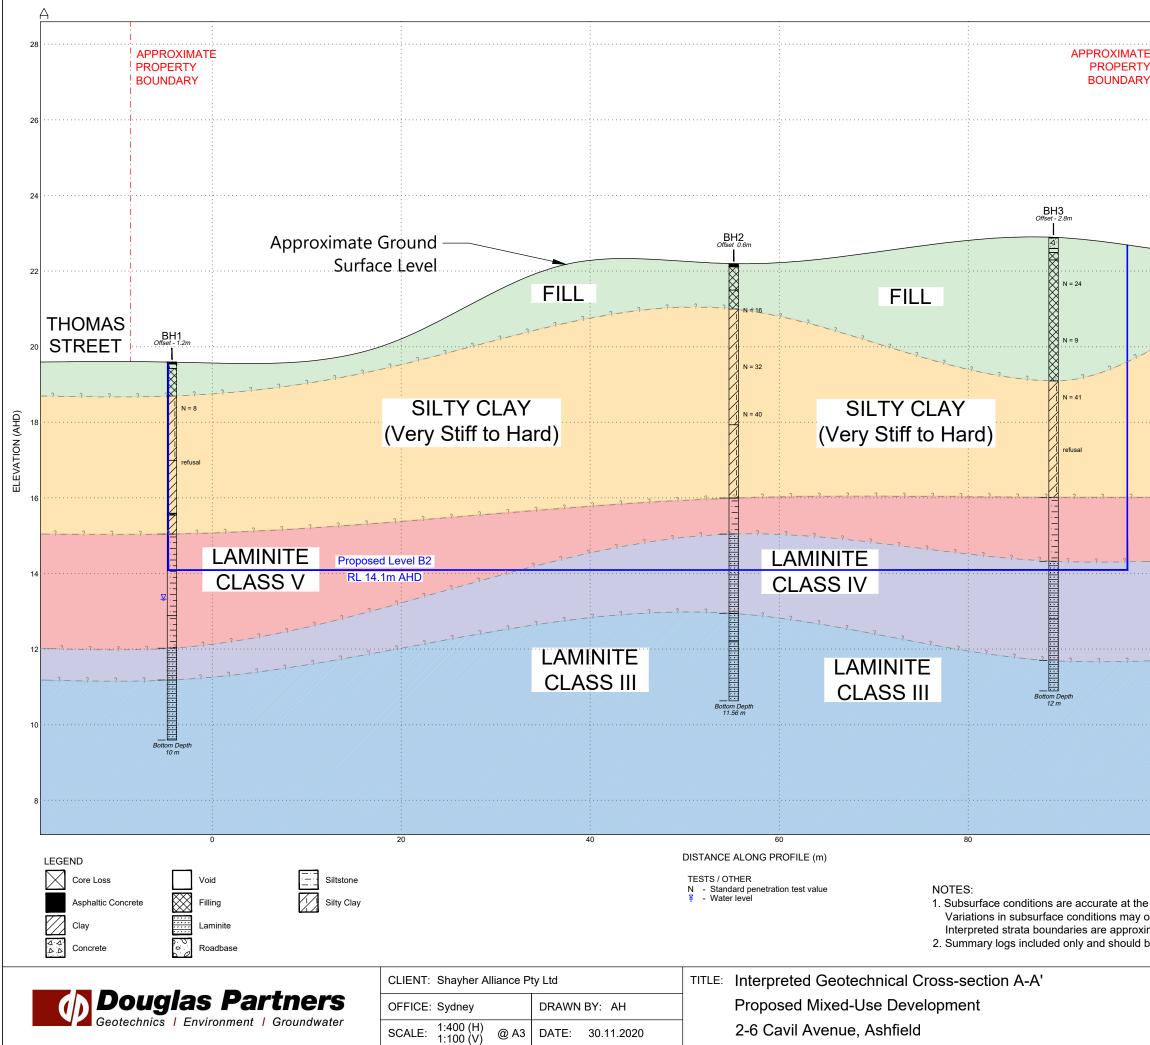
Α΄
	RAILWAY CORIDOOR
	26
	24
No. 10 CAVIL	22
	20
	14
100	8
e borehole locations only. occur between borehole locations. mate and should be used as a guide be read in conjunction with detailed lo	0 8 Horizontal Scale (metres) only. Ogs. Vertical Exaggeration = 4.0
	PROJECT No: 99573.00
	DRAWING No: 2
	REVISION: 1

It should be noted that the interpreted boundaries shown on the sections are accurate at the borehole locations only and layers shown diagrammatically on these drawings are based on inferred strata boundaries. Reference should be made to the borehole logs for more detailed information and descriptions of the soil and rock.
