Monterey Equity Pty Ltd C/- Centurion Group

Acid Sulfate Soil Assessment: 119 Barton Street, Monterey, NSW

P1706332JR03V02 February 2021

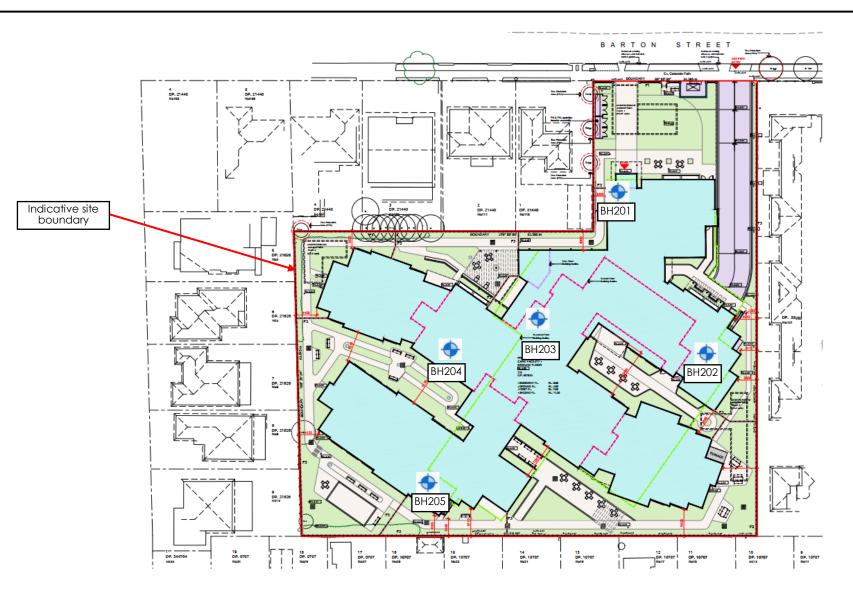
Approximate borehole test location

Martens & Associates Pty Ltd ABN 85	070 240 890	Environment Water Wastewater Geotechnical Civil Management							
Drawn:	WX	Acid Sulfate Soils Testing Plan	Drawing No:						
Approved:	JF	119 Barton Road, Monetery, NSW	FIGURE 1						
Date:	11.02.2021	(Source: Centurion Group, 2020)							
Scale:	NA	· · · · · · · · · · · · · · · · · · ·	Project Number: P1706332JR03V01

Intrusive investigation of five boreholes to a maximum investigation depth of 5.7 mBGL revealed:

- Site soils consisting of:
 - Imported gravelly sand fill material in all boreholes, apart from BH201, up to 0.5 mBGL.
 - Yellow brown sands in all boreholes up to 4.8 mBGL.
 - Red brown sandy clay observed only in BH202 between 1.4 and 1.9 mBGLI.
 - Pale grey sand in BH201 to BH203 up to 5.7 mBGL.
- o Shells were observed at 5.0 mBGL in BH203 within pale grey sand.
- No sulfuric odours or mottled soils representative of ASS were encountered during the investigation.
- o Groundwater was encountered at 3.5 mBGL (approximately between 0.5 to 1.0 mAHD) during borehole drilling.

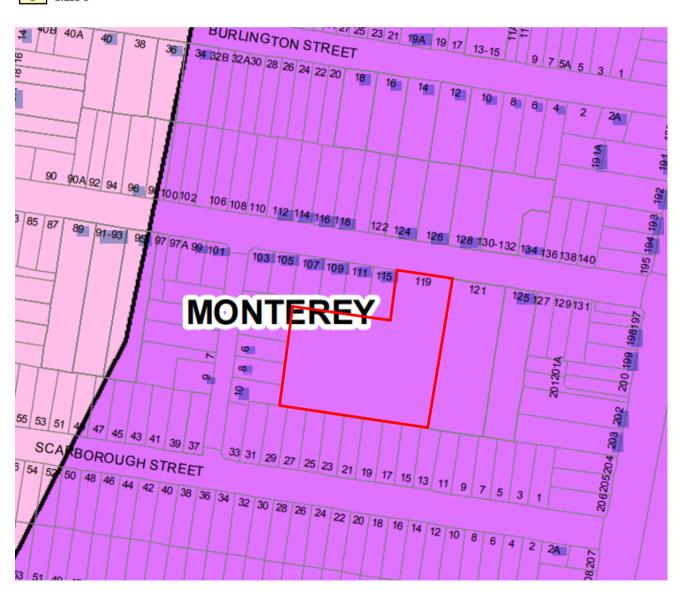
Acid Sulfate Soils

Indicative Site Boundary

Martens & Associates Pty	Ltd ABN 85 070 240 890	Environment Water Wastewater Geotechnical C	Civil Management
Drawn:	wx		Drawing No:
Approved:	JF	Rockdale LEP, 2011: ASS risk map, showing site relative to risk classes	FIGURE 2
Date:	11.02.2021	(Source: Rockdale LEP, 2011)	
Scale:	Not to Scale		File No: P1706332JR03V01

The Rockdale Local Environmental Plan (LEP) ASS risk map (2011) classifies the site as Class 4 land, as shown in Figure 2, Attachment A.

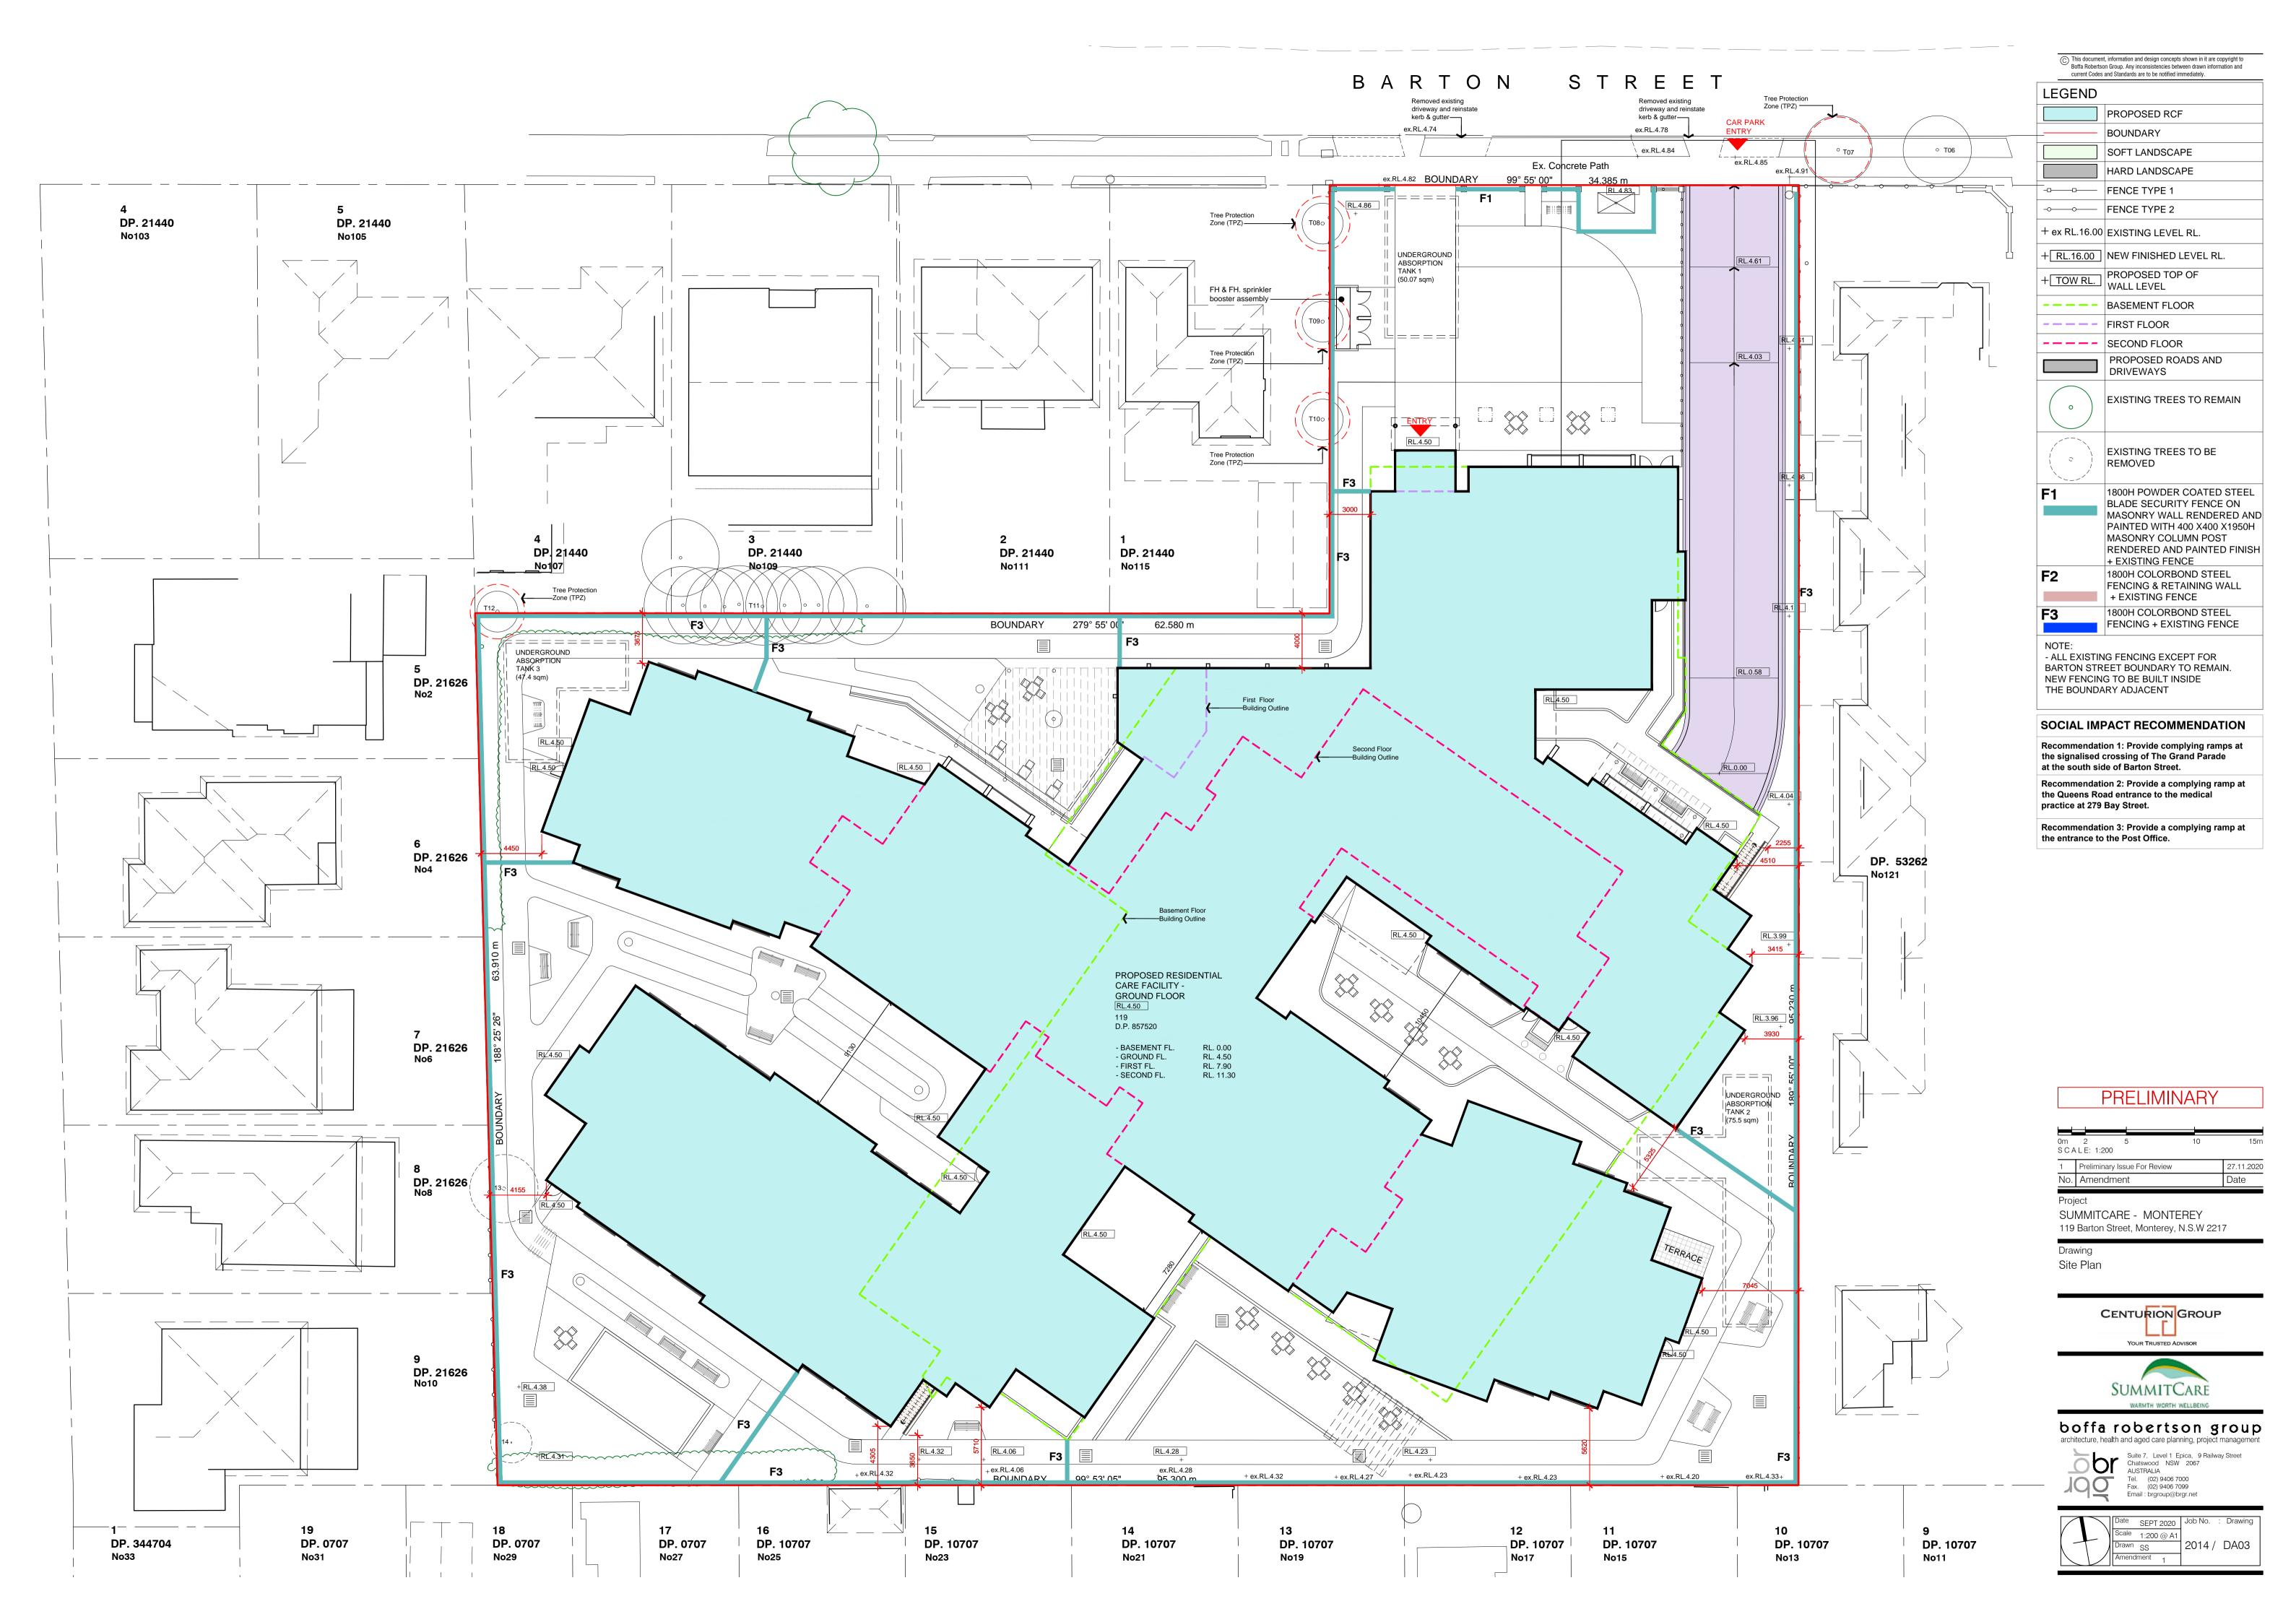
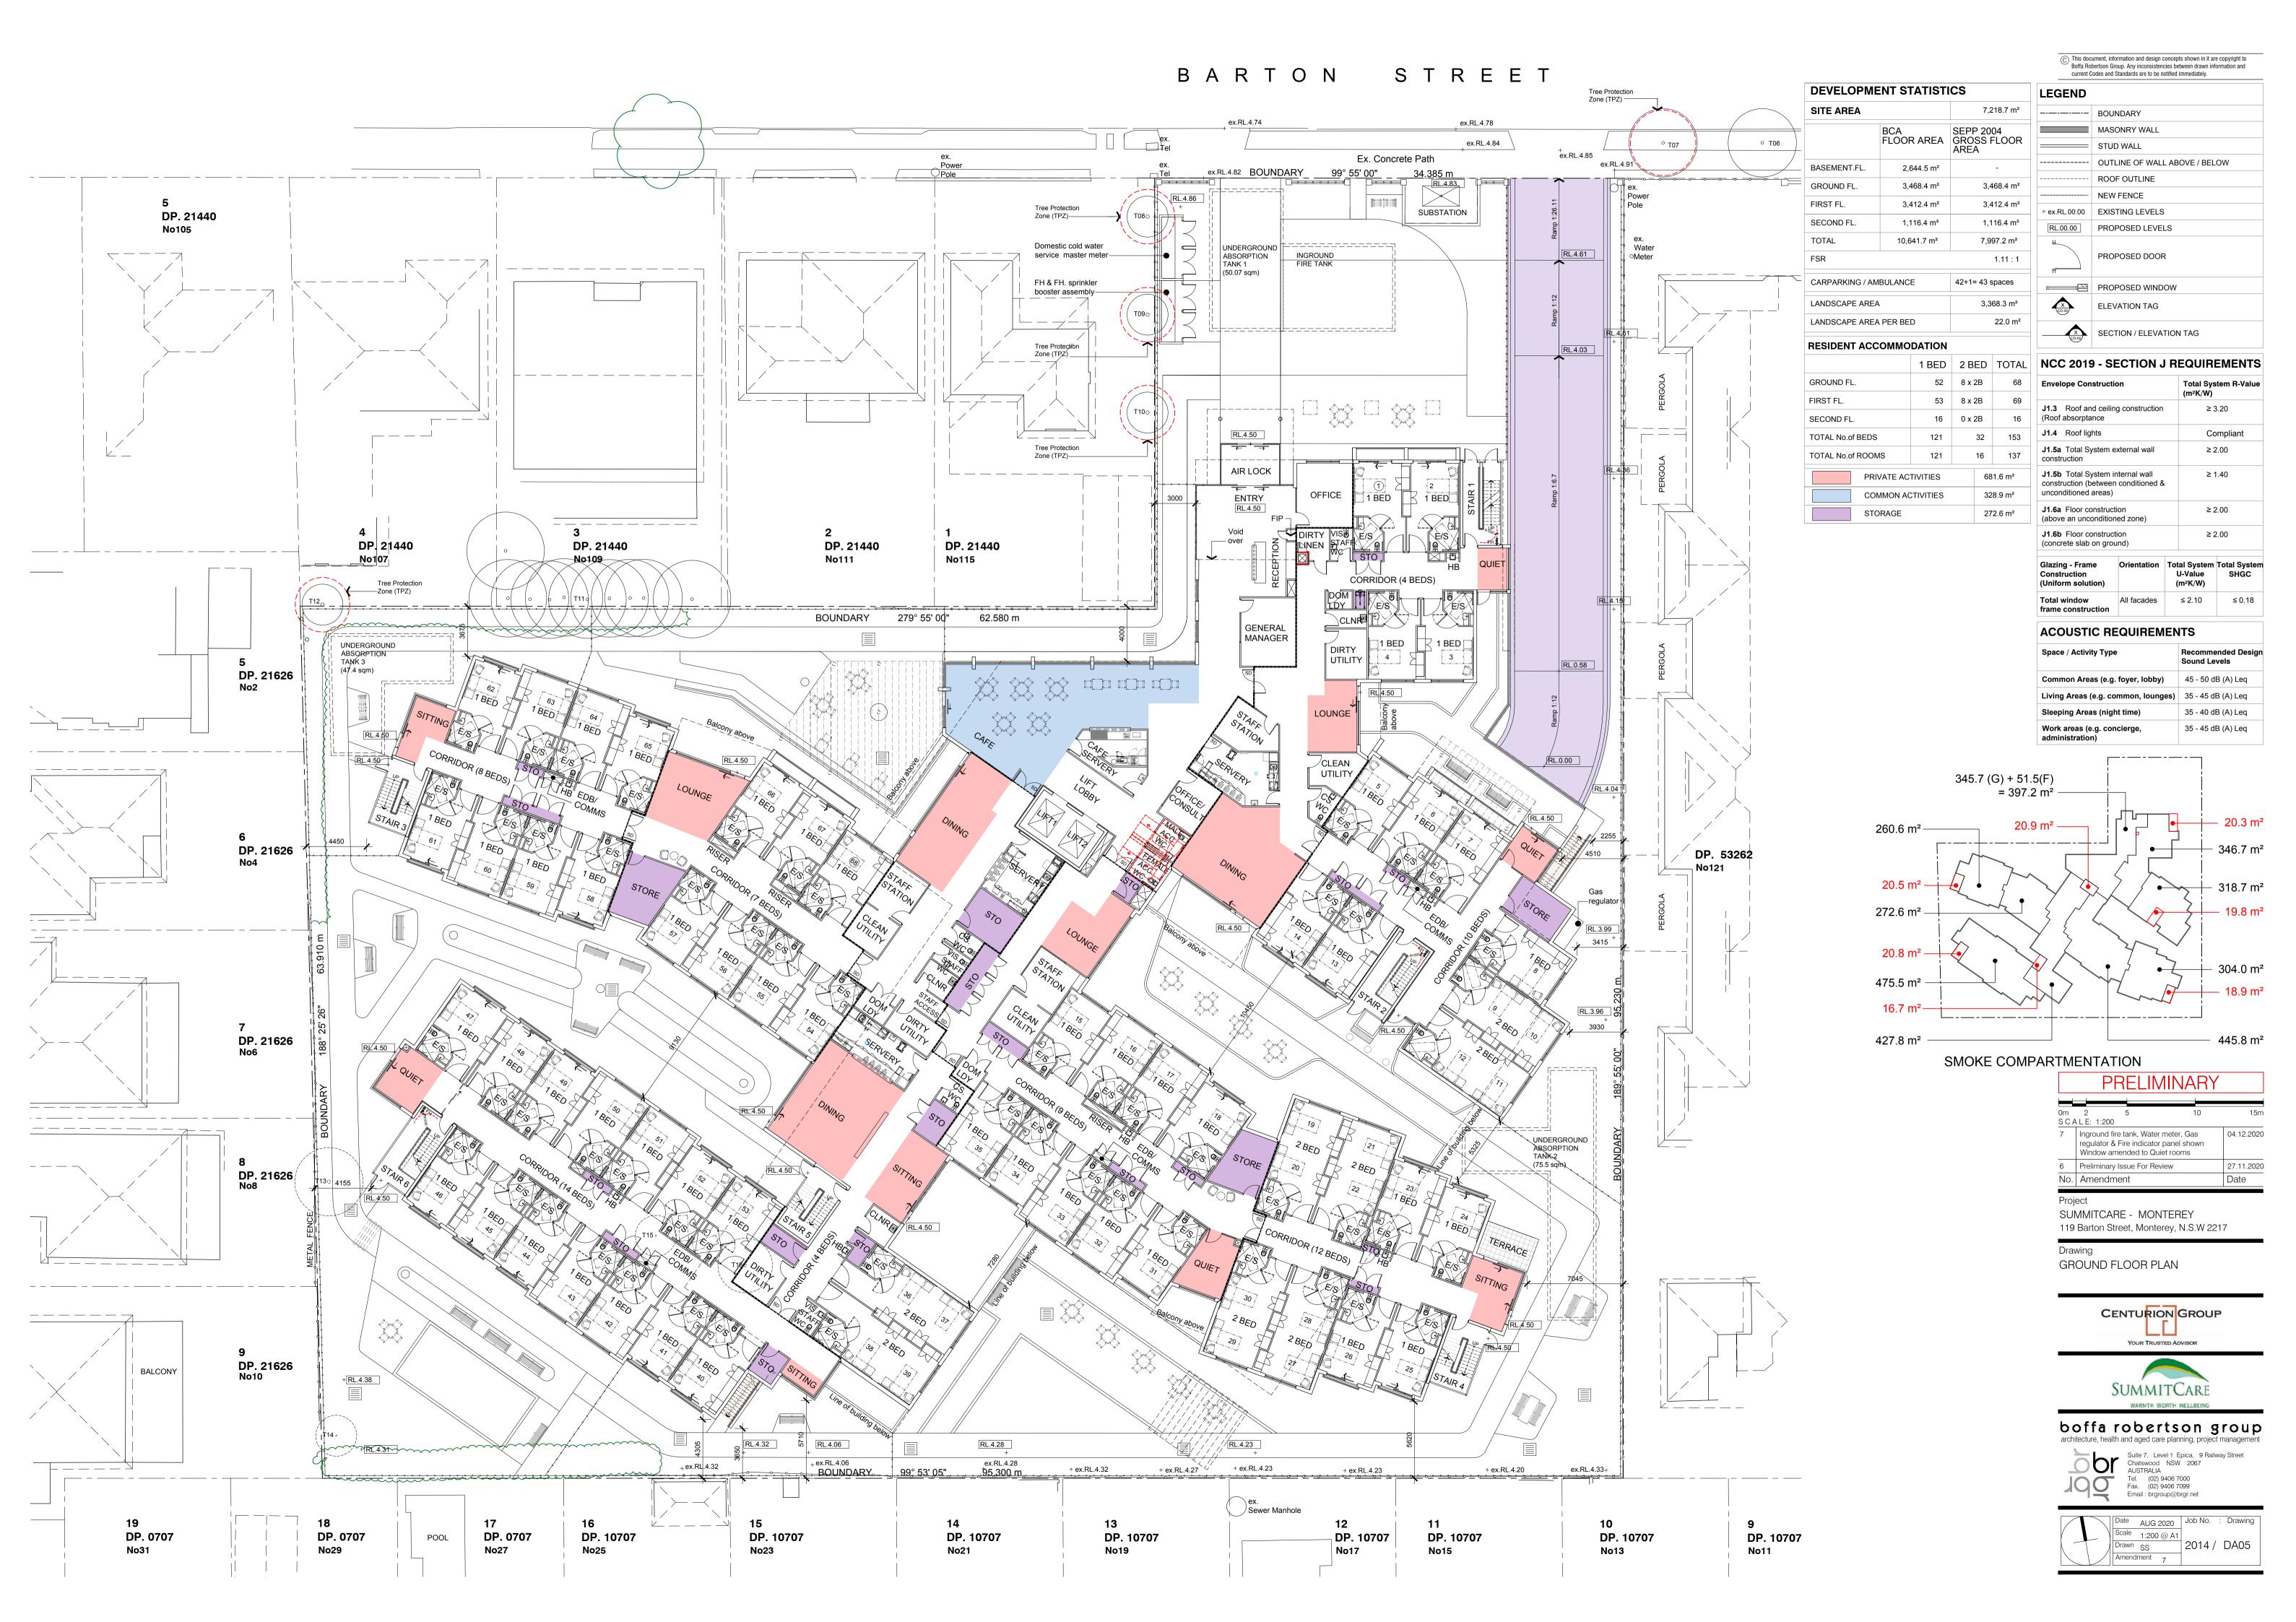
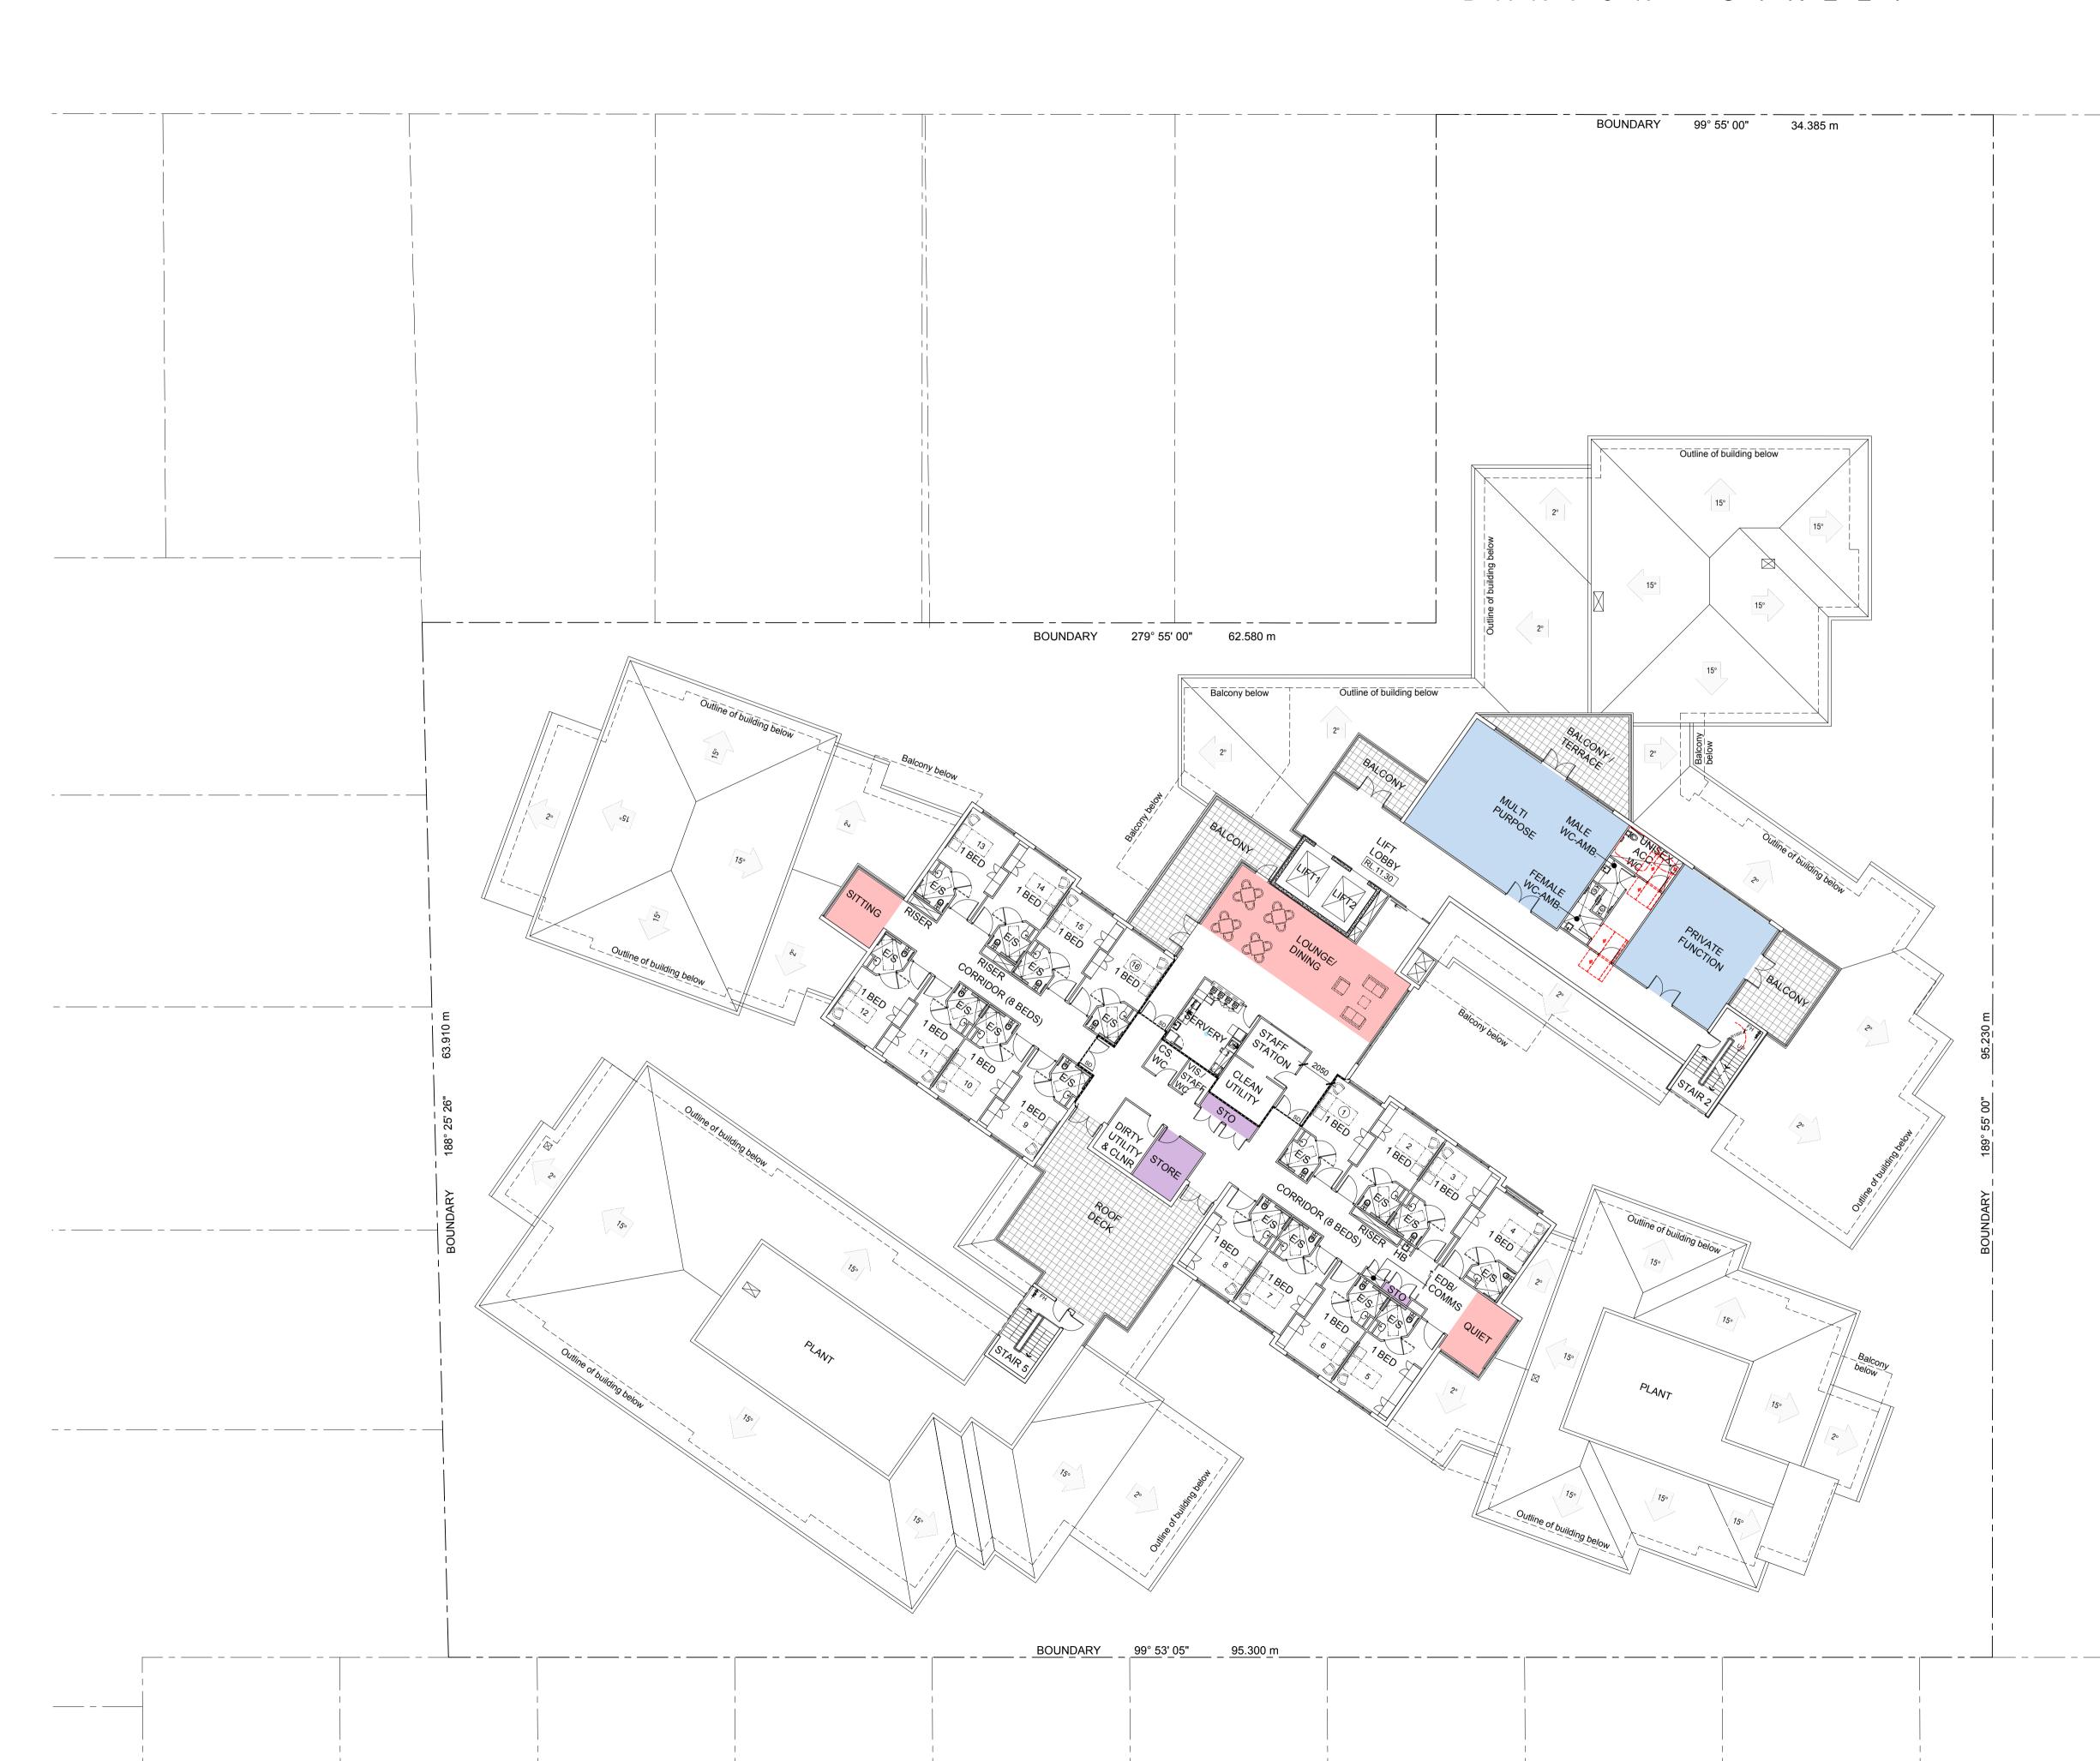
9 Attachment C – Proposed Development Plans

The proposed development (Centurion Group, 2020) will include:

- 1. Demolition of all existing structures at the site.
- 2. Construction of a three-story aged care facility with single level basement carpark which will require bulk excavation down to 0 mAHD.
- 3. Landscaped areas with deep soil planting around the perimeter of the proposed structure.

Proposed development plans are provided in Attachment C.
