Monterey Equity Pty Ltd

Contamination Assessment:  
Lot 2, DP857520,  
119 Barton Street, Monterey, NSW

P1706332JR01V01  
March 2018

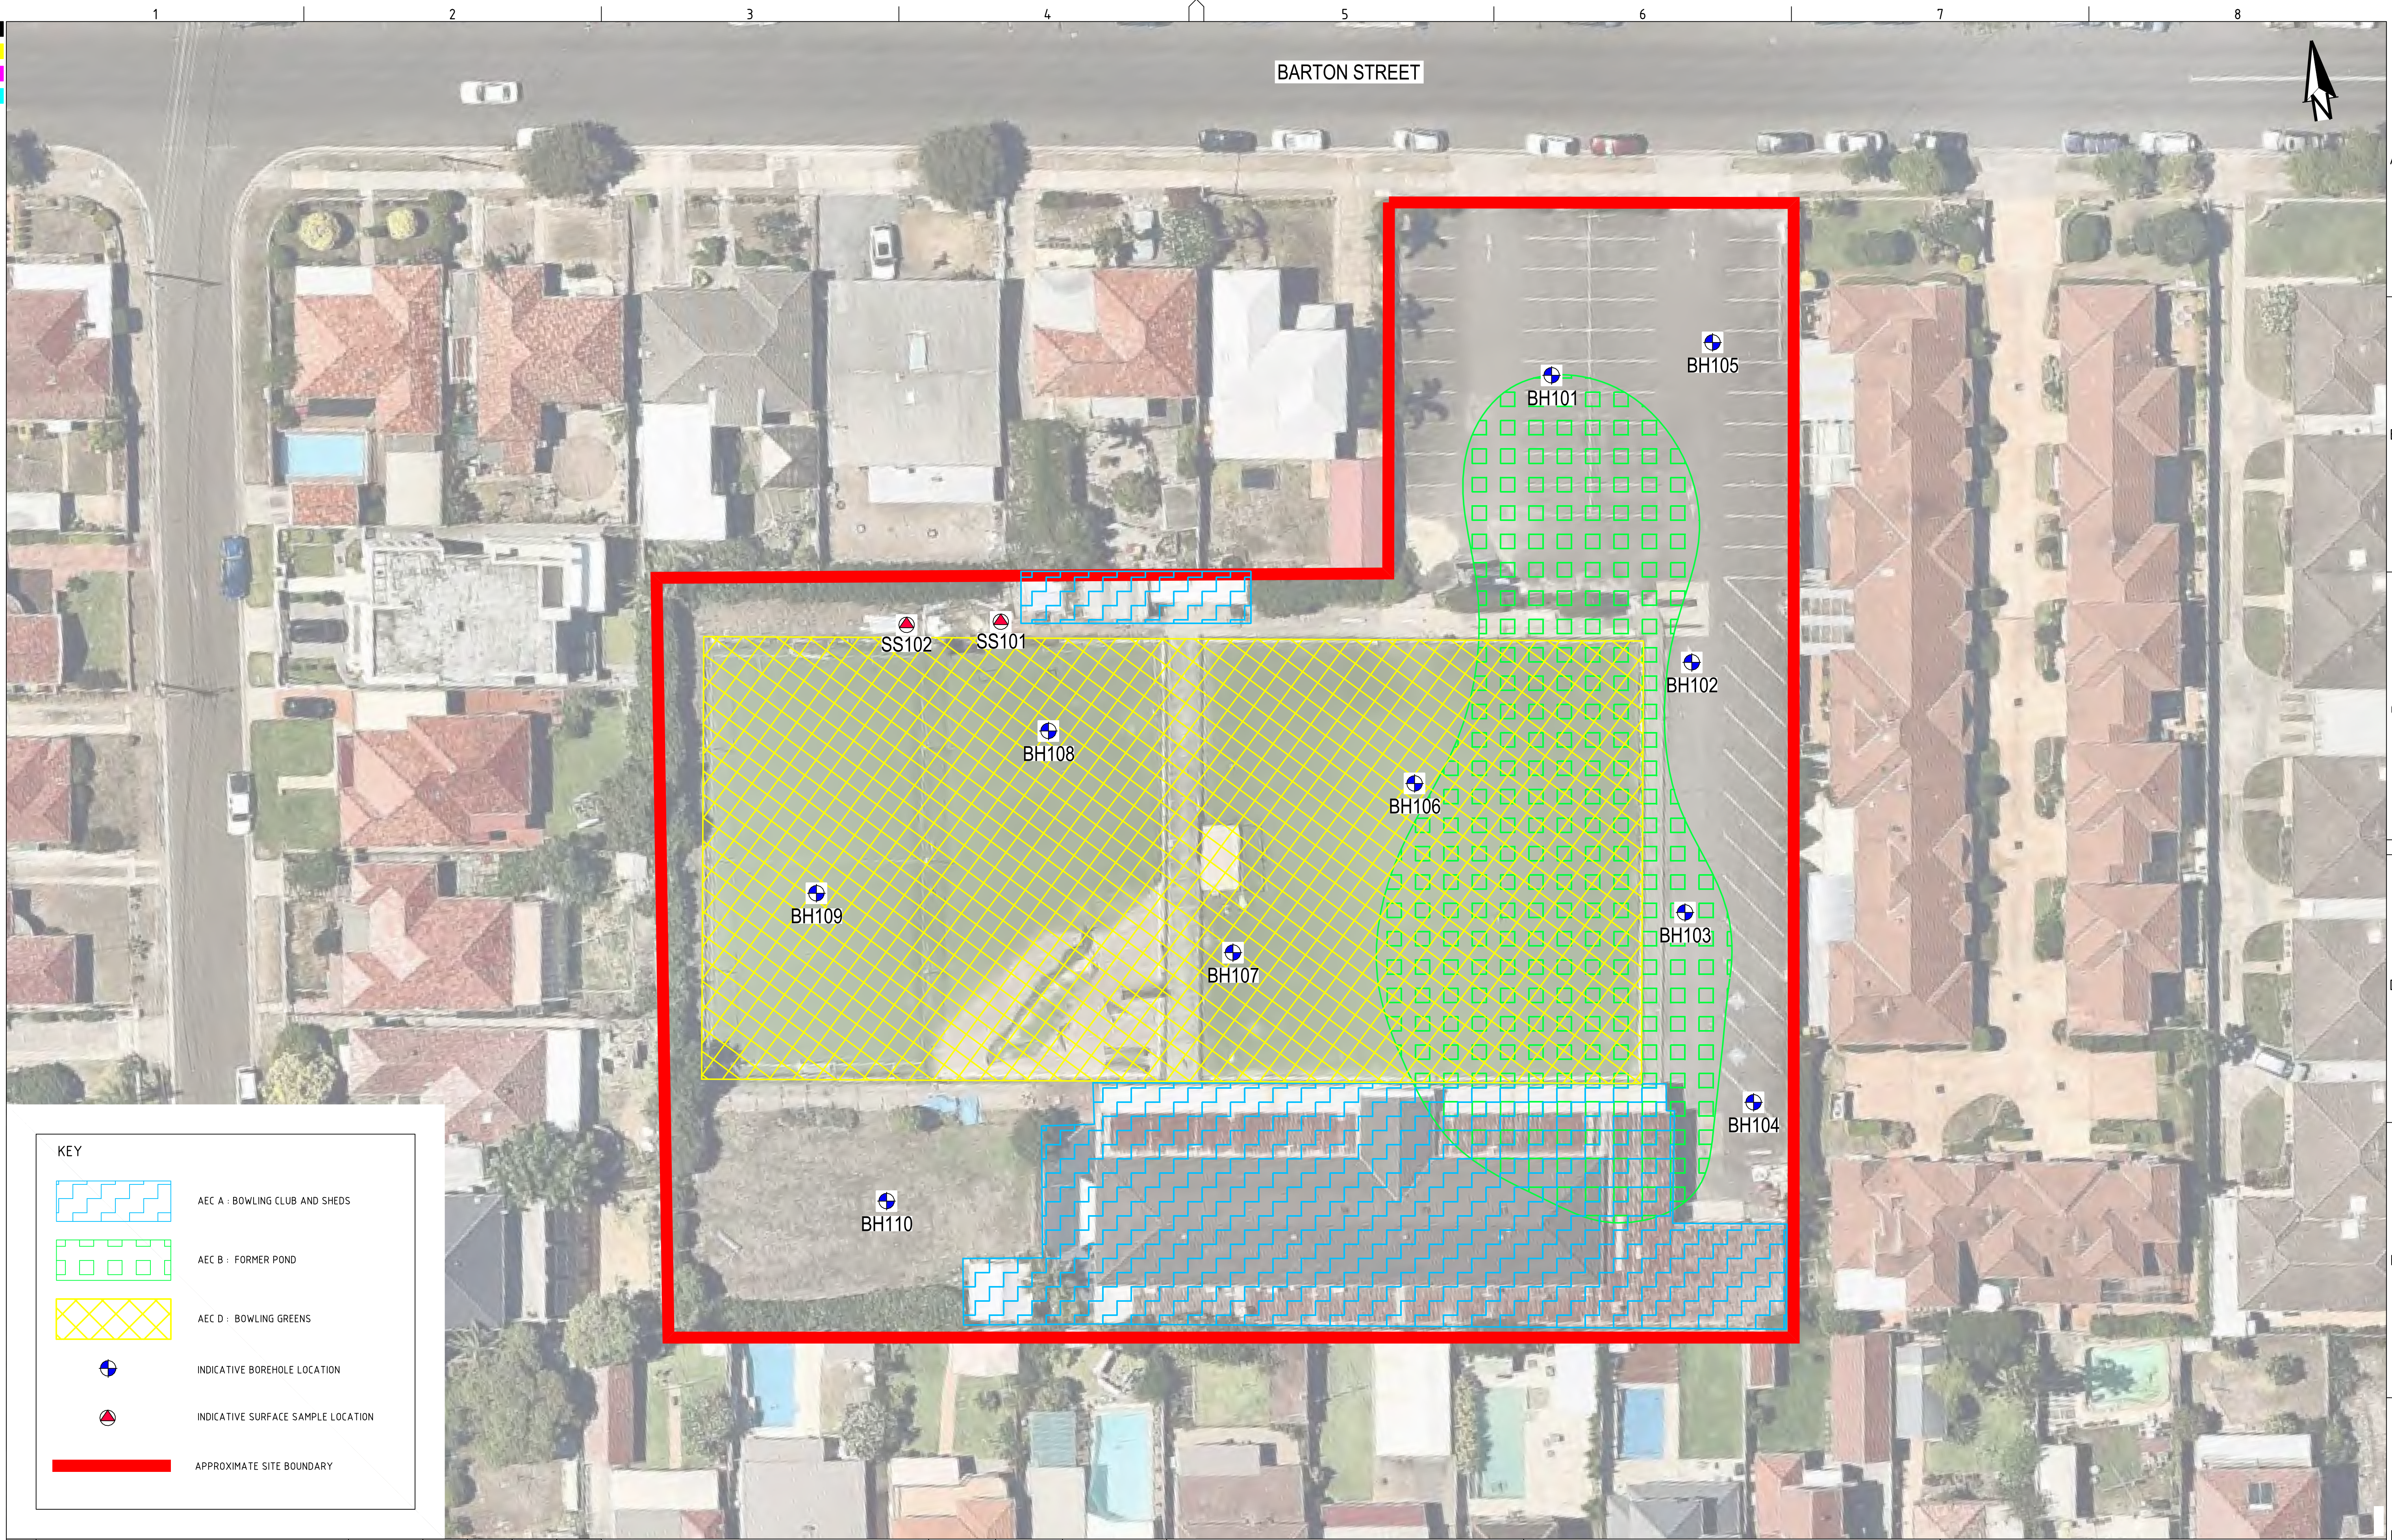
## 15      **Attachment D – Sampling Plan**

- AEC A: BOWLING CLUB AND SHEDS
- AEC B: FORMER POND
- AEC D: BOWLING GREENS
- INDICATIVE BOREHOLE LOCATION
- INDICATIVE SURFACE SAMPLE LOCATION
- APPROXIMATE SITE BOUNDARY
