Monterey Equity Pty Ltd
C/- Centurion Group

Remedial Action Plan: 119 Barton Road, Monterey, NSW

P1706332JR02V01
December 2020

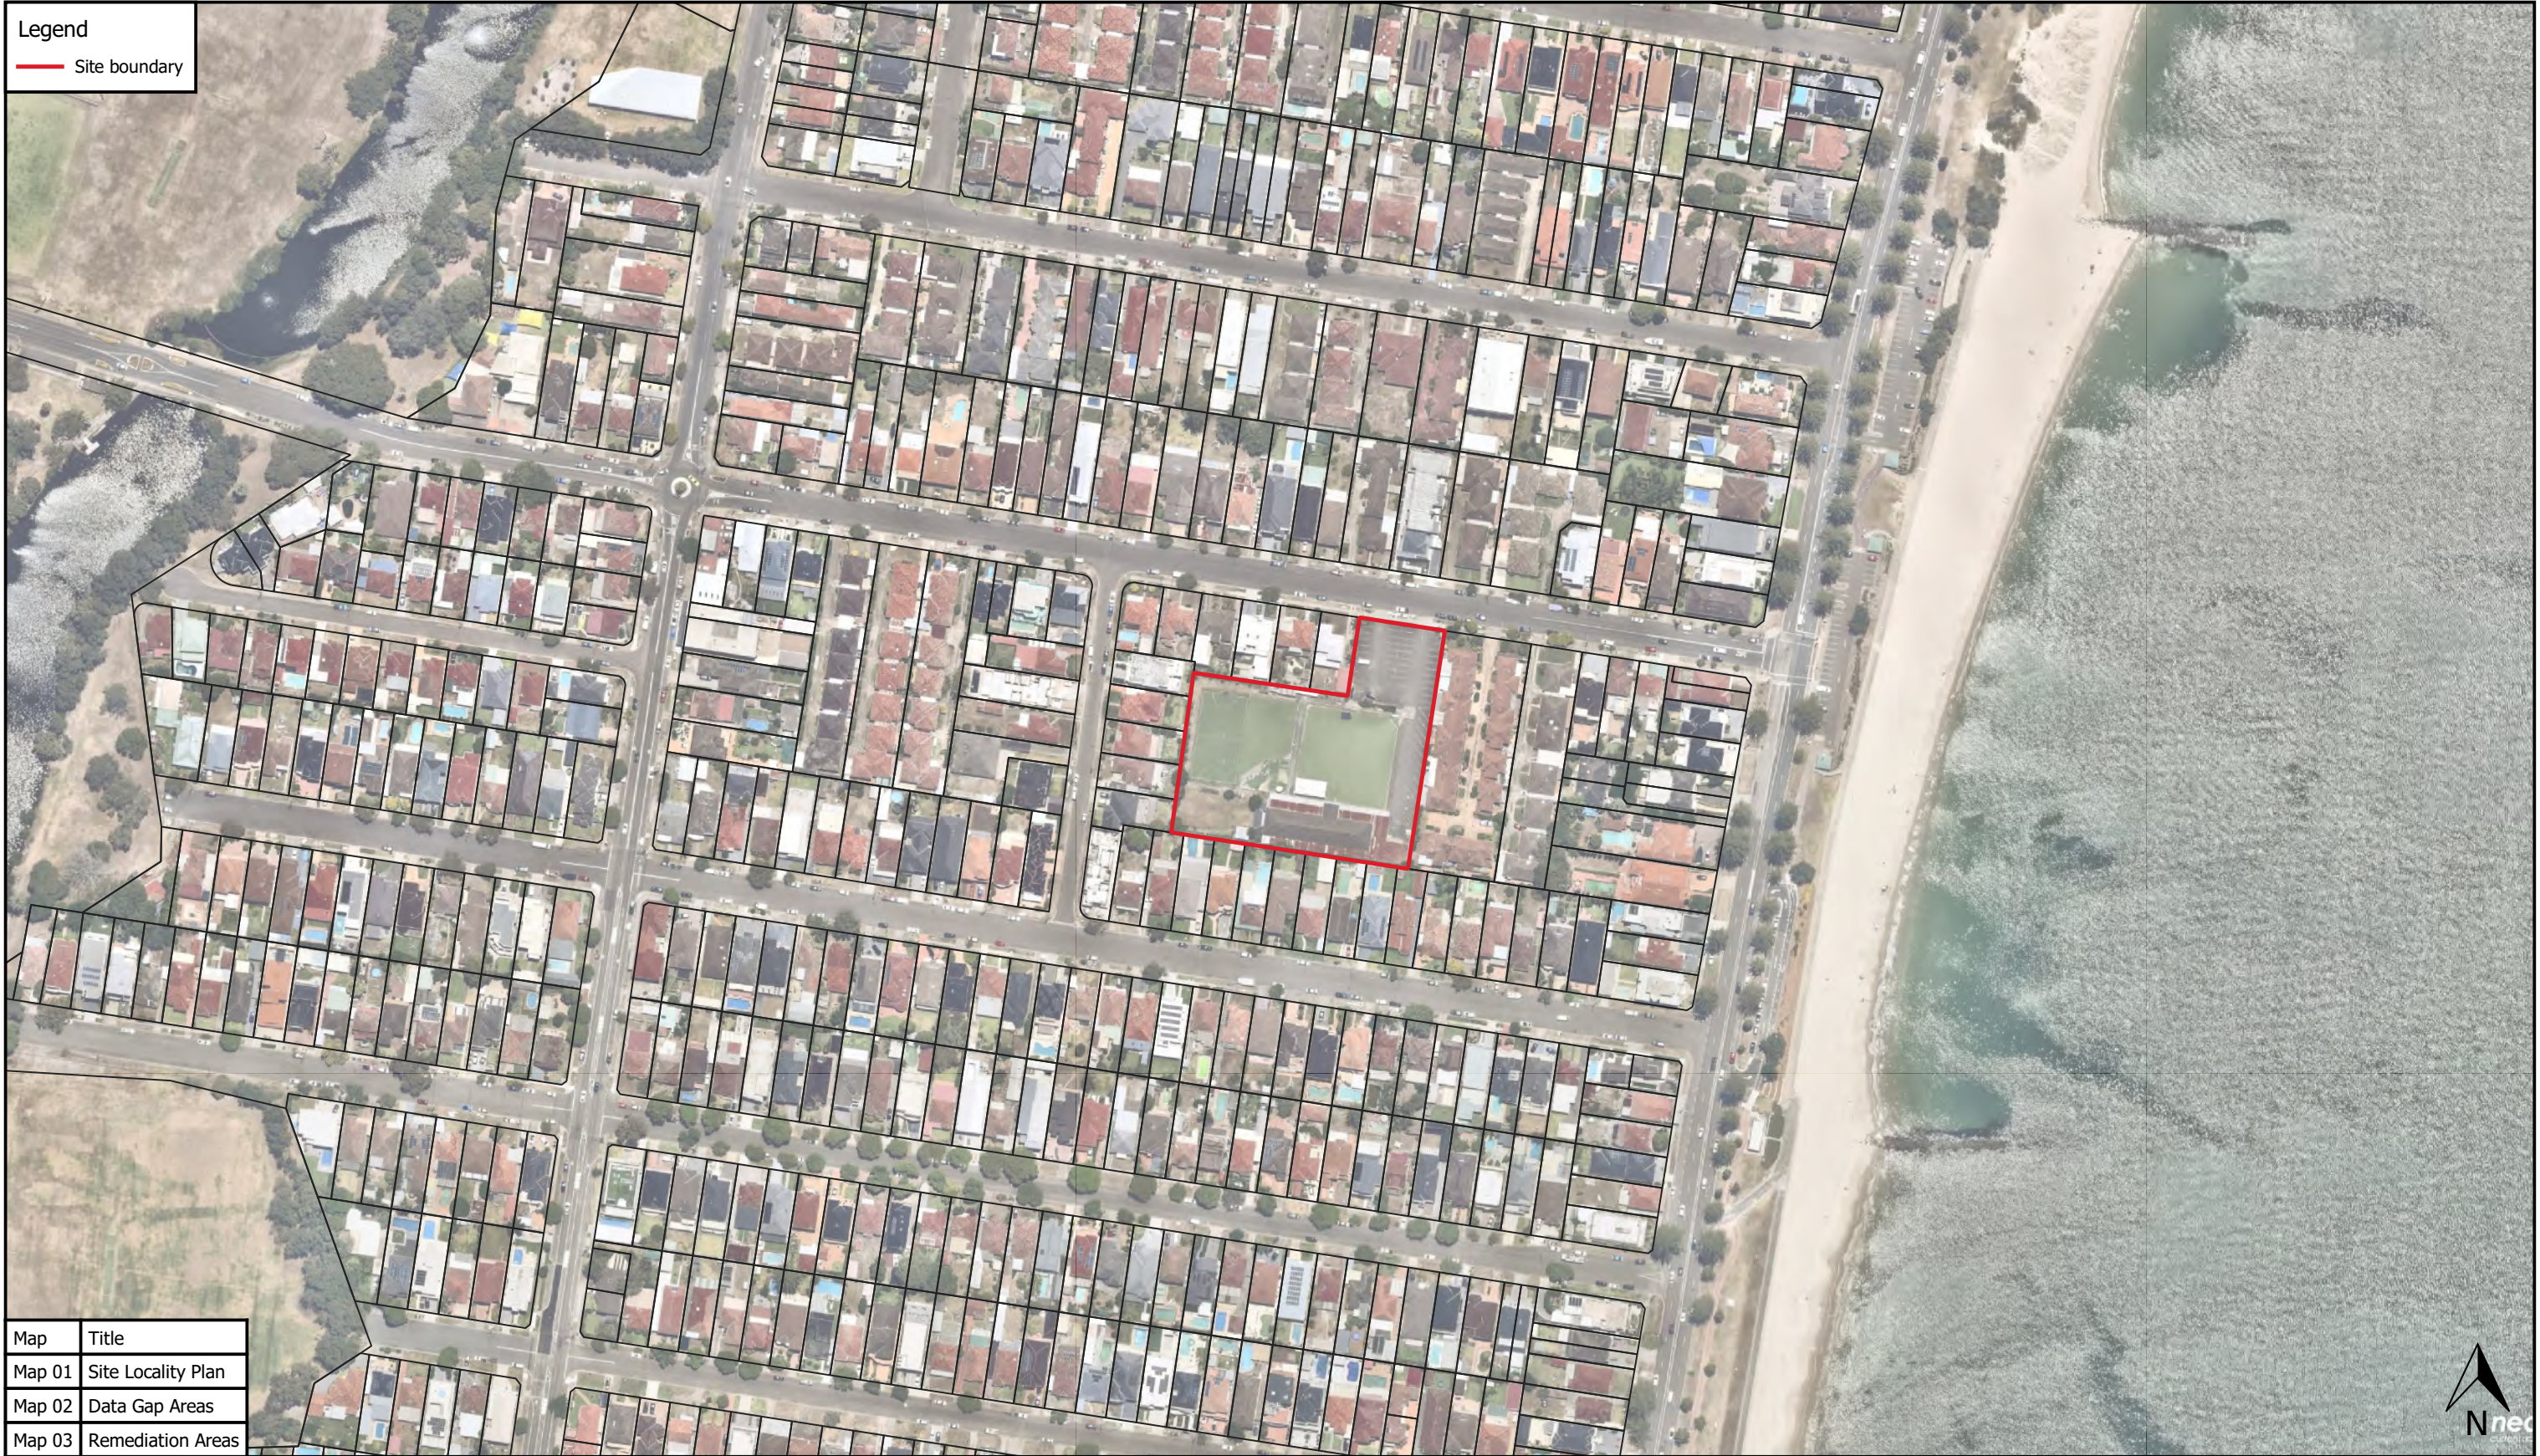
14 Attachment A – Site Plan

Site information is summarised in Table 1. The site and surrounds are shown in Attachment A.

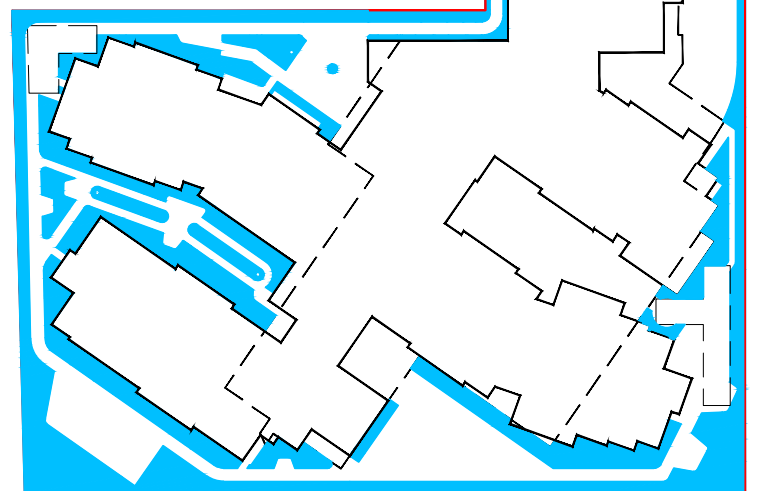
LANDSCAPE DEEP SOIL CALCULATION

DEEP SOIL AREA: 1,456.2 m²

¹ EIL and ESL only apply to landscaped areas with deep soil planting, as shown in the development plans in Attachment B.

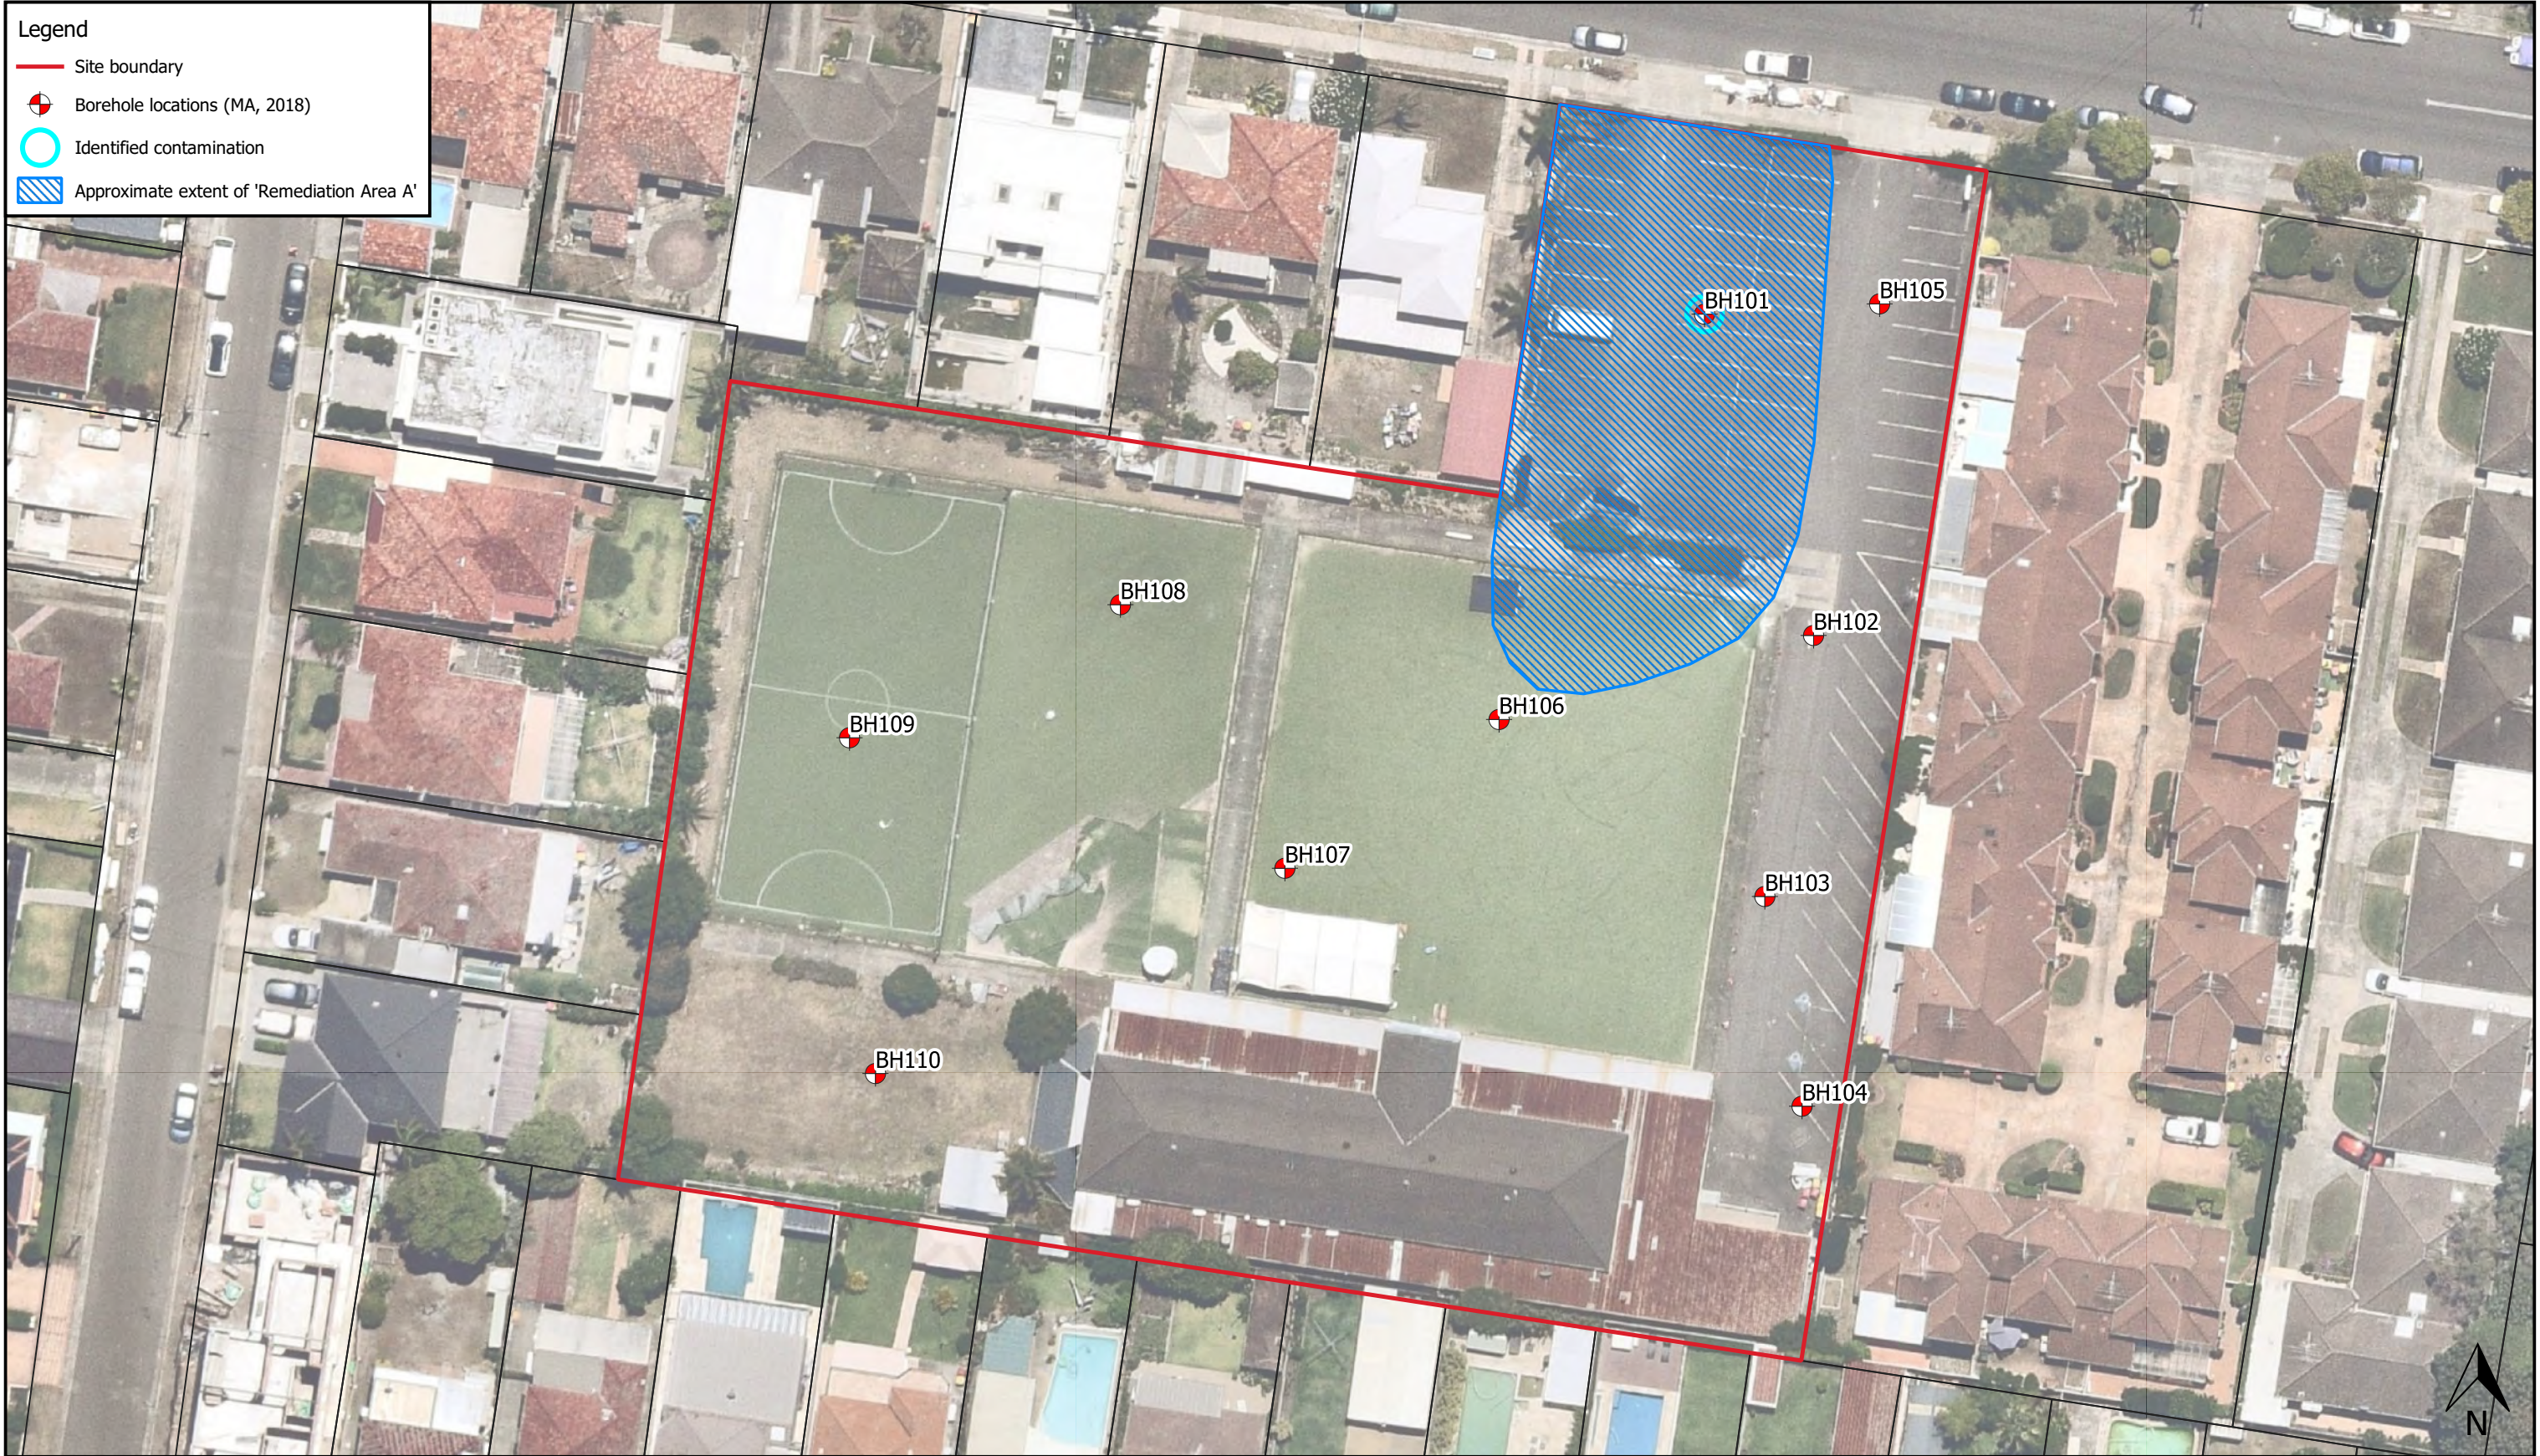
Identified contamination

Approximate extent of 'Remediation Area A'

Data gap locations and proposed sampling locations are shown in the site plan in Attachment C.

1. 'Remediation Area A' – Fill material in the vicinity of BH101.

'Remediation Area A' is mostly outside of the proposed basement footprint and subsequent bulk excavation extent. It is noted that fill material in this location was observed to a maximum depth of 1.9 mbgl. Natural sand material beneath the fill profile (at 2.0 mbgl) was sent for laboratory analysis and reported all contaminants as non-detect (TRH, BTEXN, PAH and pesticides) or indicative of background levels (heavy metals).
