Monterey Equity Pty Ltd

Supplementary Site Investigation:
Lot 2, DP857520,
119 Barton Street, Monterey, NSW

P1706332JR01V01
October 2021

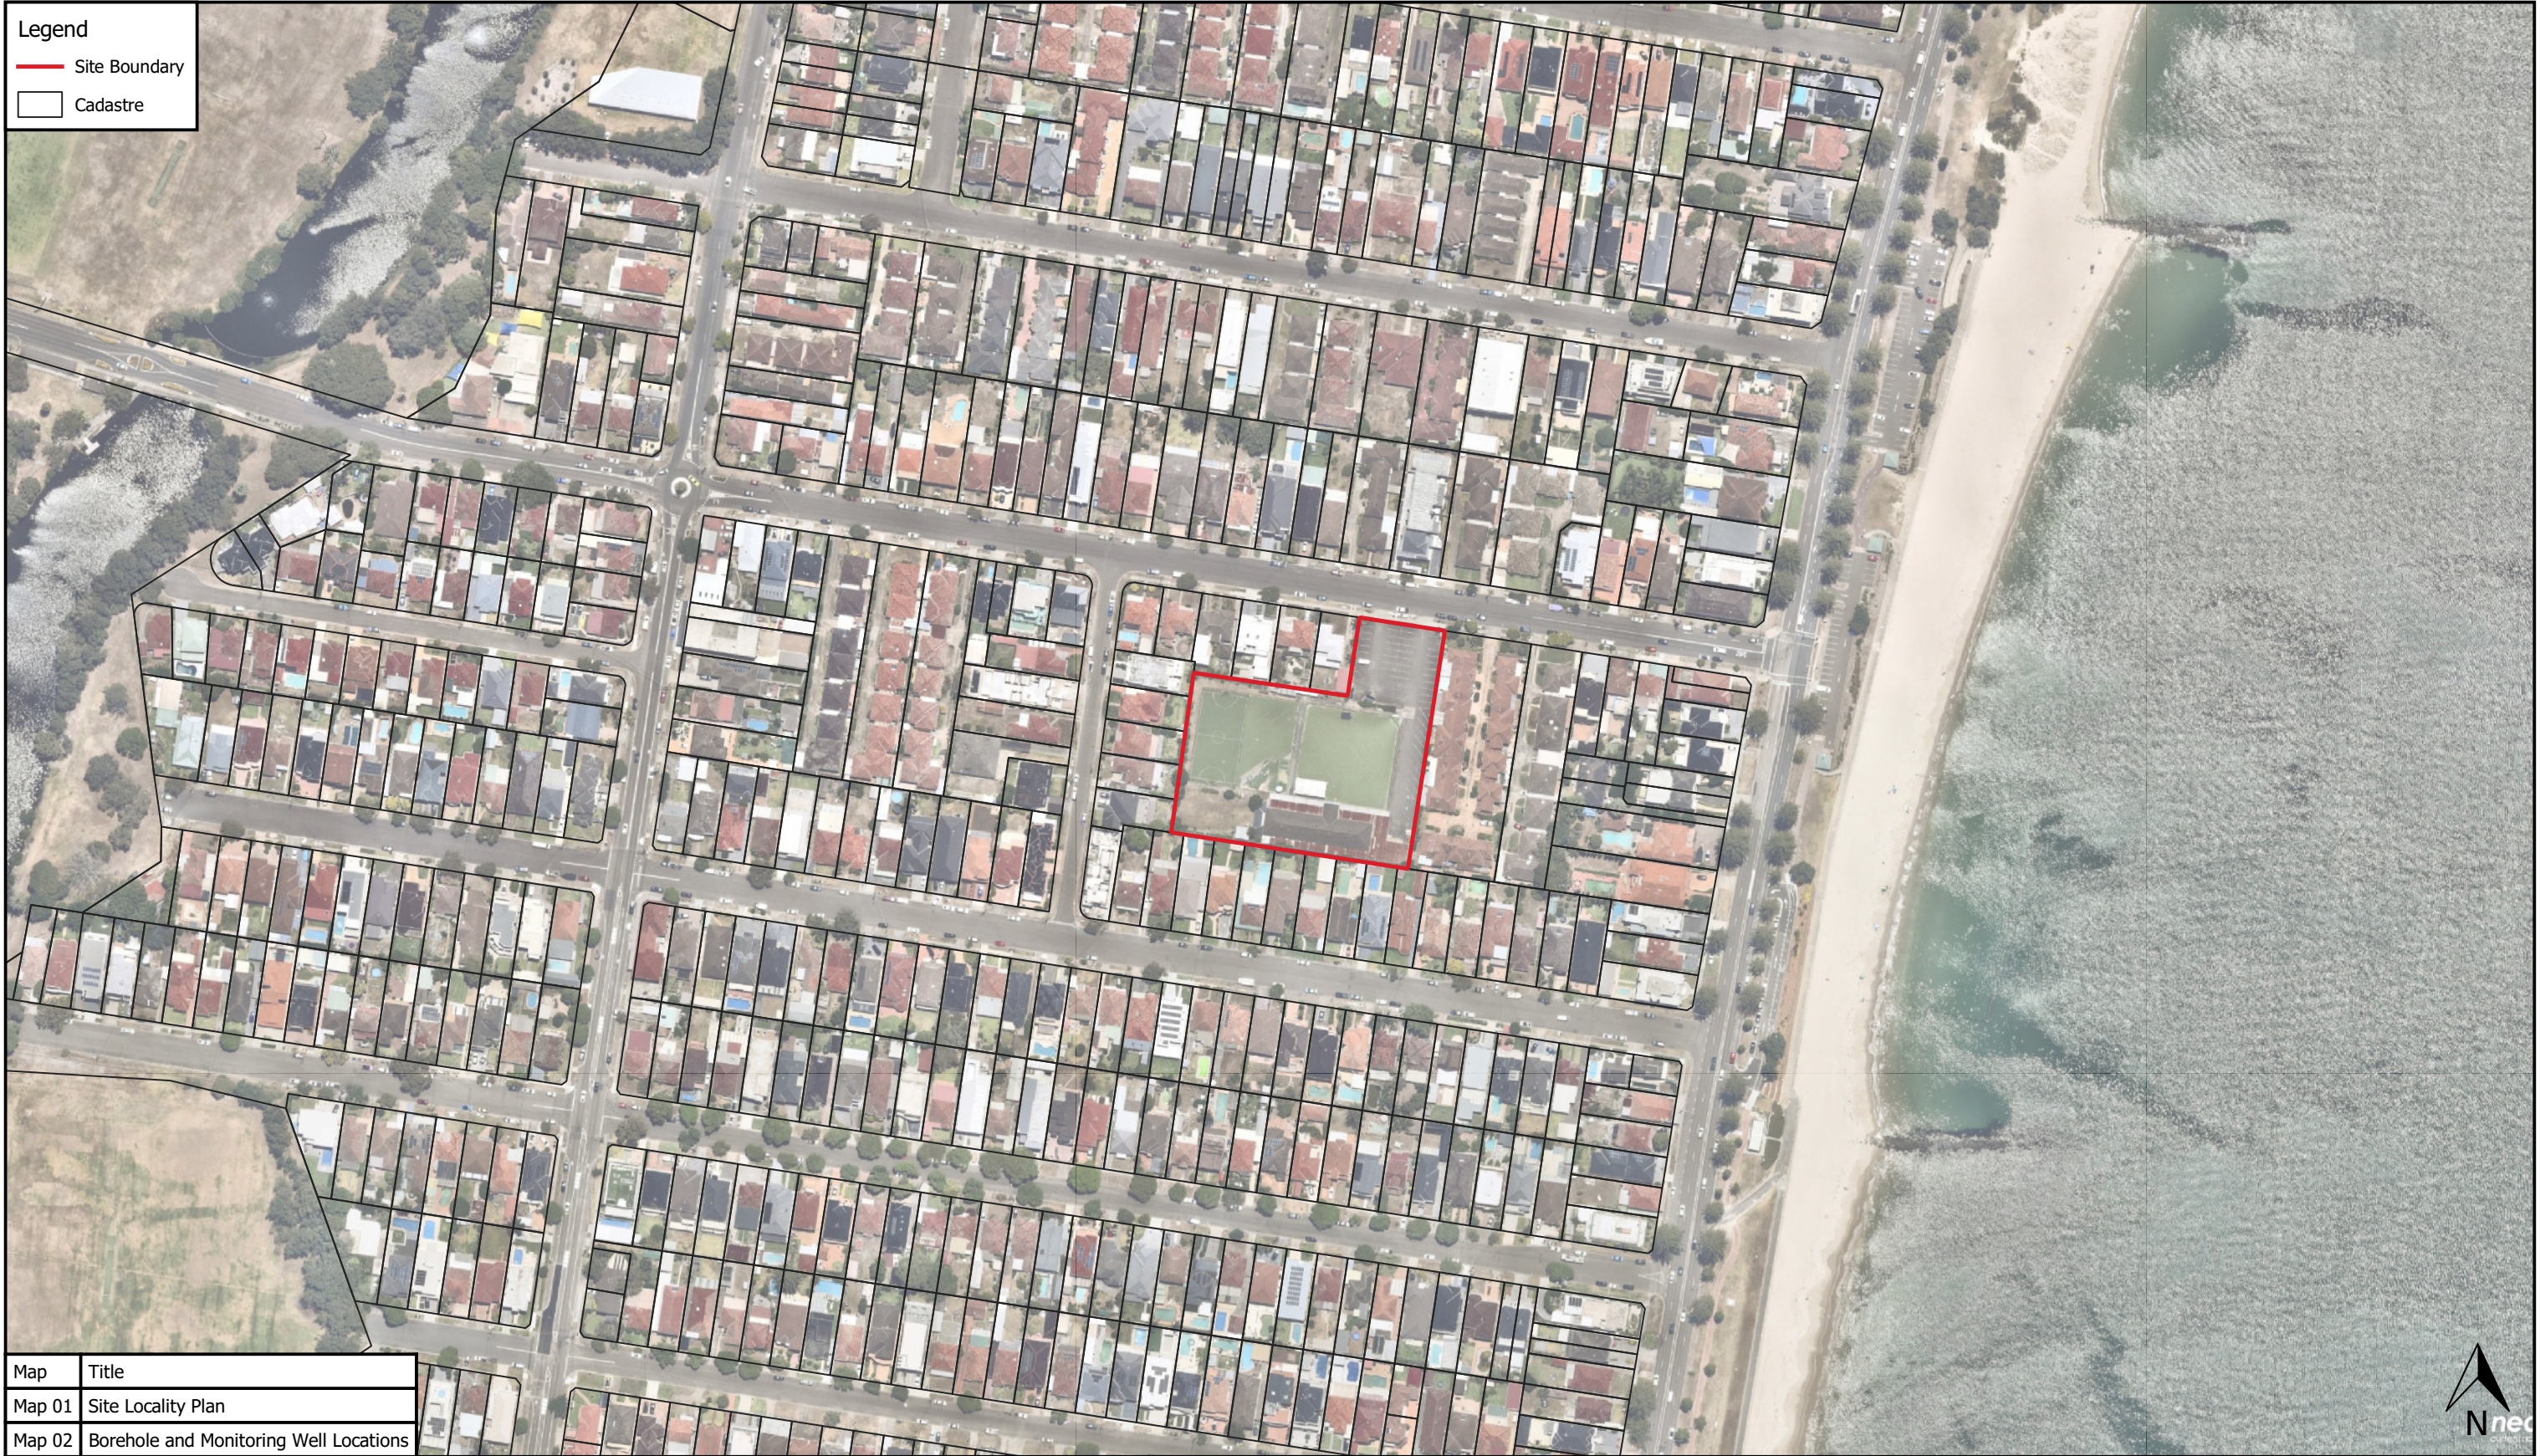
10 **Attachment A – Site Location and Testing Plan**

Map	Title
Map 01	Site Locality Plan
Map 02	Borehole and Monitoring Well Locations

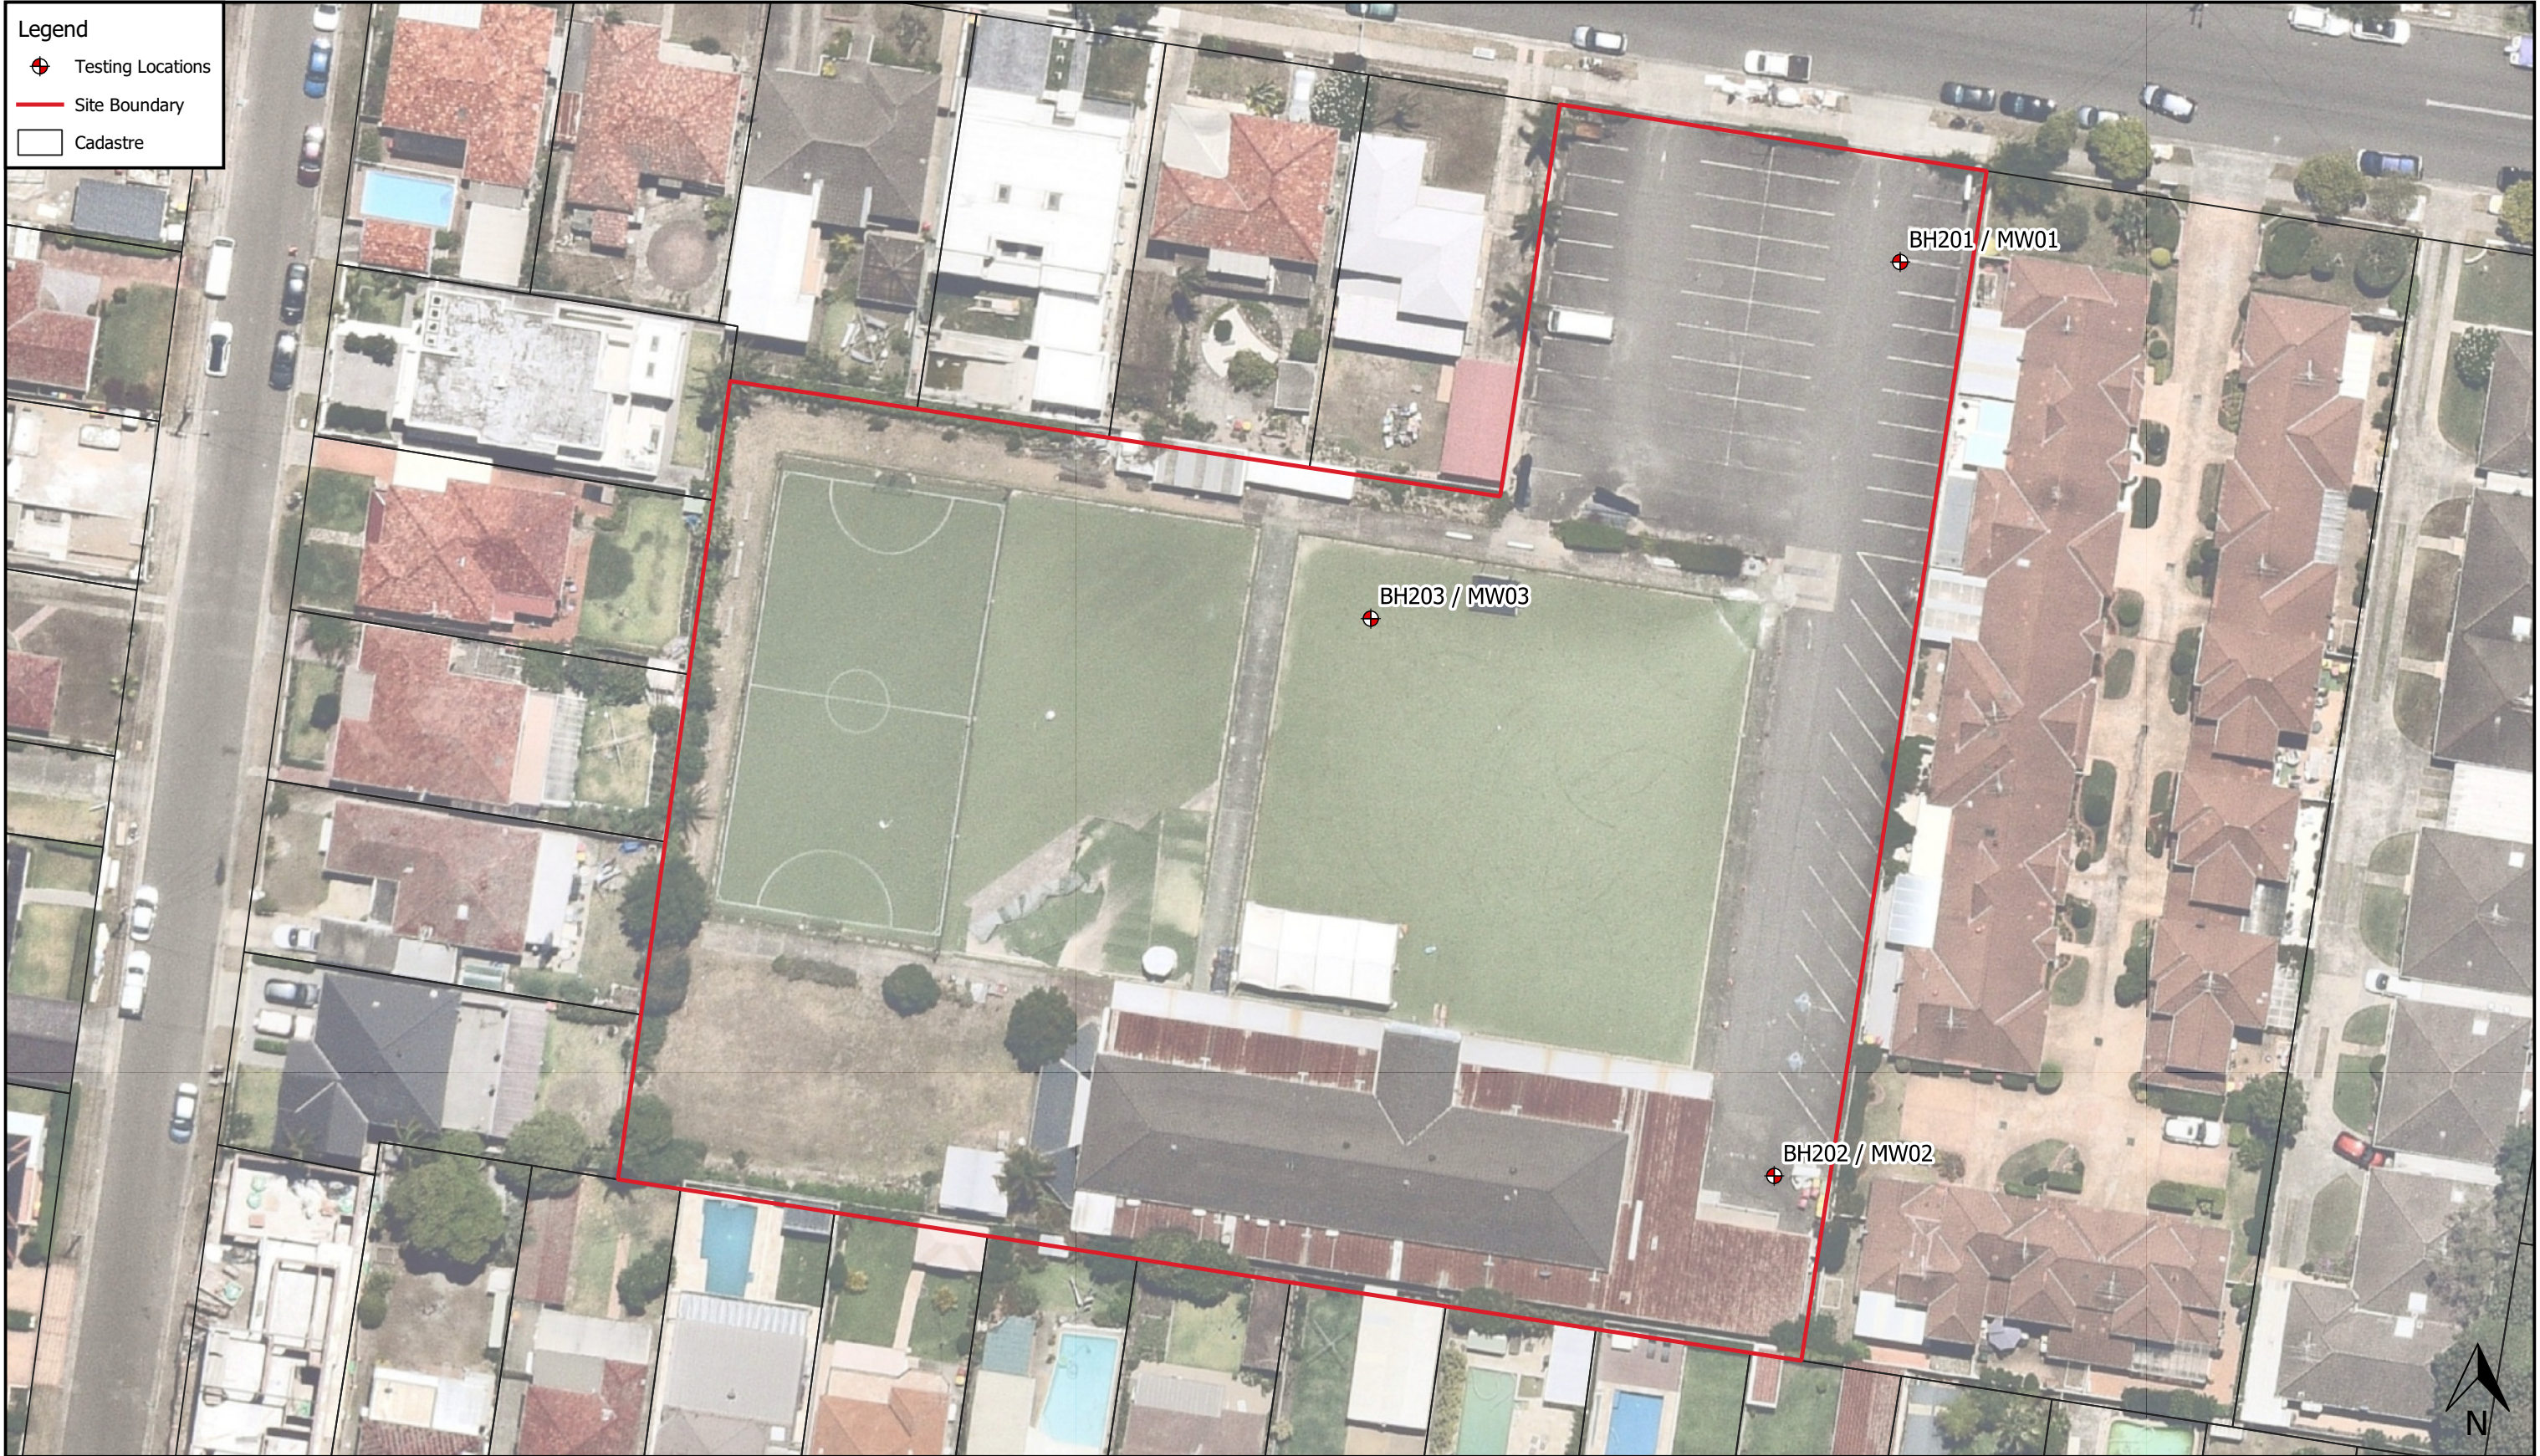
Map Title / Figure:
Borehole and Monitoring Well Locations

Three groundwater monitoring well (MW01 – MW03) have been installed onsite as part of this assessment. During the recently completed sampling event, groundwater levels were measured between 2.92 mBGL – 3.49 mBGL. These are similar depths to groundwater conditions encountered during borehole drilling as part of previous MA assessment work.
