Report on  
Geotechnical Investigation

Bondi Surf Bathers' Life Saving Club Upgrade  
Queen Elizabeth Drive, Bondi Beach

Prepared for  
Lockhart-Krause Architects Pty Ltd

Project 99567.00  
November 2020

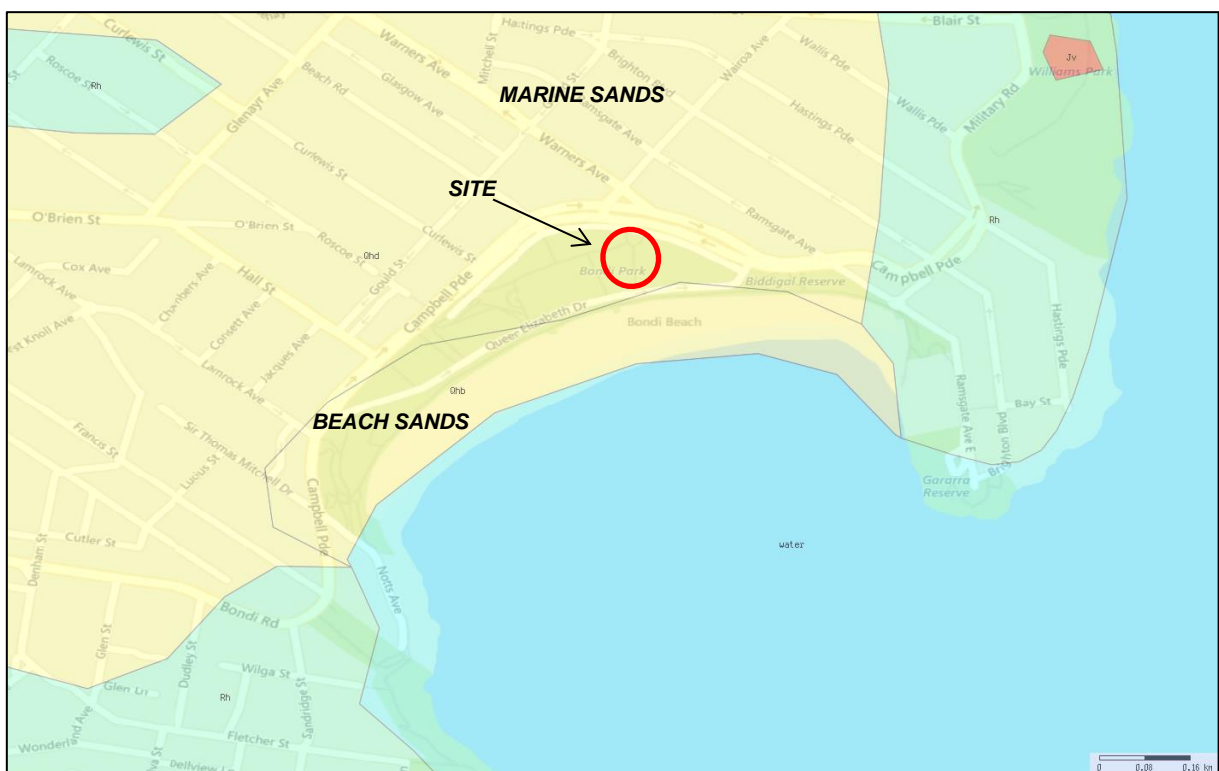
**Figure 1: Extract from geological map**

An extract from the geological map is shown in Figure 1.

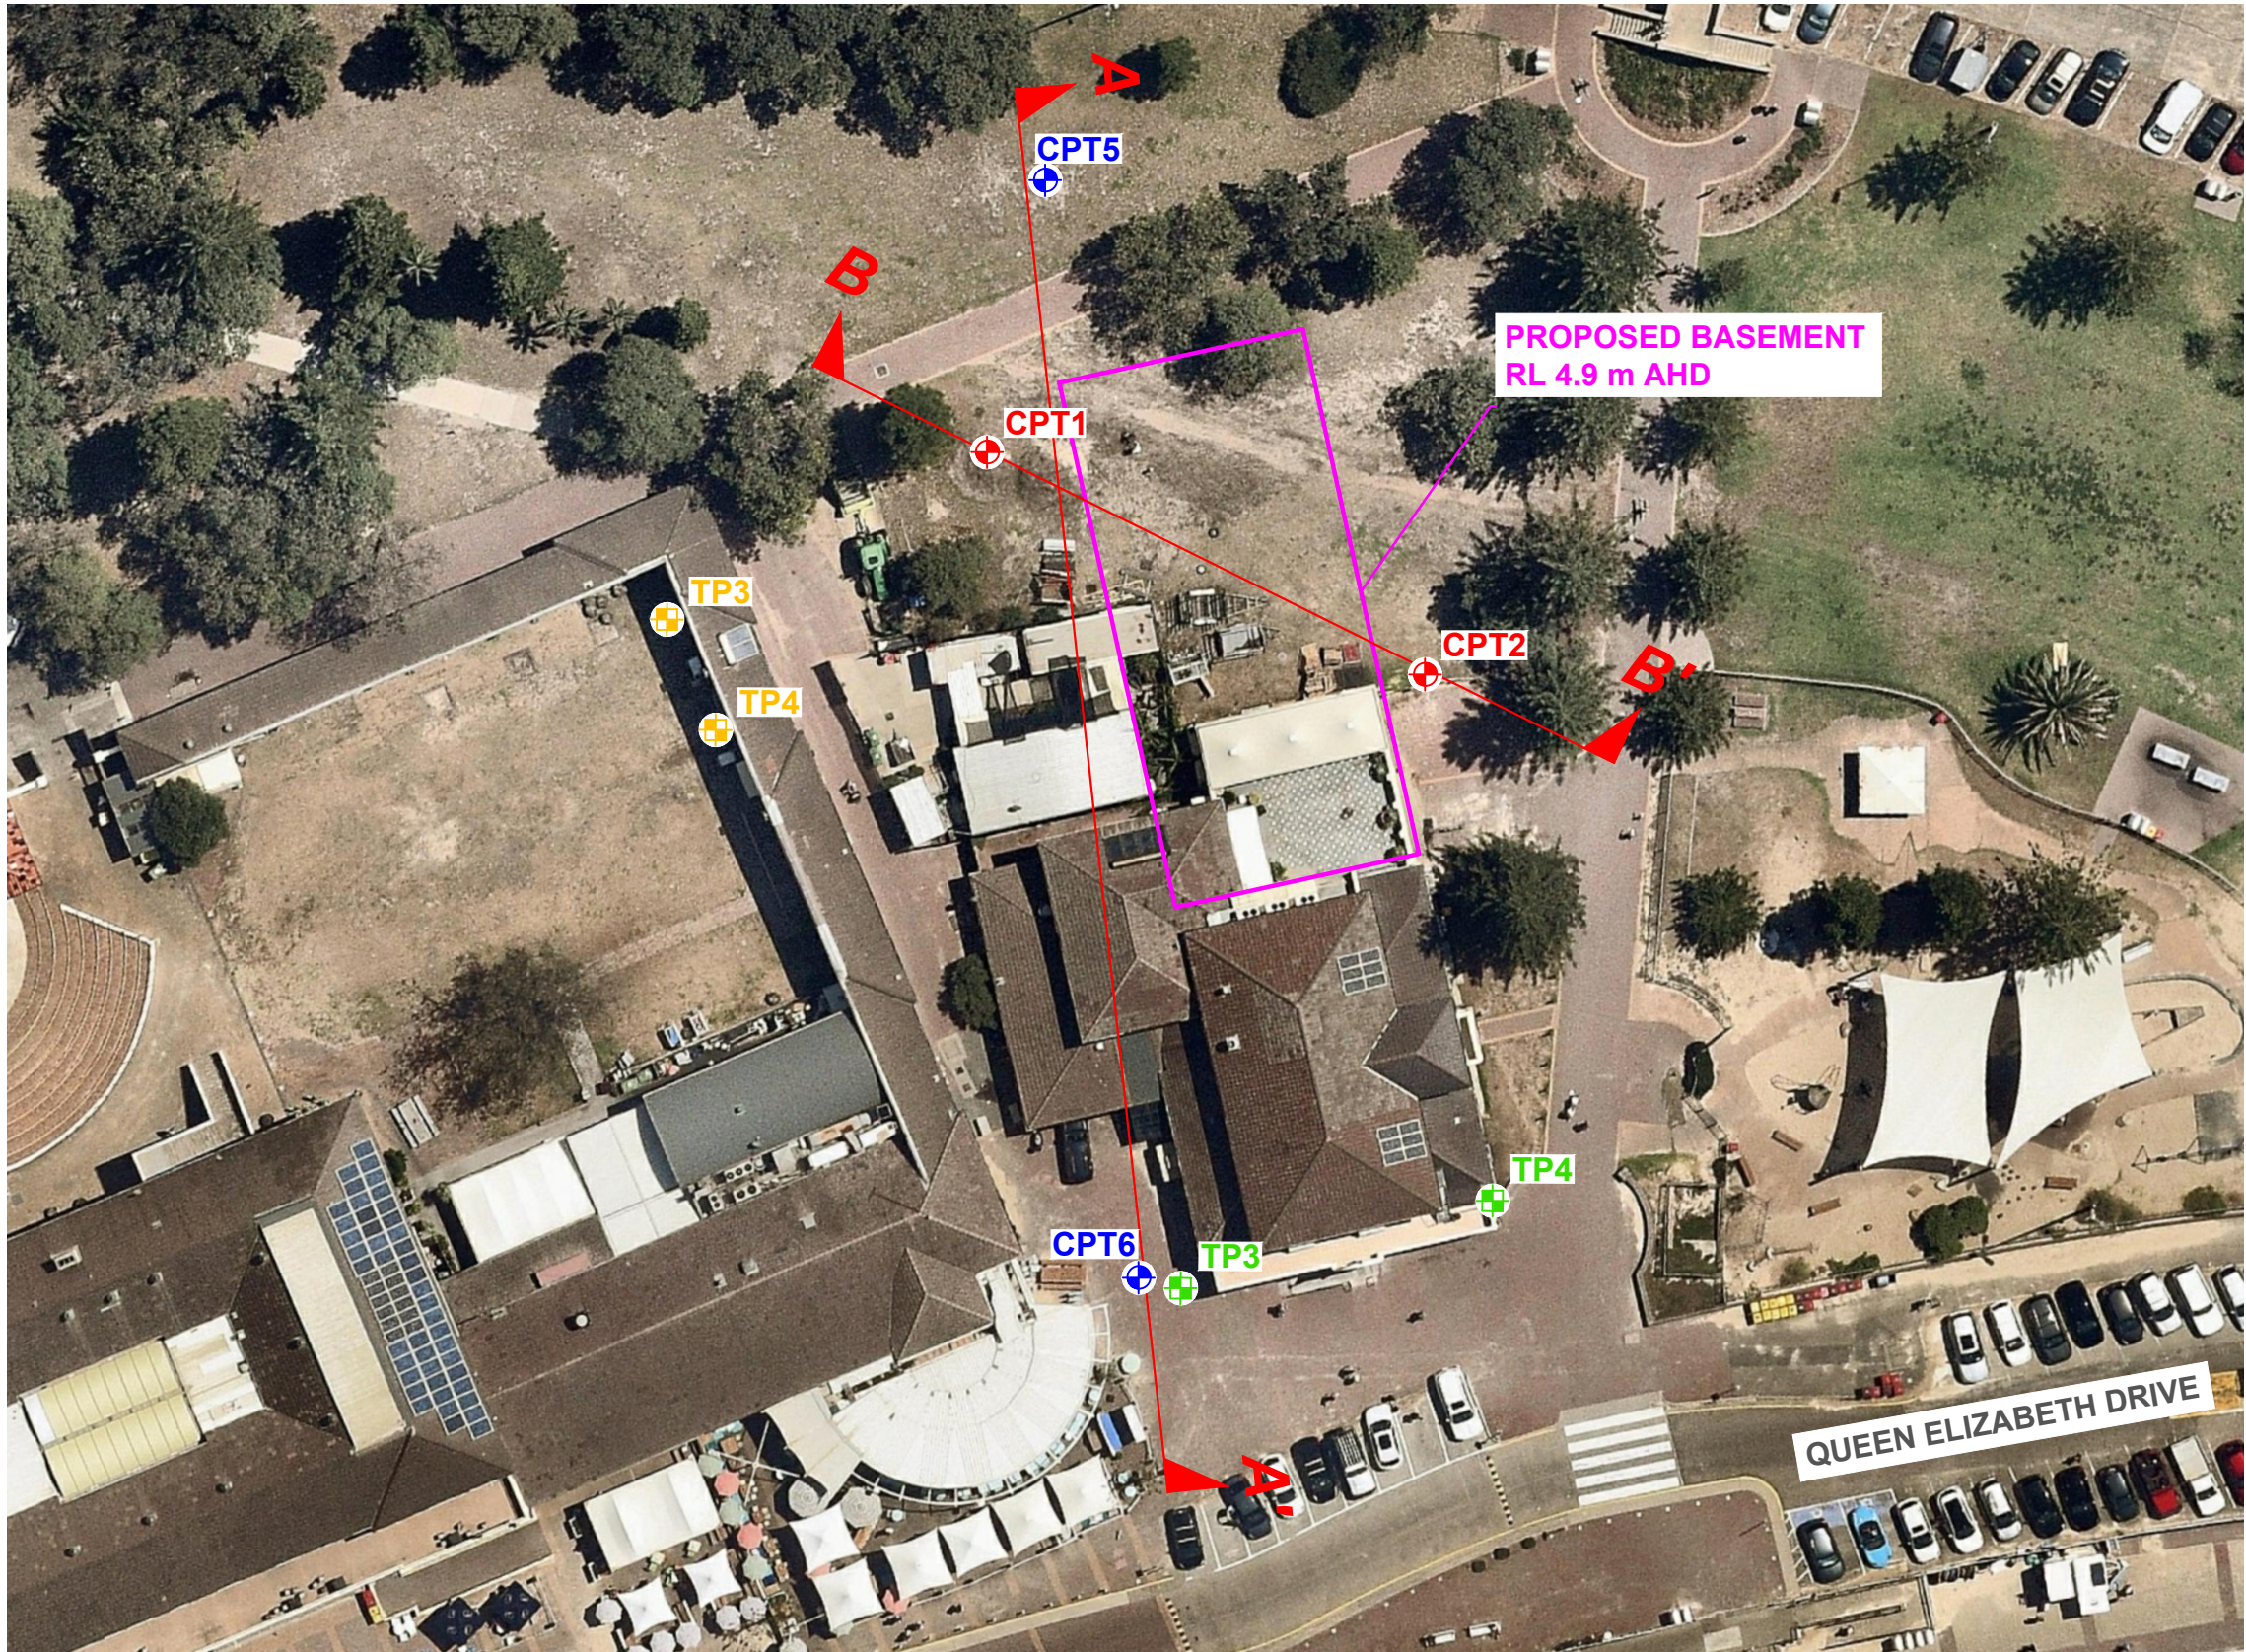
PROJECT No: 99567.00  
DRAWING No: 1  
REVISION: 1

Locality Plan

NOTE:  
1: Base image from Nearmap.com (Dated 21.1.2020)  
2: Test locations surveyed using differential GPS

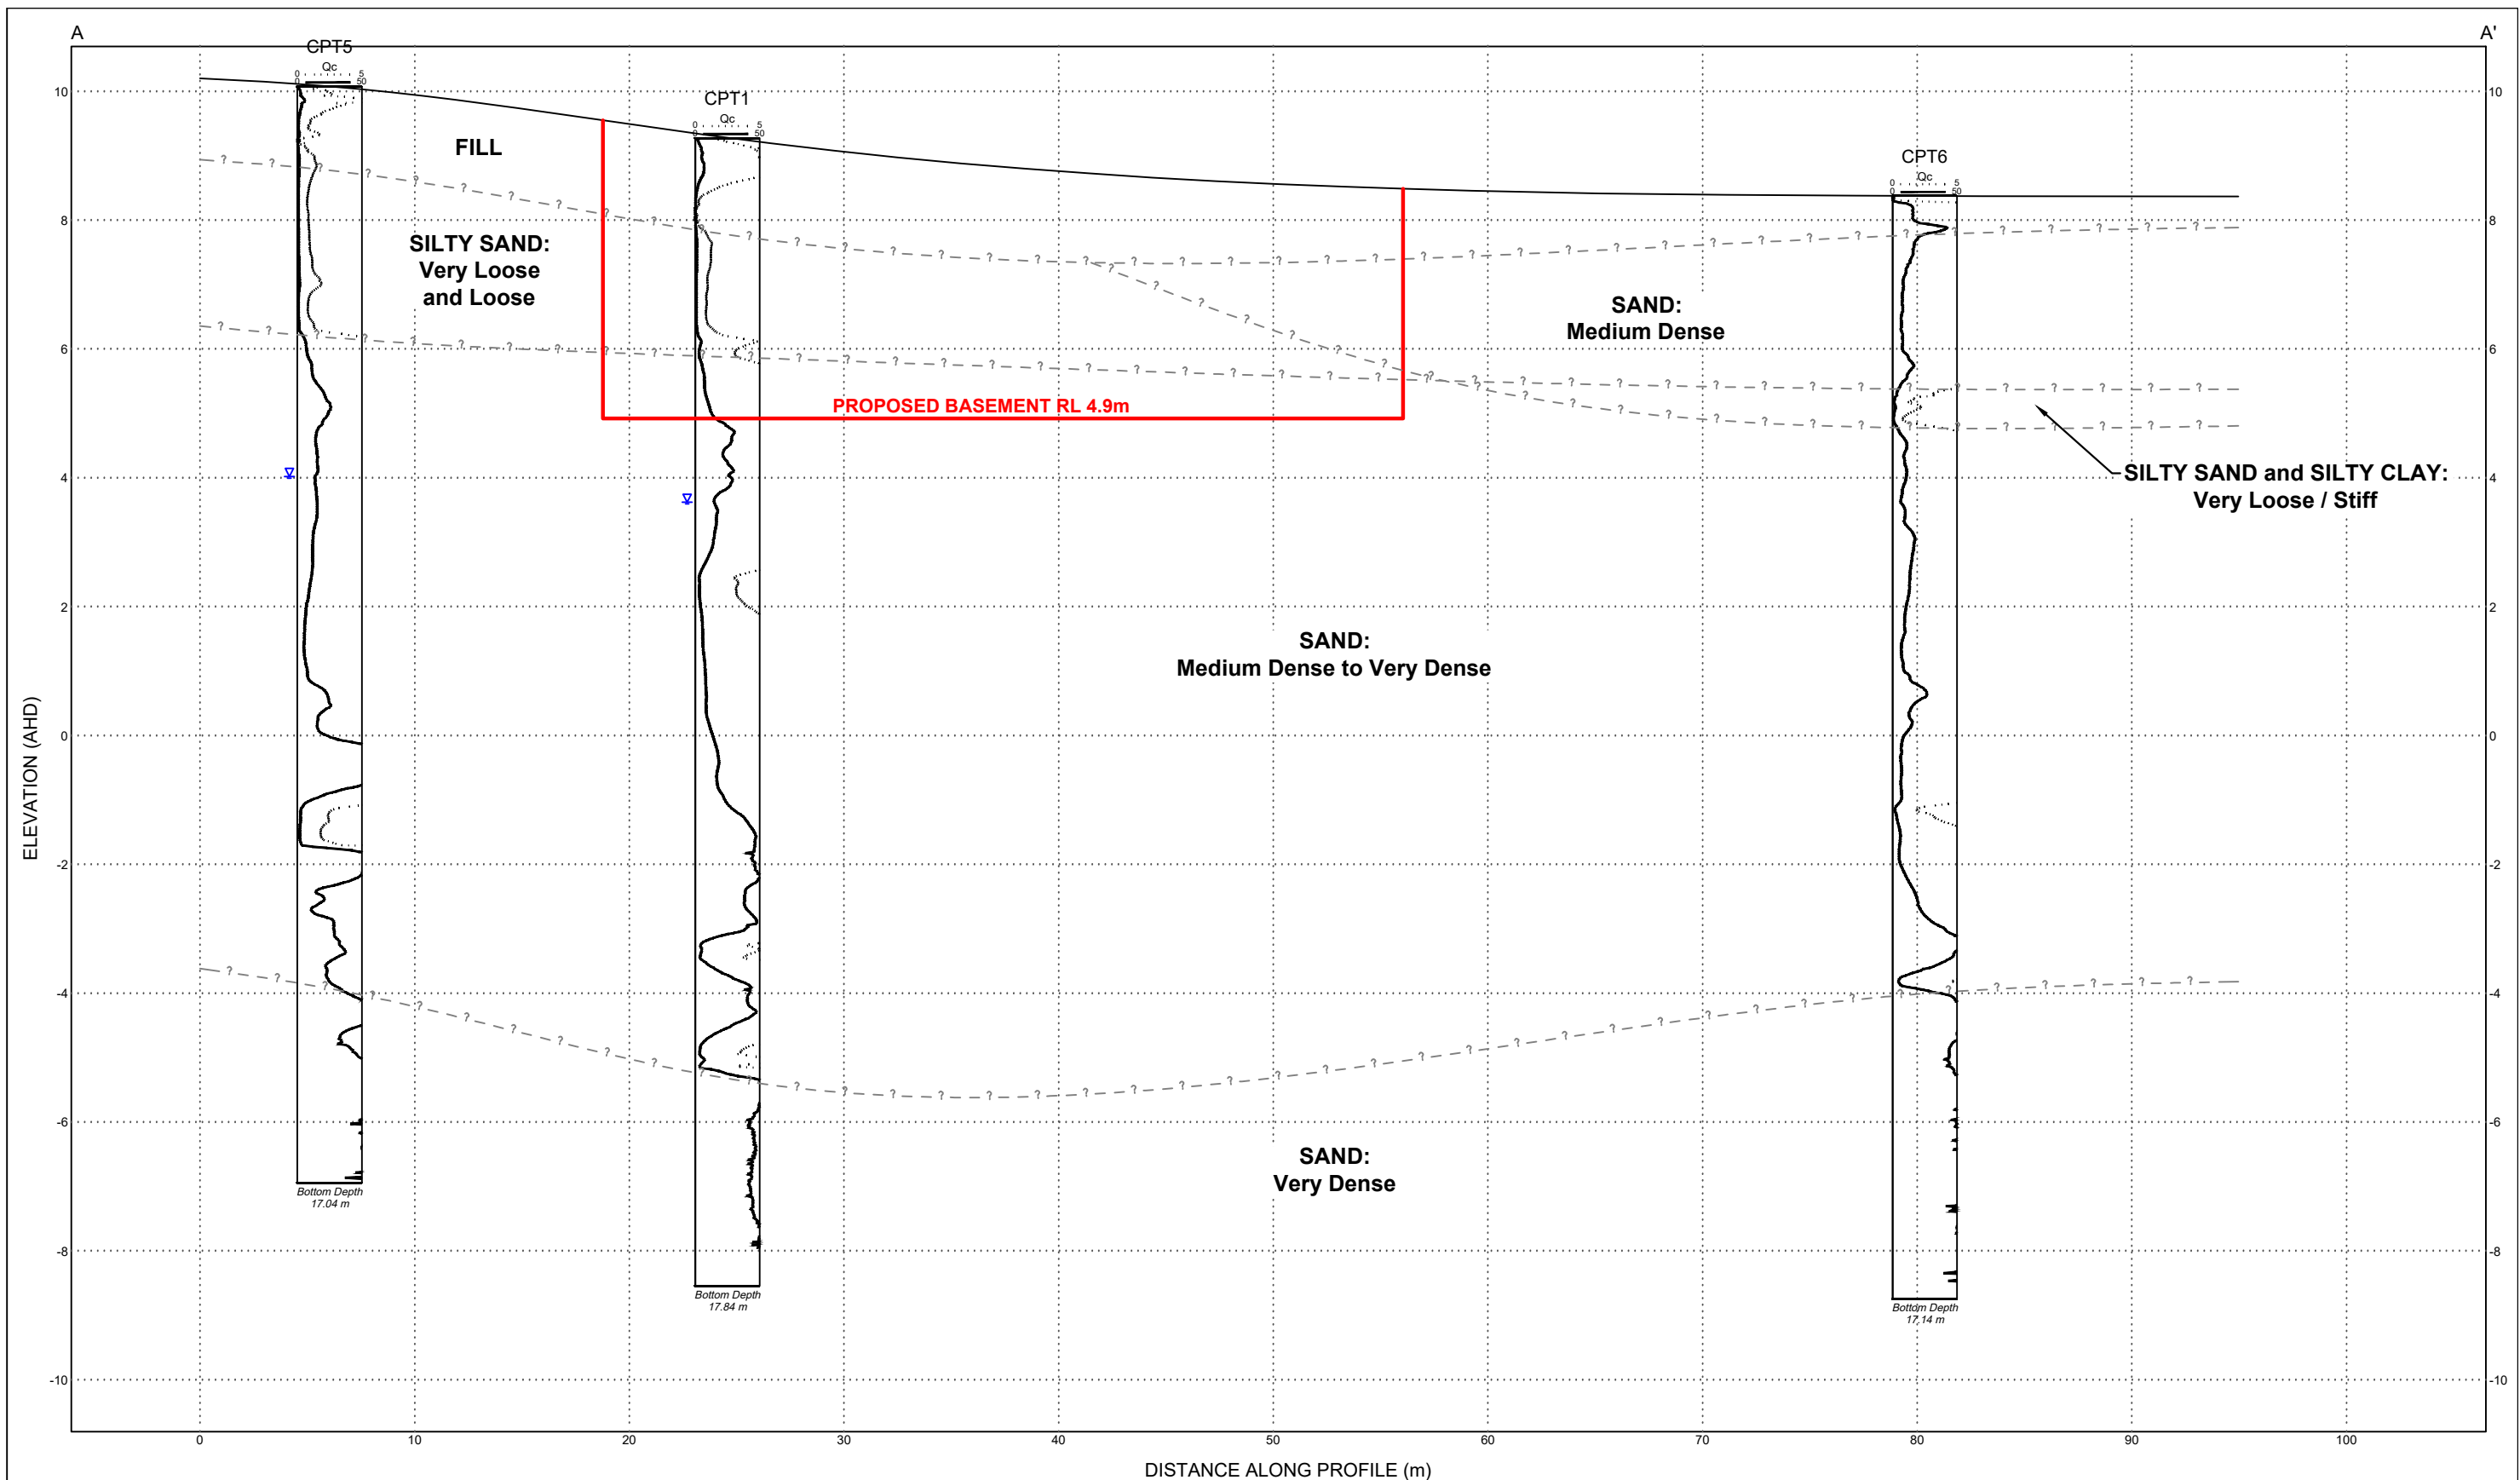
1. Subsurface conditions are accurate at the borehole locations only.  
Variations in subsurface conditions may occur between borehole locations.  
Interpreted strata boundaries are approximate and should be used as a guide only.

Vertical Exaggeration = 3.0

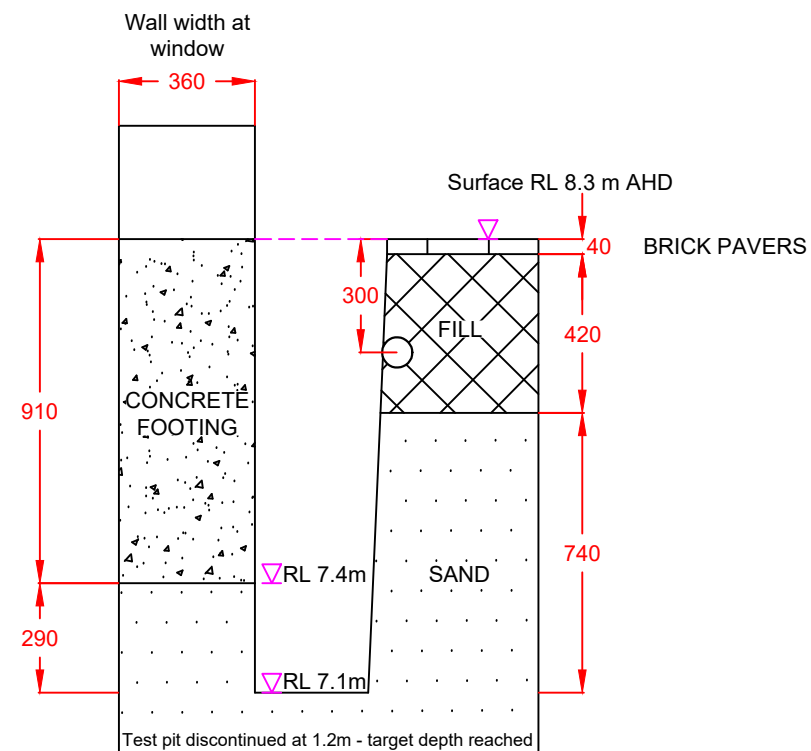
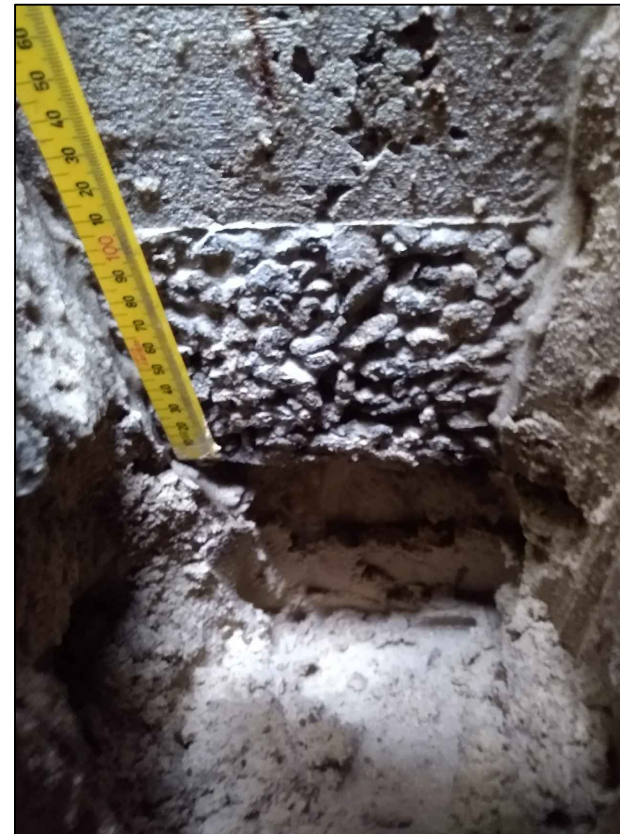
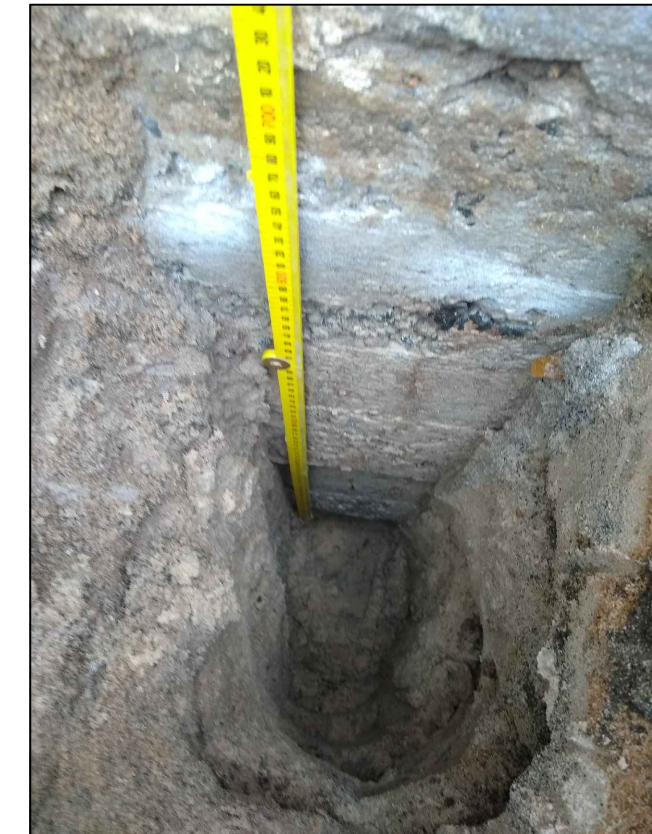
**TP3**  
(Refer to test pit log for more details on soil profile)

Two test pits (TP3 and TP4) were excavated to expose the existing footings that support the eastern wall of the Pavilion. The bases of the footings were founded at a depth of 0.55 m and 0.6 m (RL 8.1 m) on sandy filling, generally equivalent to a very loose to loose sand. These footings are located about 25 m away from the proposed BSBLSC basement.

Two test pits (TP3 and TP4) were excavated to depths of 1.2 m and 1.0 m using hand tools. The purpose of these pits was to determine the depth of the existing building footings at the pit locations. A dynamic penetrometer test (DPT) was also undertaken at the base of each test pit to assess the strength/density of the foundation soils.

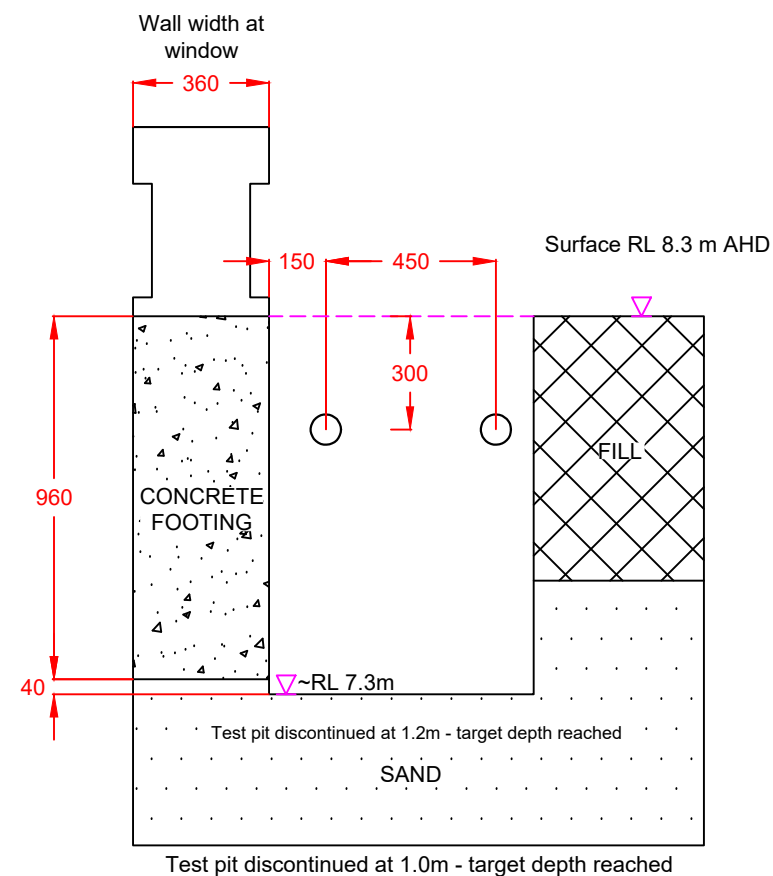
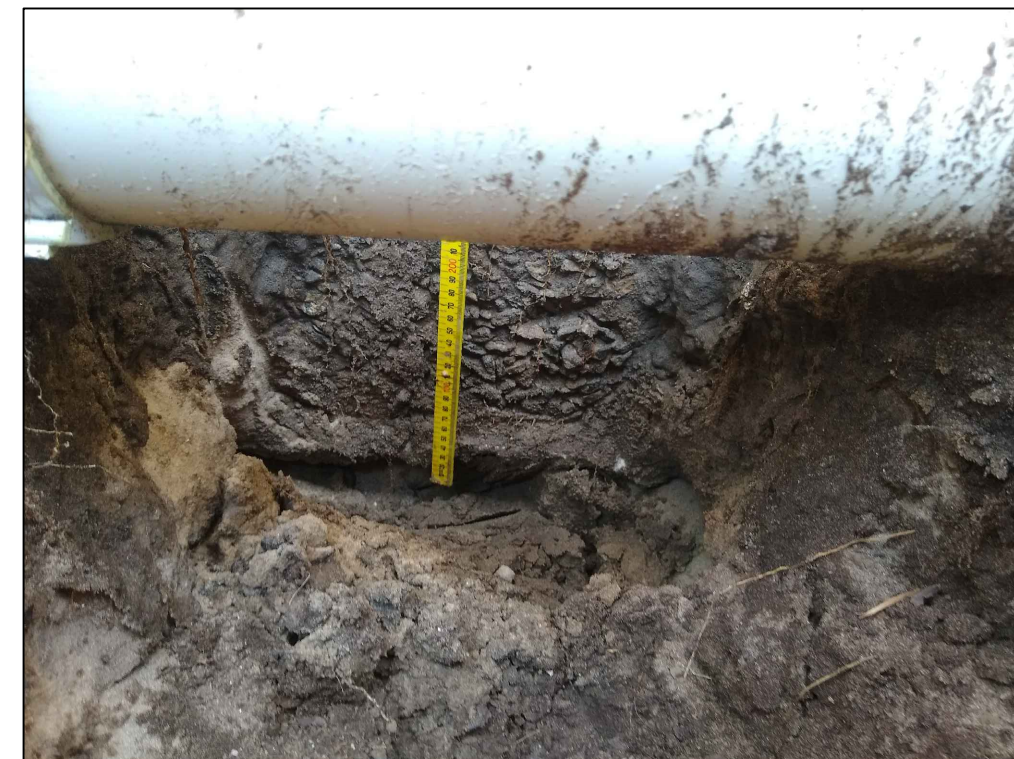
**TP4**  
(Refer to test pit log for more details on soil profile)

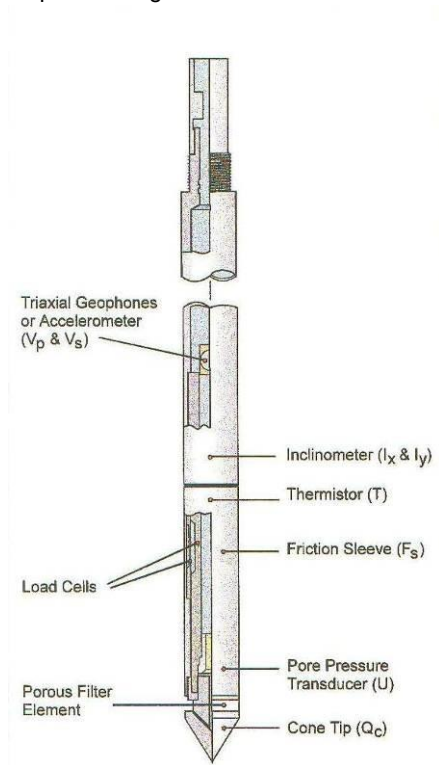
Figure 1: Cone Diagram

The inclinometer in the cone enables the verticality of the test to be confirmed and, if required, the vertical depth can be corrected.

- Cone tip resistance  $q_c$
- Sleeve friction  $f_s$
- Inclination (from vertical)  $i$
- Depth below ground  $z$

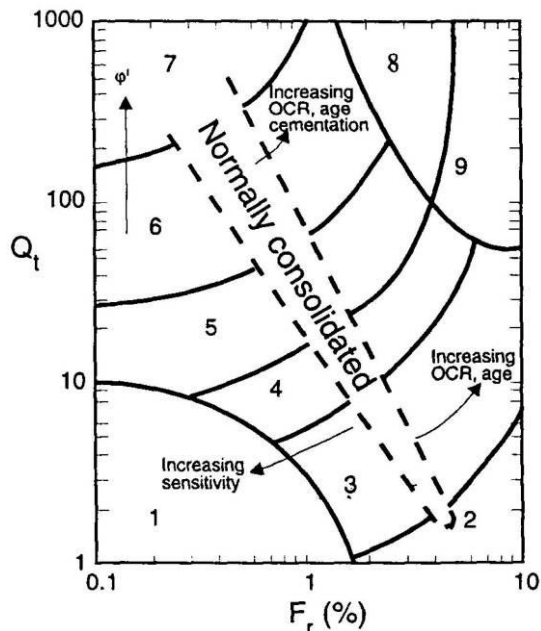
The CPT parameters can be used to infer the Soil Behaviour Type (SBT), based on normalised values of cone resistance ( $Q_t$ ) and friction ratio ( $Fr$ ). These are used in conjunction with soil classification charts, such as the one below (after Robertson 1990)

Figure 3: Soil Classification Chart

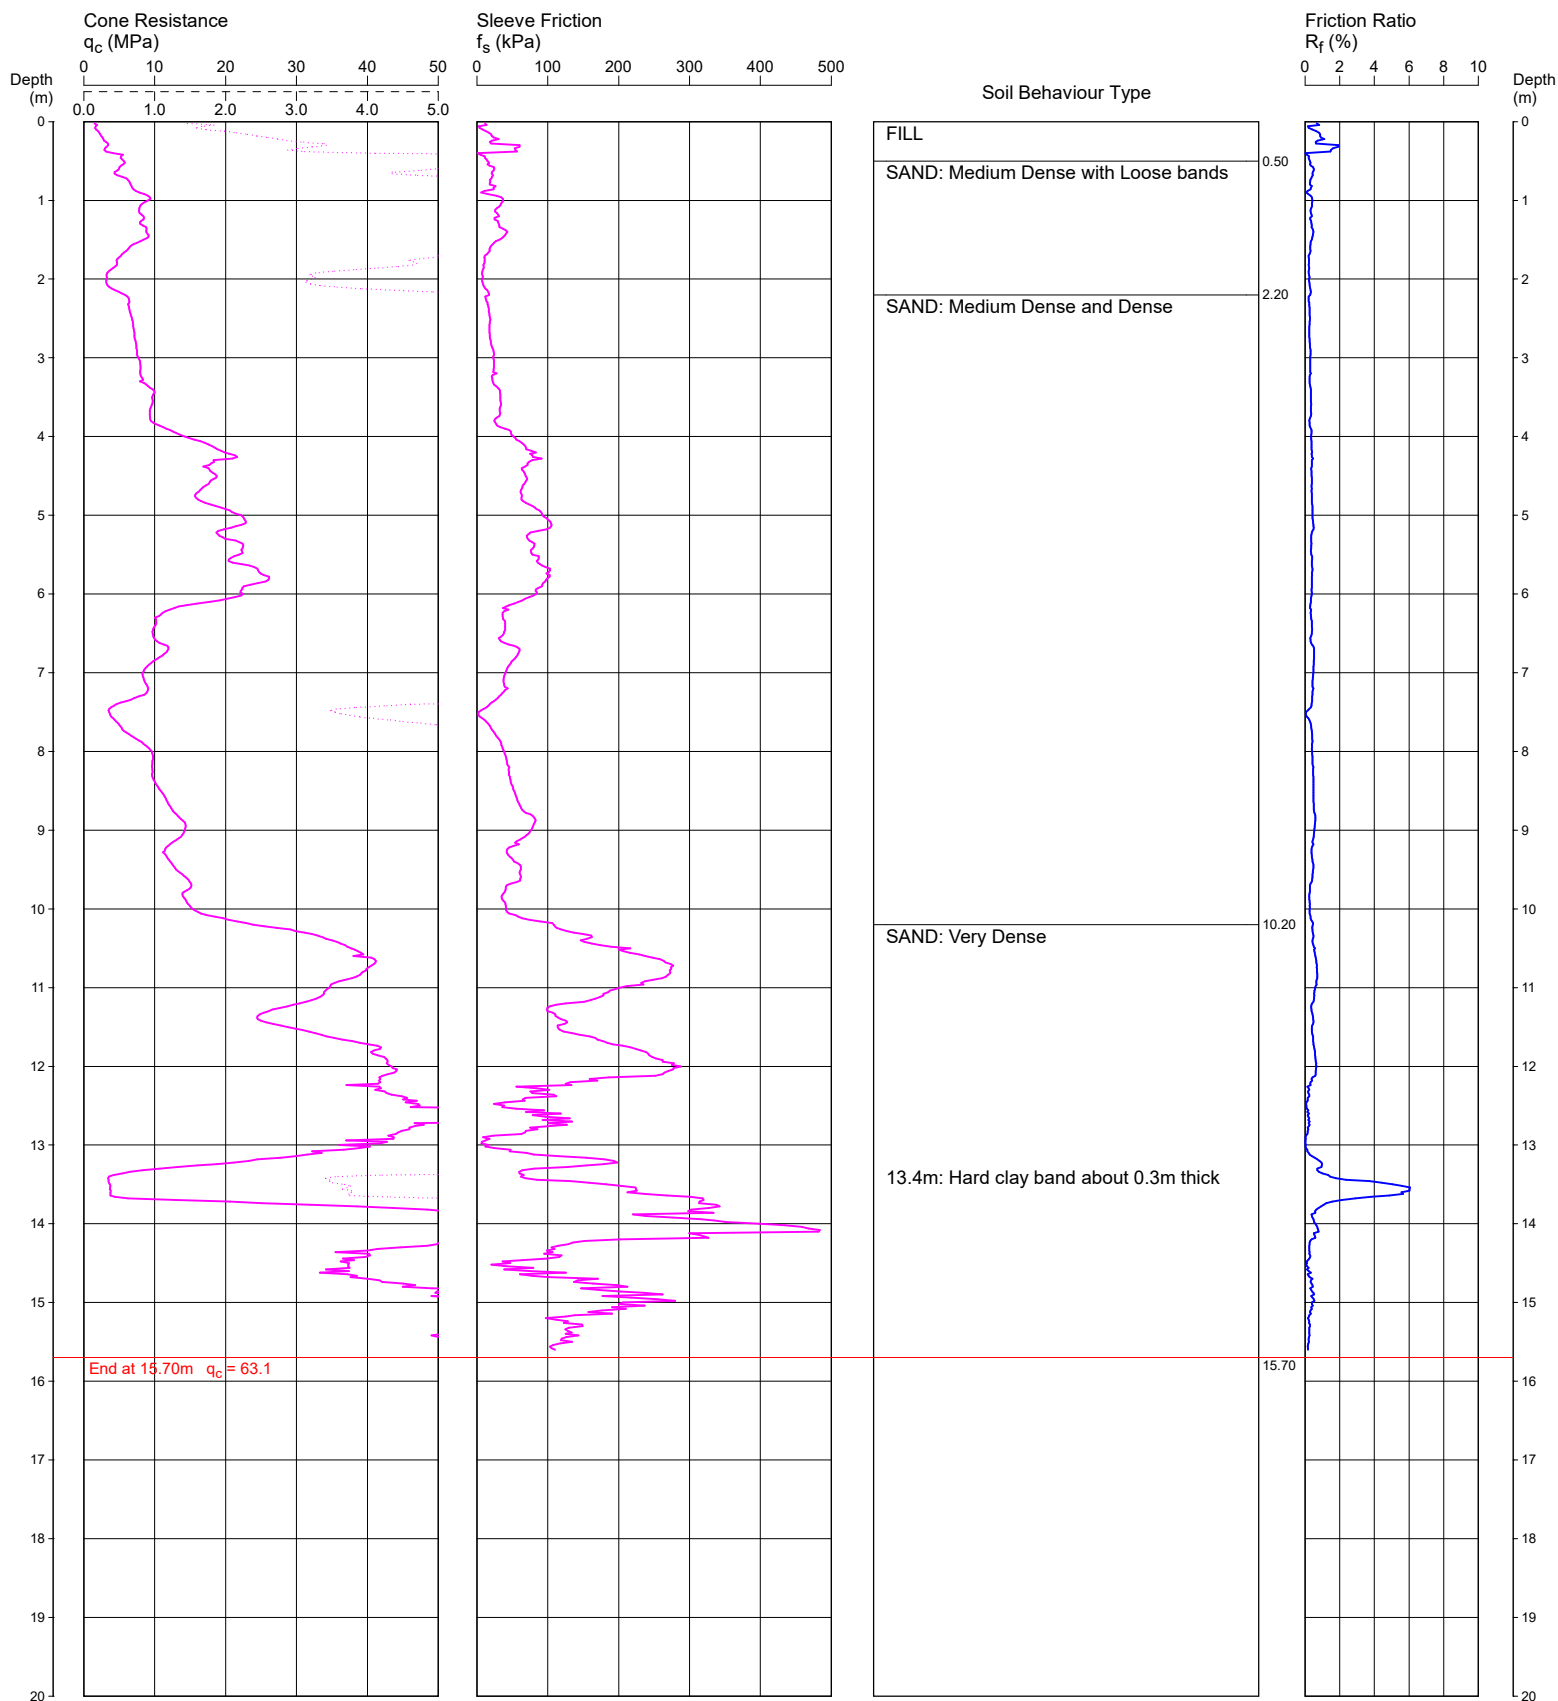
REMARKS: TEST DISCONTINUED DUE TO EXCESSIVE ROD-BOWING NEAR REFUSAL  
HOLE COLLAPSE MEASURED AT 5.2m AFTER REMOVAL OF RODS

Groundwater was observed at depths of 5.7 m (RL 3.6 m) in CPT1. The test hole collapsed at 5.2 m (RL 4.1 m) in CPT2 following withdrawal of the CPT equipment.
