ADDITIONAL GEOTECHNICAL INVESTIGATION REPORT

**23-25 Church St & 16-18 John Street
Mascot, NSW, 2020**

Report No. GS8023-3A

17/11/2020

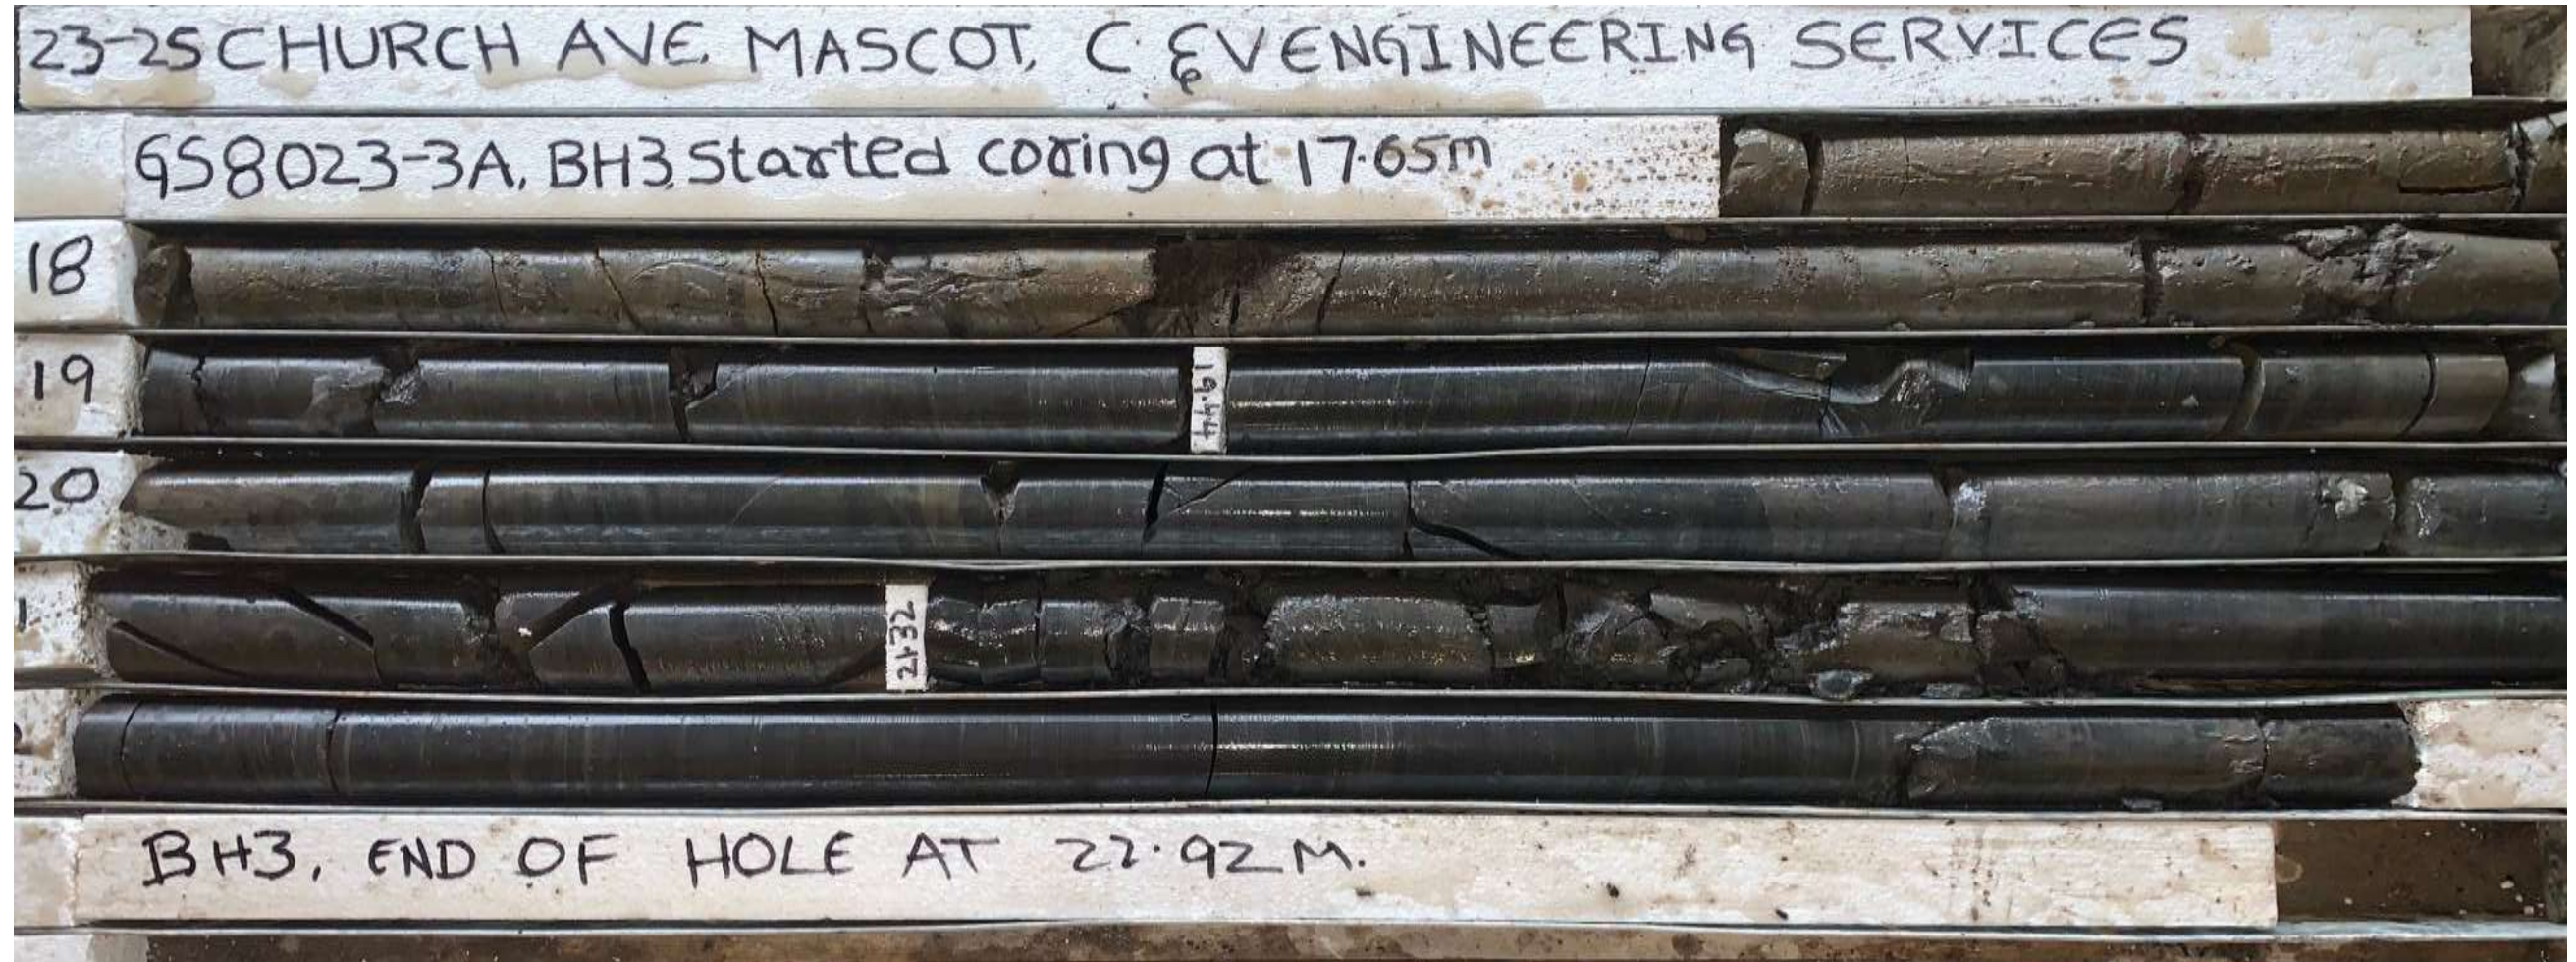
Figure	2
Title	BH3 Rock Core Photograph
Job No	GS8023-3A

Rock Core Photographs: BH3, 17.65m-22.92m.

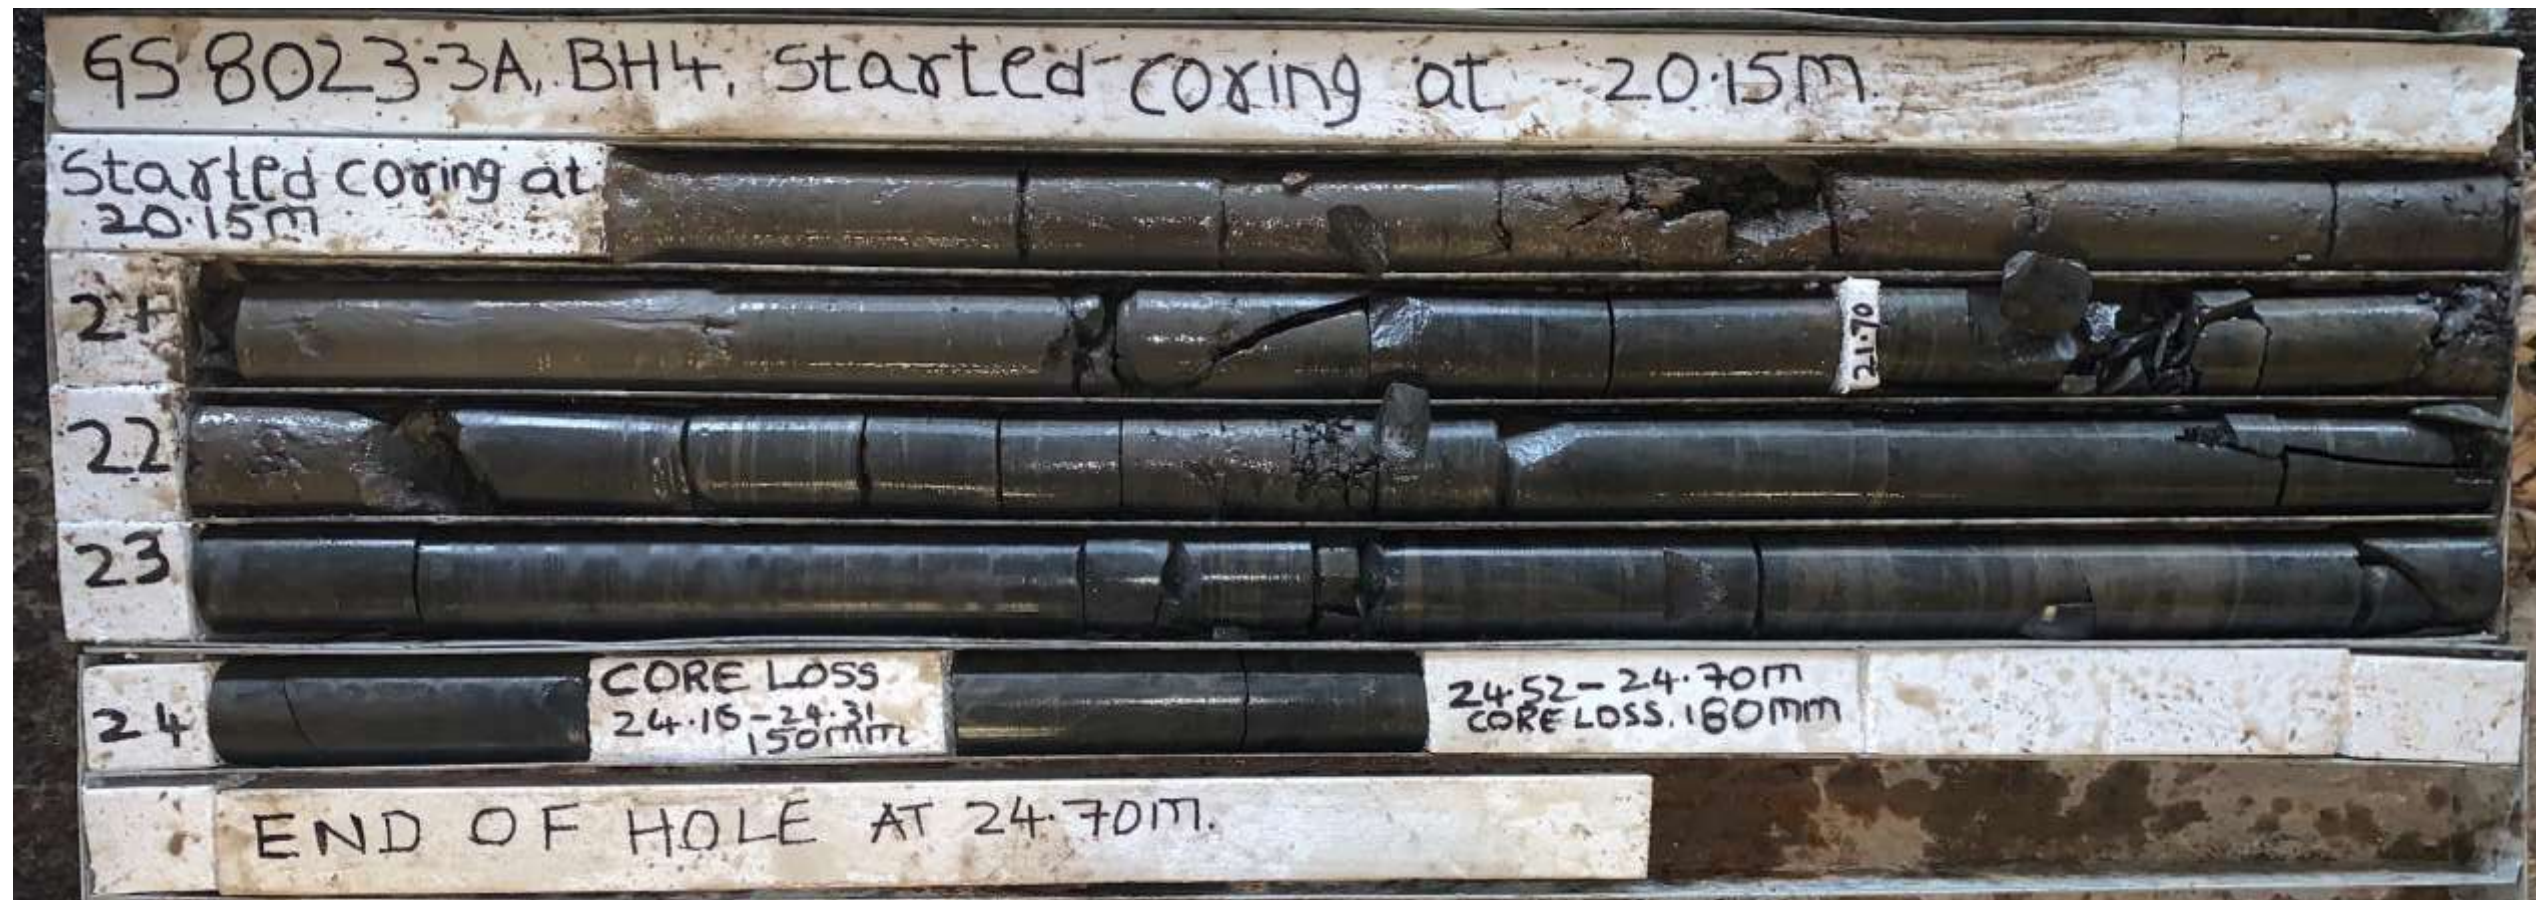
Figure	2
Title	BH4 Rock Core Photograph
Job No	GS8023-3A

Rock Core Photographs: BH4, 20.15m-24.70m.

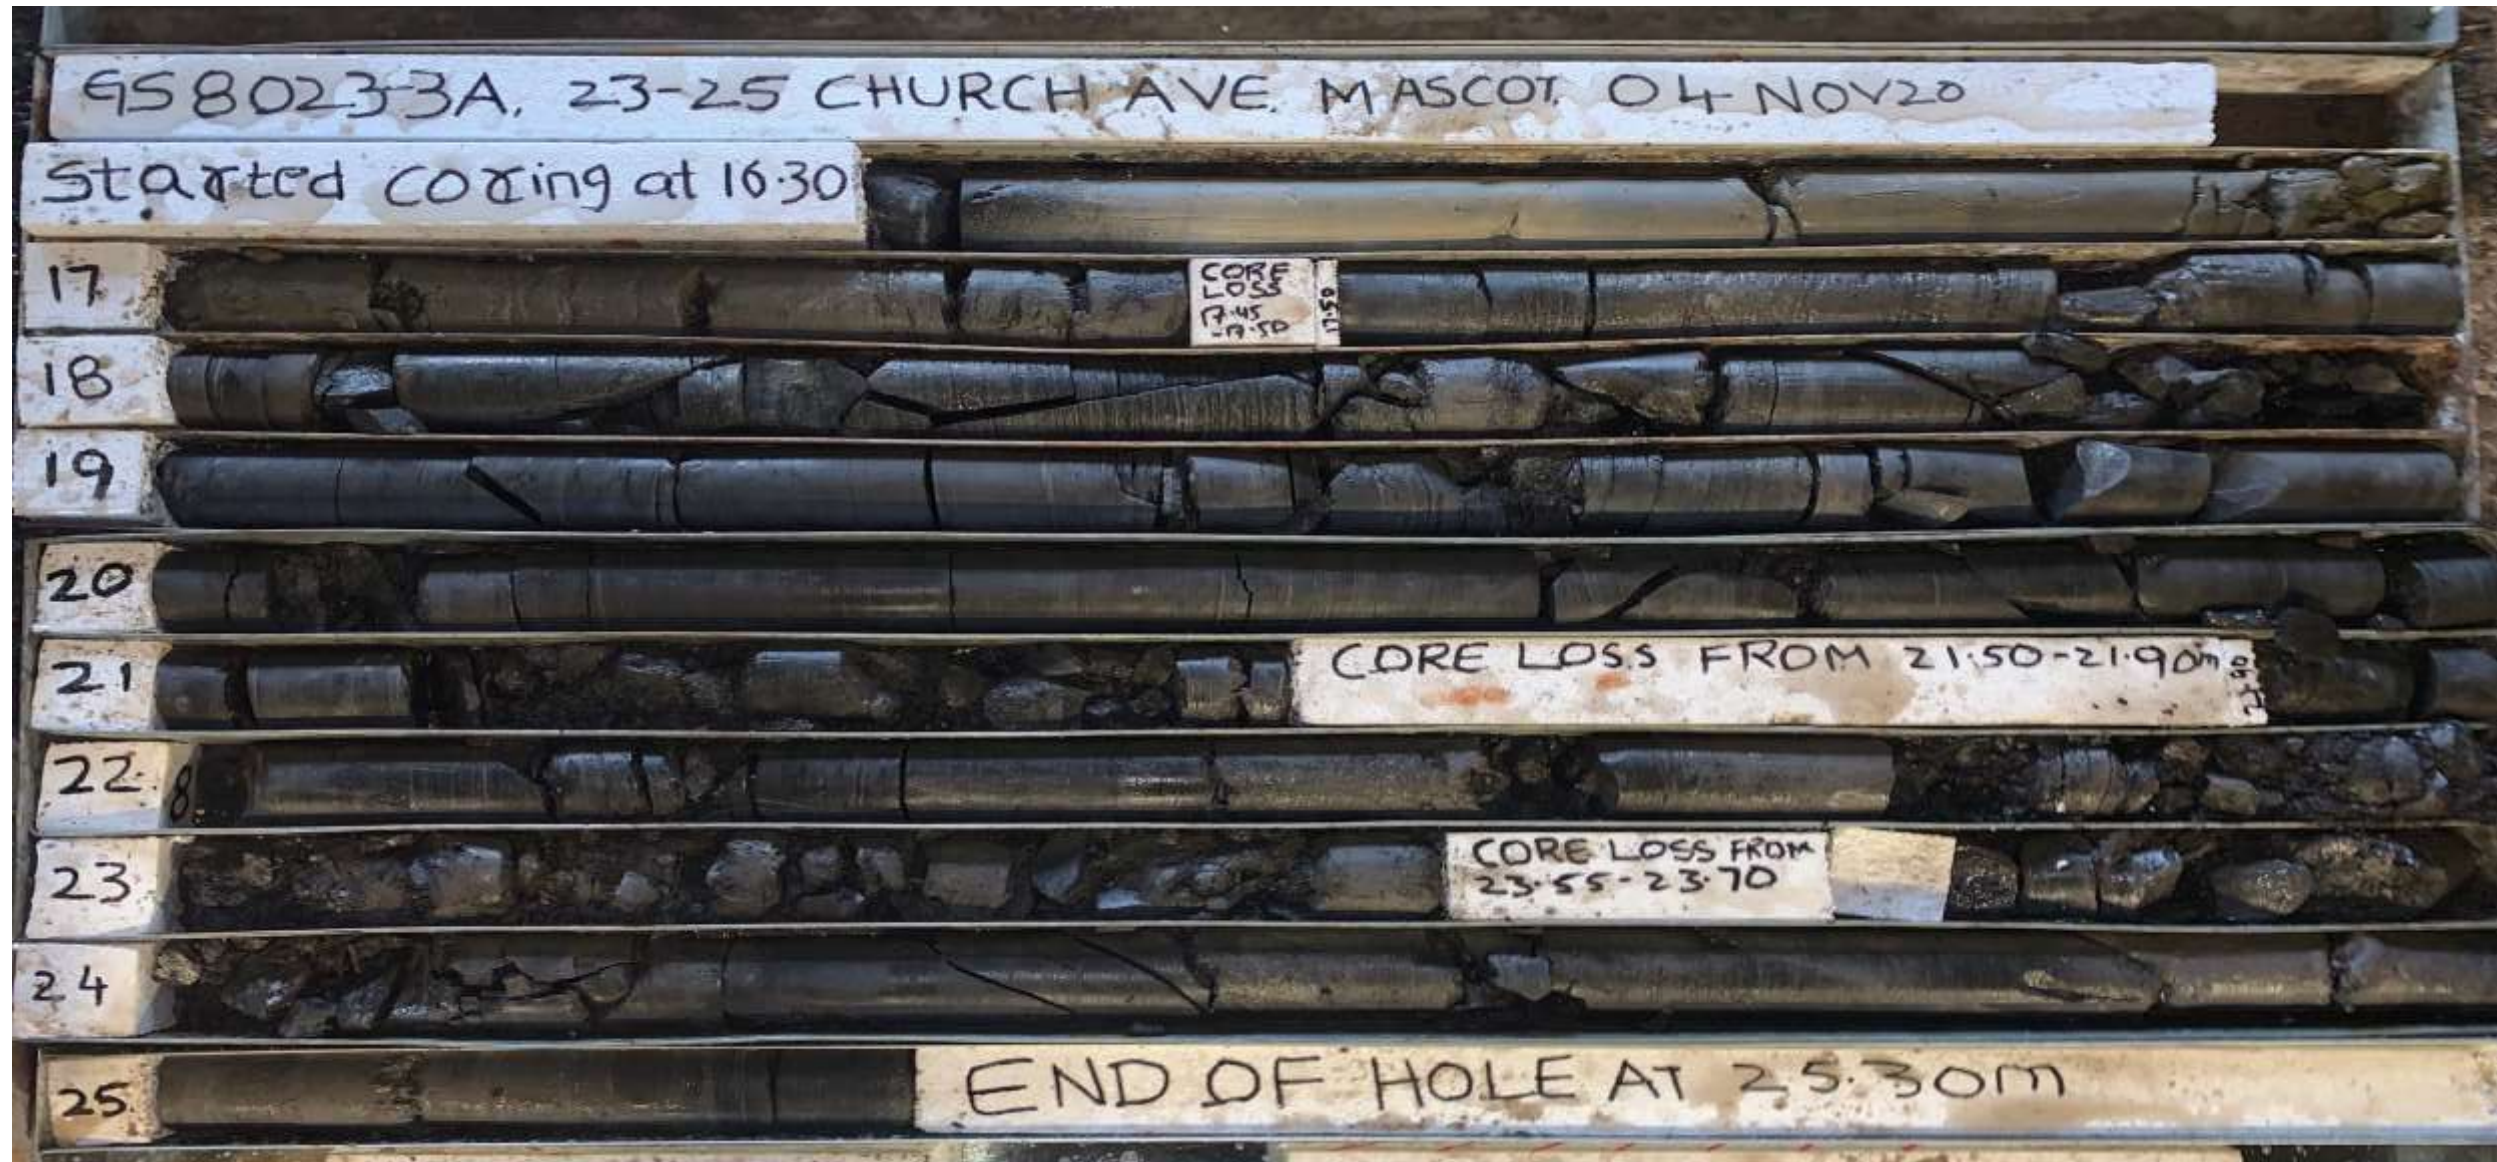
Rock Core Photographs: BH5, 16.30m-25.30m.
