HERITAGE IMPACT STATEMENT

Christ Church, Bexley

1A, 1B and 1C Dunmore Street North and 38 Albyn Street, Bexley

June 2022|J5212

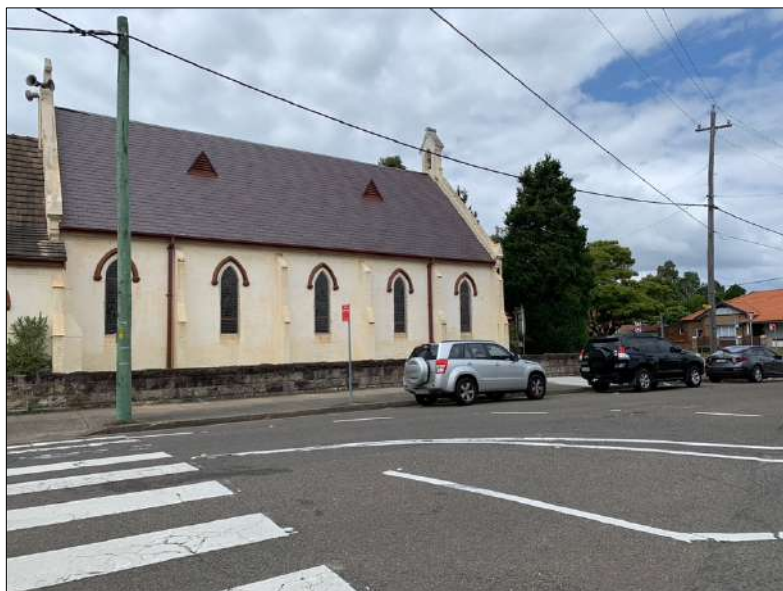
Figure 24:
Northern
elevation of the
nave and chancel.

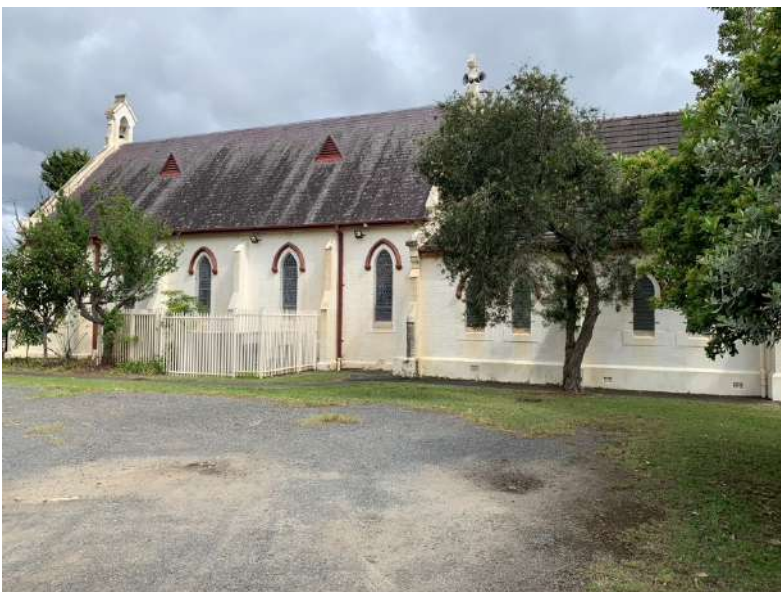
Figure 26:
Southern elevation
of the Church.

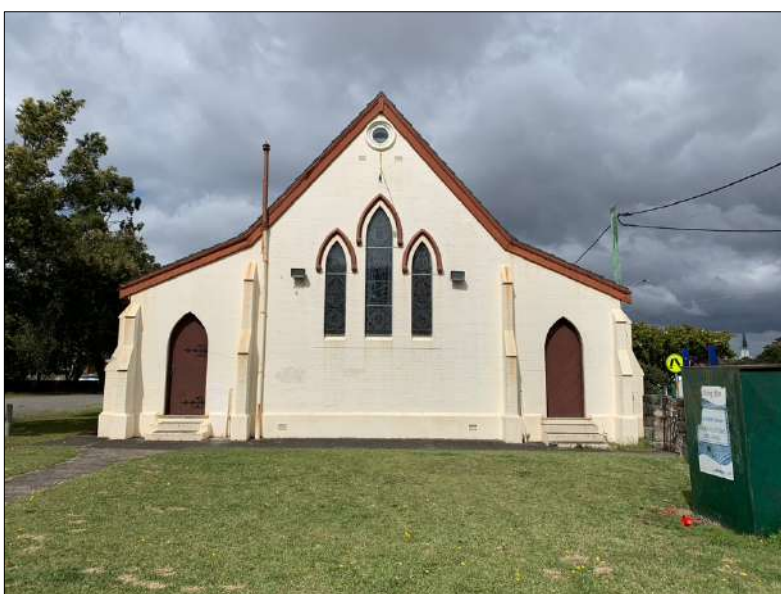
Figure 27:
Eastern elevation of
the vestry.

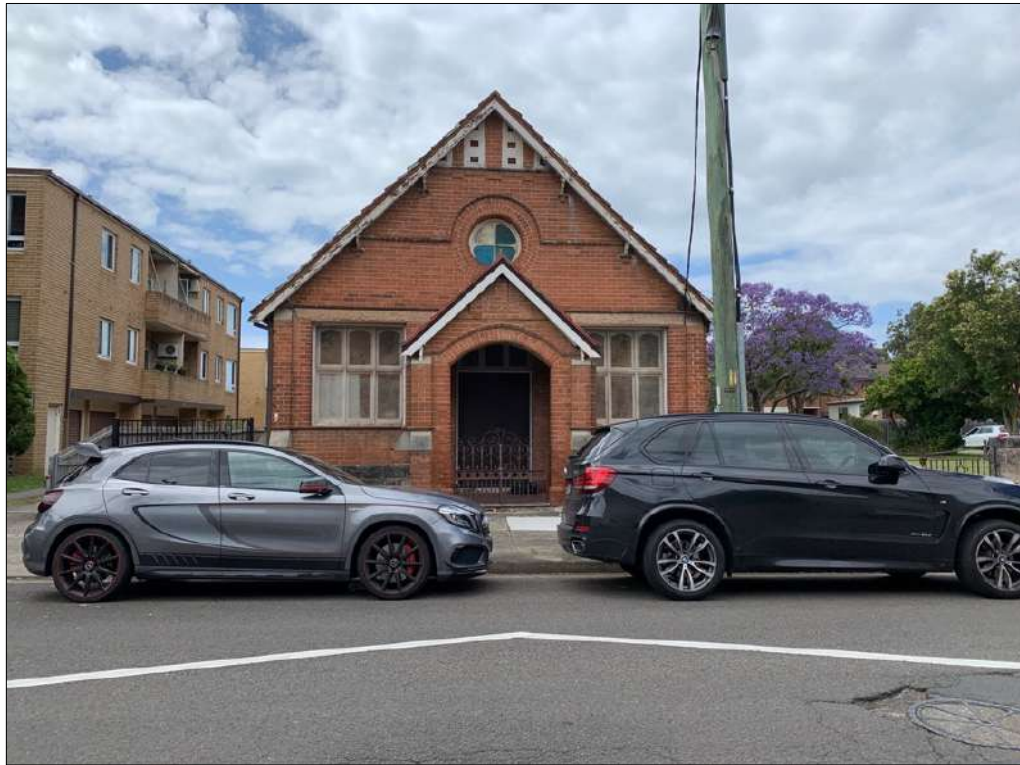
Figure 31: Front, northern, elevation of the Hall

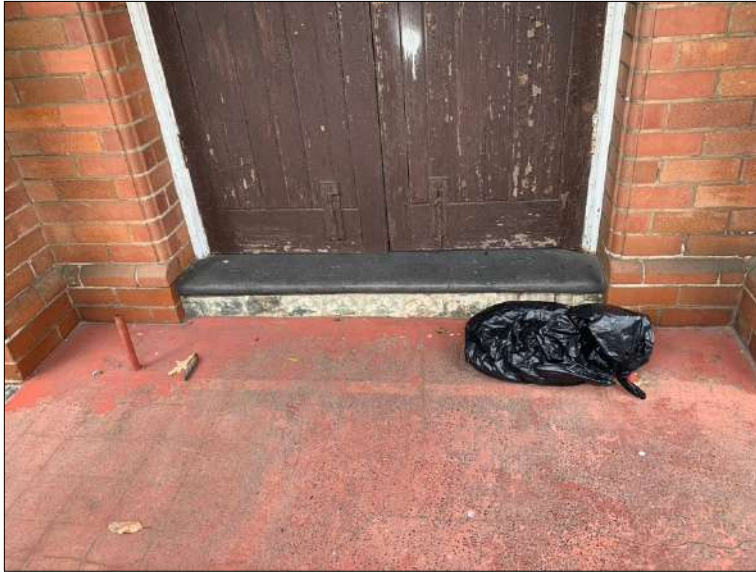
Figure 36:
Coloured concrete floor
of the porch and slate
threshold to the door.

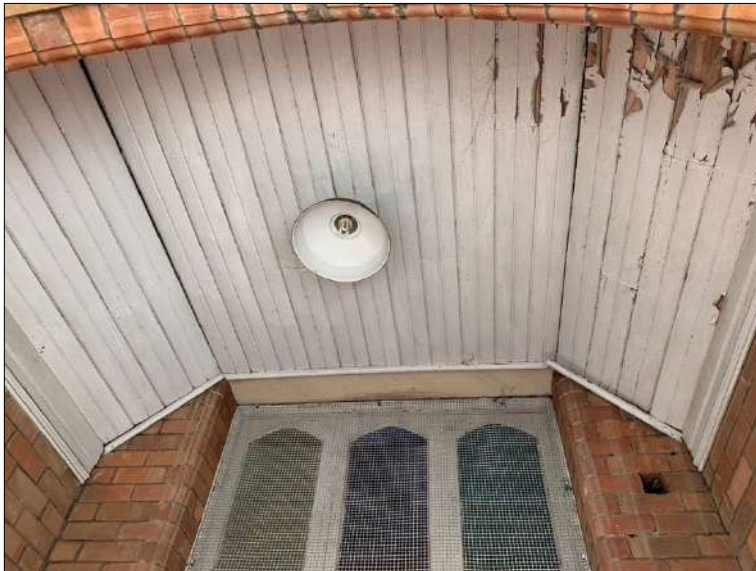
Figure 37:
Timber lined ceiling.

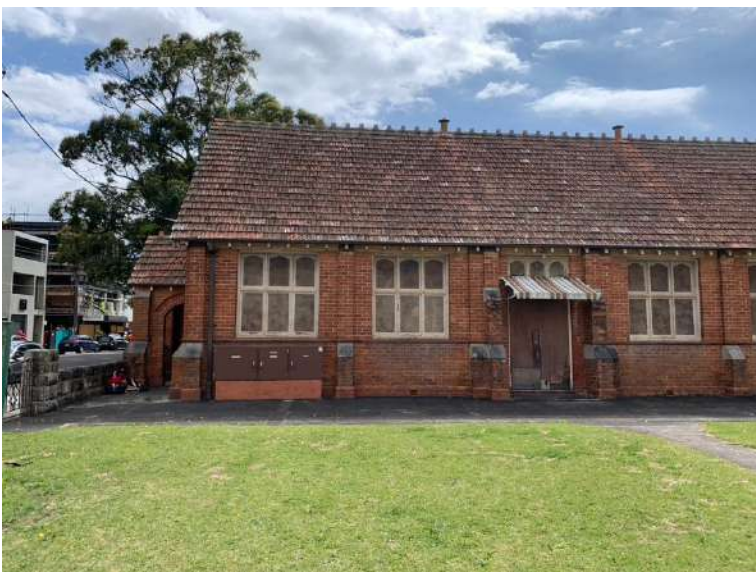
Figure 38:
The western elevation of
the hall, northern end.

- Remove three window sets in the western elevation and replace with doors. The doors will match the width of the existing windows. The doors will be timber or metal framed and have toplights matching the retained windows on this side.

Remove three window sets in the western elevation and replace with doors. The doors will match the width of the existing windows. The doors will be timber or metal framed and have toplights matching the retained windows on this side.

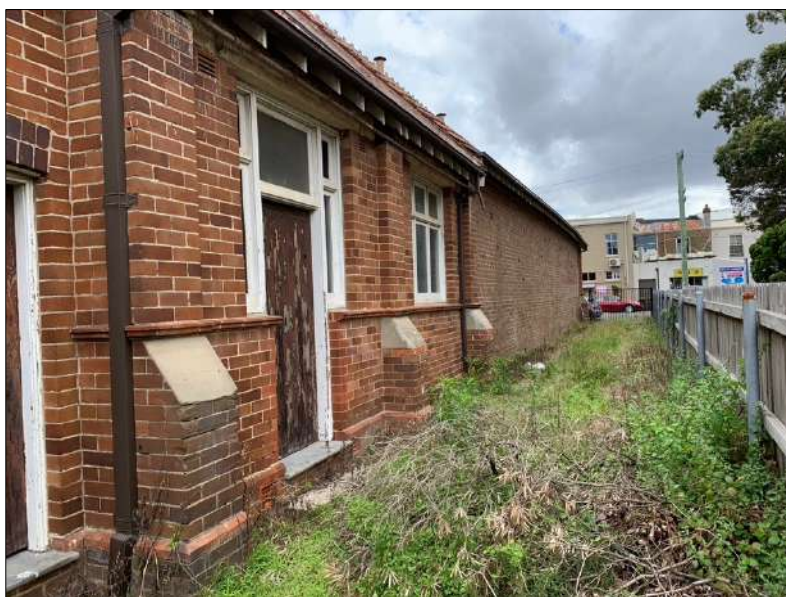
Figure 44:
Looking north along the
eastern elevation of both
phases of construction.

It is noted that the building requires structural repair. The eastern wall, in particular, is leaning outwards.

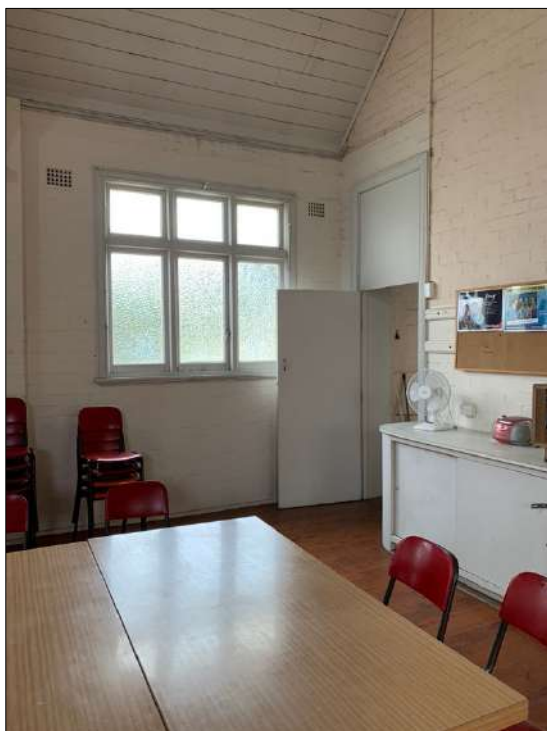
Figure 57: Window and door in the western wall. The door leaf has been replaced.

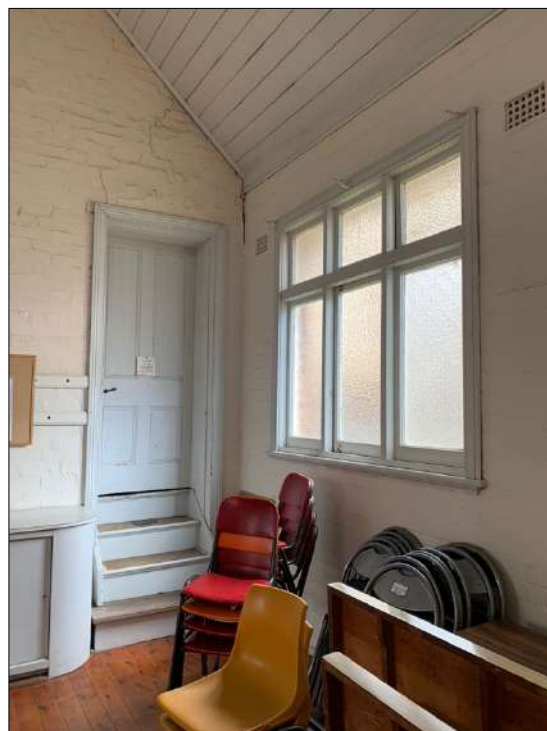
Figure 58: Window and door in the eastern wall. The door leaf is original.

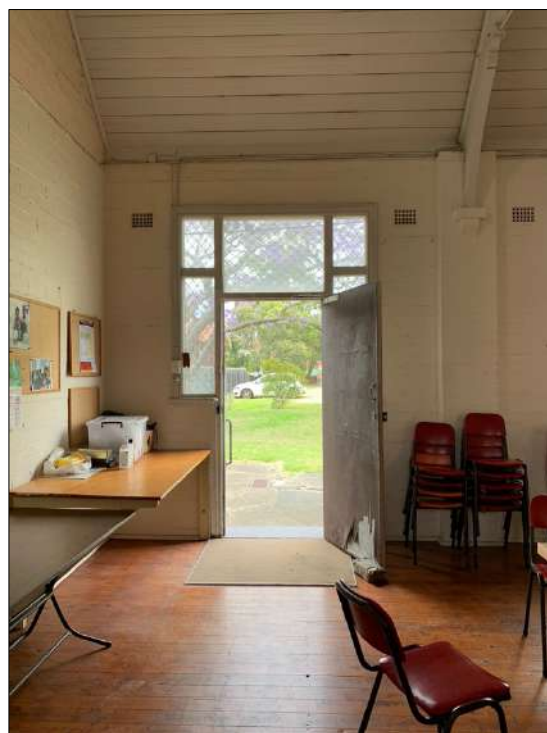
Figure 60: Doors and sidelights on the western side of the meeting hall. The door and glazing have been replaced.

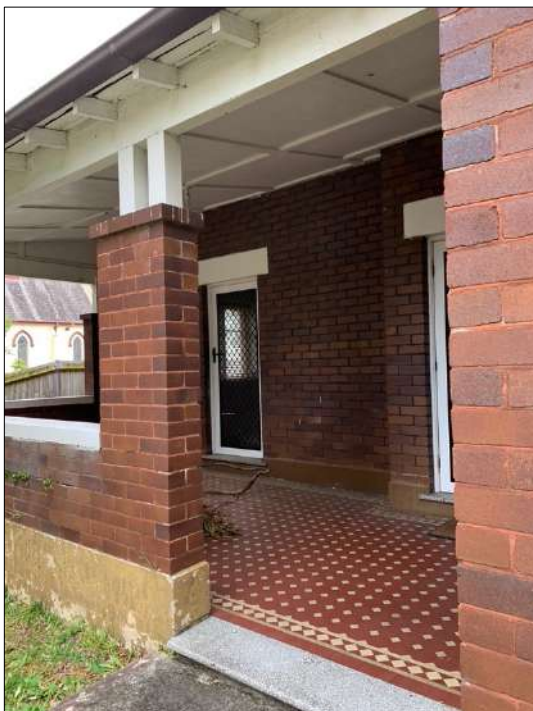
Figure 65:
Detail of the front porch, showing the
terrazzo threshold, enaustic tiling and
battened f/c ceiling.

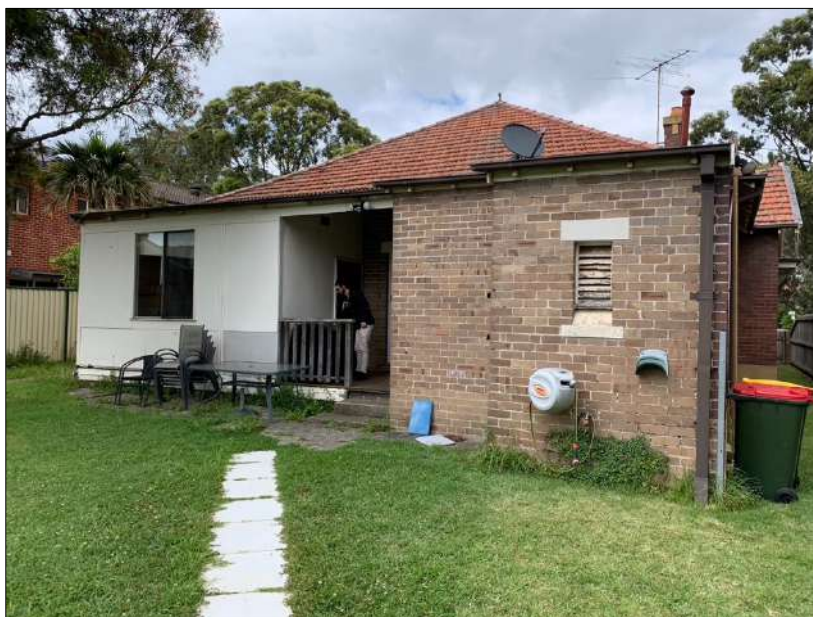
Figure 75:
Rear elevation with the
original wing on the RHS
and the addition on the
LHS.

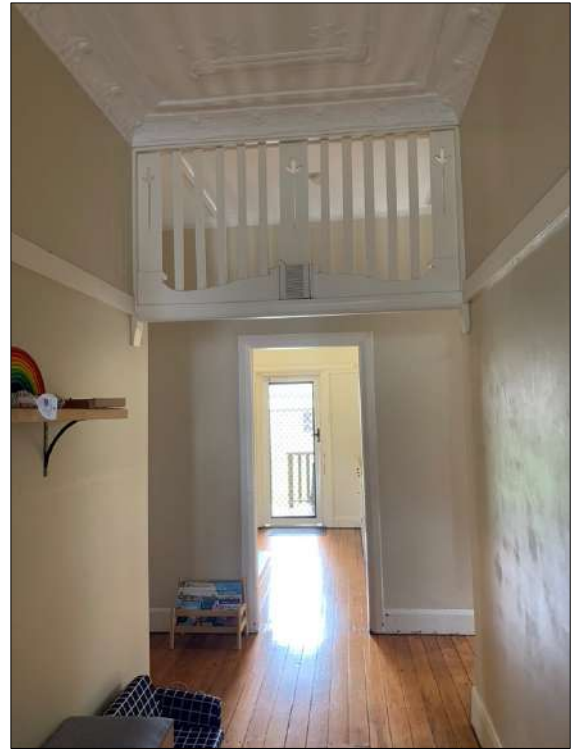
Figure 79: Decorative frieze at the end of the main hallway, opening into the secondary hallway, which runs east-west. The door in the distance is the back door.

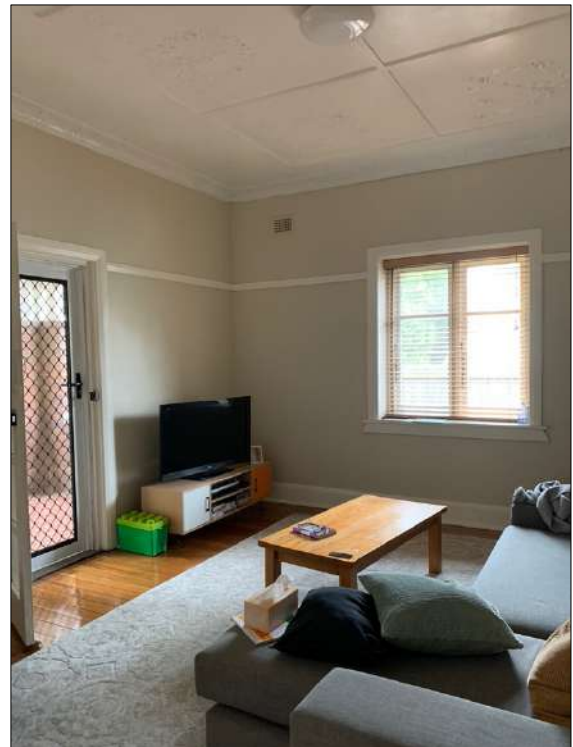
Figure 81: Front room on the northern side, showing the simply profiled joinery and decorative plaster ceiling.

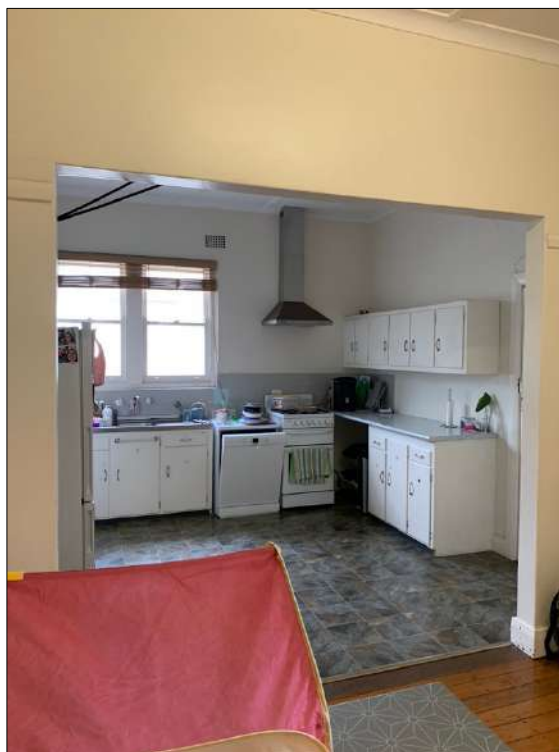
Figure 91: Kitchen with a large opening cut into the adjoining room. The ceiling has a battened ceiling.
