# DETAILED SITE INVESTIGATION

**253 Coward Street,  
Mascot NSW**

**Skylife Coward Pty Limited**

9<sup>th</sup> March 2020

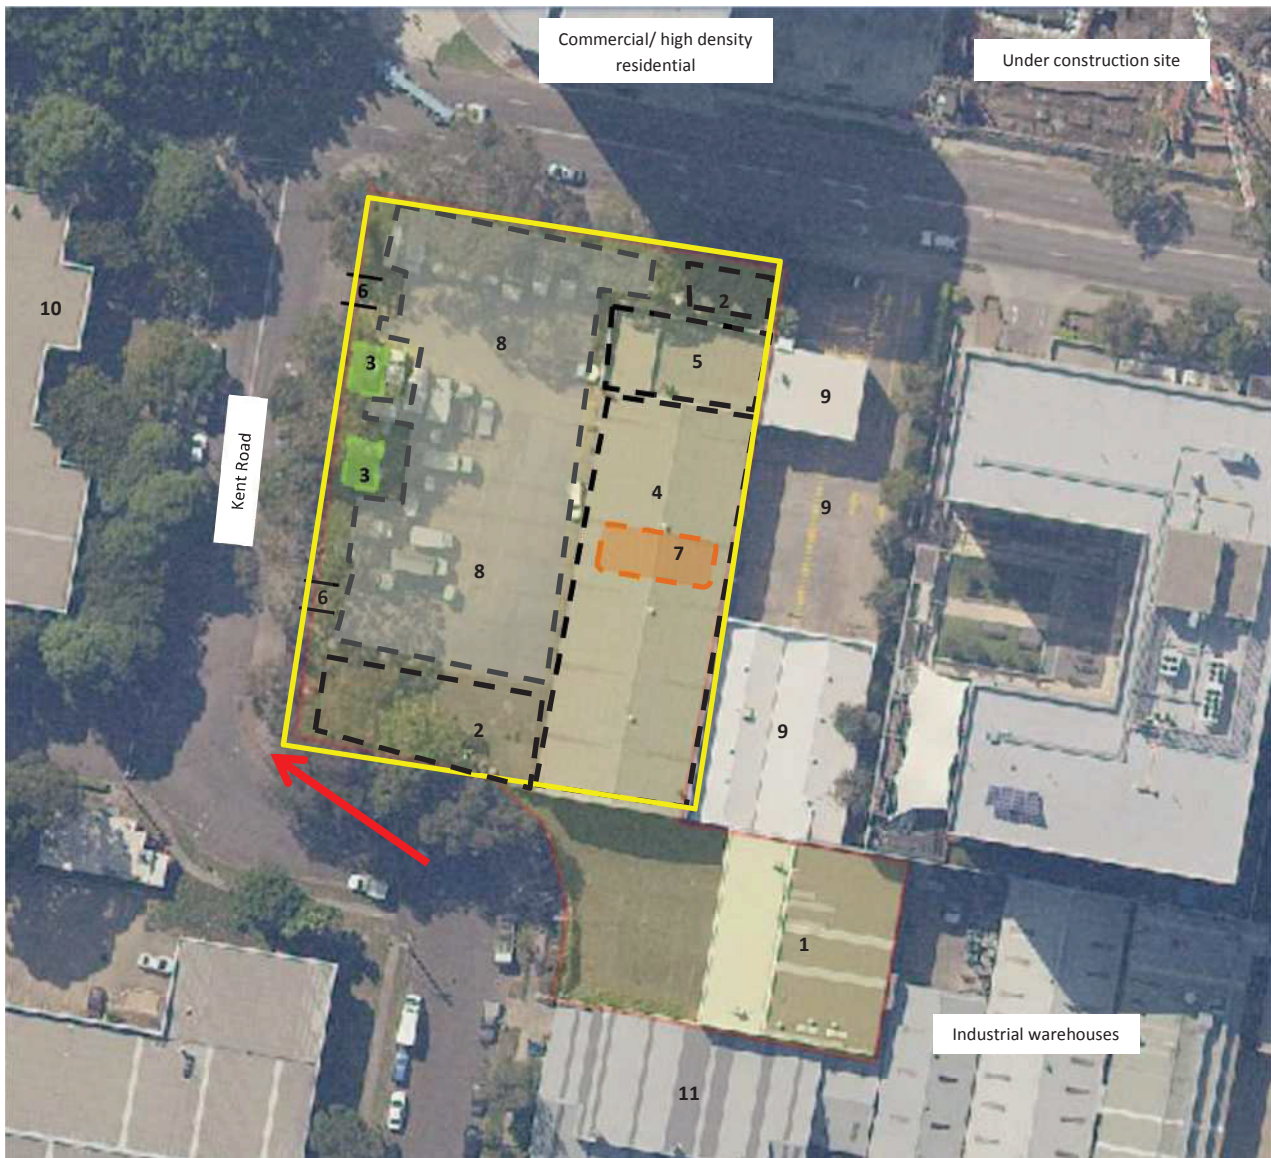
Figure No.	3	Rev No.	0
Scale	1:1128	Size	A4
Drawn by	SP	Date	23.11.2018
Approved by	MK	Date	02.08.2019

Site Features	
1	No.2 Chalmers Crescent - Commercial
2	Bitumen car park area
3	Garden bed area
4	Hino's workshop warehouse
5	Hino's office building
6	Entrance gate
7	Excavated pit, storage area for waste oil tanks and combustible liquid tanks
8	Concrete covered parking area
9	Bridgestone car and 4WD centre
10	Totally Workwear Mascot / Thrifty Offices
11	No.4 Centrum Printing

A site visit was carried out on the 27<sup>th</sup> October 2018 by an Aargus field scientist to inspect the site for any potential sources of contamination and document any observations made regarding the current site conditions. At the time of the site inspection, the following observations were made with the site features presented in Figure 3 of Appendix A and the site photographs are included in Appendix C.

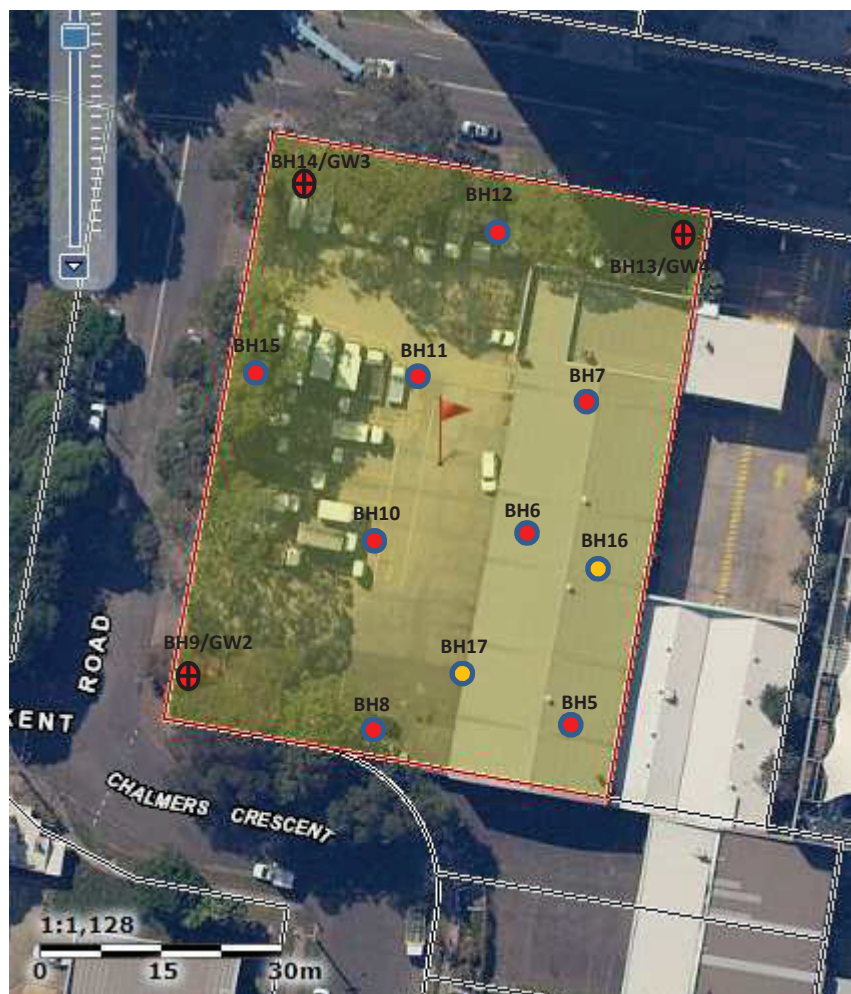
Figure No.	4a	Rev No.	0
Scale	1:1128	Size	A4
Drawn by	NZ	Date	25.02.2020
Approved by	MK	Date	25.02.2020

# BOREHOLE LOCATIONS ON AERIAL VIEW

We recommend that this section be read in conjunction with Figure 4 (Sample Location Plan) in Appendix A, the Daily Work Sheets in Appendix K and the borehole logs in Appendix J.

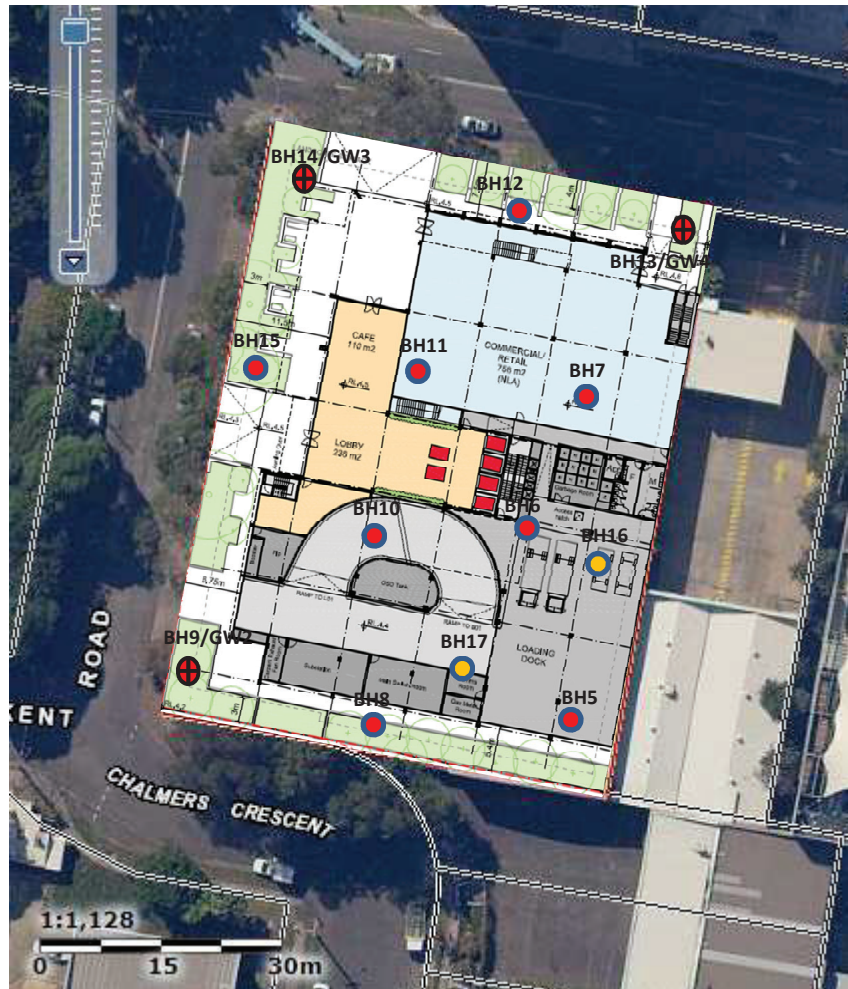
Figure No.	4b	Rev No.	0
Scale	1:1128	Size	A4
Drawn by	NZ	Date	25.02.2020
Approved by	MK	Date	25.02.2020

# BOREHOLE LOCATIONS ON DEVELOPMENT PLAN

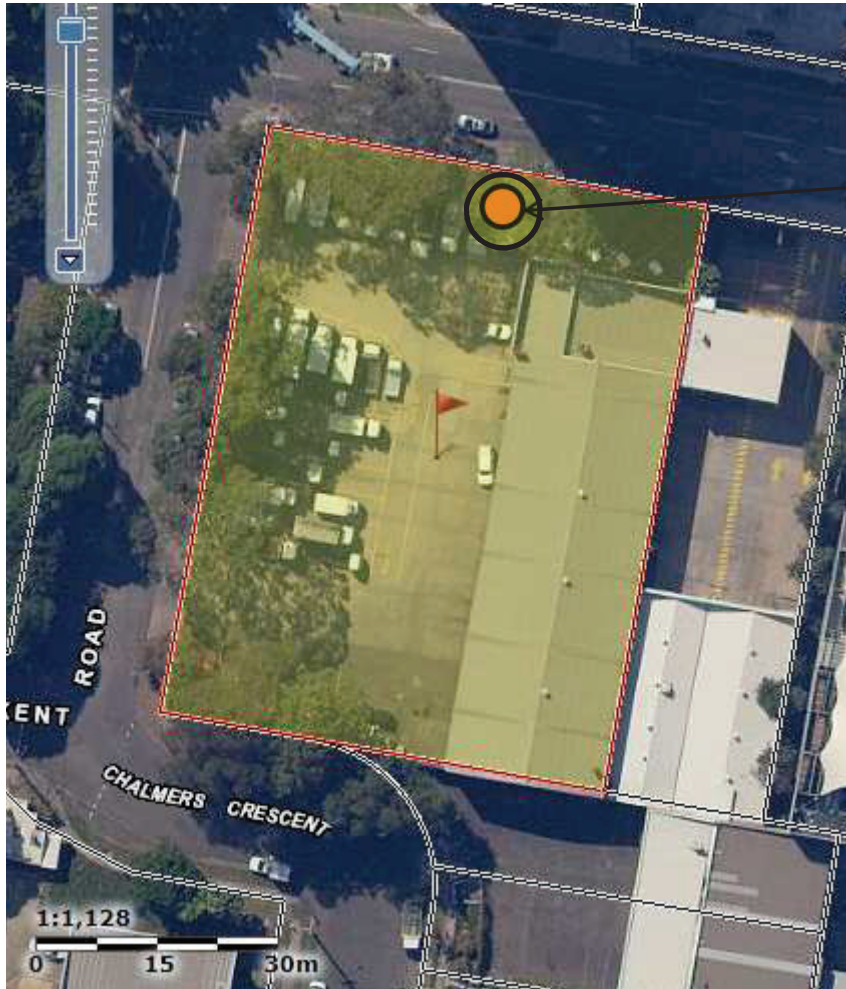
# SOIL EXCEEDANCES

BH12 (02-0.3m)

Zinc concentration of 638mg/kg, exceeded the site derived EILs of 290mg/kg

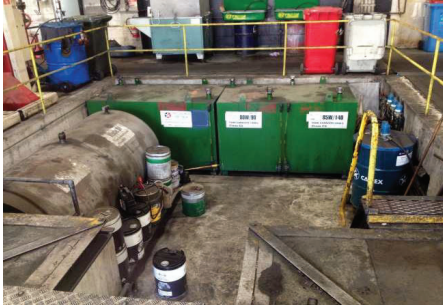
**Photograph N° 1**

- An excavated pit was noted in the centre of the workshop and used for storage of one waste oil tank and two combustible liquid C2 tanks. In addition, one 200 litre oil drum and multiple oil and liquid containers were noted inside the pit. The pit was observed to be concrete covered.

View of: Waste Oil Tank & combustible liquid C2 tanks  
Looking: East  
Inspected on : 27.10.2018

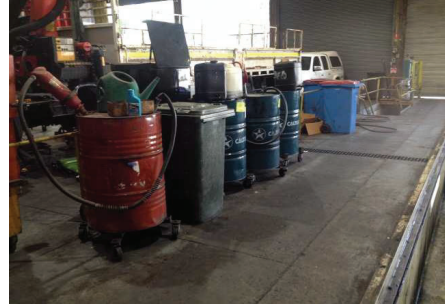
**Photograph N° 2**

- 200 litres oil drums were noted in various places in the eastern and middle portions of the workshop.
- The remainder of the site in the front was concrete covered, with exception of a bitumen covered area in the north eastern corner and along the southern boundary. The concrete and bitumen areas were used to park trucks. The concrete and bitumen were generally in good condition with some cracks on the surface.

View of: Oil drums  
Looking: South west  
Inspected on: 27.10.2018

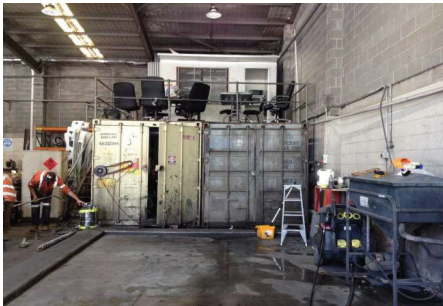
**Photograph N° 3**

- Multiples metal shelves were observed in various places to store tools and equipment.
- Two large metal shipping containers were noted in the south eastern corner within the workshop. One of the containers was used to store tools and equipment. The second container was locked at the time of the inspection.

View of: Metal containers  
Looking: South east  
Inspected on: 27.10.2018

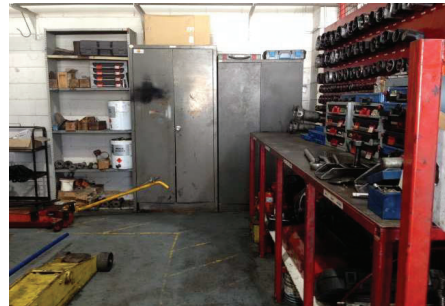
**Photograph N° 4**

View of: Metal shelves and tool area  
Looking: North east  
Inspected on: 27.10.2018

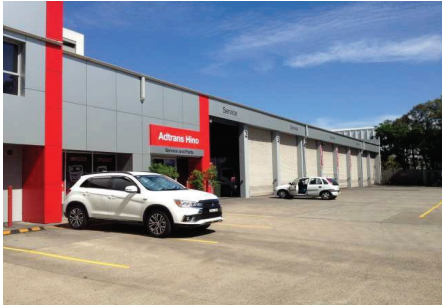
**Photograph N° 5**

- The Adtrans Hino office building was a two-storey building with the workshop constructed of brick with a colorbond roof adjacent to it and was utilised for truck services and repairs.

View of: Adtrans Hino's Office and workshop building  
Looking: South east  
Inspected on : 27.10.2018

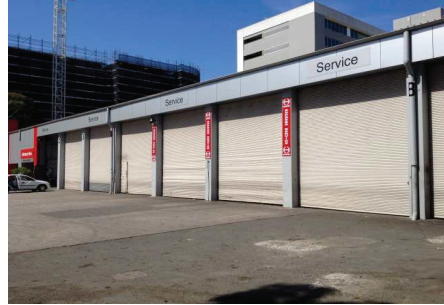
**Photograph N° 6**

- Access to the workshop was via metal garage doors facing west.
- The workshop was concrete covered. Major oil staining was noted at the time of the inspection on the surface of the concrete.

View of: Hinos' Workshop  
Looking: North east  
Inspected on: 27.10.2018

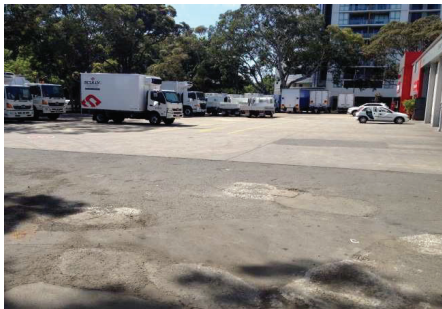
**Photograph N° 7**

View of: Bitumen and concrete parking area  
Looking: North west  
Inspected on: 27.10.2018

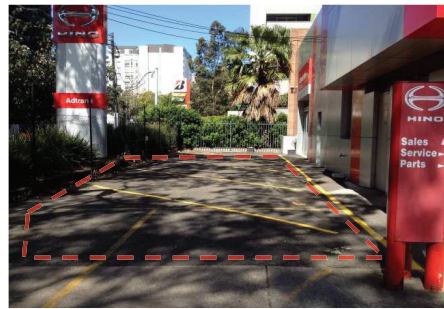
**Photograph N° 8**

View of: Parking bitumen area  
Looking: North east corner  
Inspected on: 27.10.2018

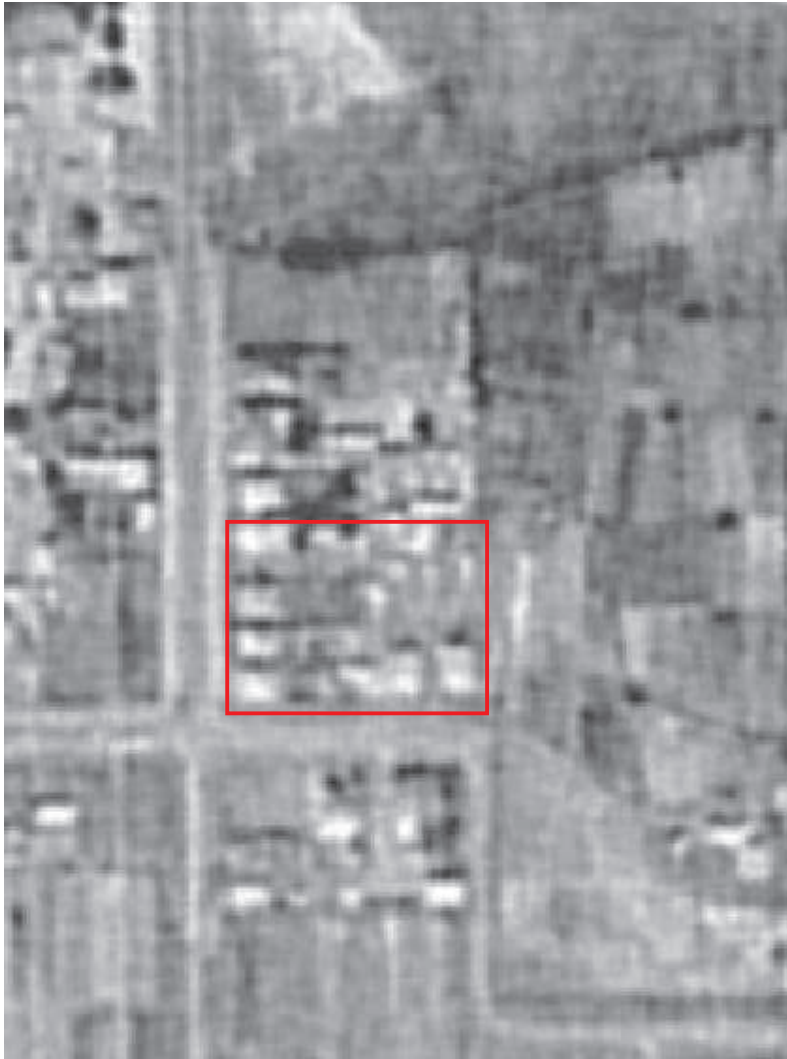
HISTORICAL AERIAL PHOTOGRAPHS - 1930

Year	Site	Surrounding areas
1930	The site comprised of building structures in the north, north east and along the western boundary. The remainder of the site appeared to be vacant land. However, it was noted that photo resolution was of very poor quality	N: A road, then vacant land S: Vacant land E: Building structures W: A road, then some building structures & vacant land
1943	The site layout appeared to be similar to that observed in 1930. The entire site was occupied by residential houses.	N: A road, the vacant land with potential market gardening activities are visible S: Vacant land, with potential market gardening activities are visible E: Low density residential W: A road, then low density residential
1970	All previous structures are gone. The site is comprised of two main large structures located in the eastern portion of site. A few other small structures also were noted along the western boundary. The remainder of the site appeared to be vacant.	N: A road, then vacant land. Market gardening activities no longer visible S: Market gardening activities no longer visible E: House structure is gone W: A road, then new commercial development
