Alterations and Additions to the Gladesville Bay Marina 380 Victoria Place, Drummoyne NSW 2047

Gladesville Bay Marina Pty Ltd 30 September 2019 18166

Zoic Environmental Pty Ltd (Zoic) was requested by Gladesville Bay Marina Pty Ltd to complete a contamination assessment of soil, sediment and groundwater at 380 Victoria Place, Drummoyne, NSW ("the site"), to support a development application. The development application relates to a proposed extension and upgrading of facilities on site, including extending the marina. Available information indicates that site excavation is not proposed during site redevelopment. The slipway has been considered as a component of this investigation, noting that slipway portions extend beyond the site boundary into Parramatta River.

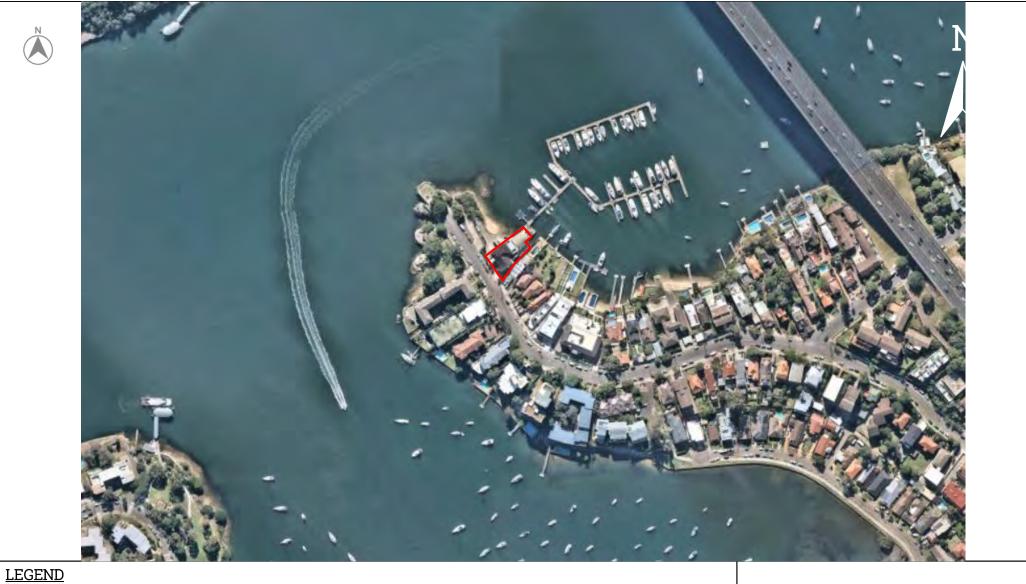
Approximate Site Location		Figure 1: Site Loca	tion Plan
		Site Address: 380 Victoria P	lace, Drummoyne NSW
This product has been created to support the main report and is not suitable for other	Not to Scale	Client: Gladesville Bay Marina Pty Ltd	
purposes. Image courtesy of Google Maps		Job Number: 18166	Date: September 2019

The site location and layout are shown in Figures 1 and 2 of Appendix A.

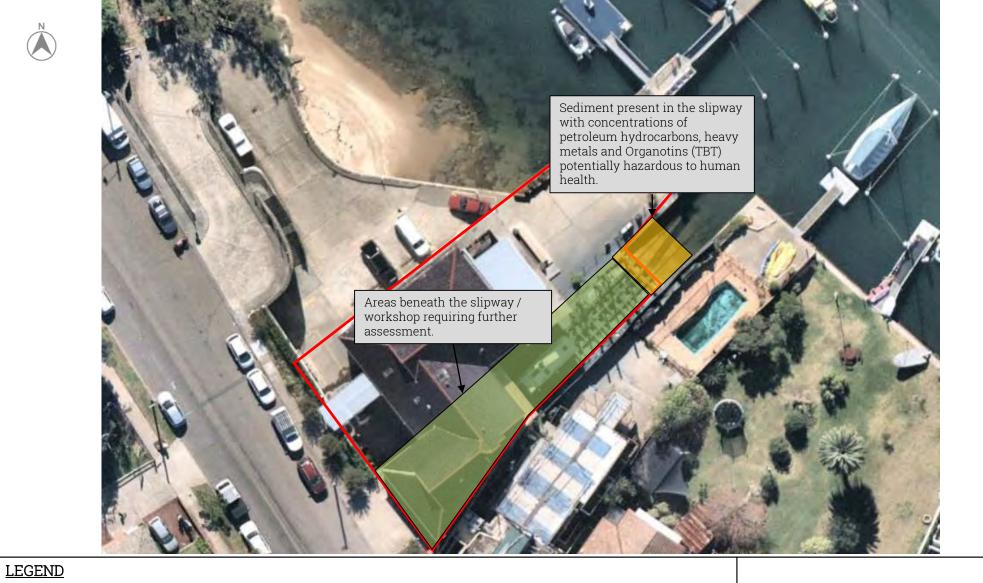
The results of this investigation indicate that any extension/improvement of the marina facilities must take into consideration the need to avoid/reduce sediment disturbance in areas proximate to the slipway to minimise impacts to marine flora and fauna. It is understood that the slipway area will not be used for maintenance operations under the new marina design and the underlying concrete slab will not be physically altered or removed as part of the works. It is noted that sediments beneath the slipway/hardstand require further assessment to confirm that the risk from potential contaminants under the slipway are acceptable for any future use of the land, as the slipway was operational at the time of investigation preventing investigations at the time. Groundwater monitoring results indicate a low risk to human health or the environment. Based on results of this investigation, there is considered to be a low likelihood that the former UST tankpit has any ongoing impact on soil or groundwater conditions on site.
