# **GLADESVILLE BRIDGE MARINA REDEVELOPMENT PROPOSAL**

## **ENVIRONMENTAL IMPACT STATEMENT:**

## **ECOLOGY ASSESSMENT REPORT**

**Marine Pollution Research Pty Ltd  
October 2019**

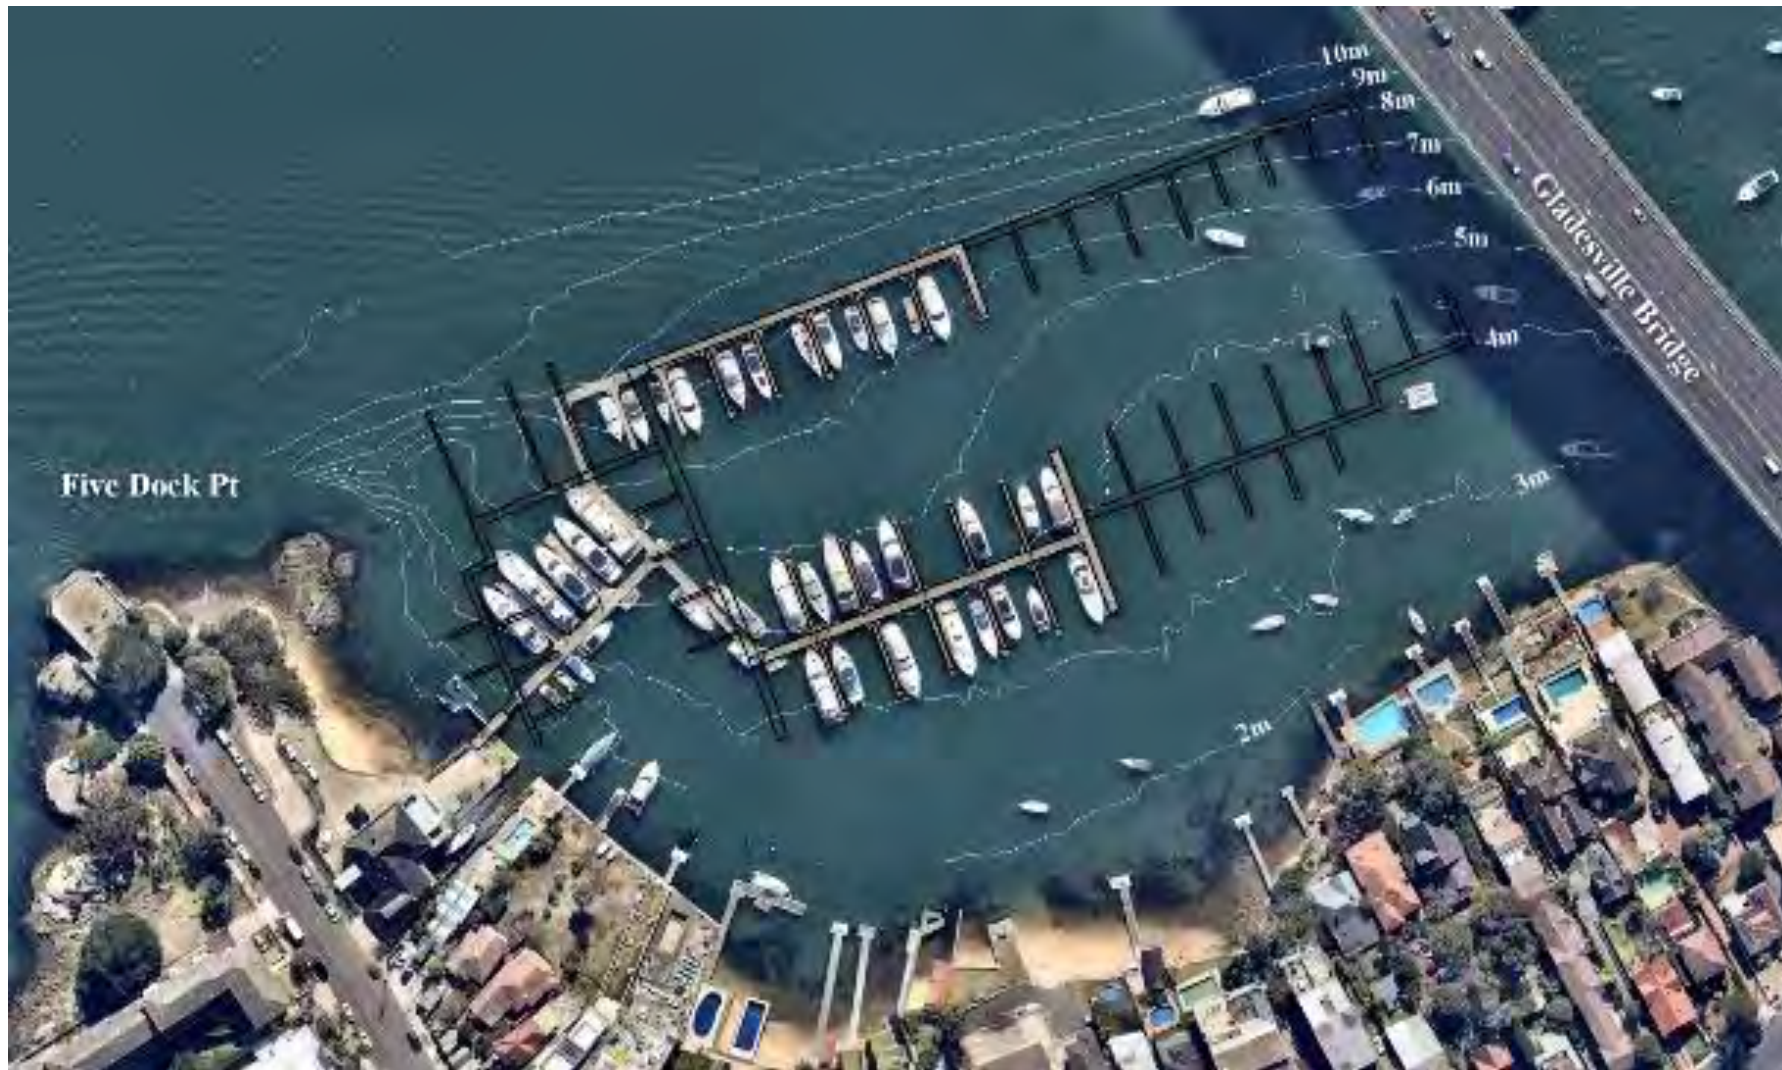
**Figure 2:** Proposed Floating Berth Marina (black outline) superimposed over existing marina configuration. Hydrographic survey detail has been added (datum 0m Fort Denison which is approximately Indian Spring Low Water ISLW).

- Current marina depths range from -3m to -5m below lowest astronomical tide (LAT) for the inner (southern) marina arm and berths, and -5.5m to -8m for the outer (northern) marina arm and berths.
- There are a series of shallow inshore berths offshore from the slipway, depths generally -1m to -2m LAT.
- Depth ranges for proposed new floating pontoons and berths are consistent with the existing structure; -3 to -4.5m depth LAT for the inner arm and -5.5m to -9m depth for the outer arm.

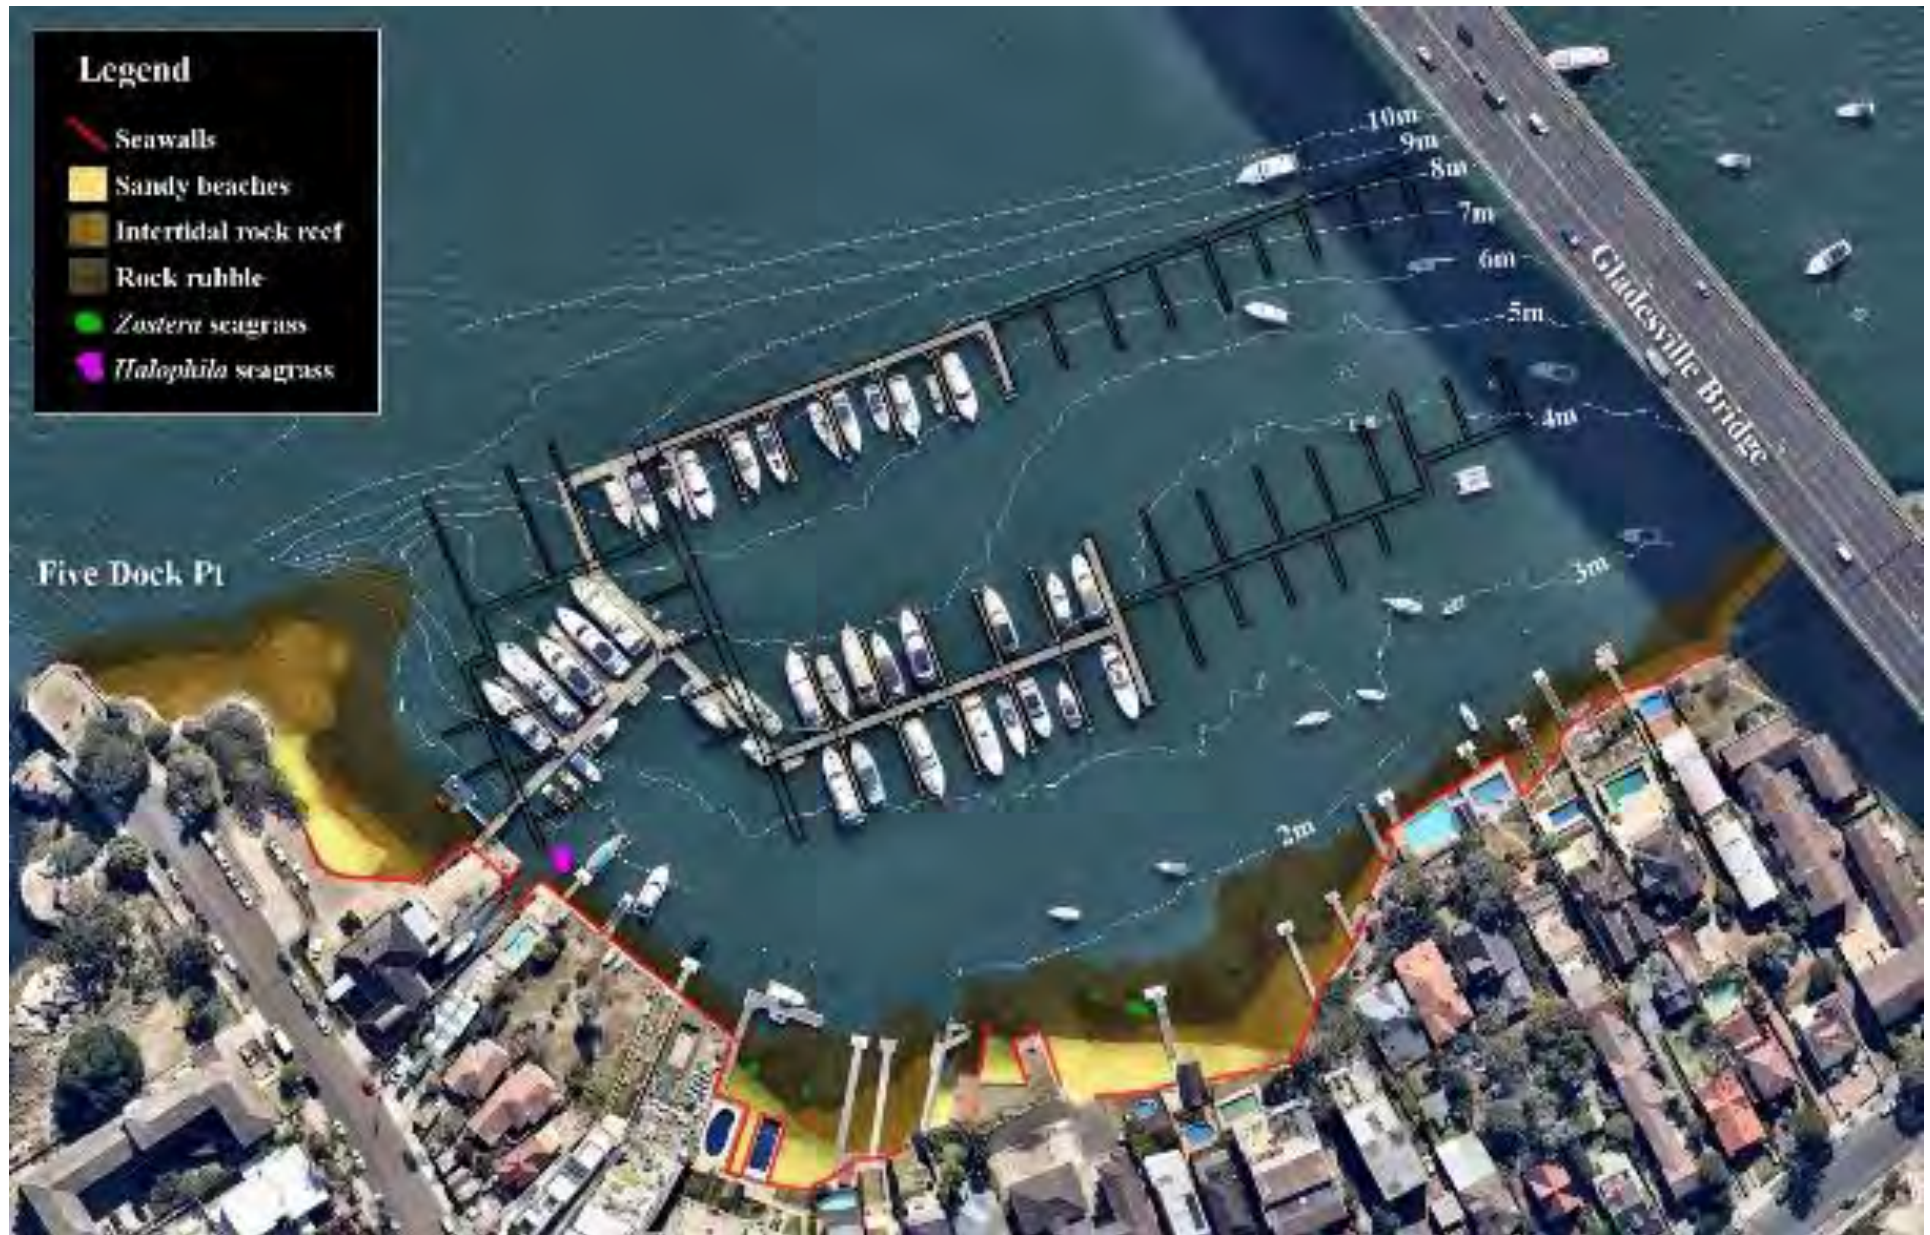
**Figure 7:** Main intertidal to shallow sub-tidal aquatic habitats bounding Gladesville Bridge Marina. The offshore habitat is bare sediment.

- There is a mixed concrete and sandstone block seawall around the land-based facilities of the Gladesville Bridge Marina with a narrow intertidal rock rubble toe. The operational slipway is a sloping concrete structure with attached slip rails and some isolated rock rubble around the toe of the slipway.

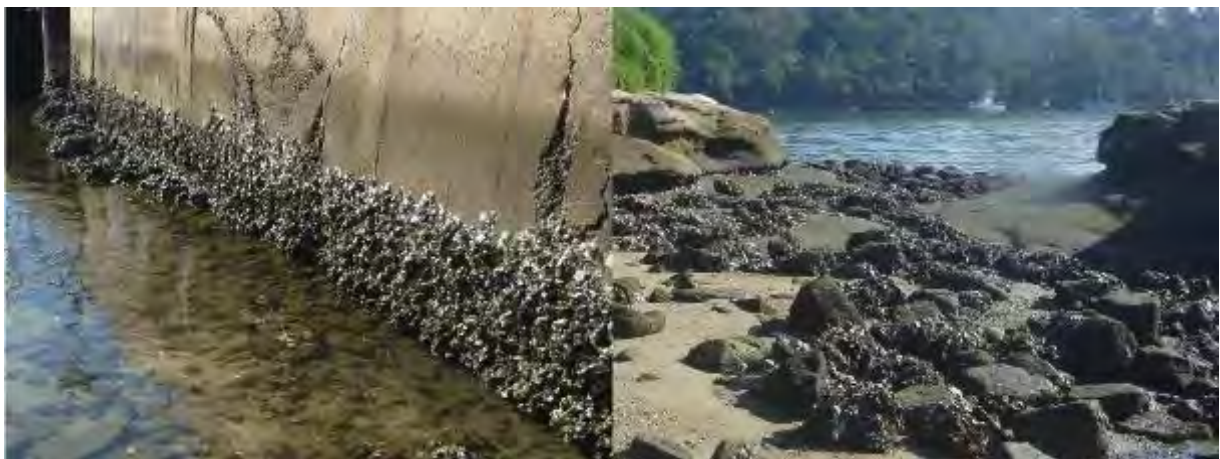
**Figure 8:** Oyster growth on seawall (left) and on rock rubble around the sandstone rock platform adjacent Five Dock Point (right).

- Only Sydney Rock Oysters (*Saccostrea glomerata*) were observed and there were no Pacific Oysters (*Crassostrea gigas*), which are known from Sydney Harbour. Oyster density was generally greater in the protected areas on vertical seawall faces. There were several sections of wave-exposed seawall and bedrock platforms that were bare or supported sparse oyster growth, and this was presumably due to the effect of wave action from the Rivercat Ferries which traverse this section of the Parramatta River adjacent to the proposal.

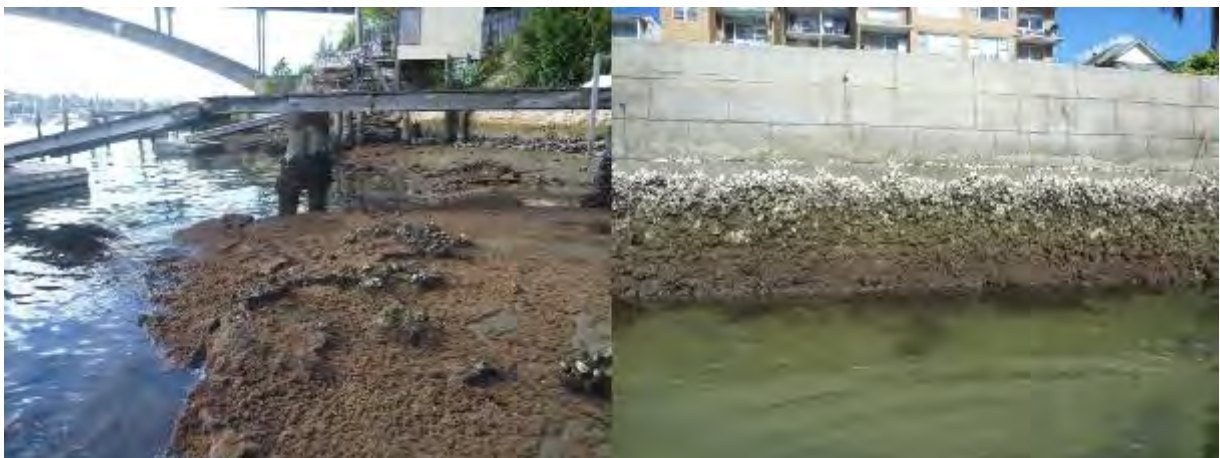
**Figure 9:** Turf algae growth on rock platforms (left) and underneath oyster band on vertical seawall (right).

- Coralline algae (*Corallina officinalis*) forming turf mats were prominent on intertidal hard substrata, particularly horizontal bedrock platforms and the concrete boat ramp (see **Figure 9** below) at 0.4 to 1.0m above LAT.

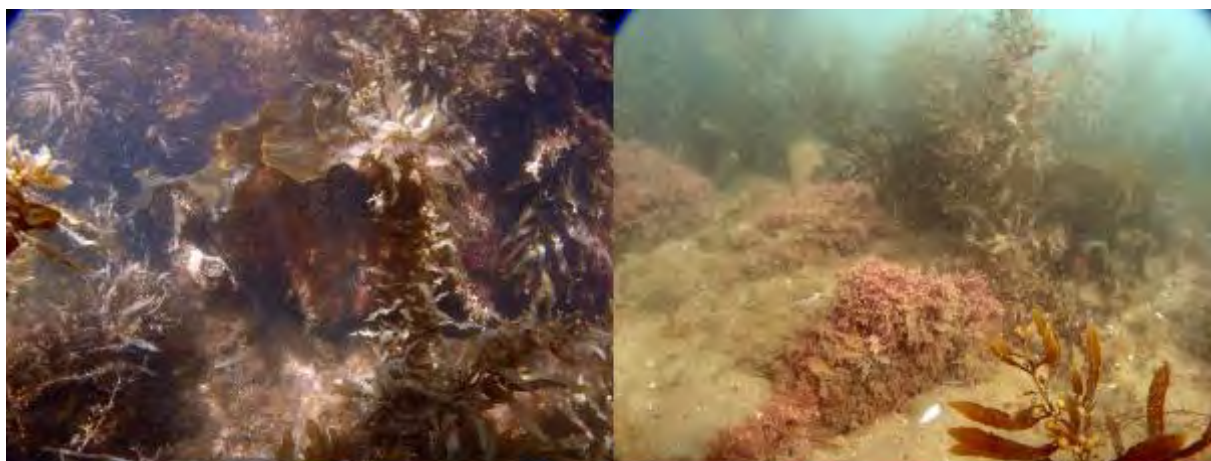
**Figure 10:** Shallow sub-tidal to sub-tidal sandstone boulders with kelp and sargassum sp (left), and rock rubble with coralline algae, *Sargassum sp*, kelp and *Dictyota* (right).

- Rocky reef and rubble toe habitats in the low intertidal and shallow sub-tidal fringe habitats supported a mixture of encrusting and frondose algae species, including coralline algae, *Sargassum sp*, *Padina sp*, kelp and *Dictyota dichotoma* (see **Figures 10 and 11** below).

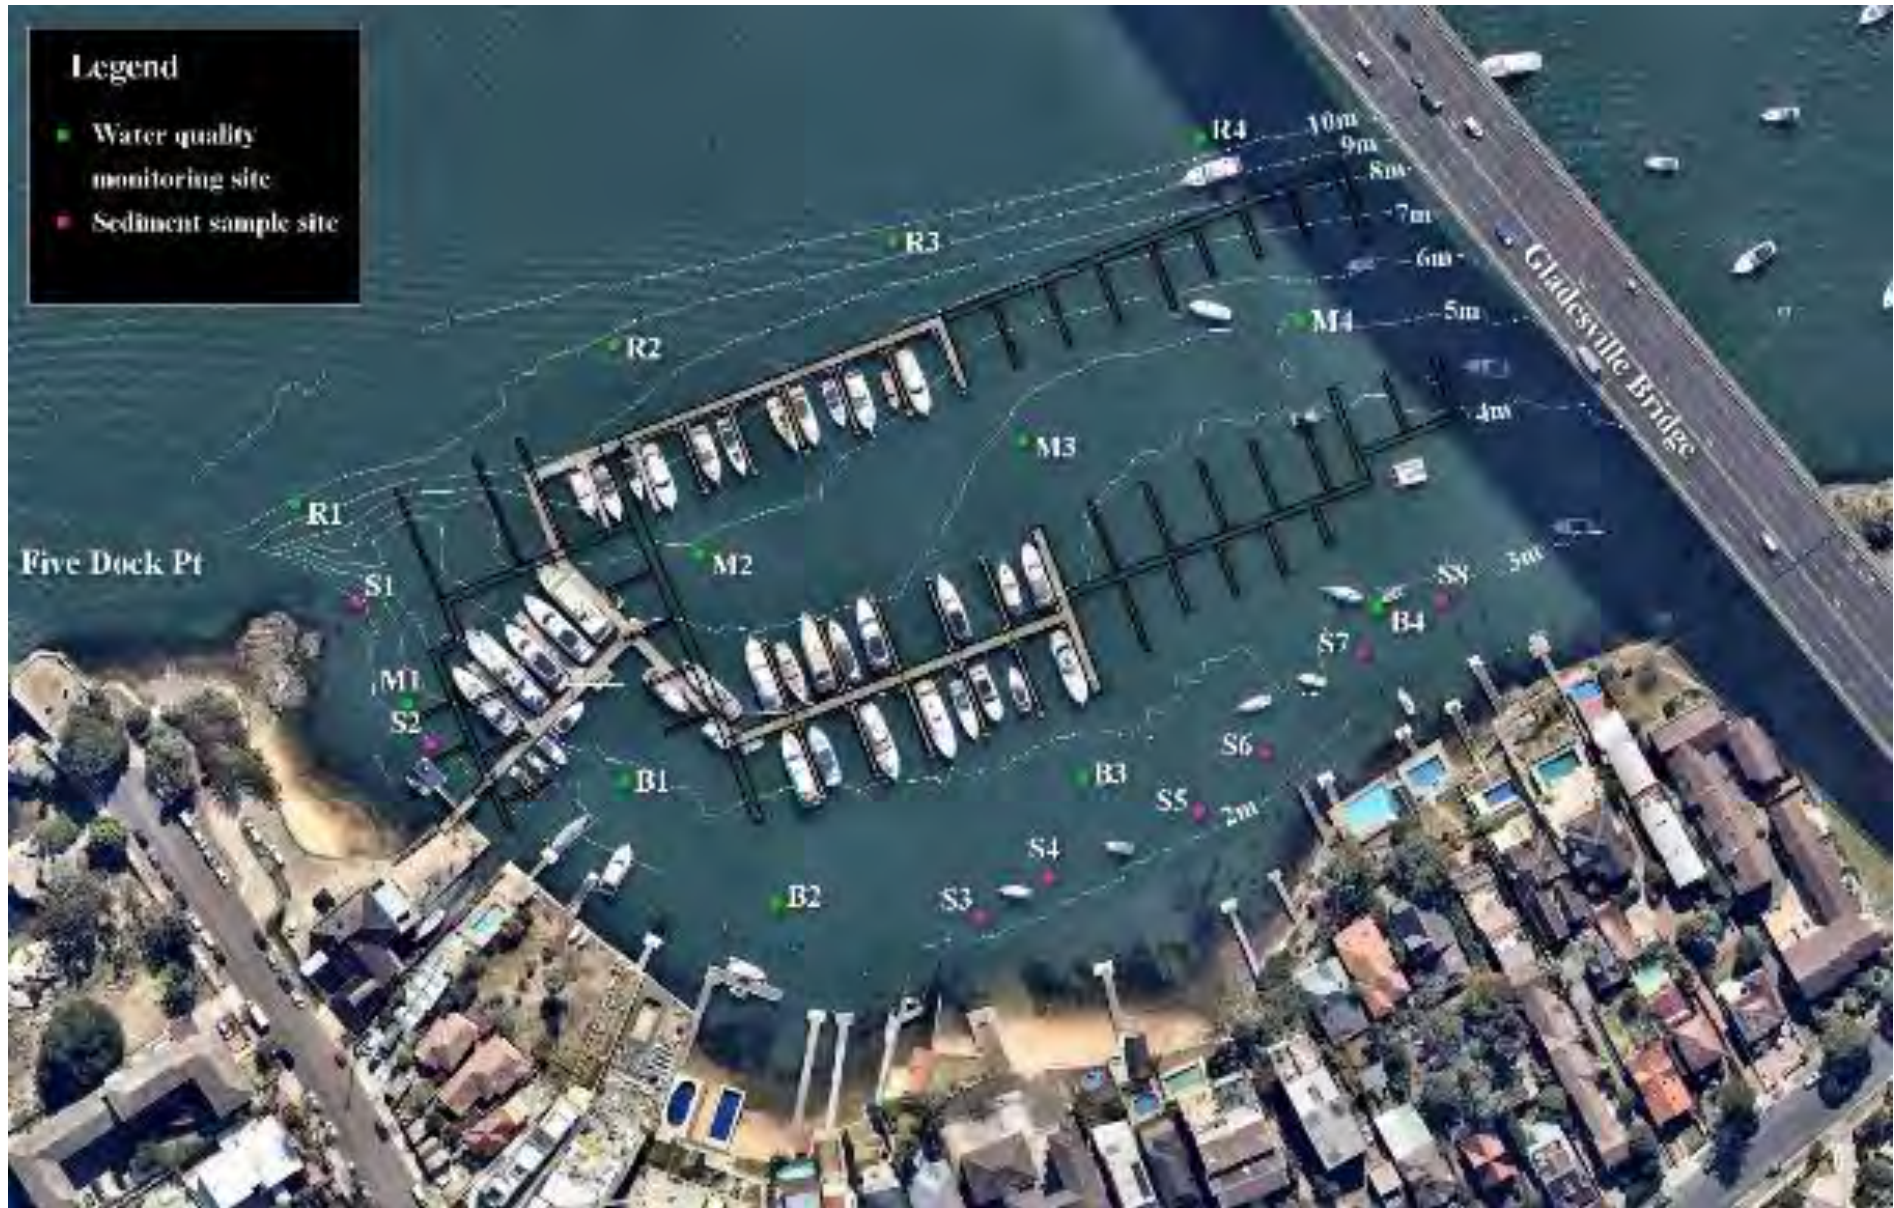
**Figure 14:** Site figure showing locations for water quality and sediment sample sites. Note the footprint of the proposed marina (black outline).

- Sampling of surface and bottom waters from up to 12 locations bounding the study area over three events; neap dry, spring dry and wet weather conditions (see **Figure 14** for site locations).
- Water samples were analysed for total suspended solids (TSS), Copper and dissolved organic carbon (DOC).
- Depth profiling of water quality was undertaken using a submersible Yeo-Kal 915 water quality data logger which records water depth, temperature, dissolved oxygen concentration and saturation, pH, conductivity and turbidity.

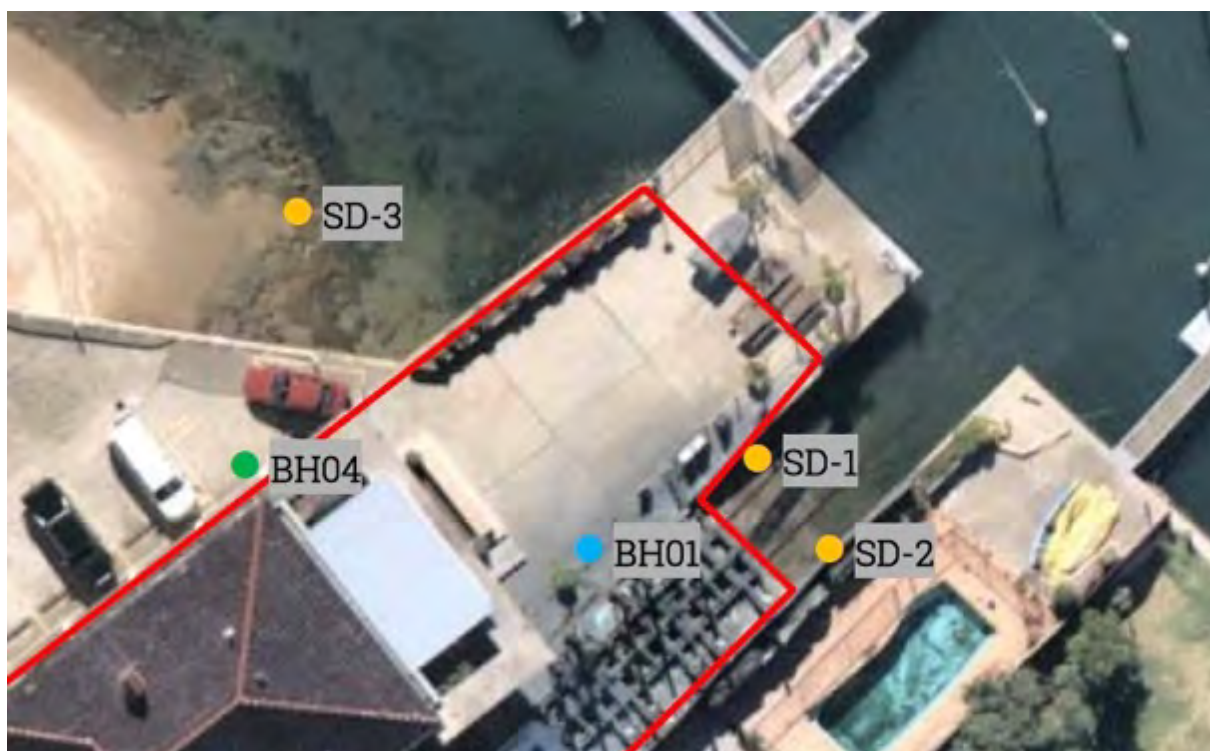
**Figure 15** Portion of Zoic (EIS Appendix G) Figure 3 showing the location of Surface Sediment Samples (SD-1 to SD3).

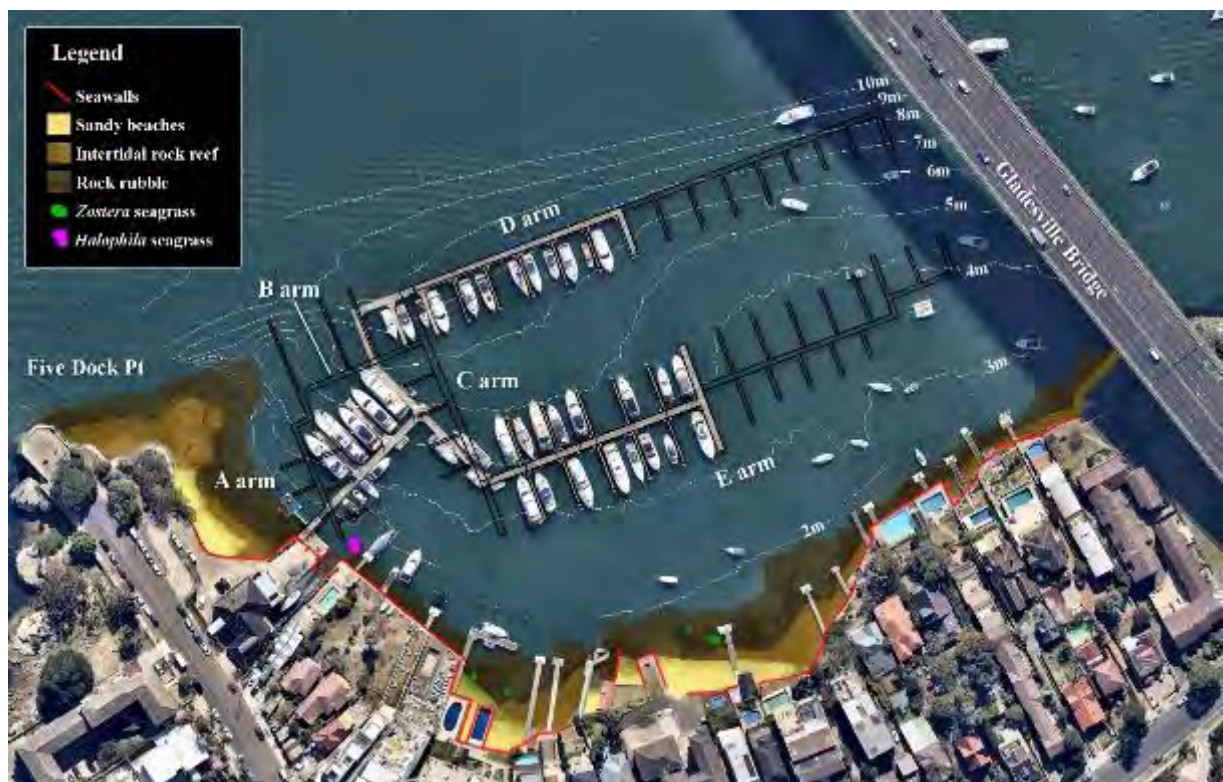
**Figure 16:** Gladesville Bridge Marina showing the proposed Marina layout (black outline) and proximity of identified aquatic habitats.

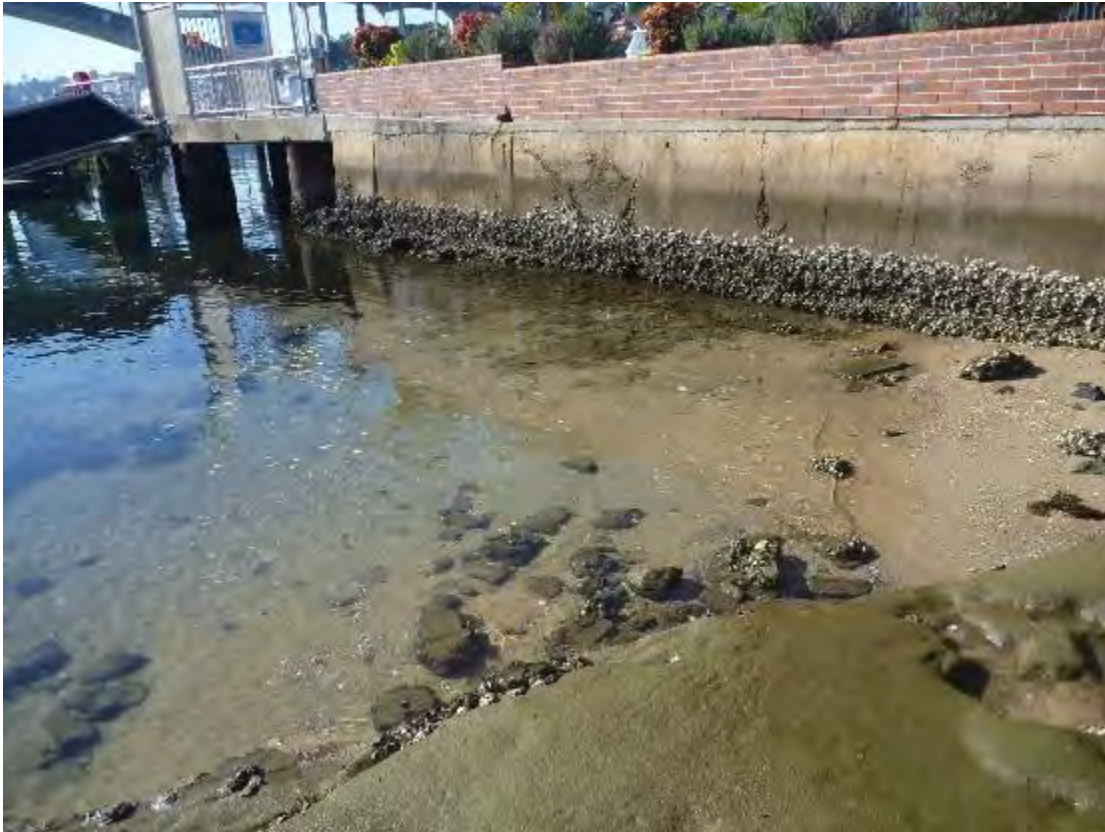
Plate 3: Concrete seawall bounding Gladesville Bridge Marina. Note the dense band of oysters above the waterline.

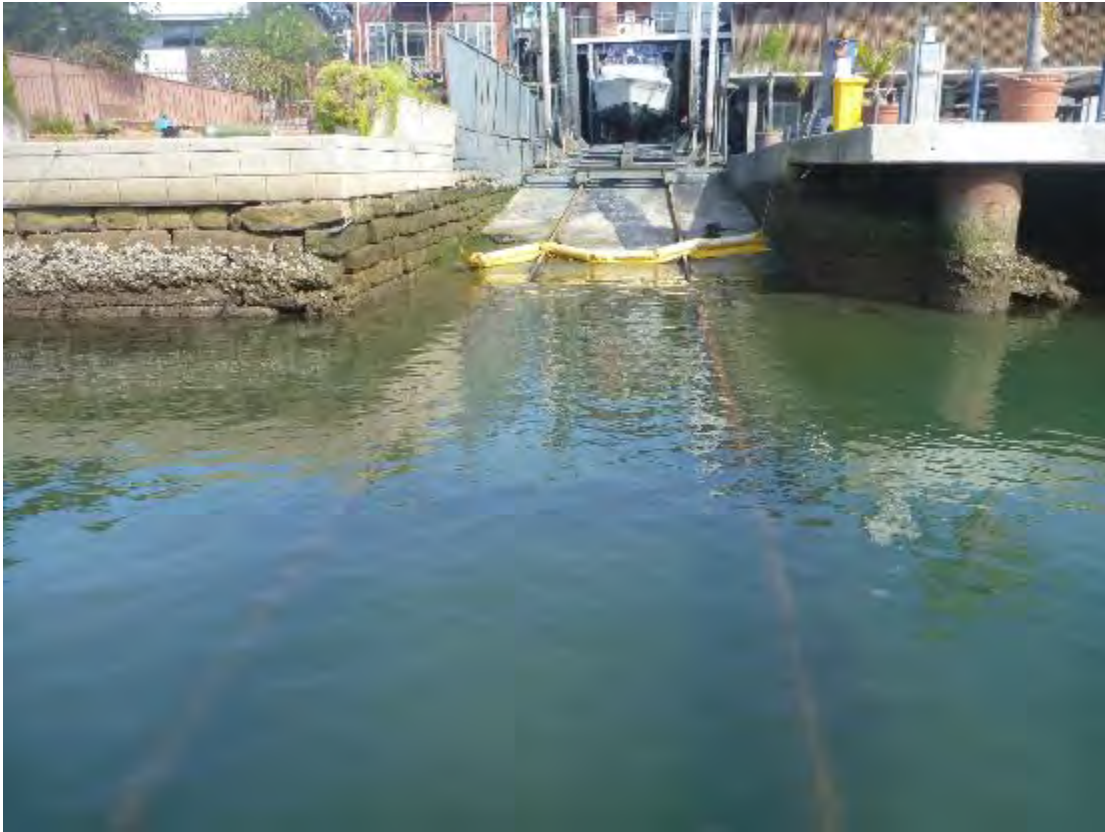
Plate 5: Gladesville Bridge Marina slipway (to be removed under proposal), with beginning of seawall (left hand side) bounding the waterfront residential properties.

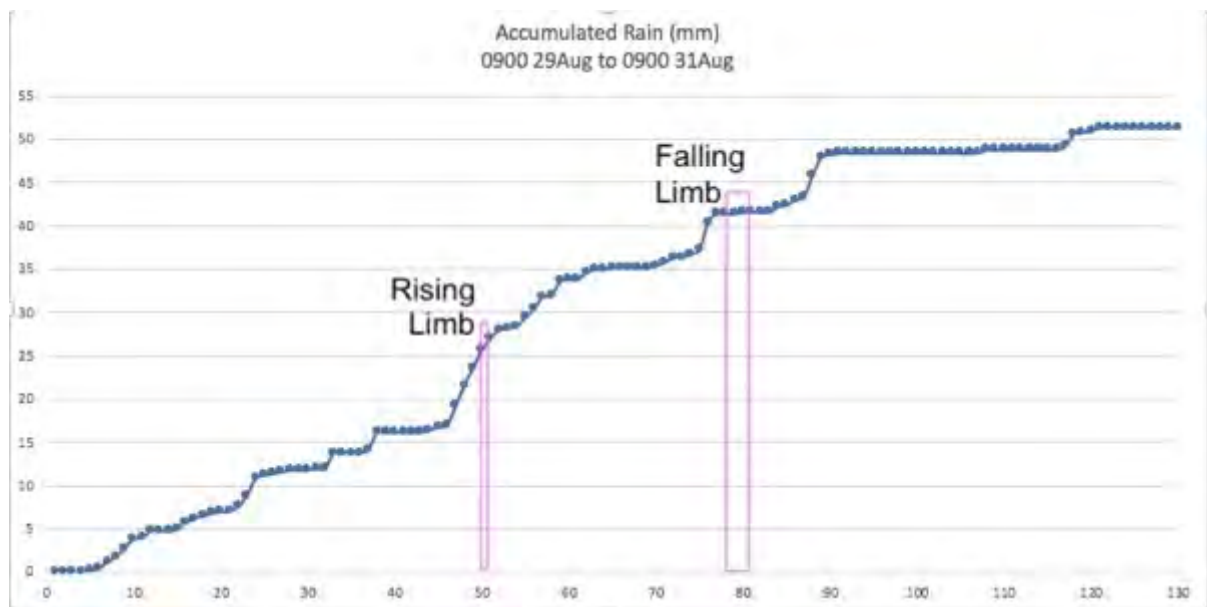
**Figure C-3** Accumulated rainfall recorded at Sydney Olympic Park BoM Gauge. from 09:00 on 29th to 09:00 on 31st 2019. The pink boxes indicate the sampling times for the Wet Weather sampling (15:00 to 16:00 on 29th for Raising Limb and 12:00 to 13:00 on 30th August for Falling Limb).

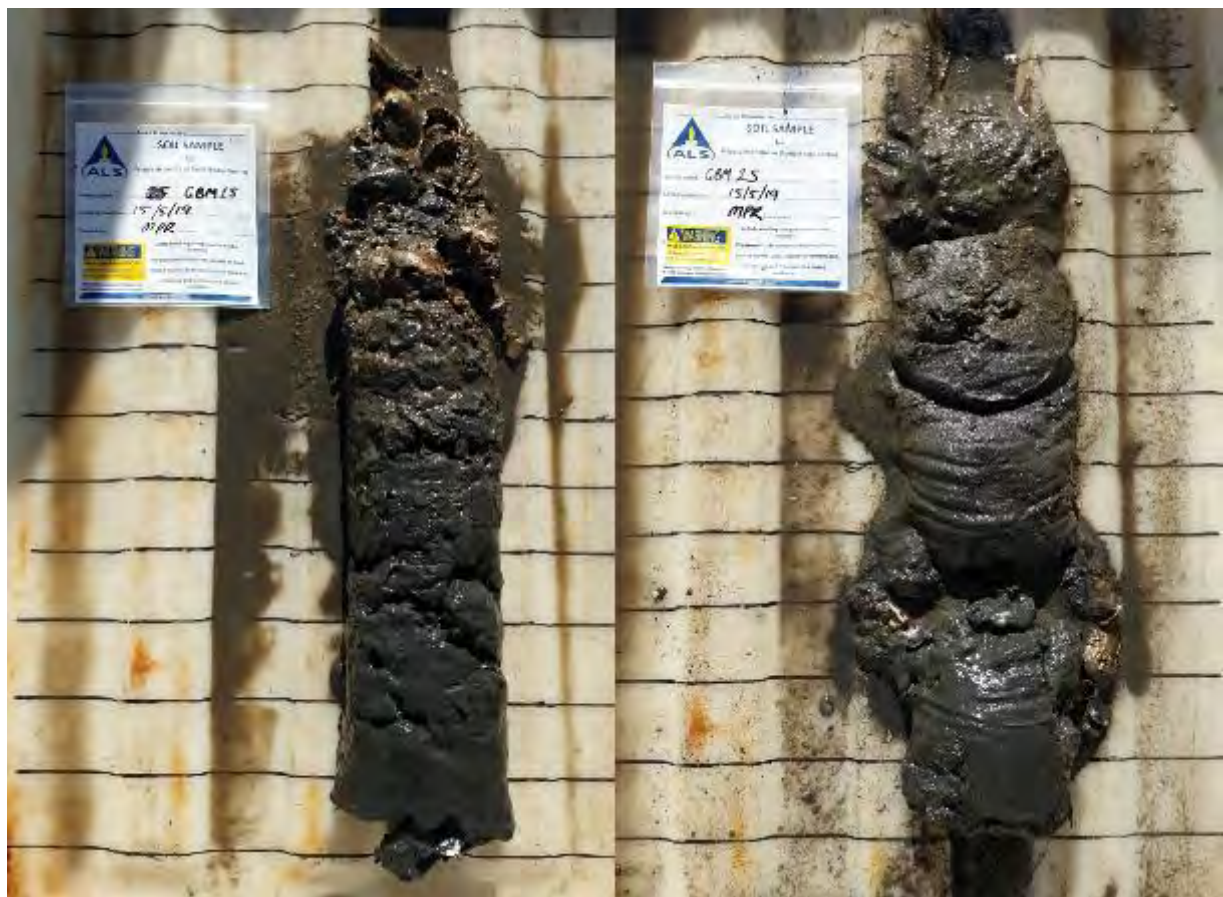
Plate 1: Sediment core samples from S1 (left) and S2 (right). Note the 5cm lines for scale.

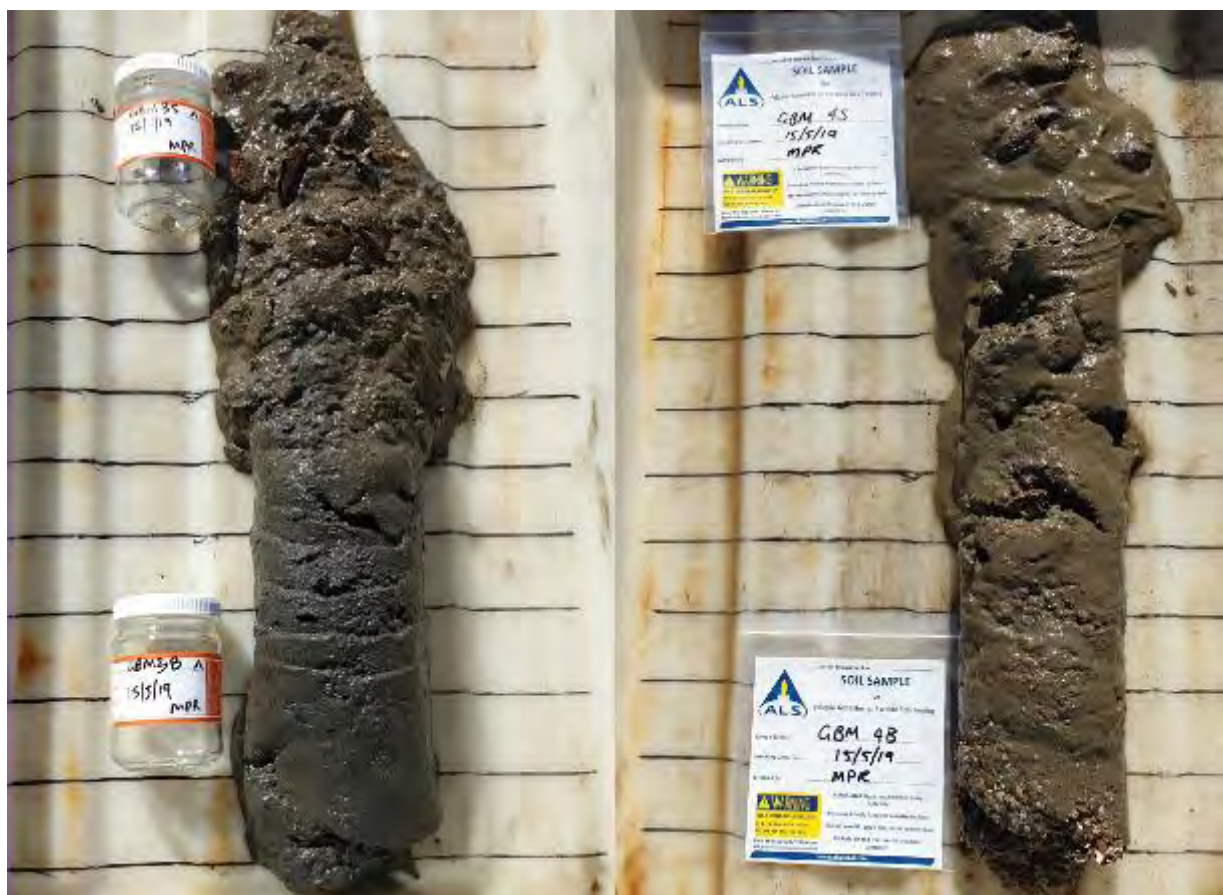
Plate 2: Sediment core samples from S3 (left) and S4 (right).

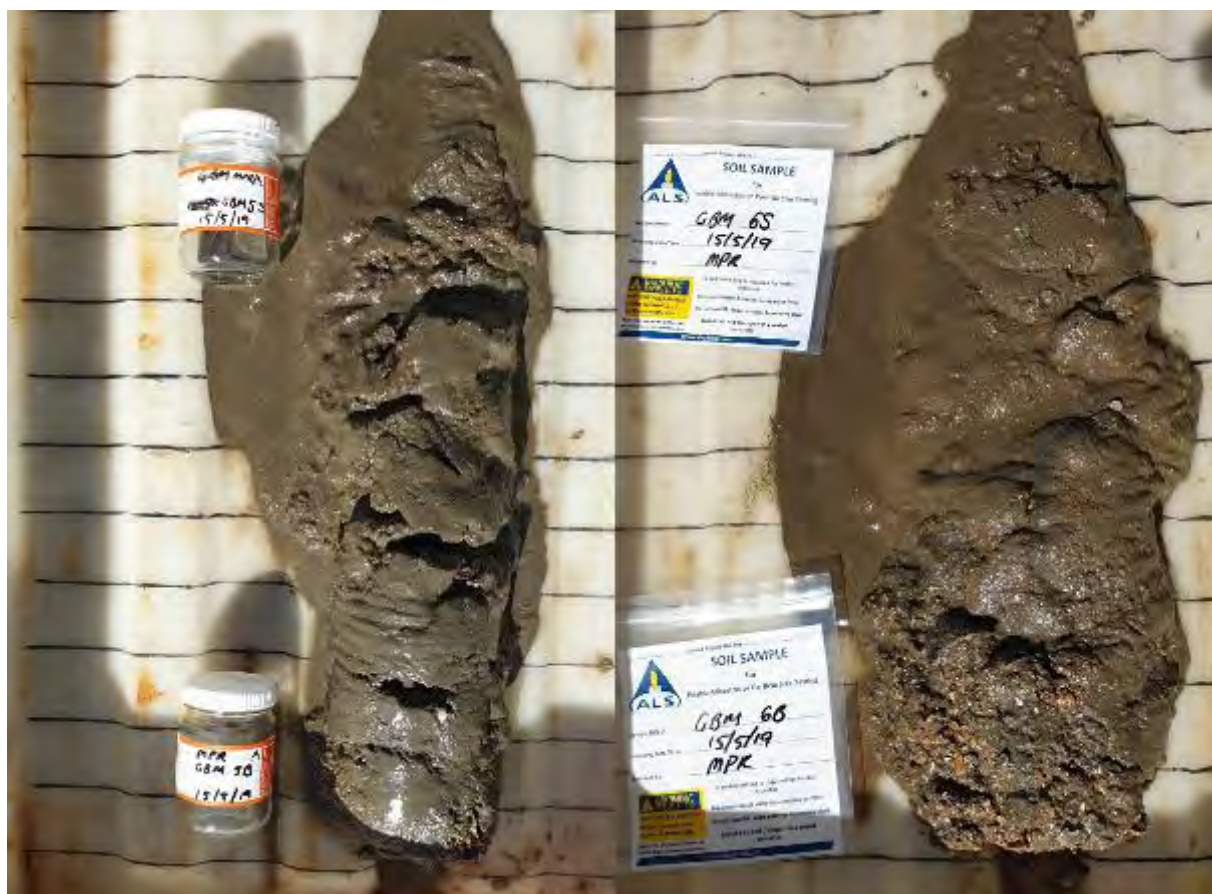
Plate 3: Sediment core samples from S5 (left) and S6 (right).

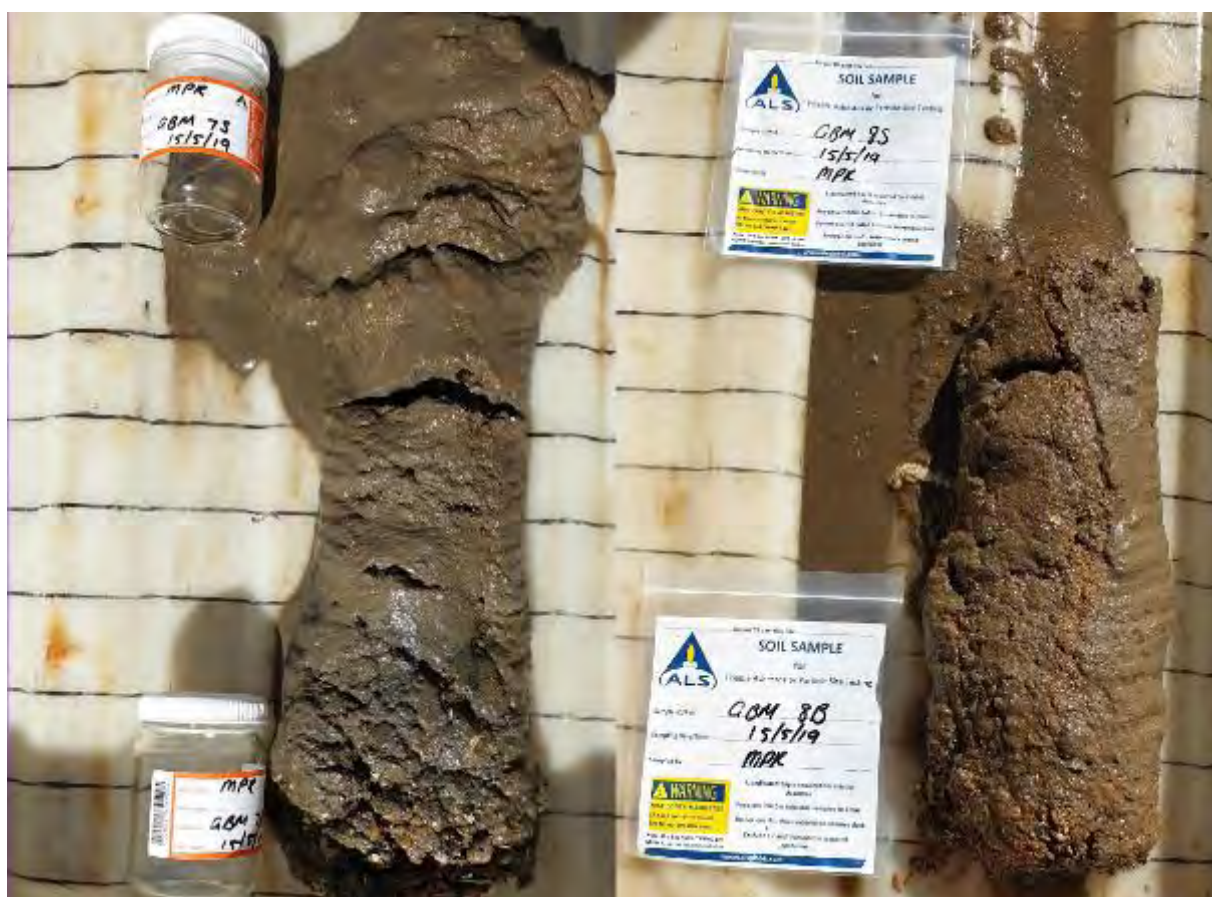
Plate 4: Sediment core samples from S7 (left) and S8 (right).
