Remediation Action Plan

Botany Aquatic Centre  
Cnr Myrtle St and Jasmine St, Botany

Prepared for  
CO-OP STUDIO Pty Ltd

Project 201489.01  
October 2023

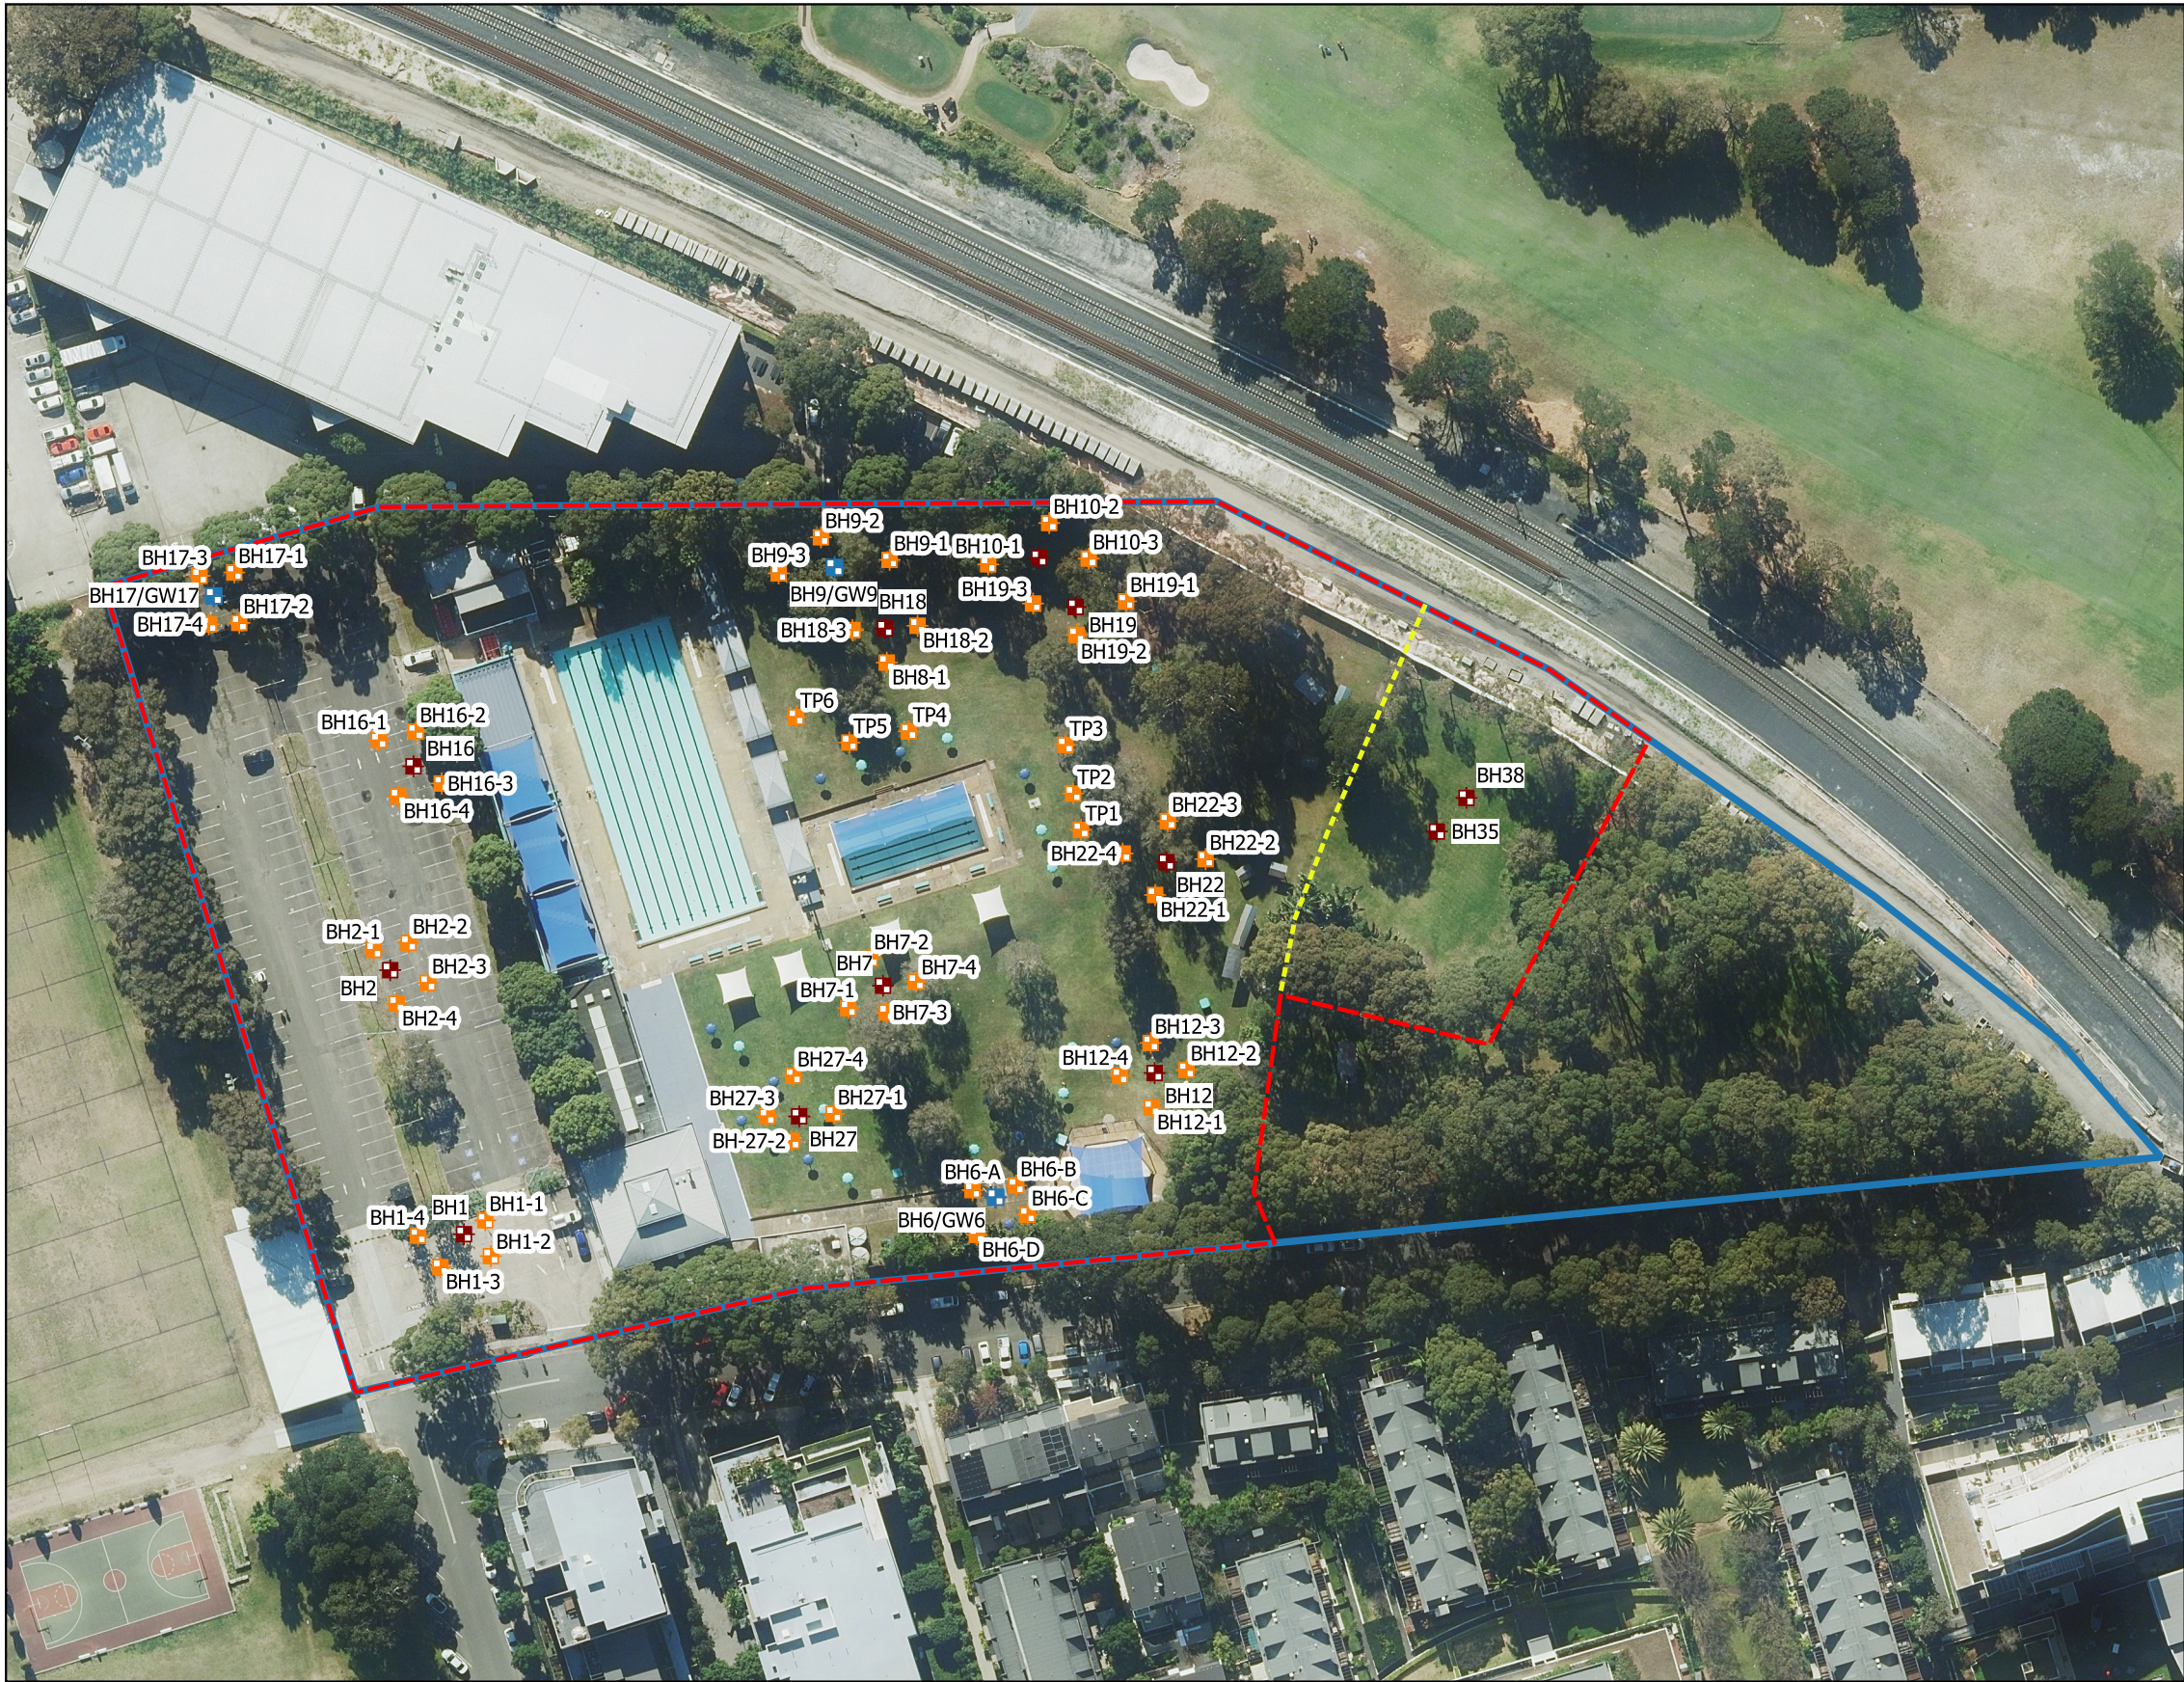
PROJECT No: 201489.01	
DRAWING No:	1
REVISION:	0

Subsurface conditions within the site were previously summarised as (refer attached Drawing 1 and 2 Appendix A for previous test locations):

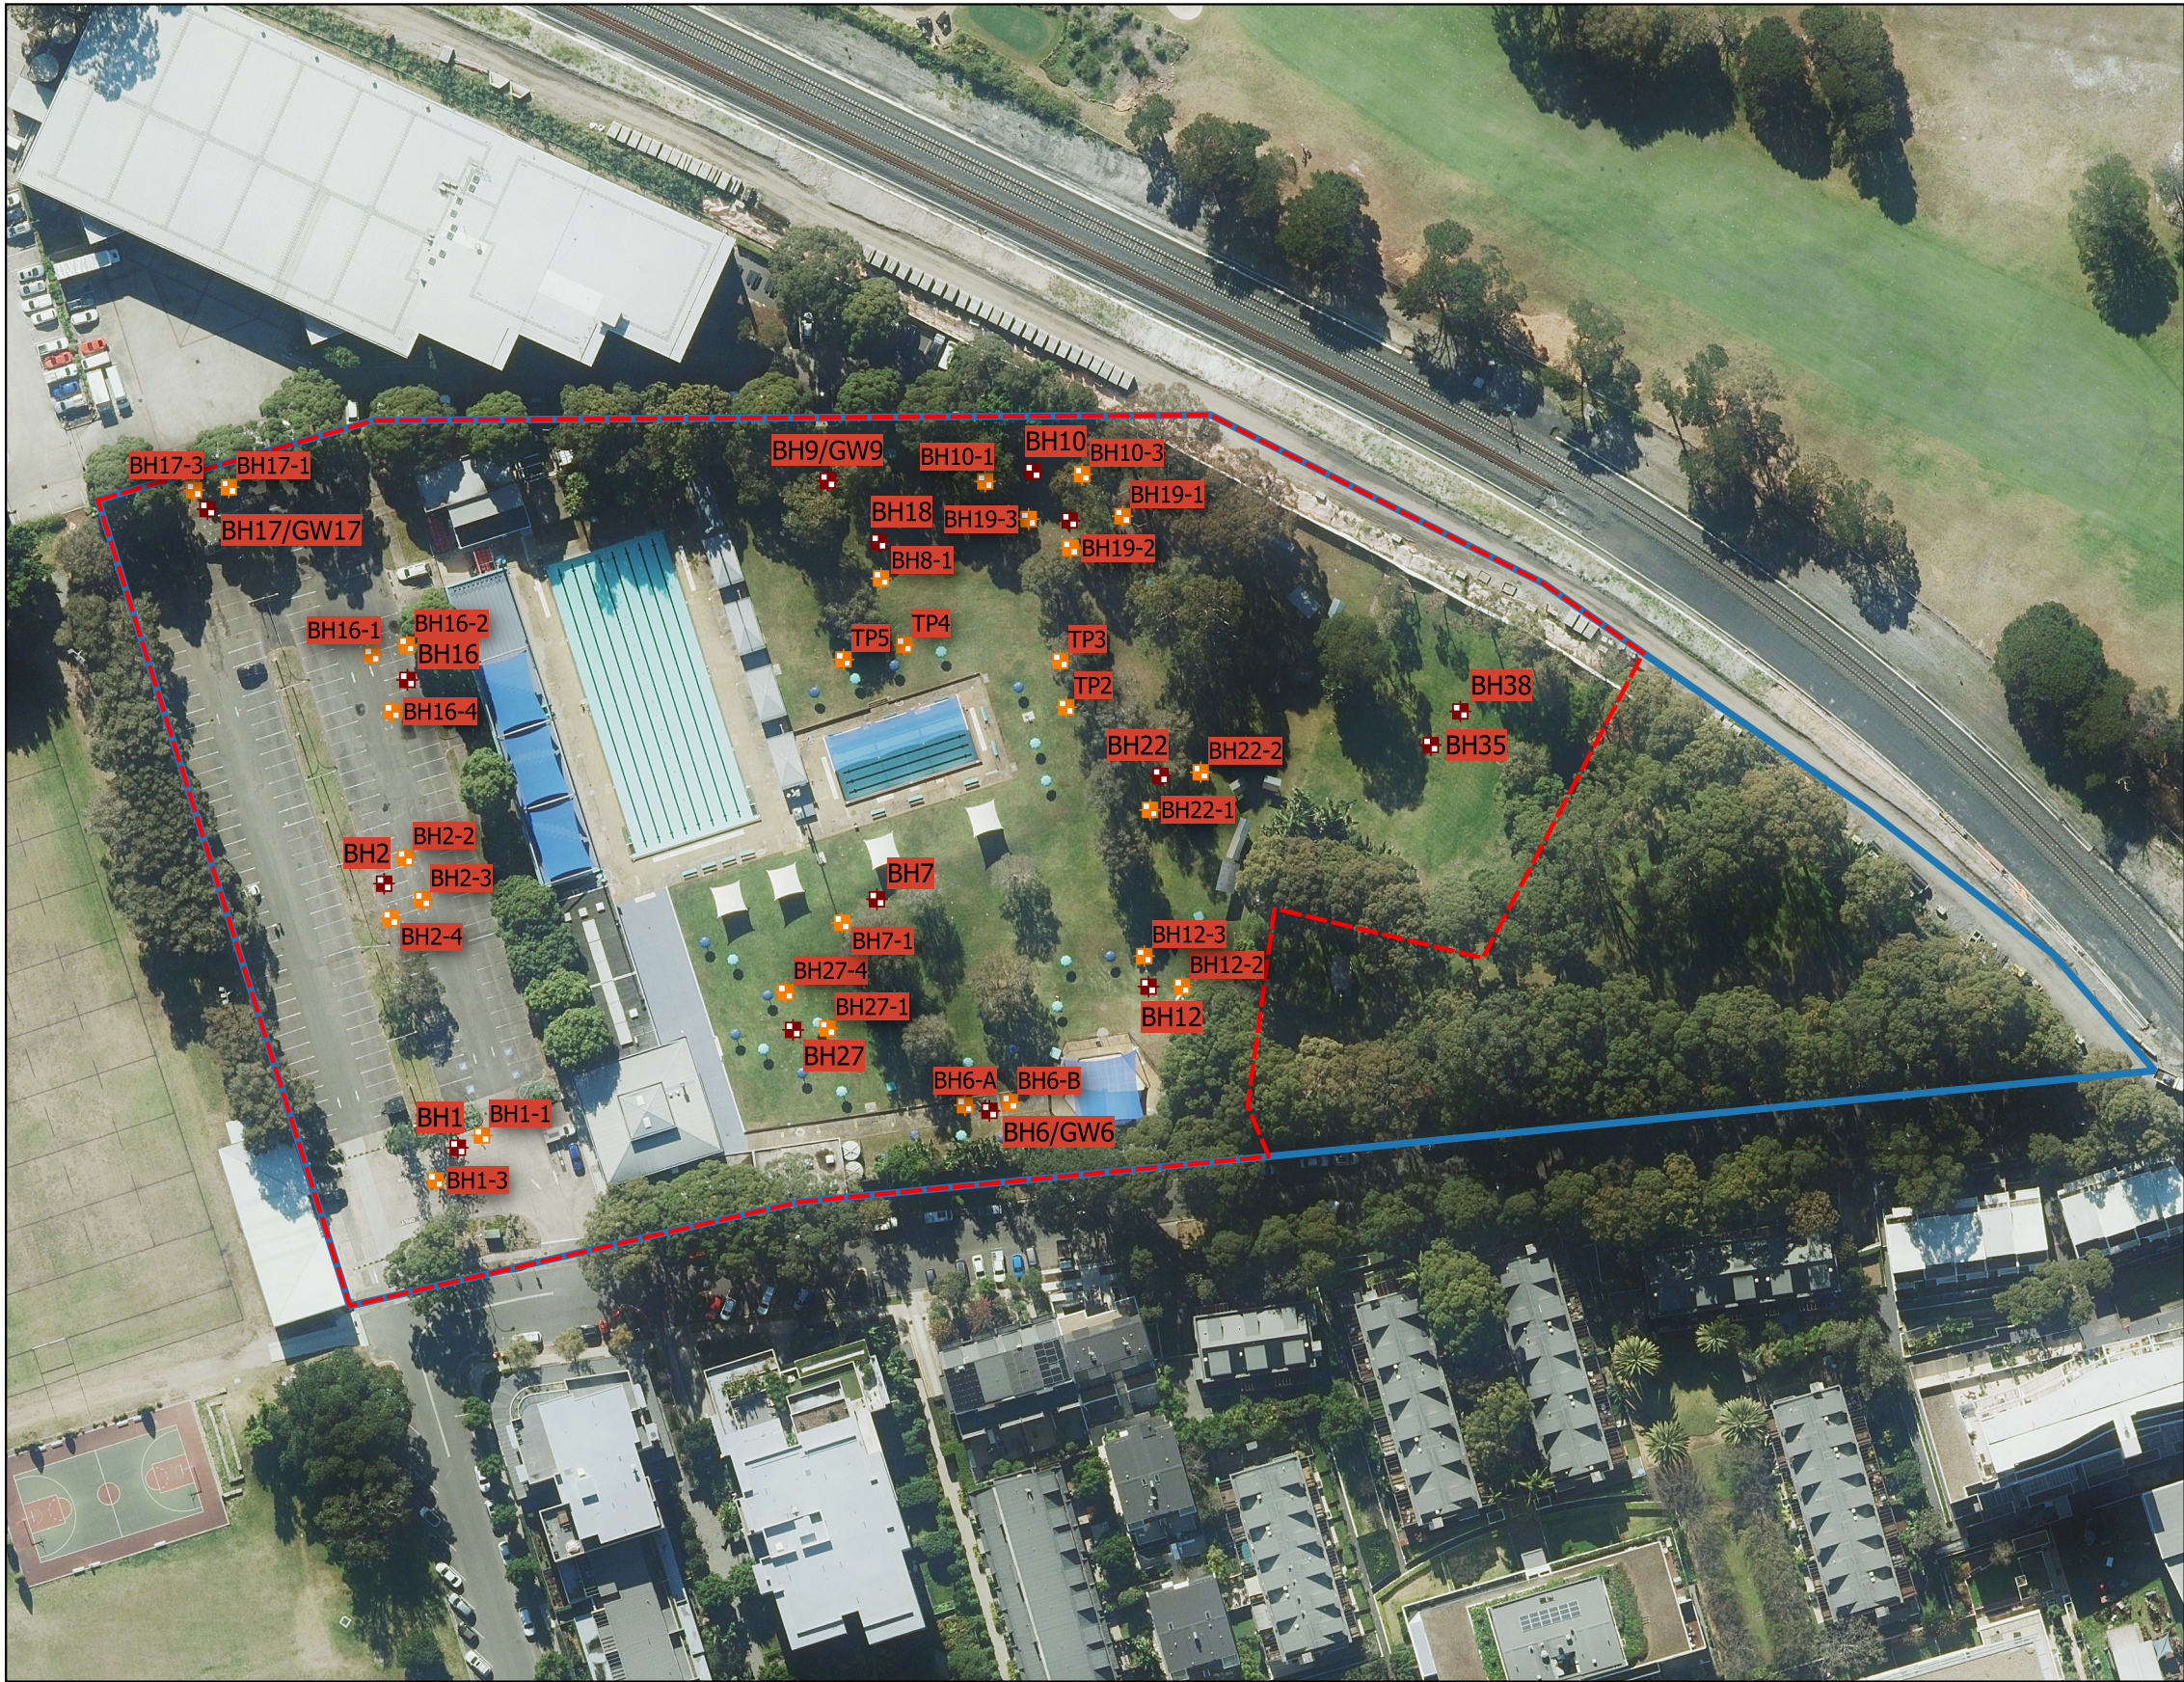
Environmental Borehole Locations (DP 2020)

- Current Site Boundary
- Larger Aquatic Centre Boundary
- Exceedance(s) Above SAC
- Previous Test Locations With Exceedances Above SAC (DP, 2020)

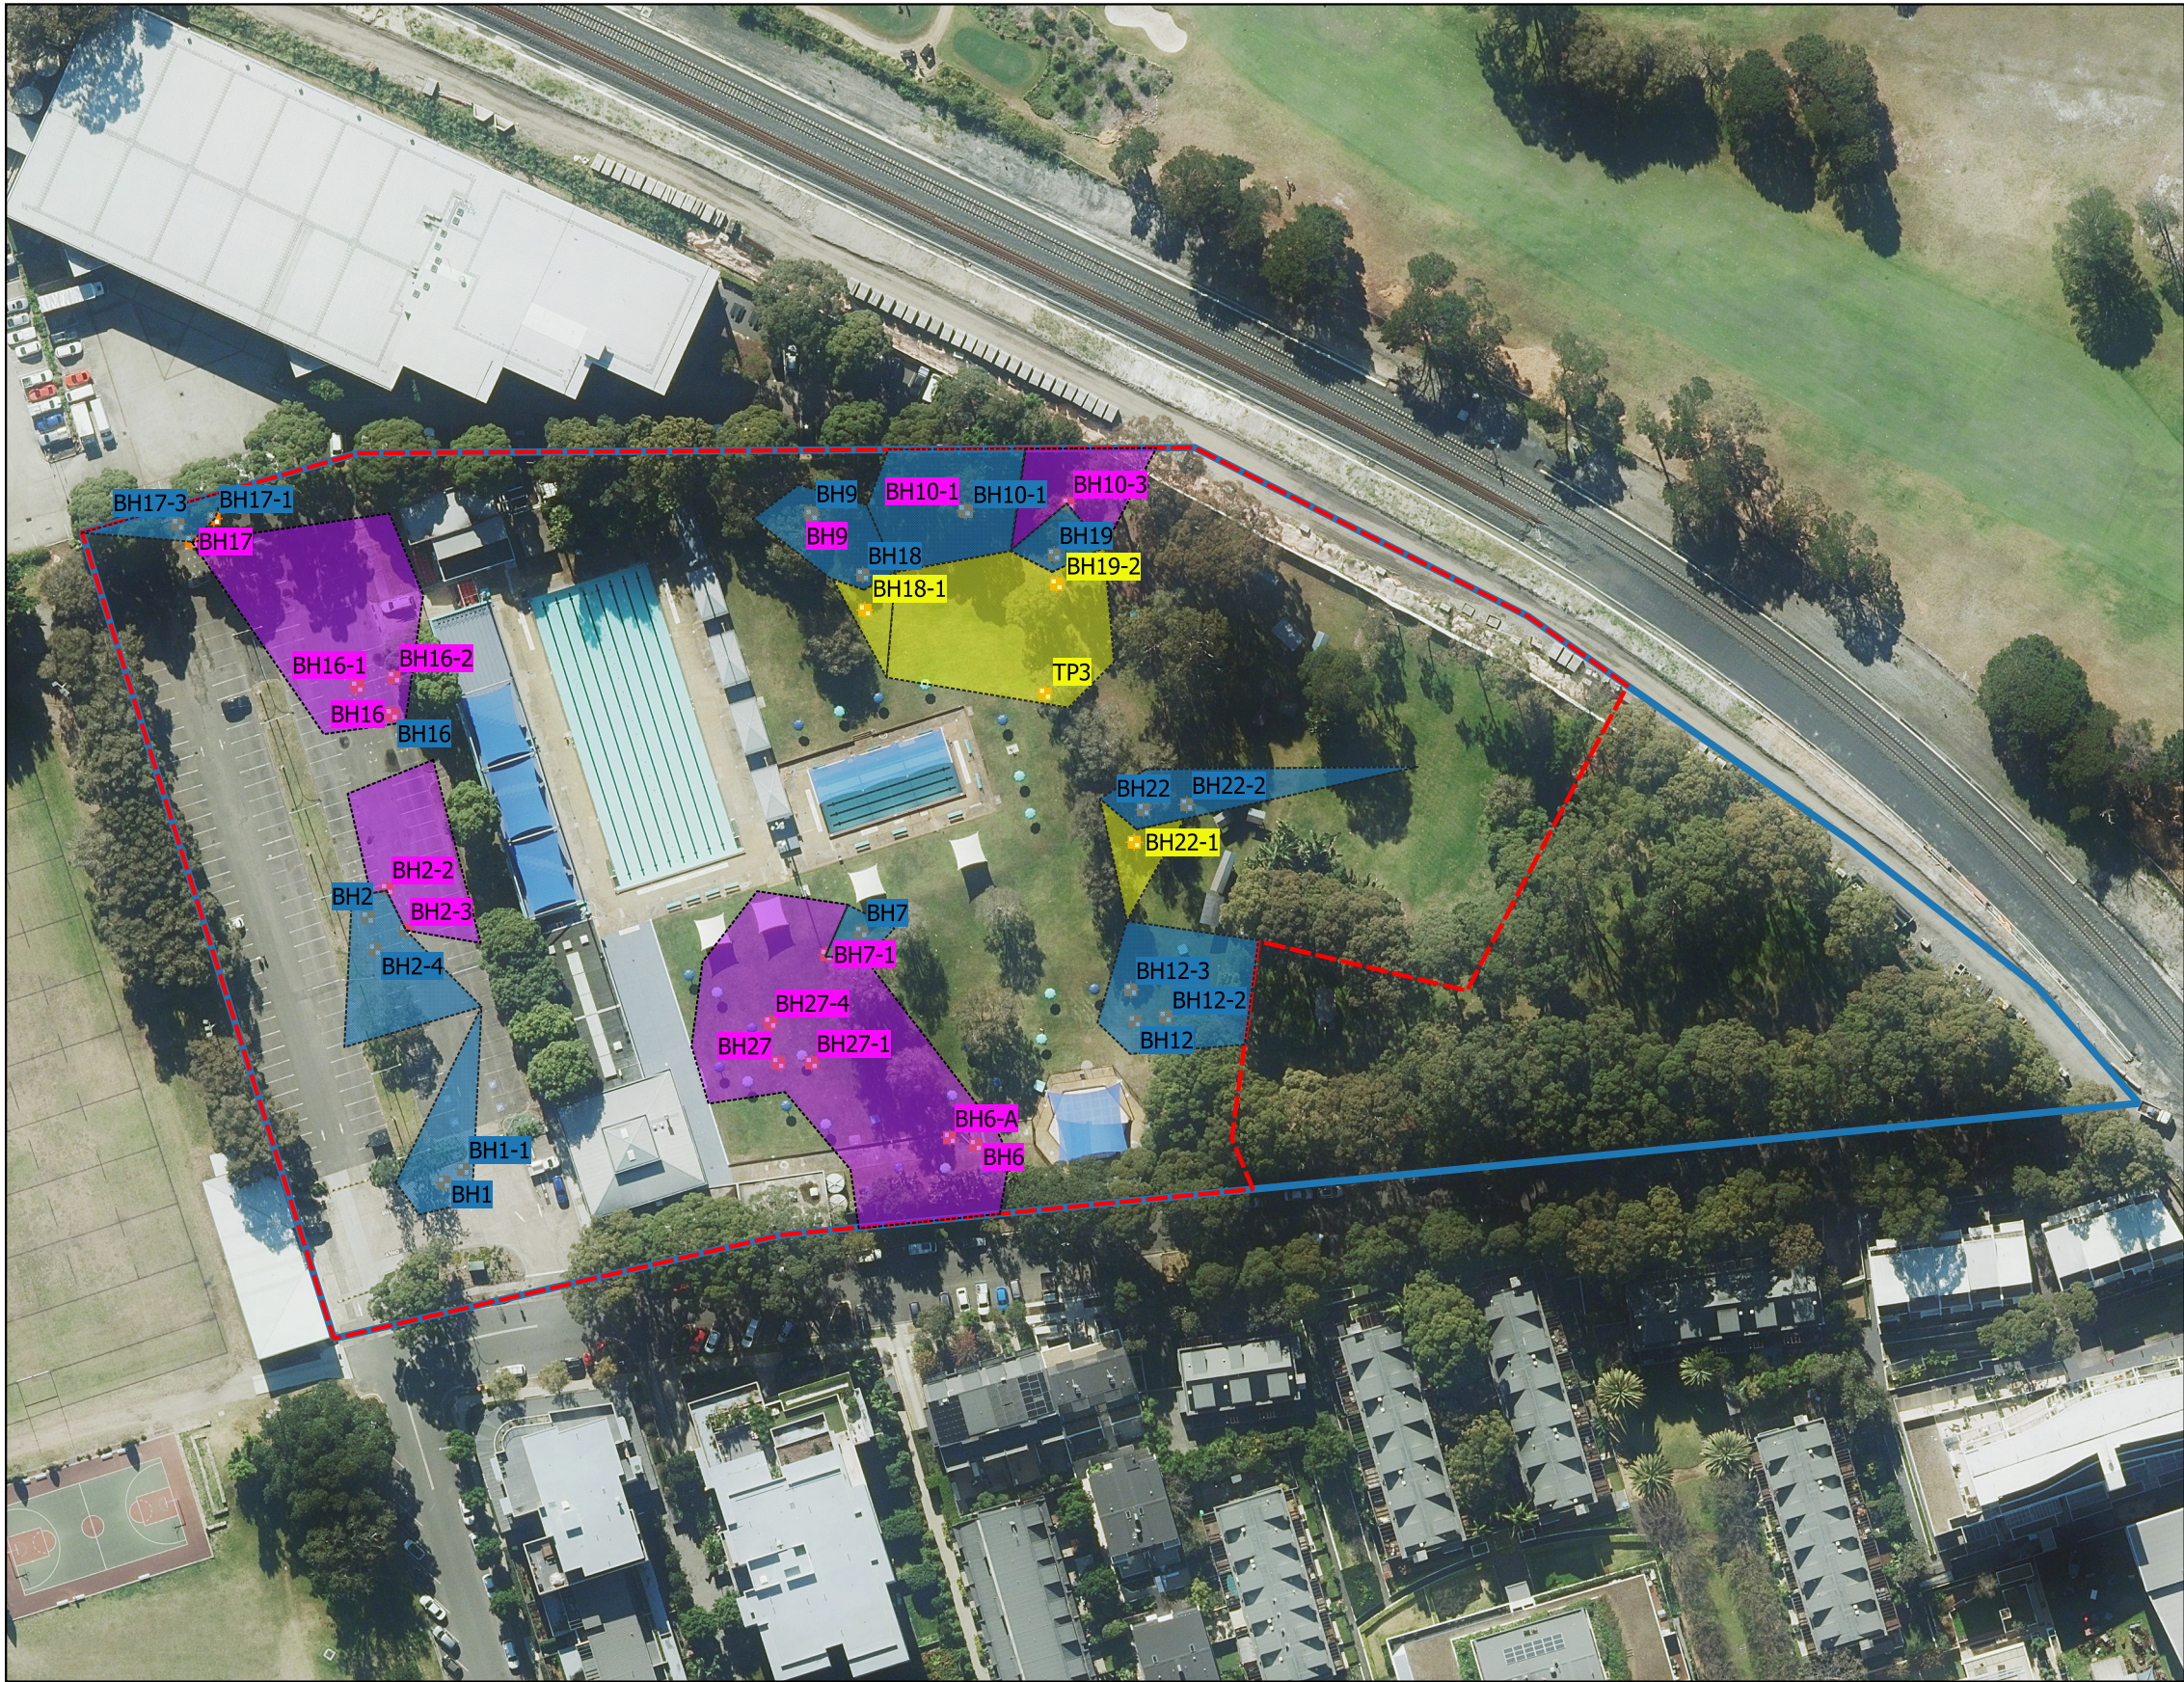
Approximate areas for the various waste classifications were previously identified and are shown on Drawing 5 in Appendix A. The supplementary investigation however noted that the areas could not be positively delineated laterally, and therefore there exists a risk for additional finds, e.g., elevated metals/TRH/PAH associated with ash, or as asbestos in fill. Drawing 5, provides the following preliminary extents:

- Areas highlighted in blue: approximate areas containing fill soil that has been preliminary classified as Hazardous Waste (however refer to Notes 1 and 2 below);
- Areas highlighted in purple: approximate areas containing fill soil that has been preliminary classified as Restricted Solid Waste (however refer to Notes 1 and 2 below);
- Areas highlighted in yellow: approximate areas containing fill soil that has been preliminary classified as General Solid Waste (Non-putrescible), Special Waste (Asbestos); and
- The fill soil within the remaining areas preliminary classified as General Solid Waste (Non-putrescible) (however refer to Note 1 below).
