Report on  
Geotechnical Investigation

Botany Aquatic Centre  
2 Myrtle Street, Botany

Prepared for  
CO-OP Studio Pty Ltd

Project 201489.03  
31 July 2023

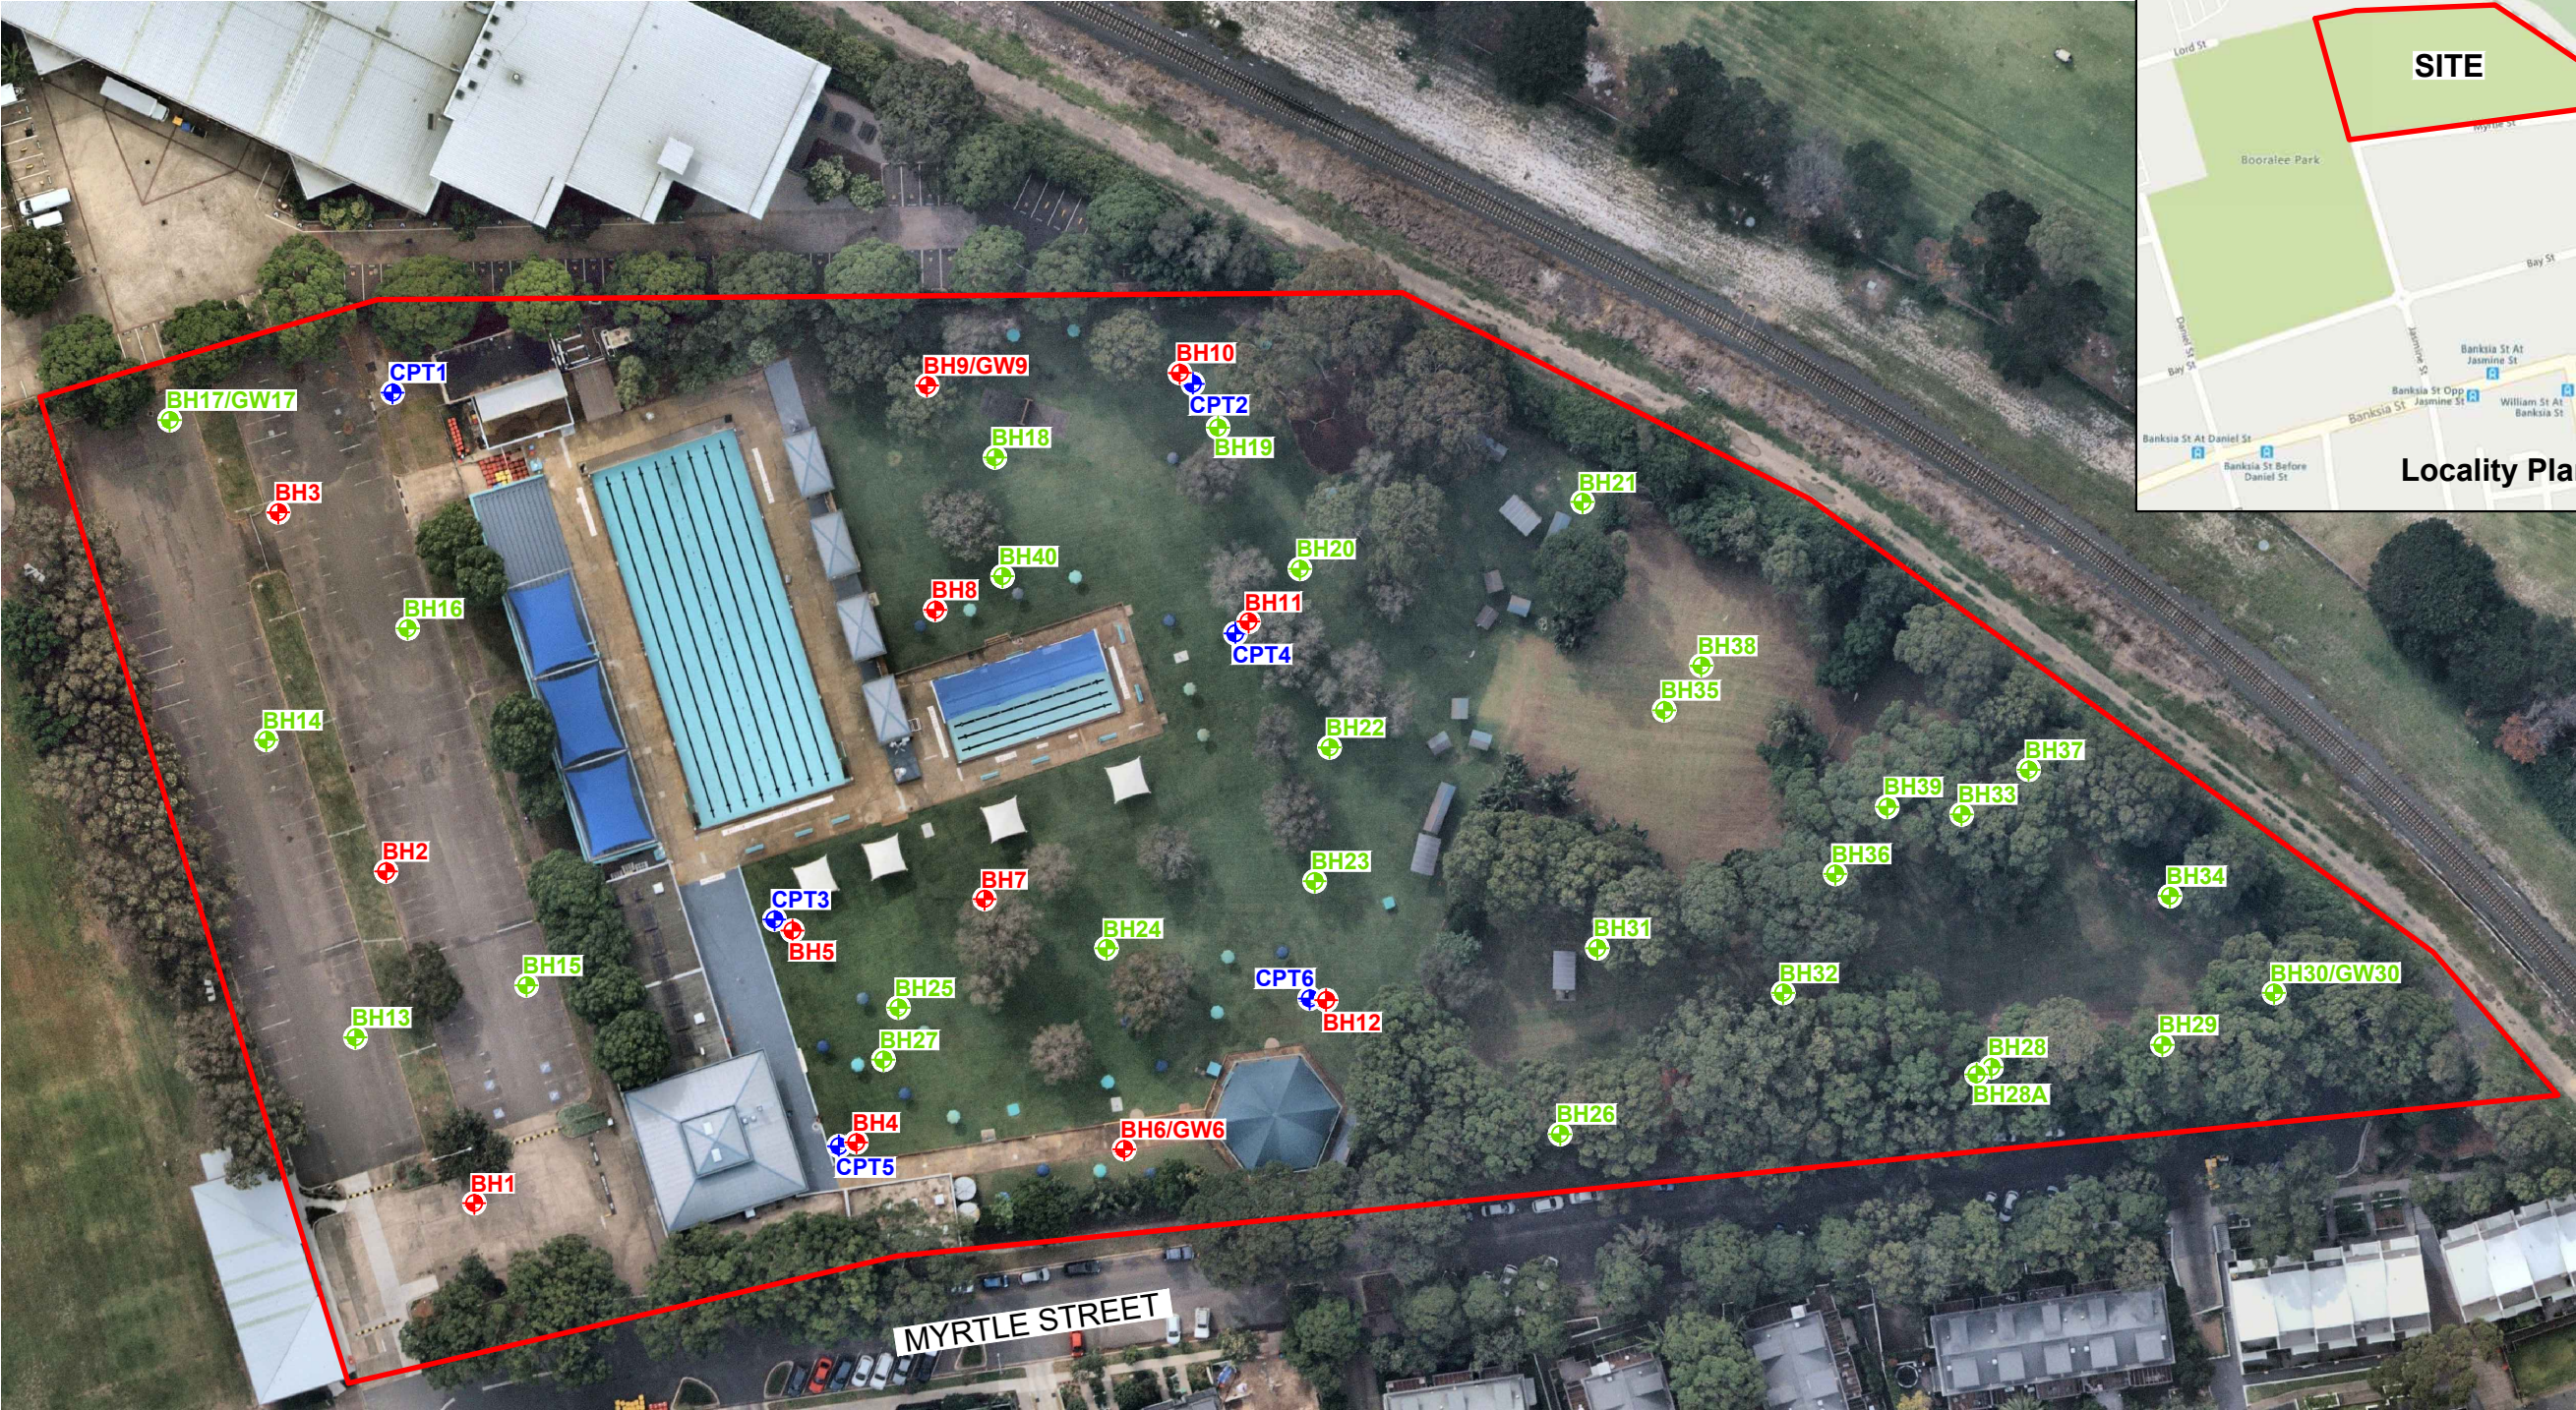
Drawings

NOTE:  
1: Base image from Nearmap.com (Dated 12.04.2020)  
2: Test locations are measured using a high-precision differential GPS.
