GEOTECHNICAL REPORT

PROPOSED ALTERATIONS AND ADDITIONS TO EXISTING BUILDING

19 DARLING POINT ROAD, DARLING POINT, NSW

Project No.: 2022-273

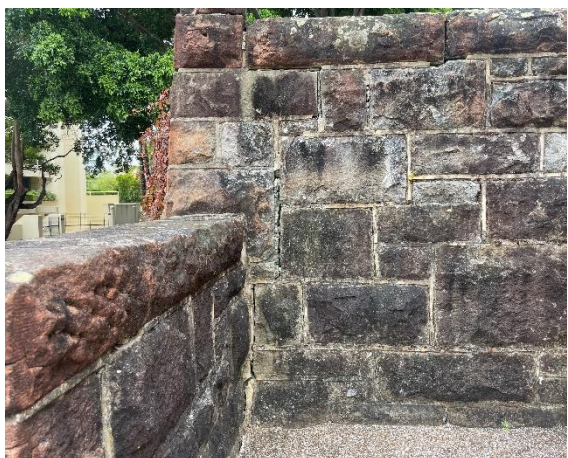
The western front of the site is approximately 3m higher than the street and contains two near level front grass lawns (above the site-garages) with an entry staircase and pathway through the centre. The lawns are partly supported along the western side by an approximately 3m high mortared sandstone block retaining wall. Along the southern boundary is another concrete staircase which allows access to the site. The front lawns and walls showed no signs of excessive ground movement, however the retaining walls contained minor cracking and loss of mortar at some locations (Photograph-5 and Photograph-6).

*Photograph-5: Loss of mortar/cracking in retaining wall.
View looking north.*

The field observations identified cracking and minor bulging at the western front wall and whilst this only appears related to age deterioration and soil creep. It is recommended that a structural engineer assess the competency of the wall and provide remedial recommendations if necessary. CGC can assist for any geotechnical investigation into the front wall's footings/founding conditions, if deemed necessary by the Structural Engineer.

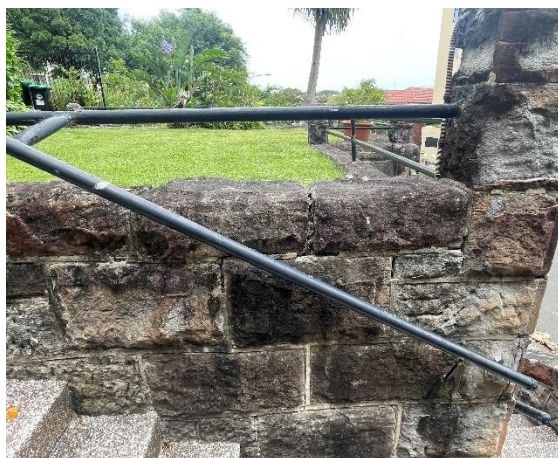
*Photograph-6: Loss of mortar/cracking in retaining wall.
View looking south.*
