**Geotechnical Investigation Report**

**Proposed School Building Development**

**268 – 272 Fitzgerald Ave., Maroubra NSW 2035**

Report No: 9194.2-GR-1-1 (Rev B)

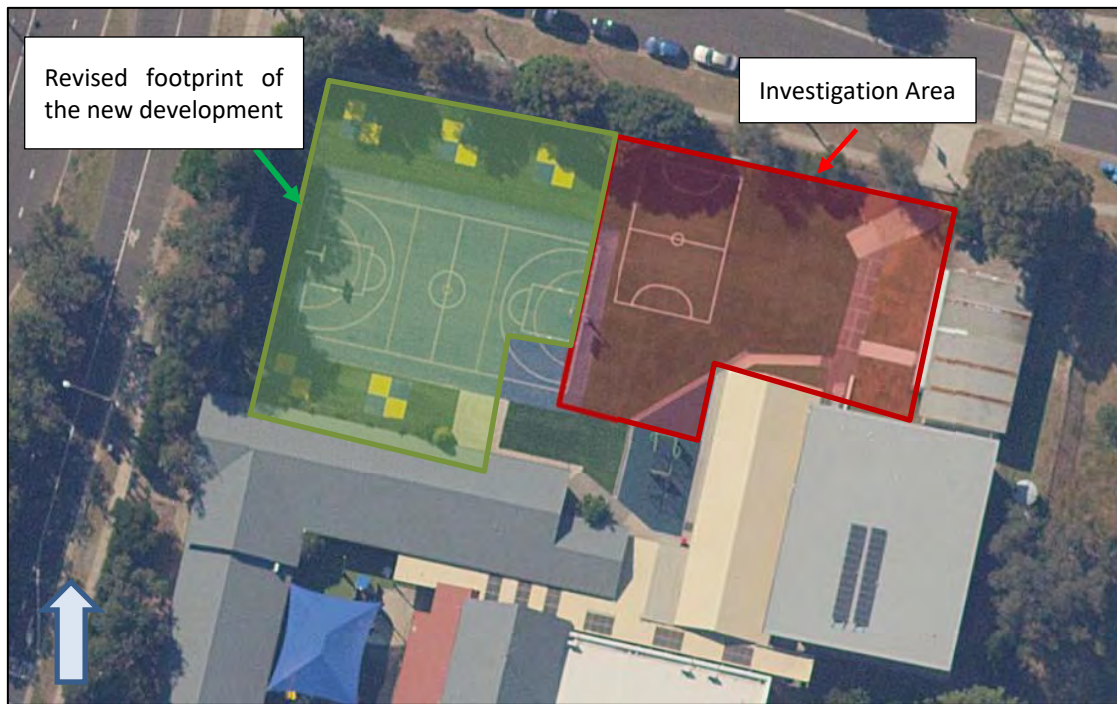
Figure 2 – Investigation area and the new building location in Satellite View (Source: Six Maps)

The proposed borehole and CPTu locations were located within the footprint of the proposed building (indicated as Block I in the provided plans). The locations were mostly covered by synthetic turf overlying compacted fill at the time of investigations.

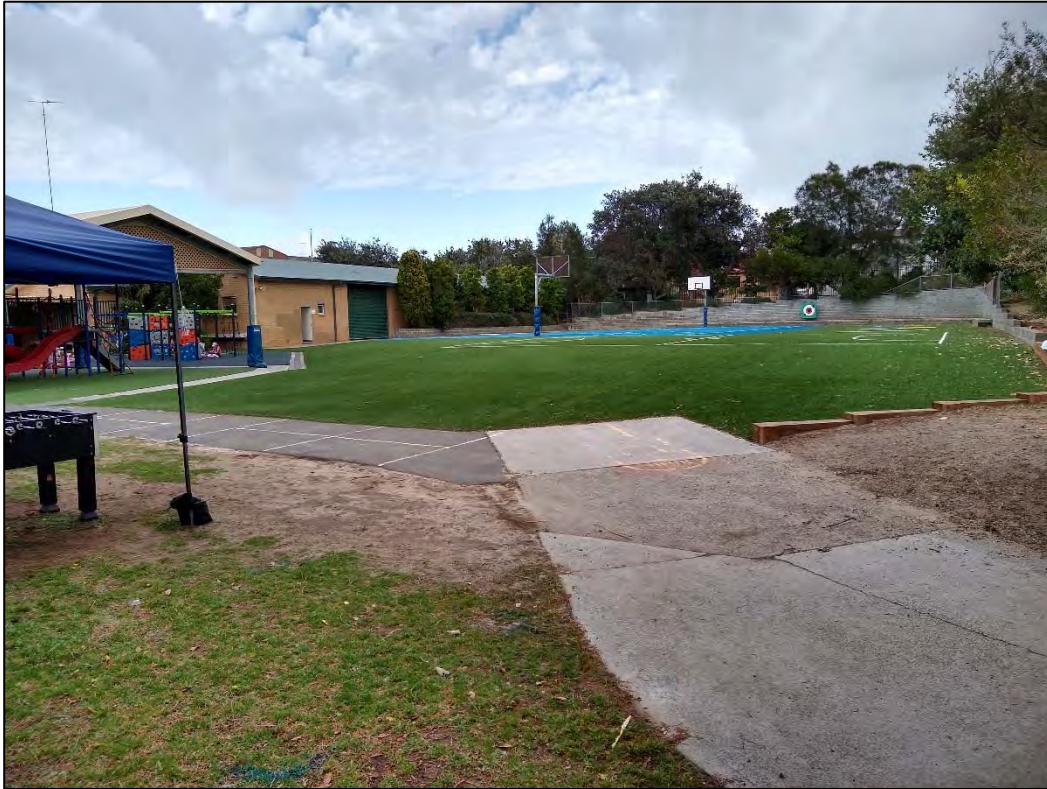
**Photo 1 – General Site Overview – Looking West**

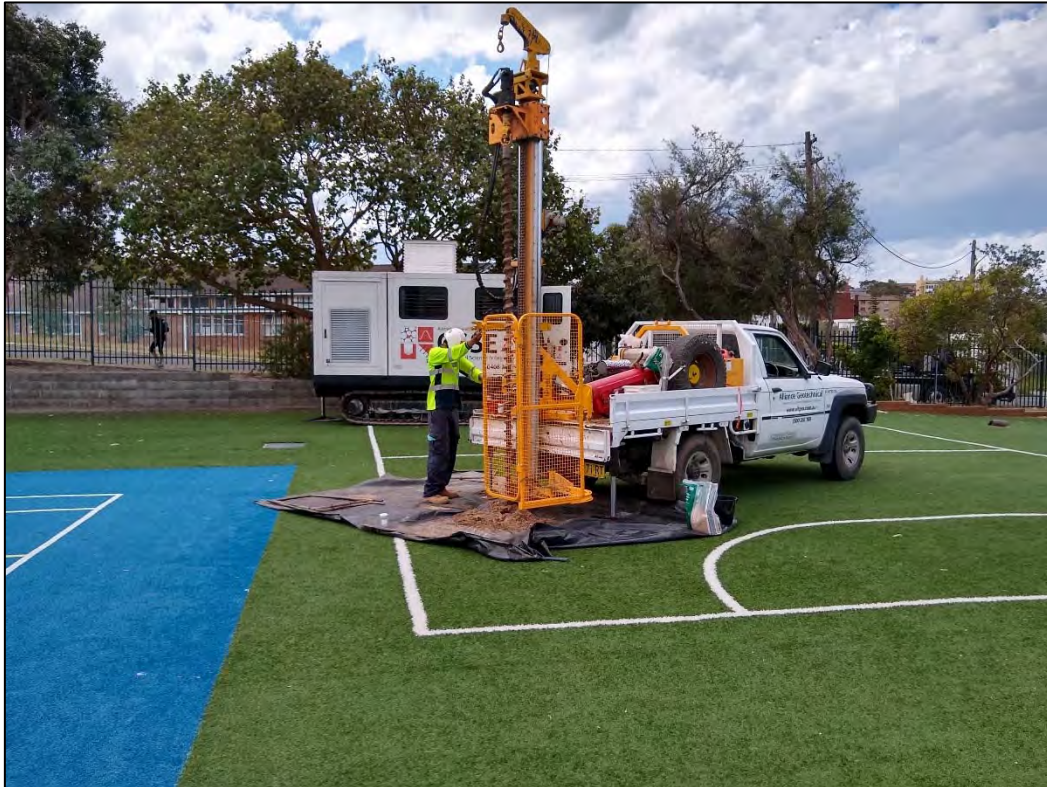
**Photo 2 – Drilling in the location of BH3 and performing CPT4**

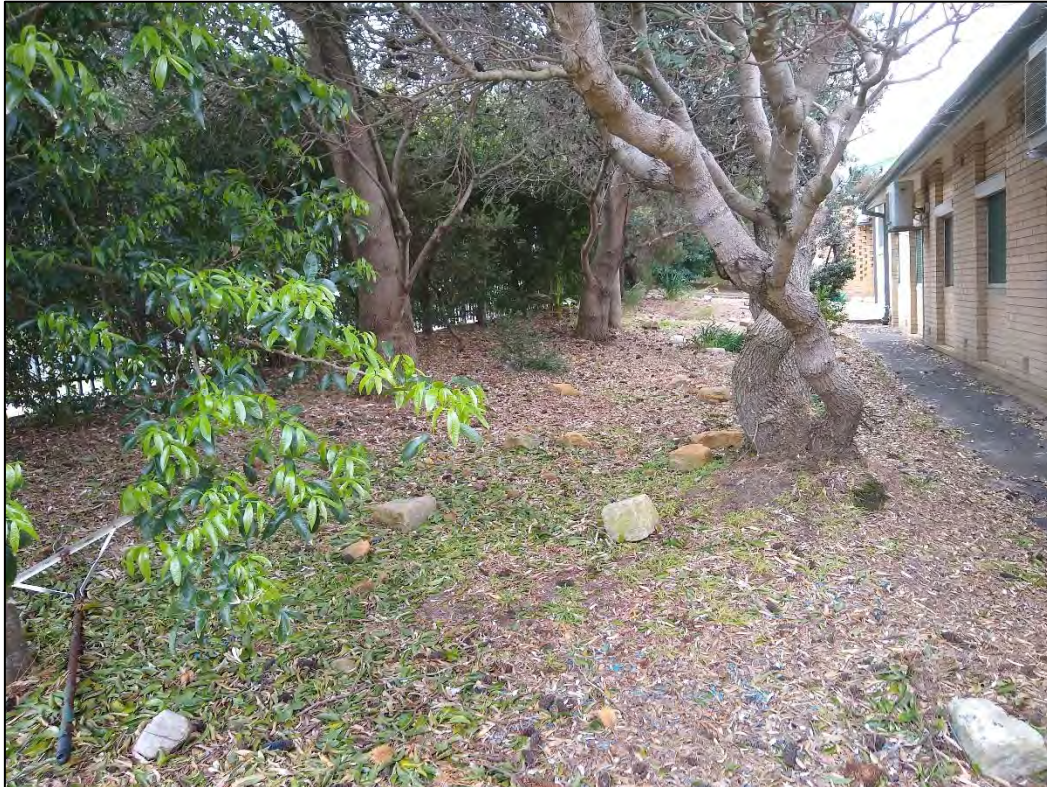
**Photo 3 – Site features in the western side of the existing buildings**

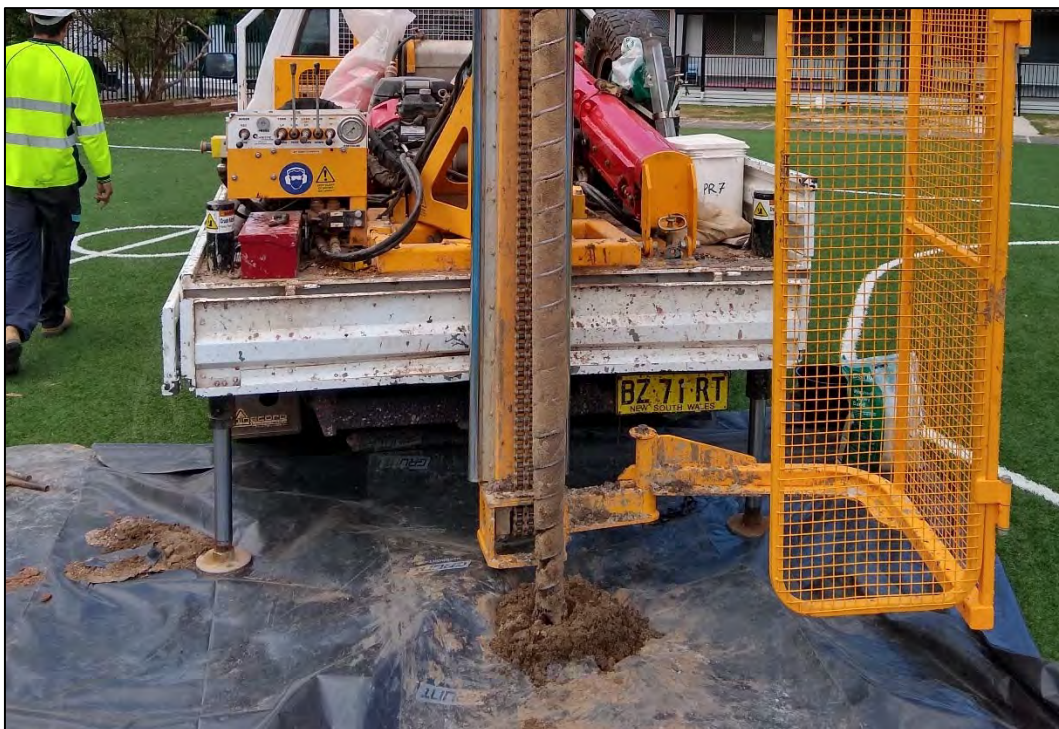
**Photo 4 – Soil cuttings retrieved from drilling of BH2**

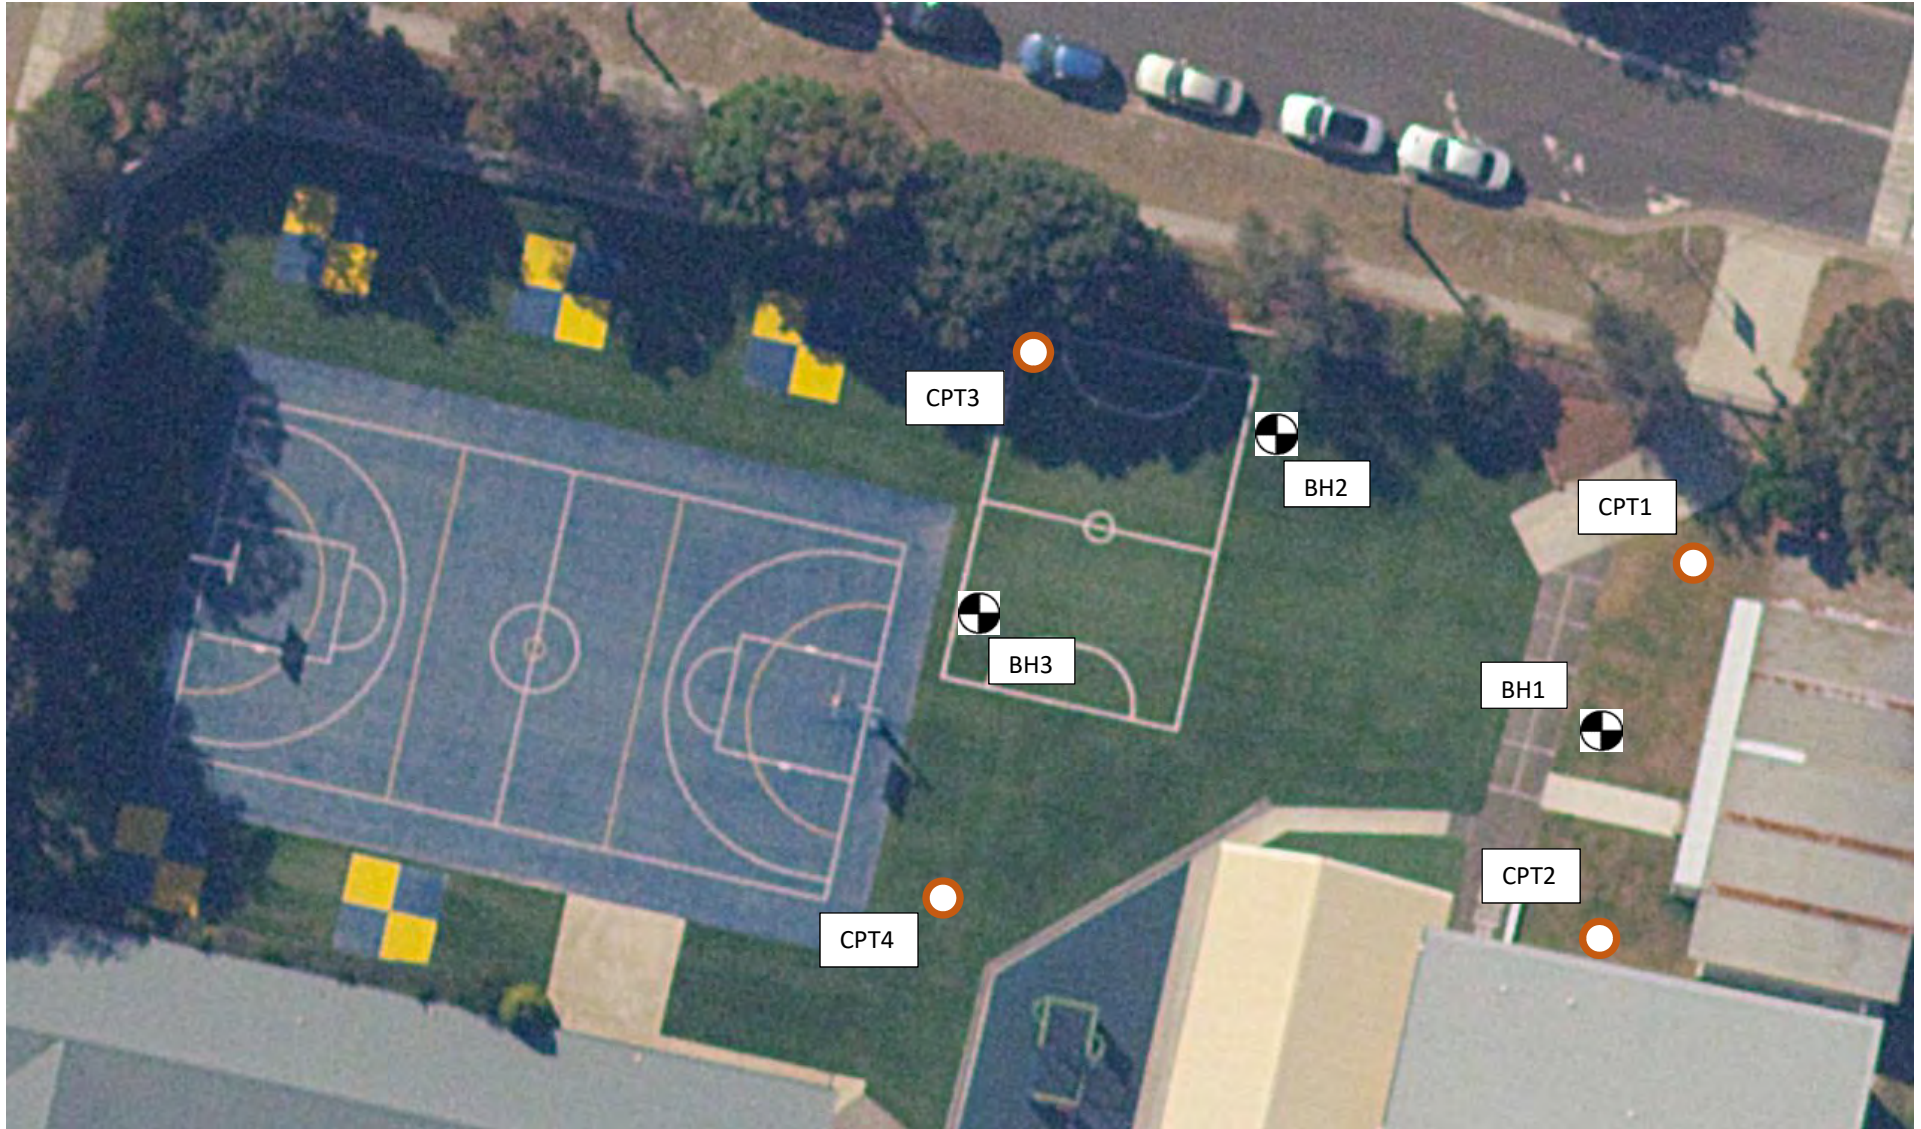
Figure / Drawing Number:	9194.2-GR-1-A
Figure / Drawing Date:	18/10/2019
Report Number:	9194.2-GR-1-1

**Geotechnical Investigation Plan (1/2)**

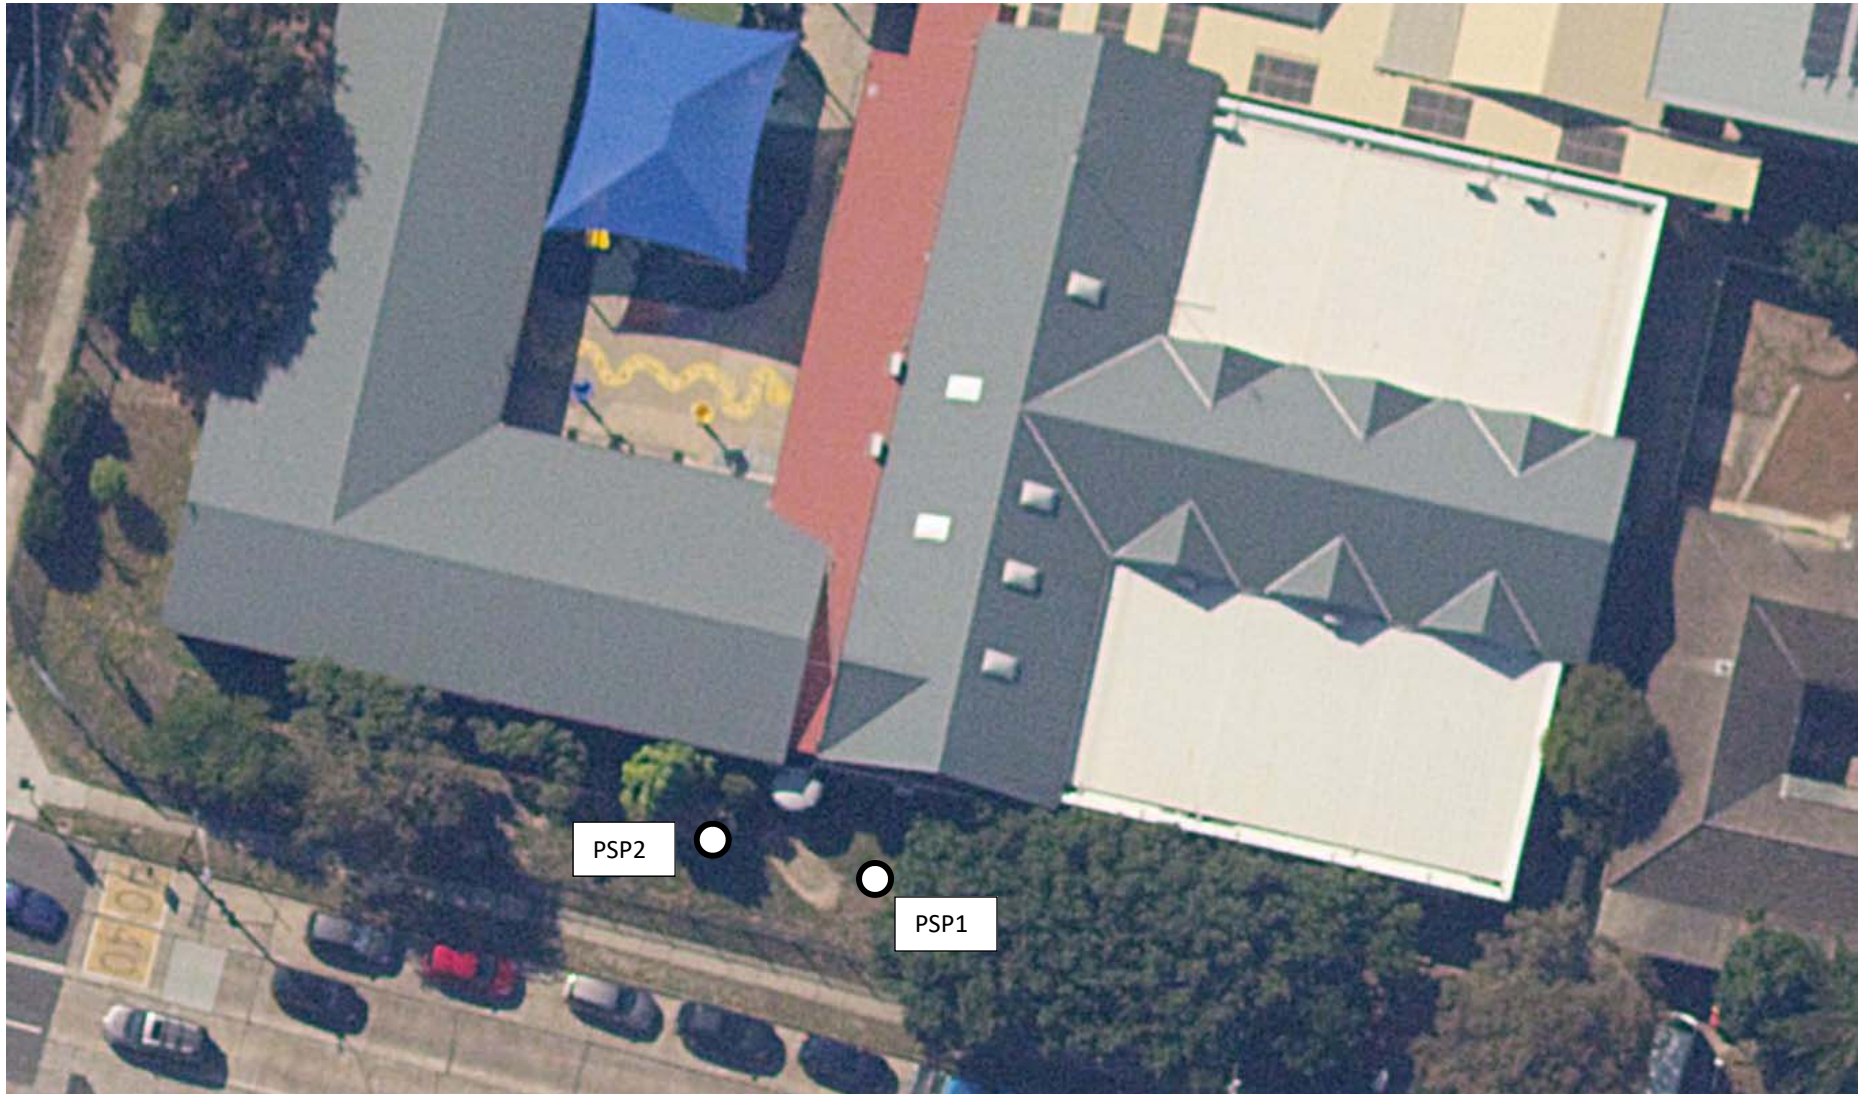
**Geotechnical Investigation Plan (2/2)**

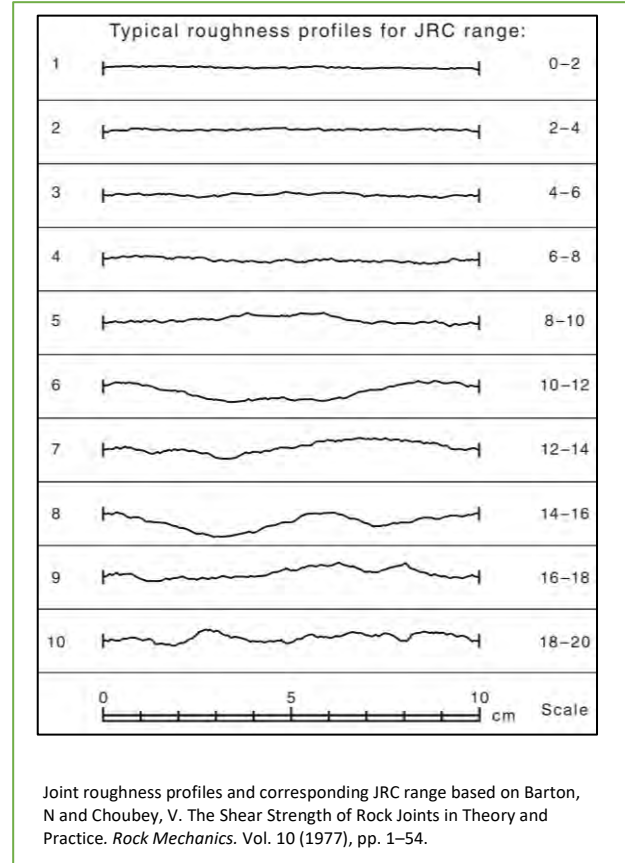
Where applicable Joint Roughness Range (JRC) is provided as follows:

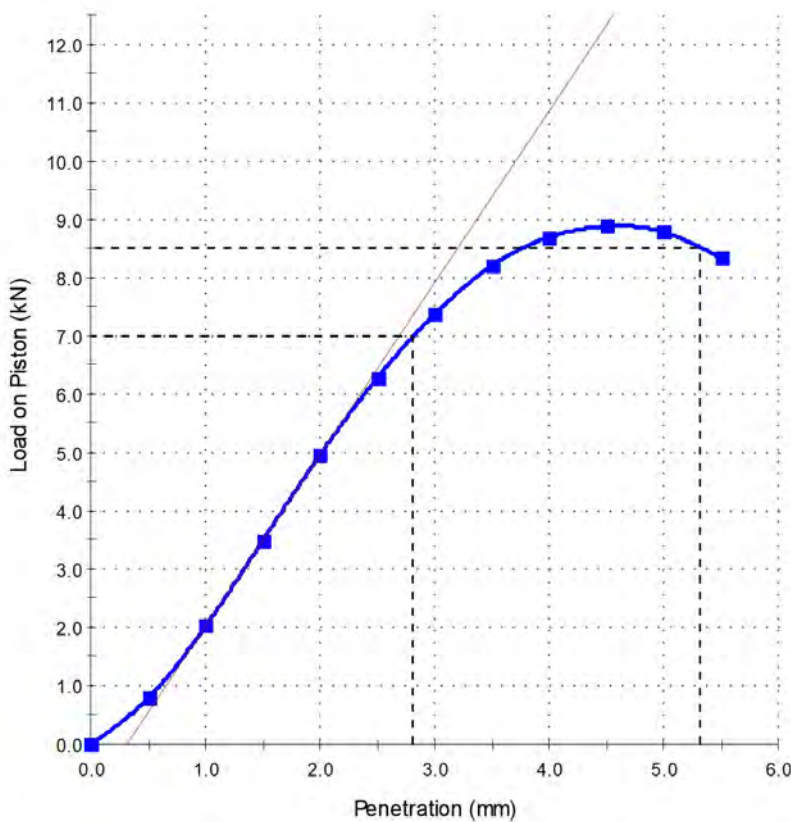
Sample Location: BH 2 (0.2m-0.8m)      Date Sampled: 8/10/2019  
 Sample Description: FILL - SAND, fine to medium grained with medium      Date Tested: 18/10/2019

### Load vs Penetration

Based on the obtained results of CBR tests on the collected samples from the site, design CBR value of 10% is recommended for pavement design purposes. The recommended design values are lower than the obtained laboratory results, but it takes into account the presence of the uncontrolled fill at the site AG's experience with similar materials and probable variety of the parameters.

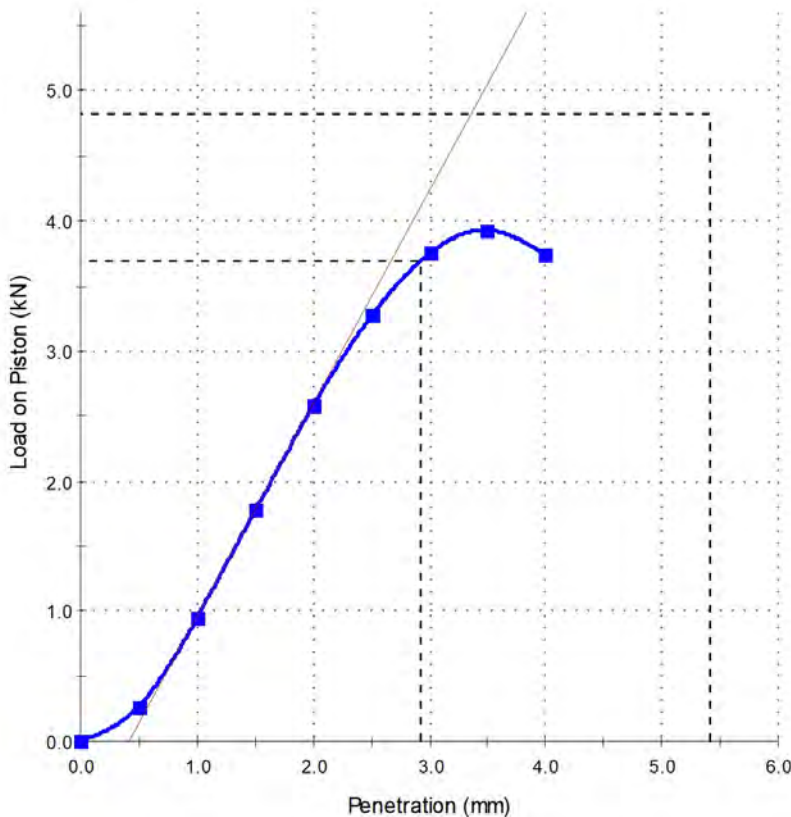
Sample Location: BH 1 (0.4m-0.8m)      Date Sampled: 8/10/2019  
 Sample Description: SAND, medium grained, pale brown to brown      Date Tested: 18/10/2019

### Load vs Penetration

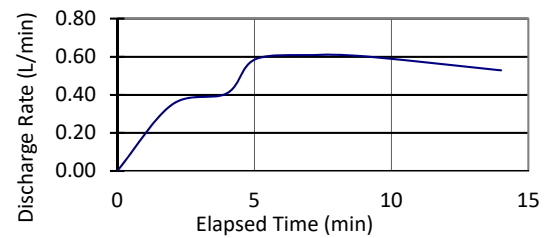
Reading No.	Elapsed Time	Accumulated Volume	Discharge Rate
	t (mins)		
0	0	0.00	0.0
1	2	0.6	0.3
2	4	1.3	0.4
3	5	2.9	0.6
4	7	4.1	0.6
5	9	5.2	0.6
6	14	7.2	0.5

Discharge Rate versus Time

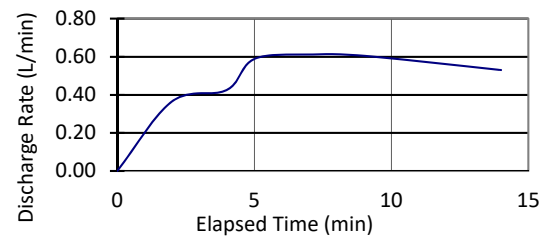
Reading No.	Elapsed Time	Accumulated Volume	Discharge Rate
	t (mins)		
0	0	0.00	0.0
1	2	0.6	0.4
2	4	1.4	0.4
3	5	2.9	0.6
4	7	4.1	0.6
5	9	5.2	0.6
6	14	7.2	0.5

Discharge Rate versus Time
