Report Type:
**Combined Stage 1 Preliminary Site Investigation
& Stage 2 Detailed Site Investigation**

Project Address:
**268-272 Fitzgerald Ave, Maroubra NSW
Portions of Lot 4370 & Lot 4916 in
DP752015**

Client Name:
Sydney Catholic Schools c/o JDH Architects

**29 October 2019
Report No: 9194.1-ER-1-1**

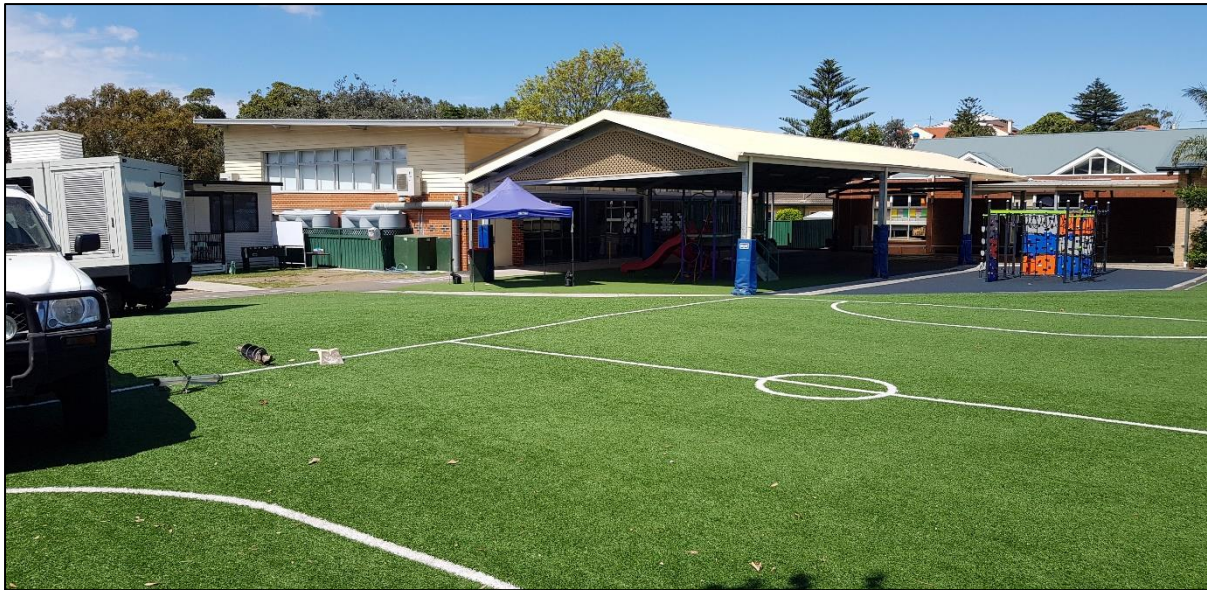
The land use setting on the site appeared to be a primary school.

Image 6.1.1 View of current site conditions, facing east

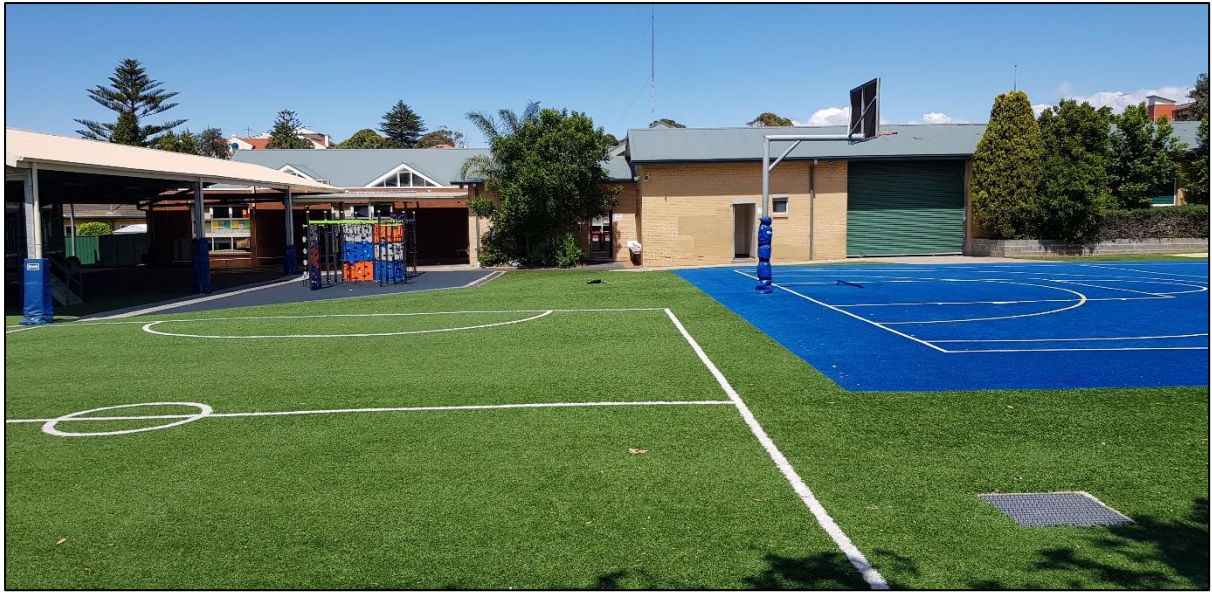
The following buildings and infrastructure were observed within the proposed site boundaries:

- Four multi storey brick office buildings;
- Demountable; and
- Artificial turfed playing fields.

Image 6.2.1 View of buildings and artificial turfed areas.

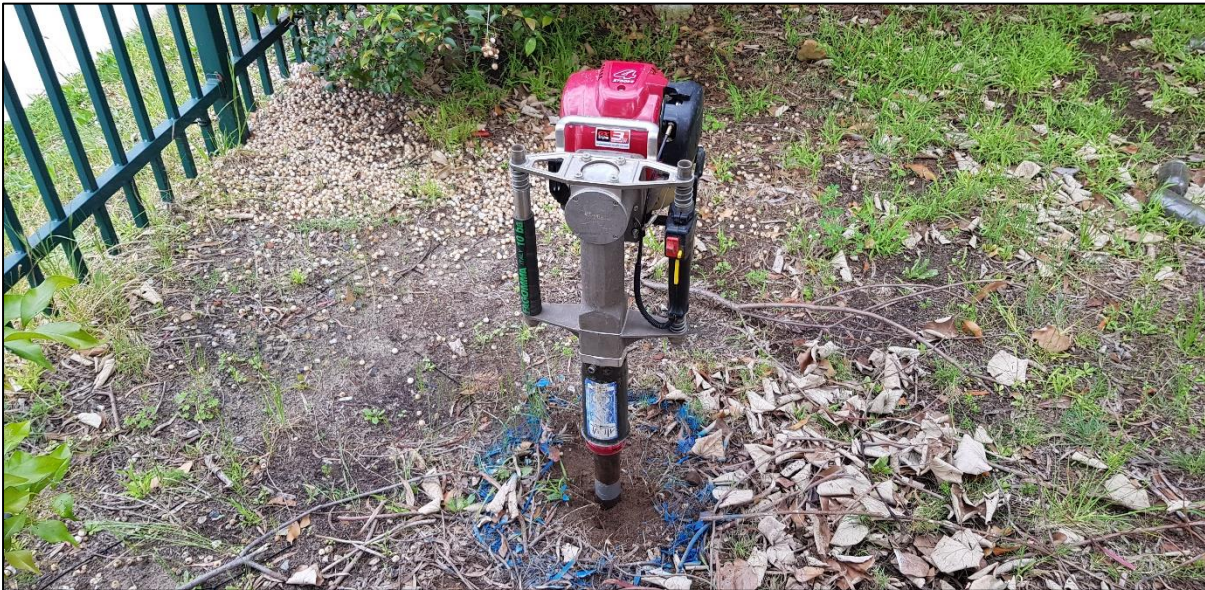
Soil sampling was undertaken by AG on 8 October 2019. A total of twelve (12) boreholes (BH01-BH12) were advanced across the site using a combination of track mounted drill rigs or hand tools until reaching inferred natural materials between 0.3-0.5m bgl. Samples for potential analysis were collected from the near surface, at 1.0 m intervals within the soil profile or with change of strata, and in areas of observed contamination. Each soil sample was collected using a new clean pair of nitrile gloves and placed in the appropriate acid rinsed sample containers provided by the laboratory.

Image 11.1.1 View of sampling technique as observed in BH10

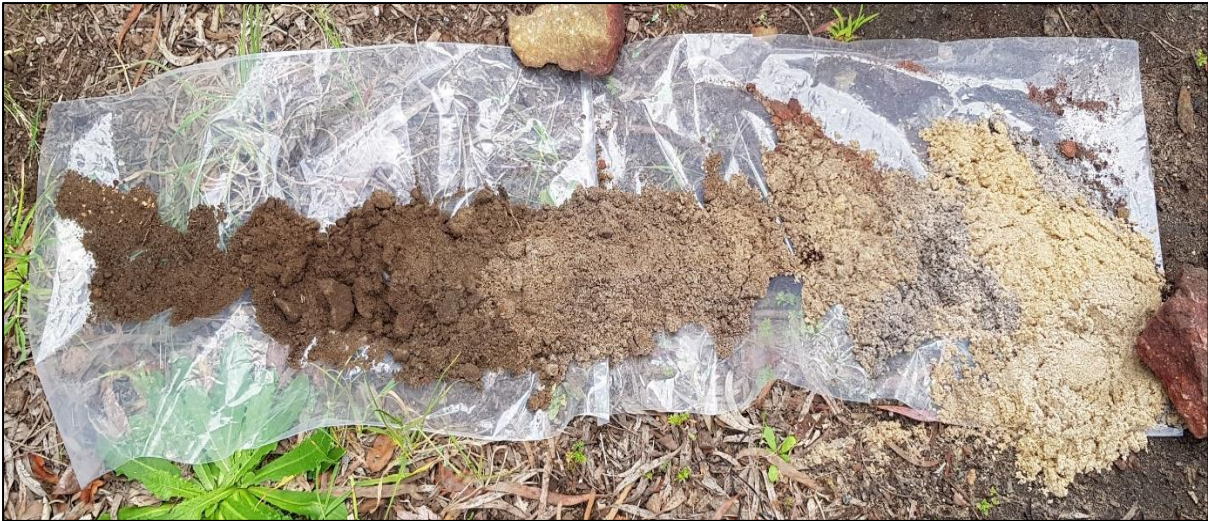
Anthropogenic materials were not observed in the fill profile of any of the locations sampled. Inferred natural material was encountered in every sampling location (BH01-BH12). Soils were generally observed to comprise fill topsoil followed by residual sand.

Image 11.24.1 Example of soil profile, as observed within BH12

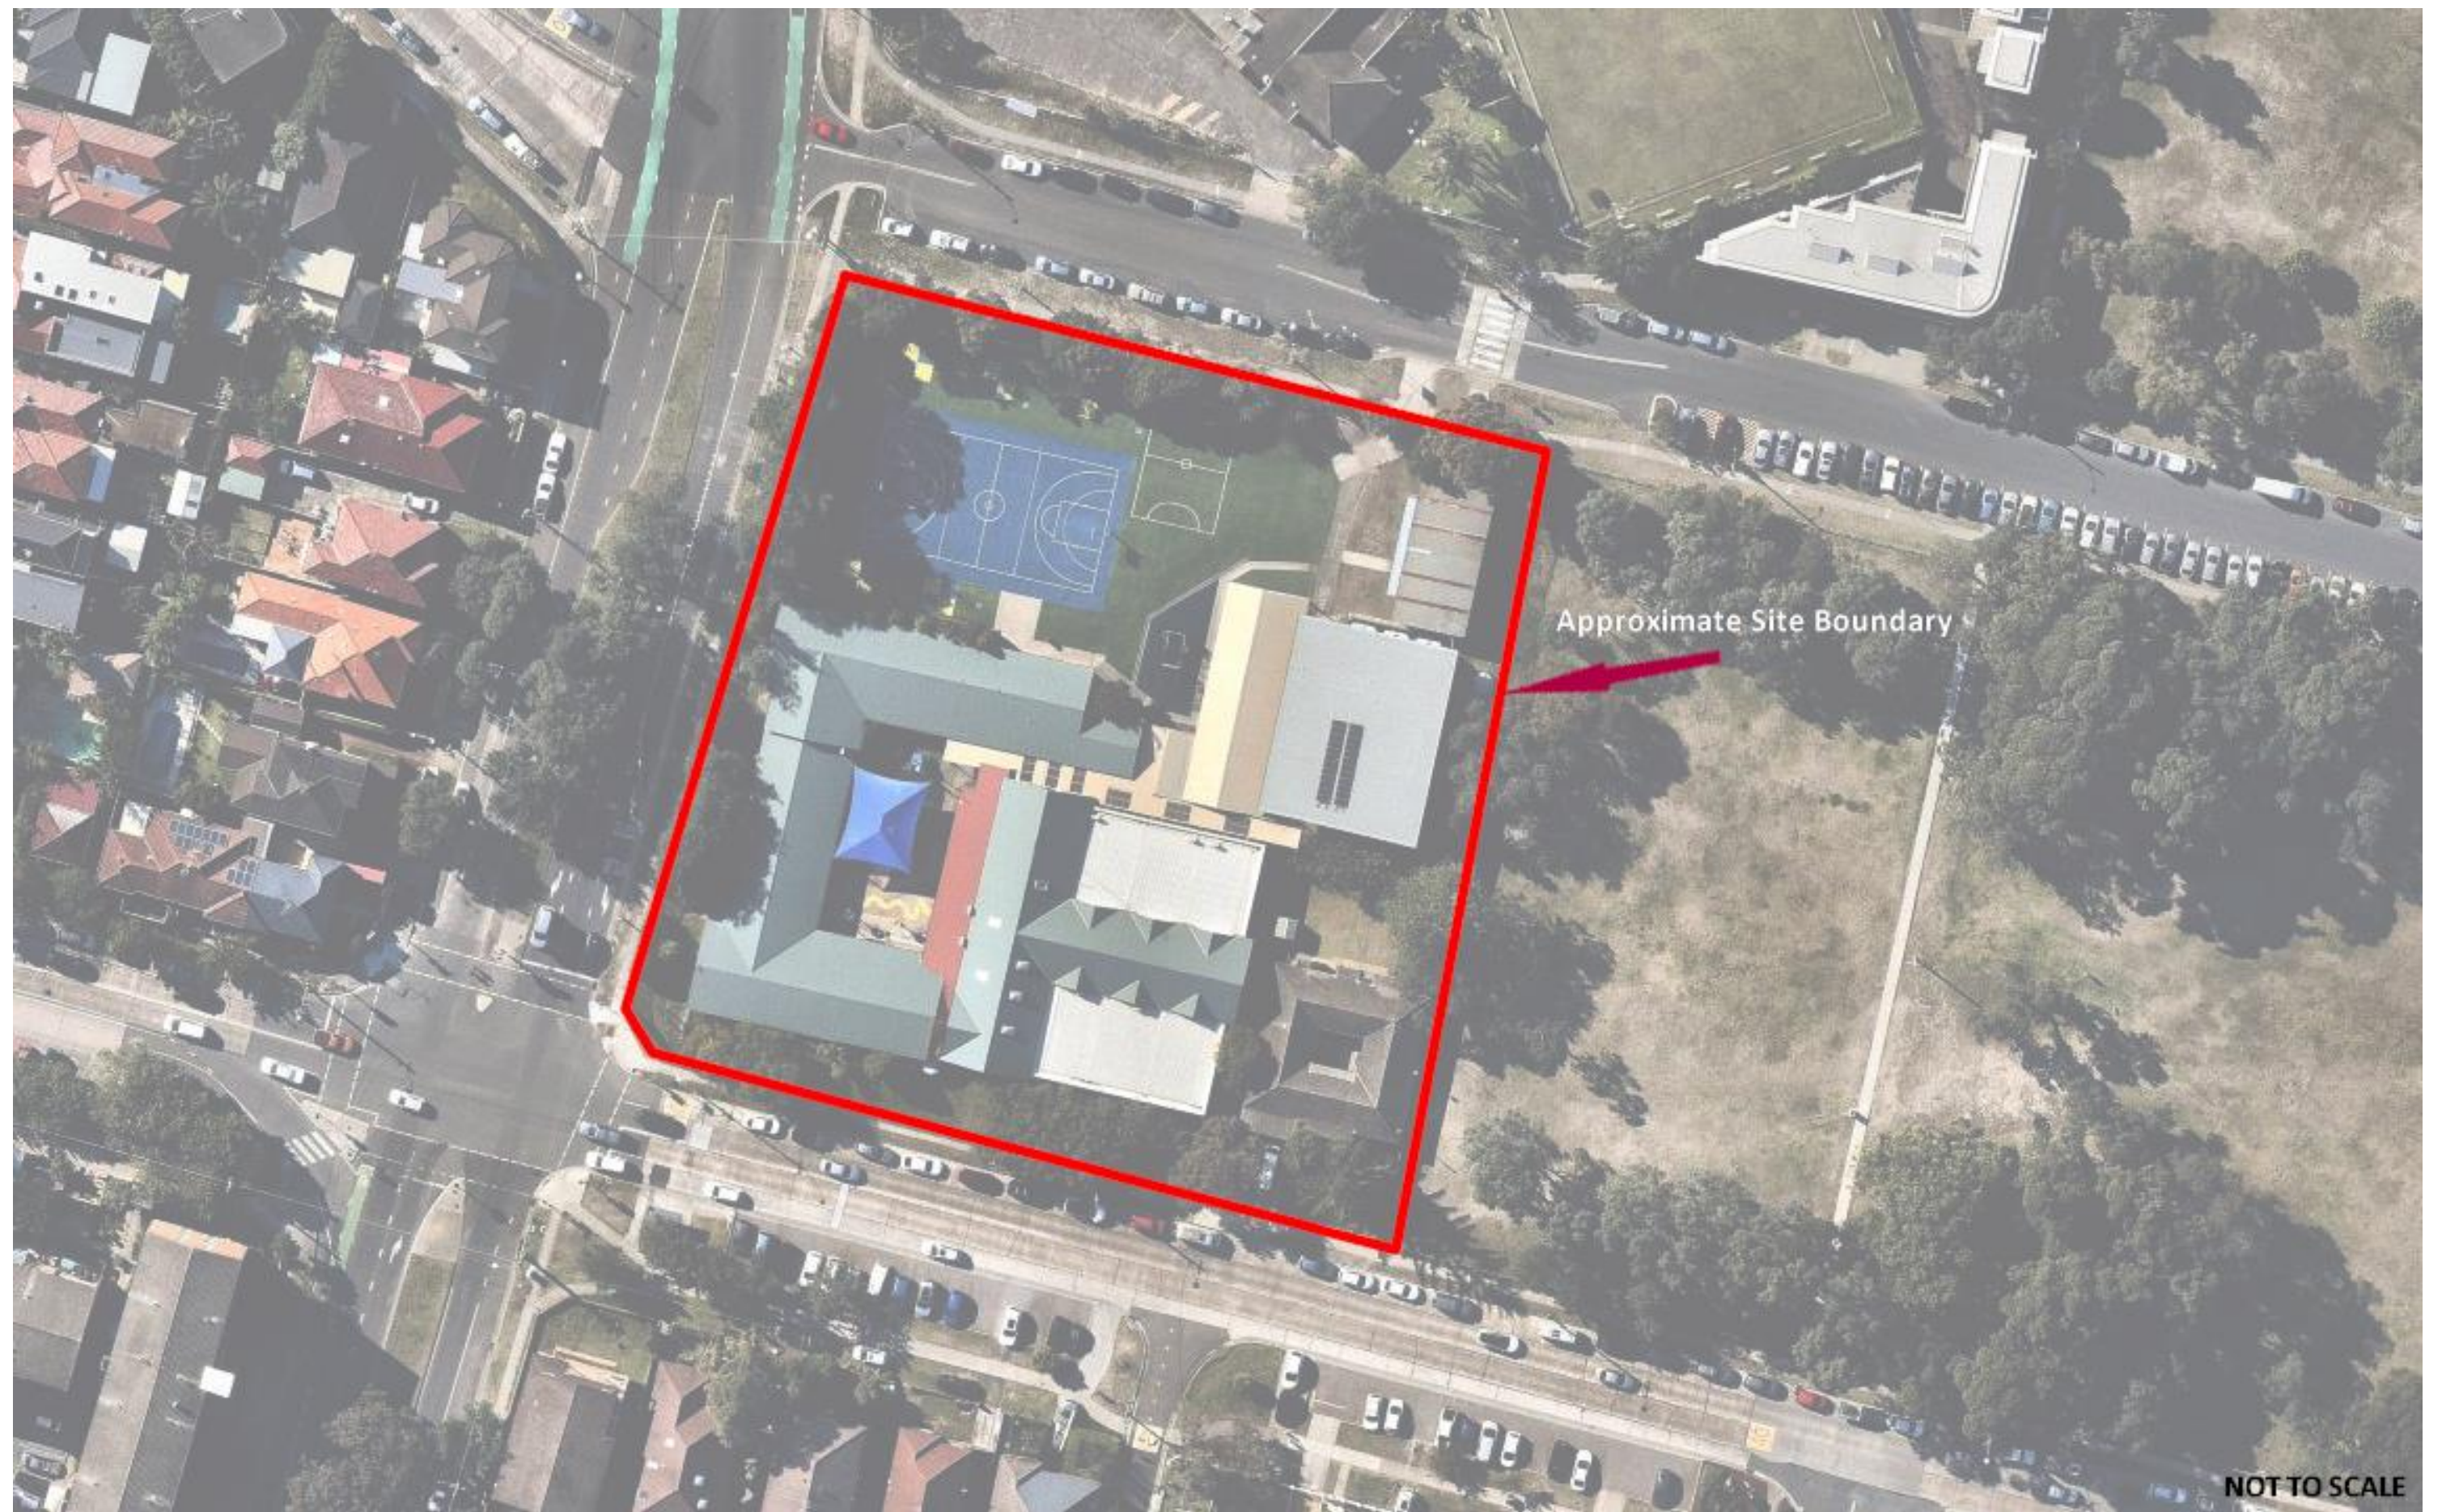
Figure Number:	2
Figure Date:	29 October 2019
Report Number:	9194.1-ER-1-1

Site Layout

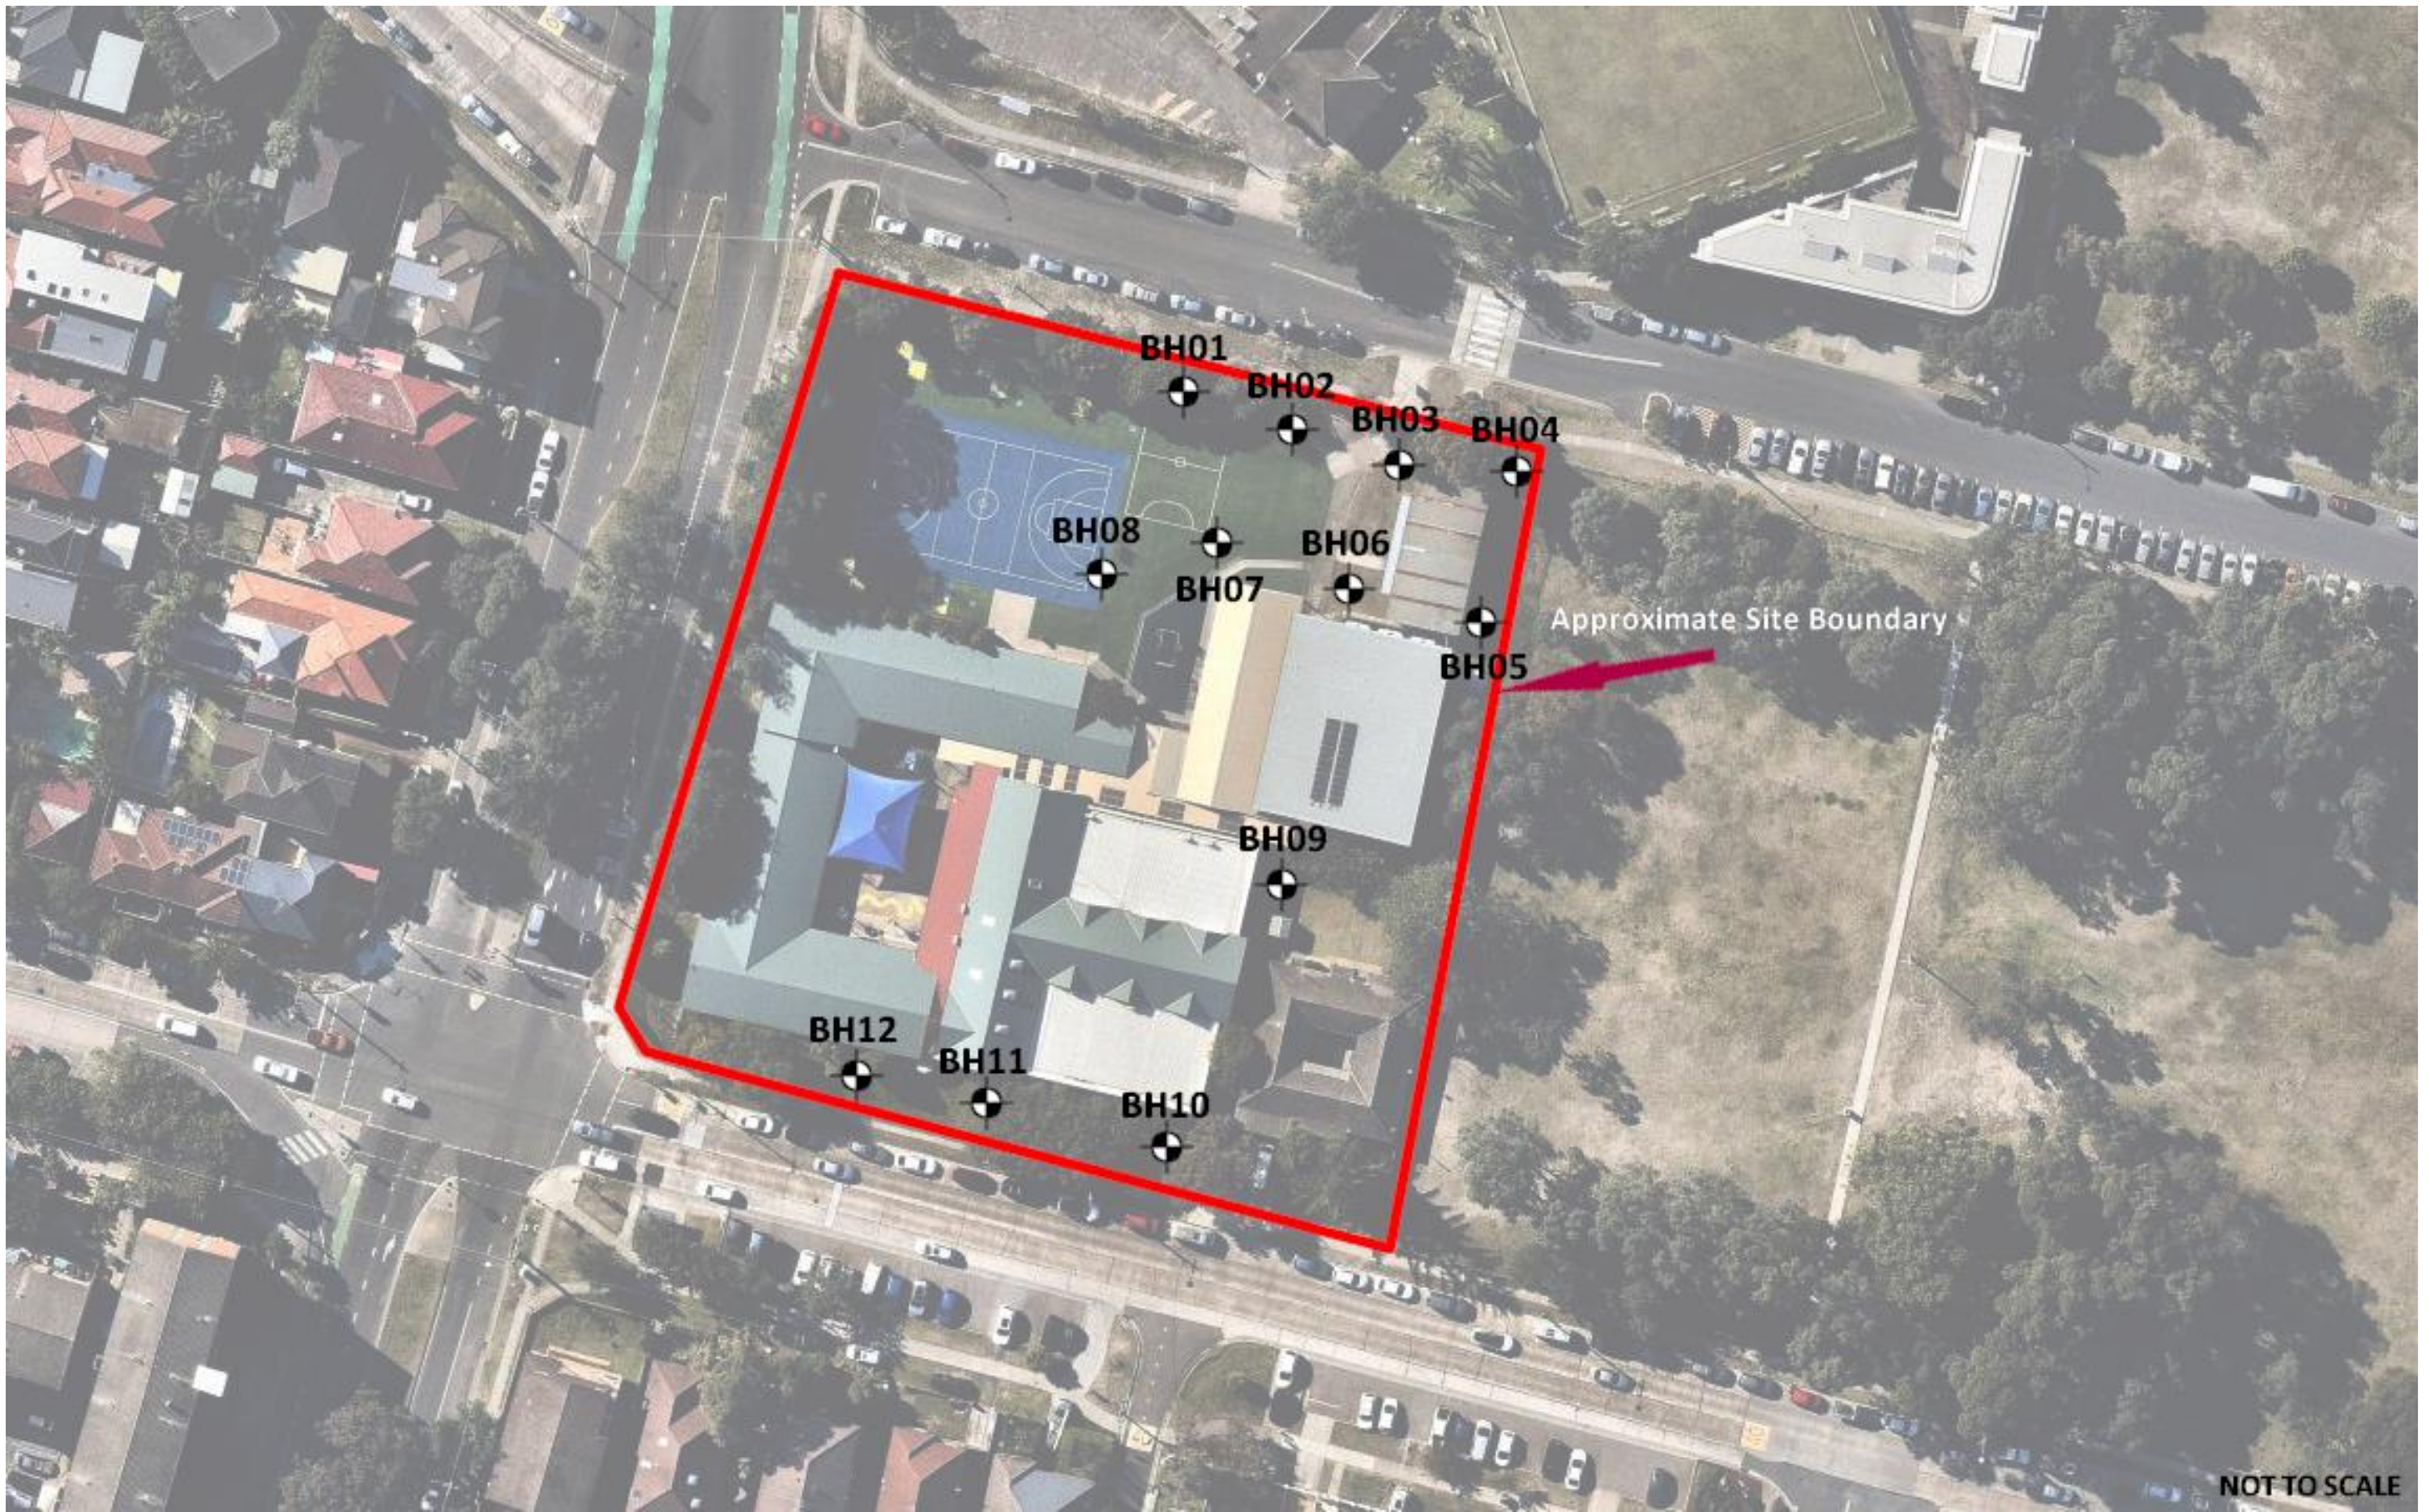
Each sampling point established was marked on a site plan. The locations of these sampling points are presented in **Figure 4**.

Sampling Plan

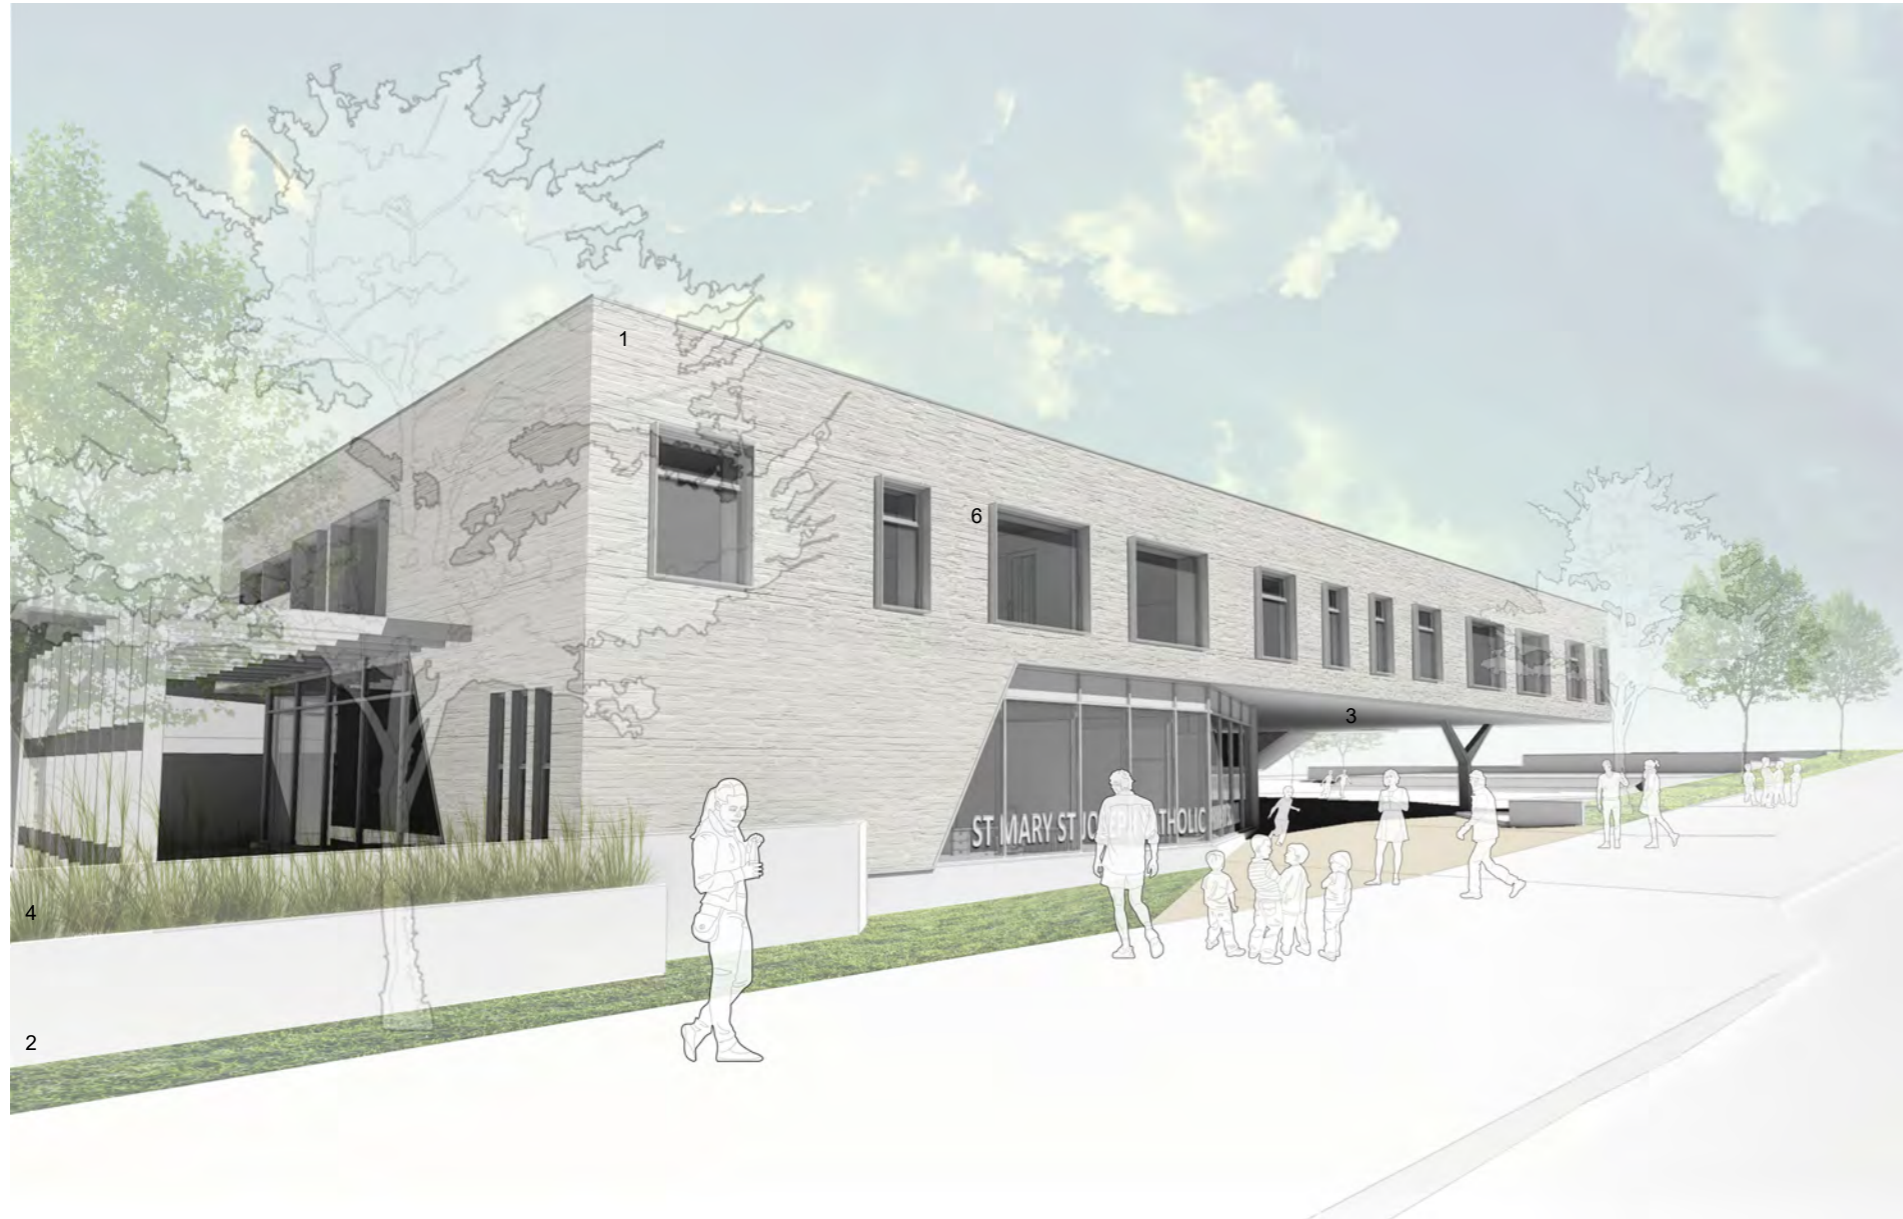
MP-14_PROPOSED MATERIAL PALETTE OPTION 1

- MATERIAL PALETTE:**
1. LIMESTONE COLOURED FACEBRICK WITH LIGHT GREY MORTAR JOINTS.
 2. RAW CONCRETE FINISH TO COLUMNS, FEATURE WALLS AND EXPOSED SLAB EDGES.
 3. TIMBER CEILING PANELS FOR UNDERCROFT AREAS.
 4. NATURAL VEGETATION OF THE REGION.
 5. COLOUR PALETTE RELATING TO THE OCEAN.
 6. DARK GREY POWDER COATED FRAMES.

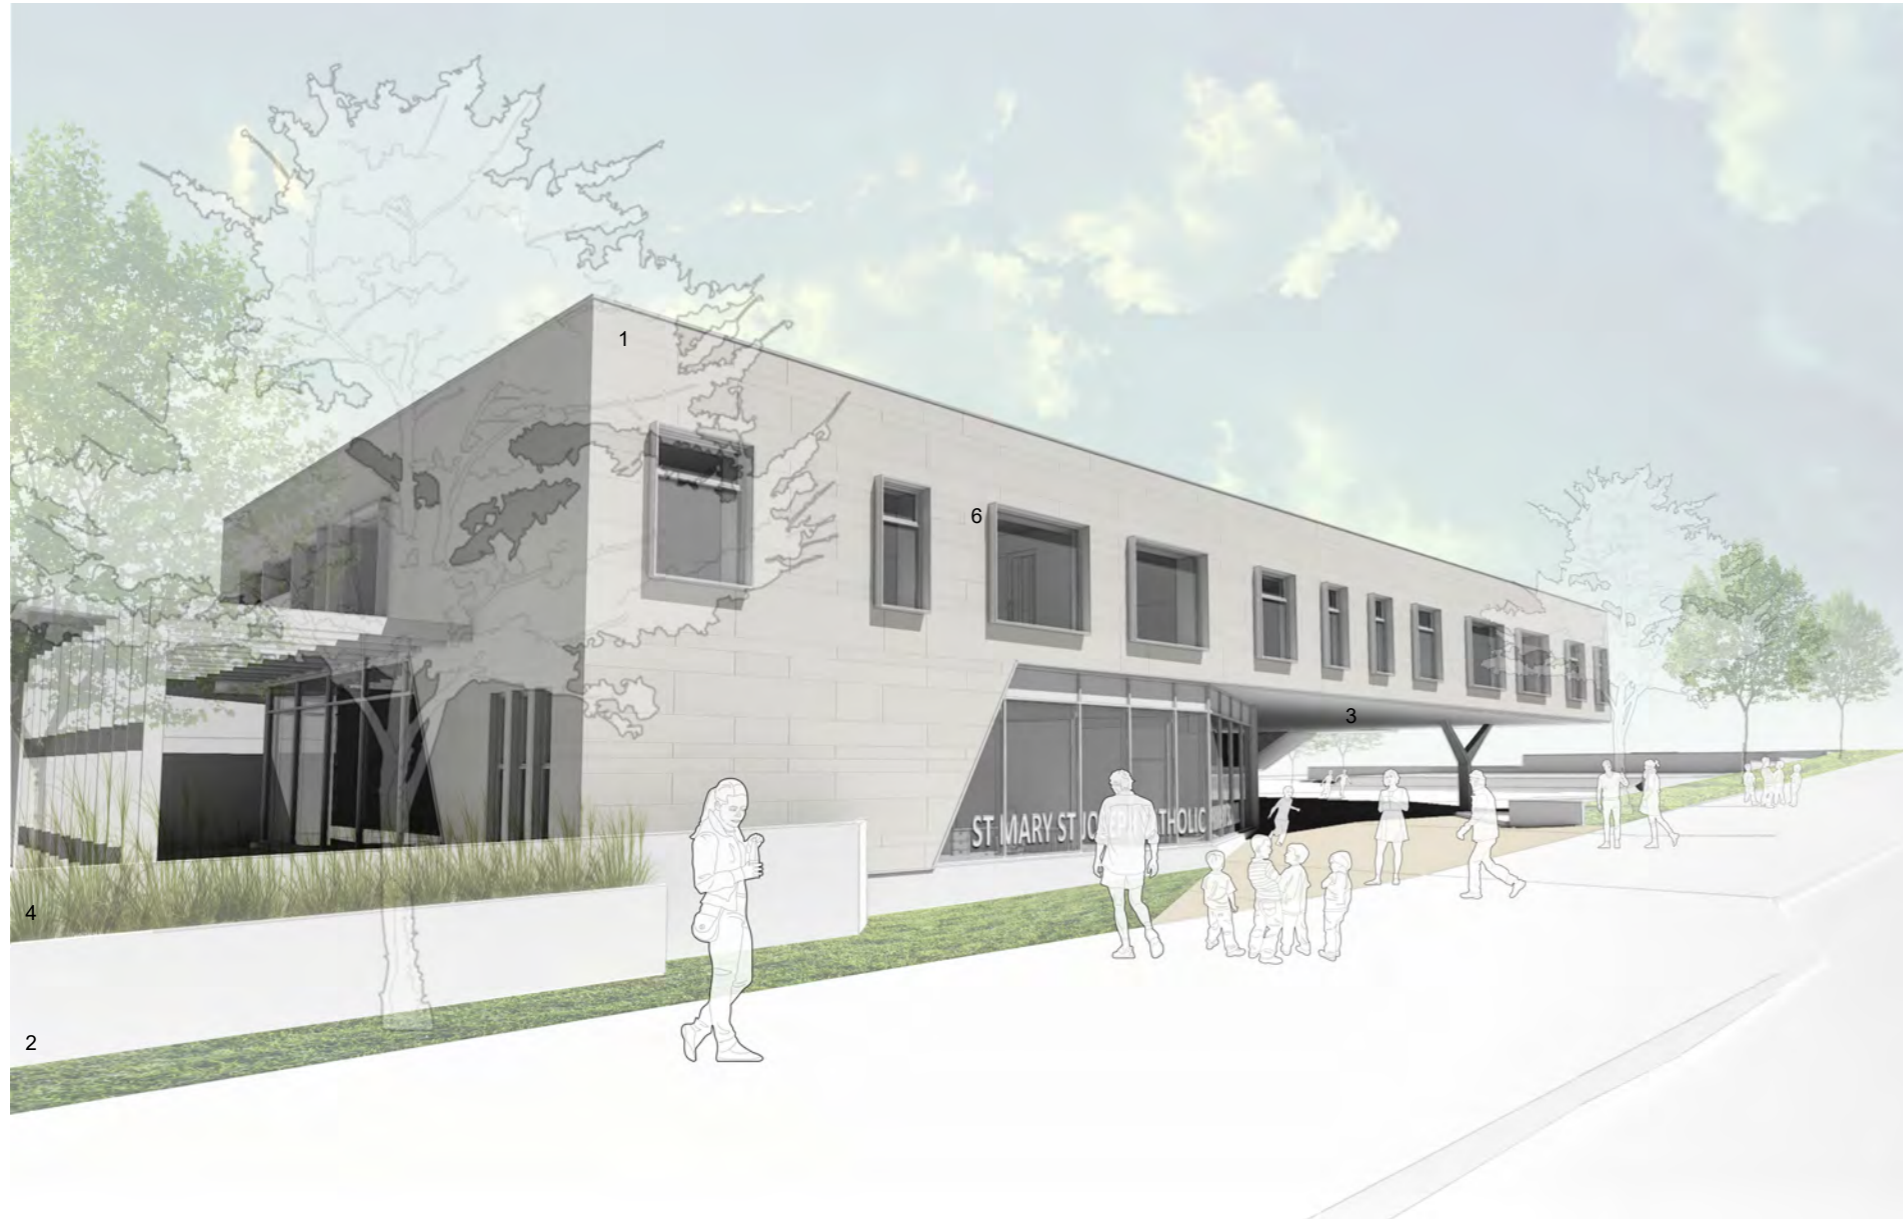
MP-15_PROPOSED MATERIAL PALETTE OPTION 2

- MATERIAL PALETTE:**
1. CEMINTEL BARESTONE EXTERNAL CLADDING PANELS.
 2. RAW CONCRETE FINISH TO COLUMNS, FEATURE WALLS AND EXPOSED SLAB EDGES.
 3. TIMBER CEILING PANELS FOR UNDERCROFT AREAS.
 4. NATURAL VEGETATION OF THE REGION.
 5. COLOUR PALETTE RELATING TO THE OCEAN.
 6. DARK GREY POWDER COATED FRAMES.
