## DEICORP PROJECTS (ASHFIELD) PTY LTD

# Geotechnical Investigation

73-75 Norton Street, Ashfield

E24659.G03\_Rev2  
23 June 2020

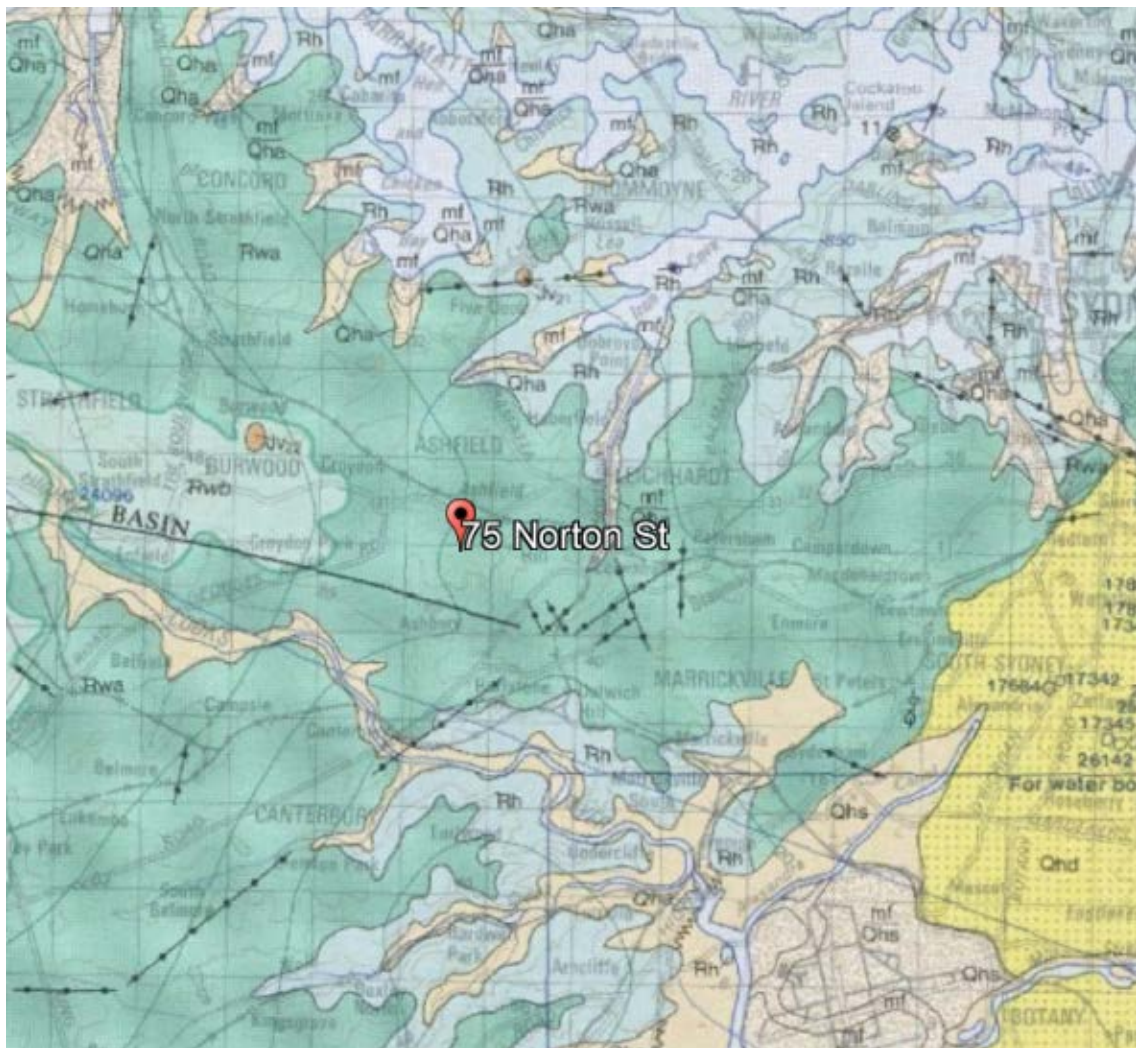
**Plate 2:** Excerpt of geological map showing location of site.

| Attribute | Description |
|---|---|
| <b>Regional Geology</b> | Information on regional sub-surface conditions, referenced from the Department of Mineral Resources Geological Map Sydney 1:100,000 Geological Series Sheet 9130 (DMR 1983) indicates the site to be underlain by Ashfield Shale (Rwa), which consists of black to dark grey shale and laminite. |
