Acid Sulfate Soil Management Plan

11-17 Columbia Lane, Homebush NSW

Report No: E24275.E14_Rev1

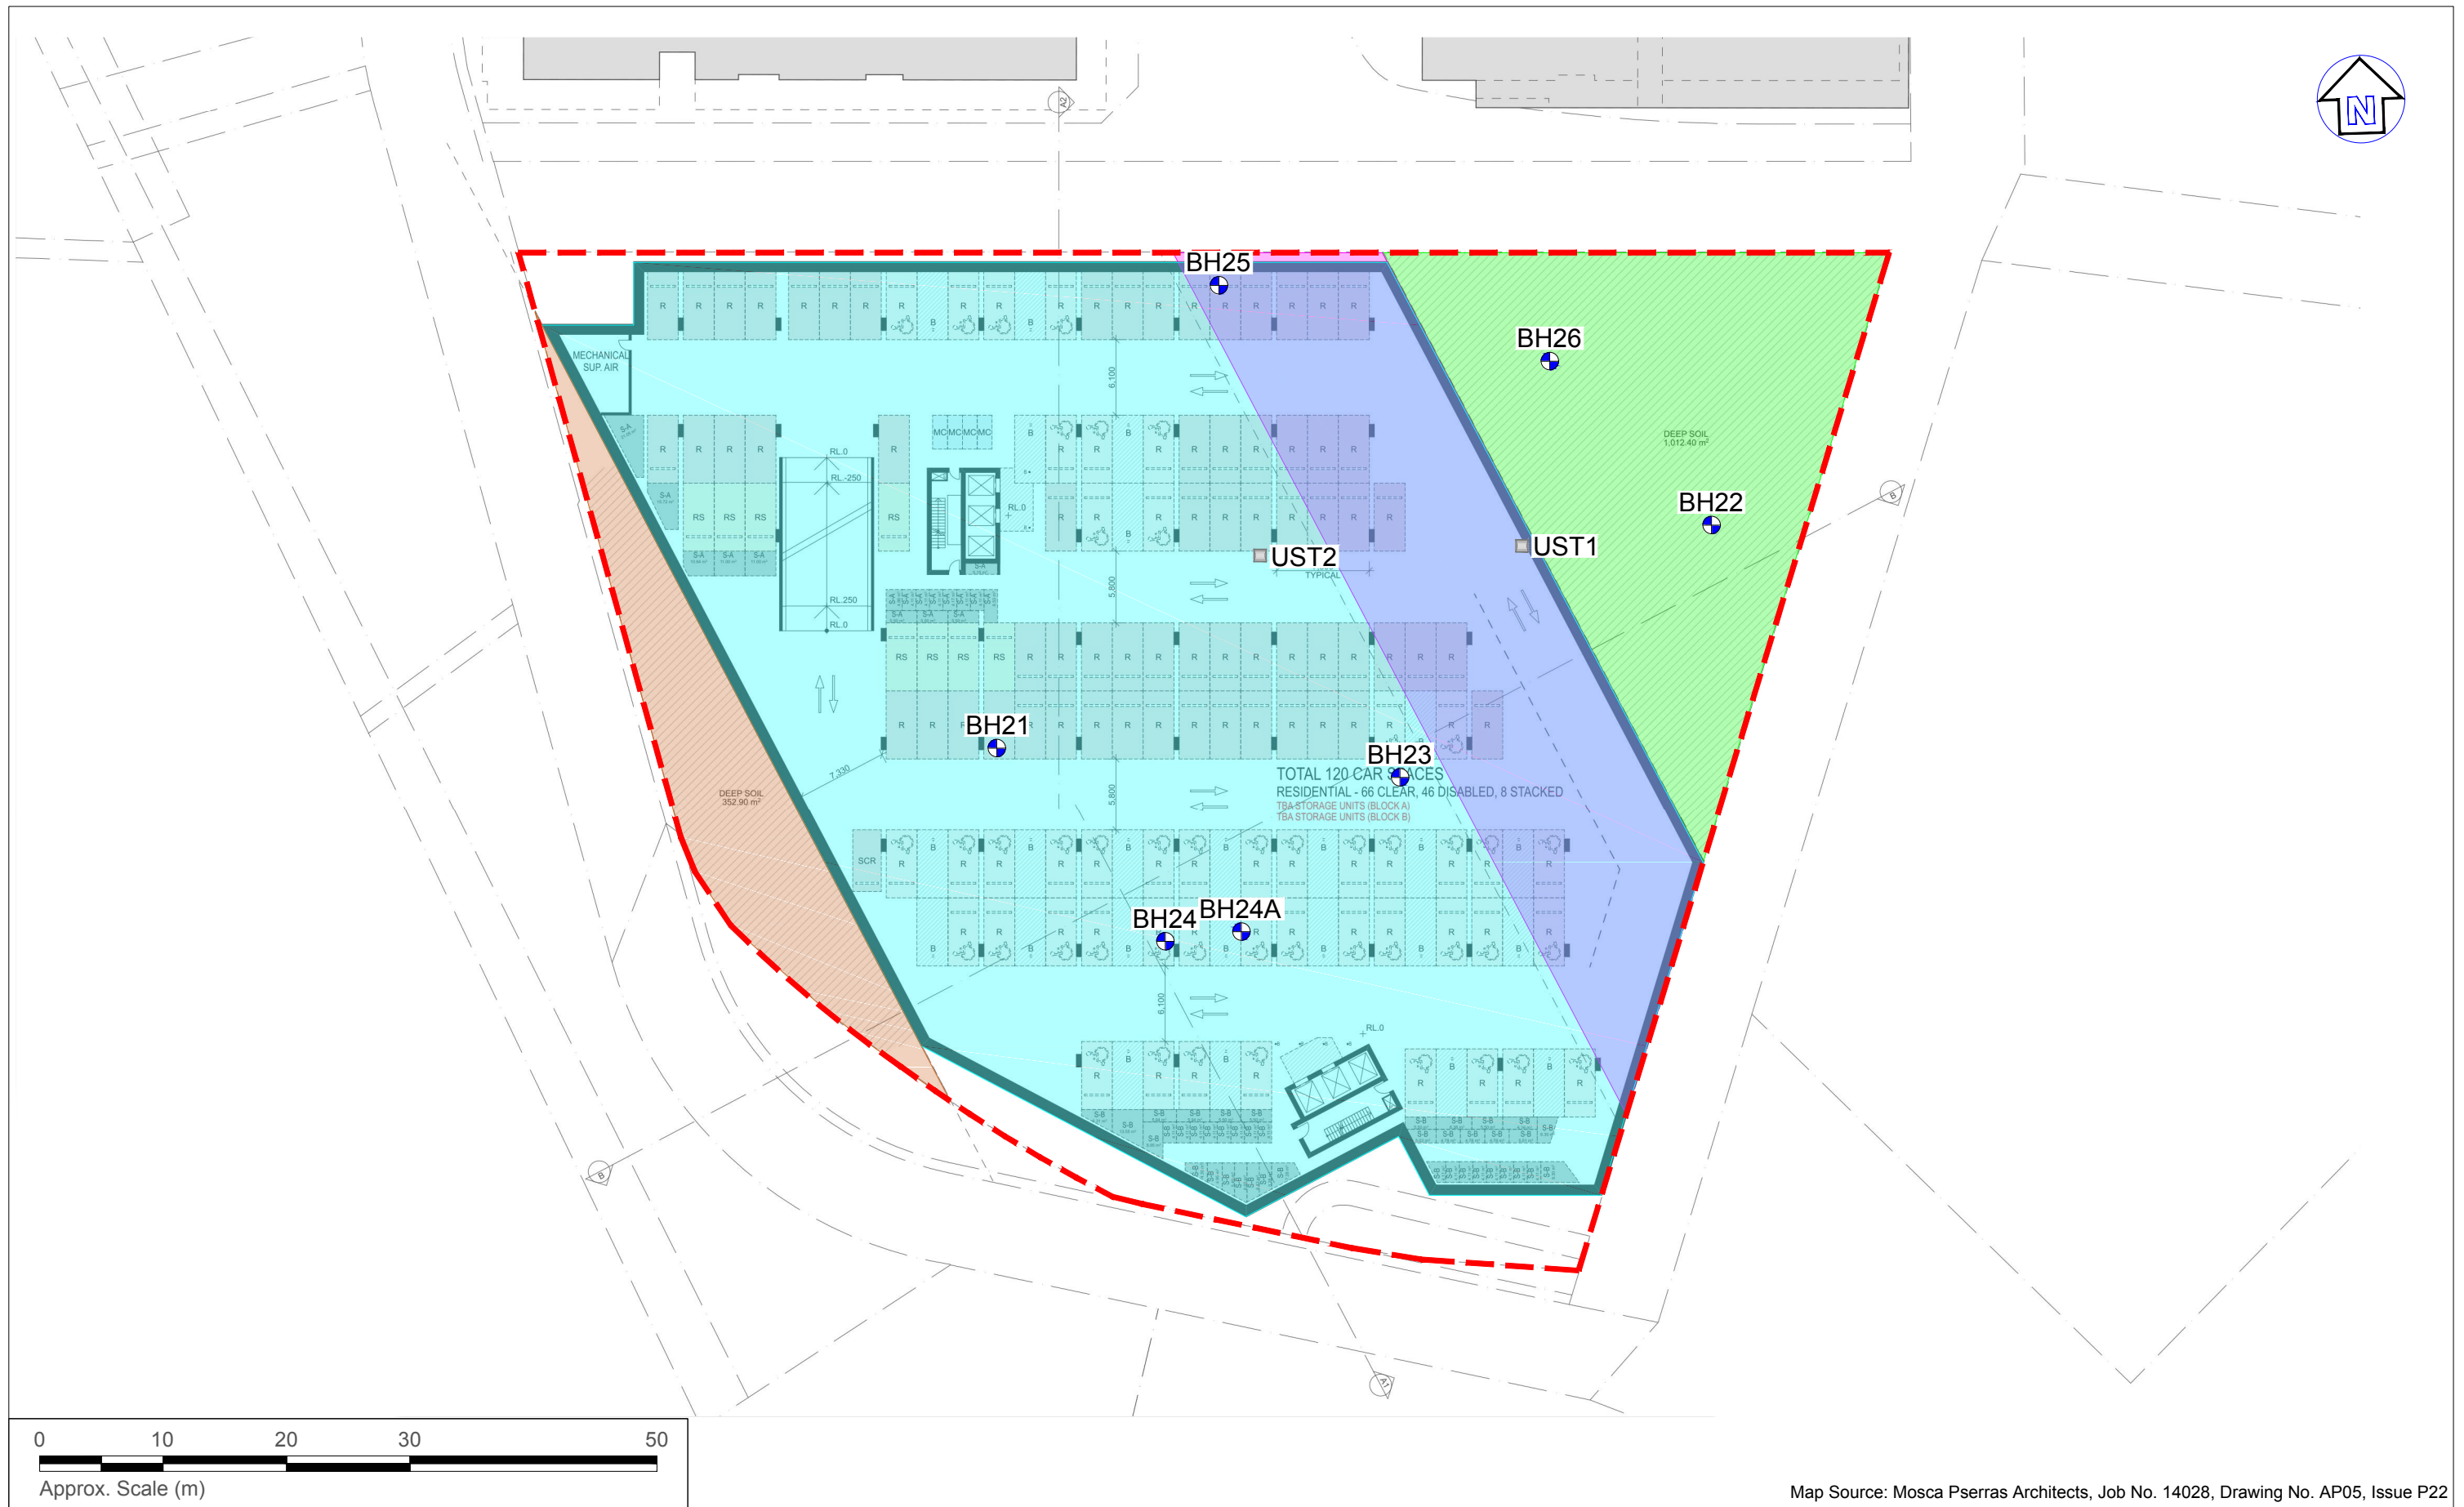
A.2

- Screening of forty-seven samples for PASS did not record any pH_f values of less than pH 5, indicating that the site soils were not affected by sulfuric soils (ASS). Field oxidation analysis indicated that samples ranged from pH 2.9 – pH 10. The recorded difference in pH_f to pH_{ox} ranged between 0.4 – 3.8 pH units, with reactions ranging from slight to vigorous. Based on the initial analysis, a number of samples showed signs for the presence of PASS.
- Following field screening, twelve representative samples were selected for laboratory chromium suite analysis (S_{CR}) to ascertain the potential for acid sulfate soils. Nine samples returned positive results, with seven samples noted to exceed the adopted action criteria. Exceedance locations and their corresponding approximate depths are noted in **Table 3-3** and **Figure A.2**.

As noted by STS (2019), based on the locations of boreholes returning exceedances, PASS are anticipated to be encountered within the historic tributary creek alignment, which is located along the western and southern portions of the site (**Figure A.3**). Whilst analyses from these boreholes were the only ones which exhibited PASS, confirmation testing should be conducted during bulk excavation works.
