**REPORT TO
PATHWAYS PROPERTY GROUP**

**ON
GEOTECHNICAL INVESTIGATION**

**FOR
PROPOSED MIXED-USE DEVELOPMENT**

**AT
274-278 LONGUEVILLE ROAD AND 4-18
NORTHWOOD ROAD, LANE COVE, NSW**

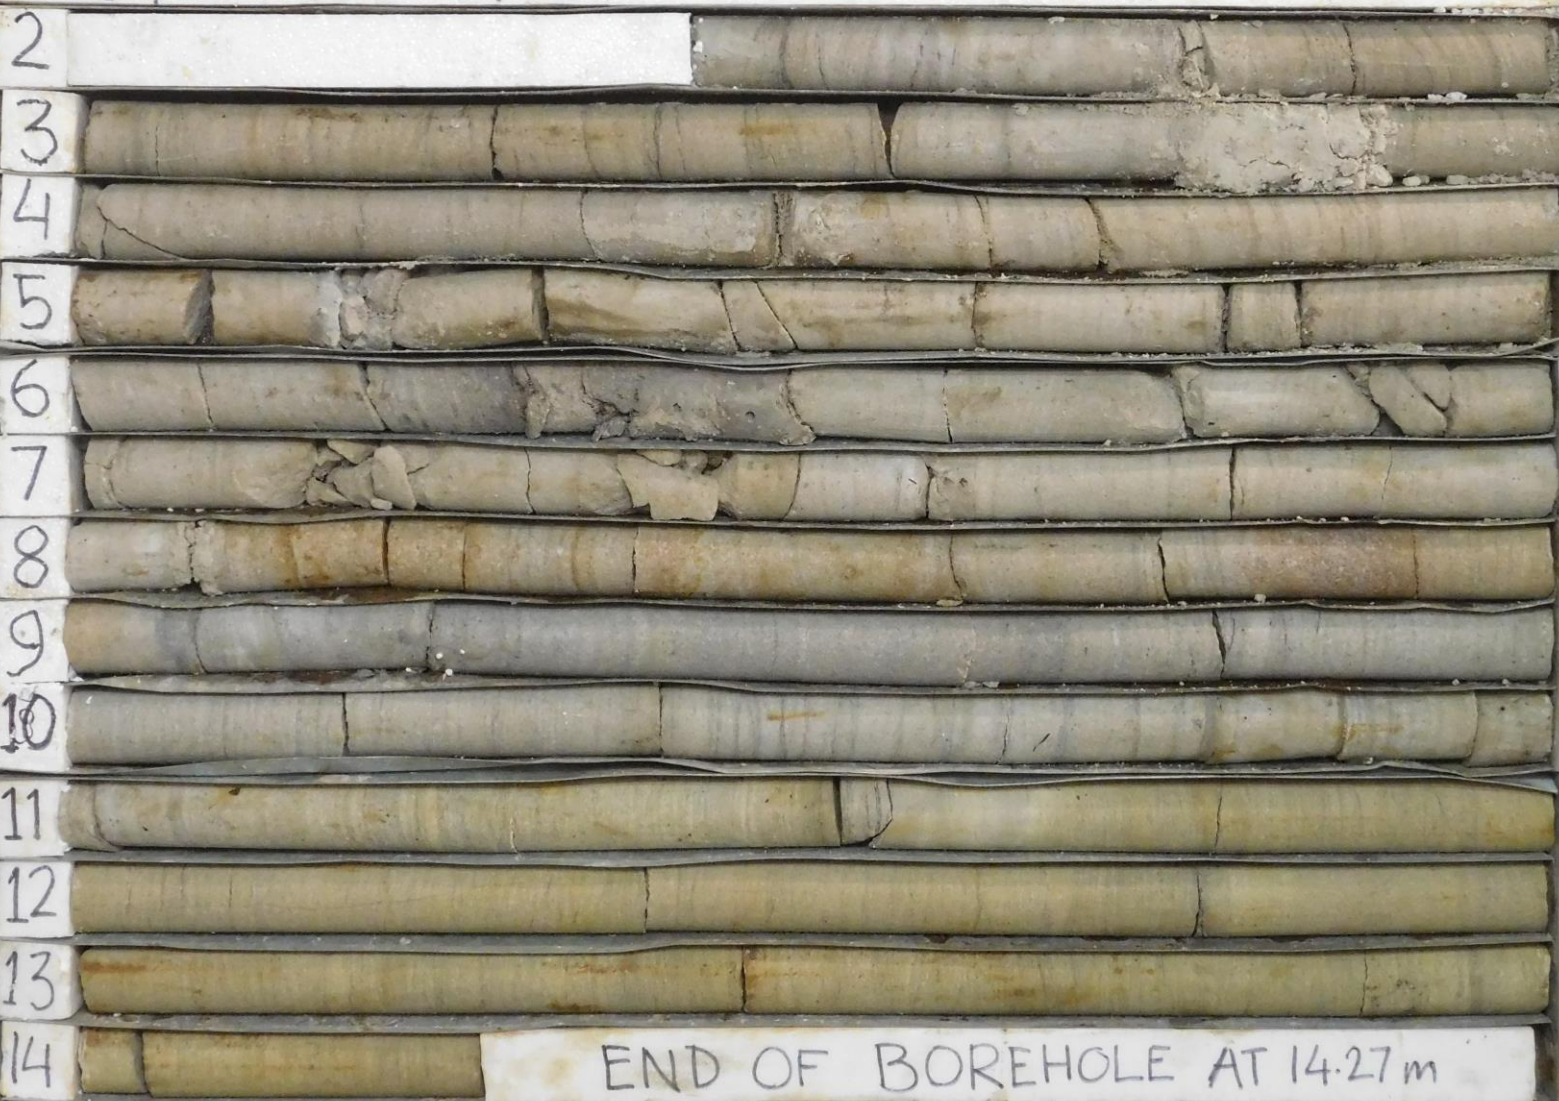
Job No: 33311ST
Borehole No: BH1
Depth: 2.41_m - 14.27_m

JOB NO. 33311ST BH1 CORING STARTS AT 2.41_m

END OF BOREHOLE AT 14.27_m

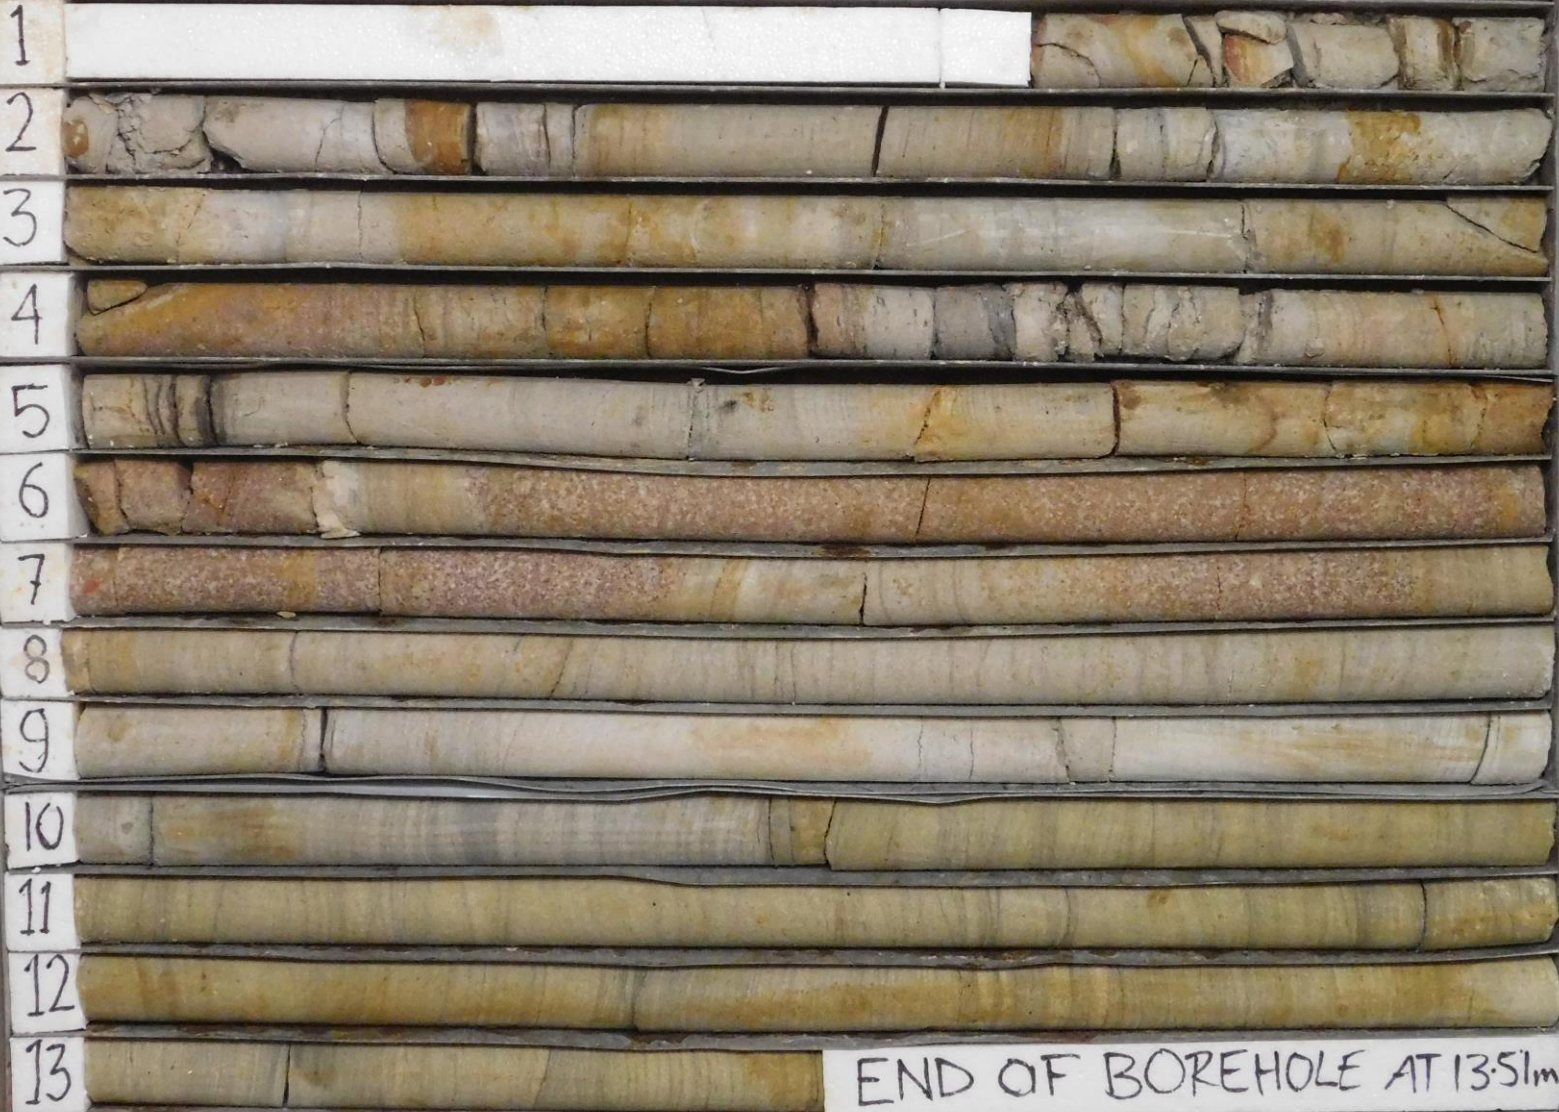
Job No: 33311ST
Borehole No: BH4
Depth: 1.65m - 13.51m

JOB NO. 33311ST BH4 CORING STARTS AT 1.65 m

END OF BOREHOLE AT 13.51m
