Environmental assessment

4-18 Northwood Rd & 274 & 274a

Longueville Rd, Lane Cove

Prepared for Lane Cove Council

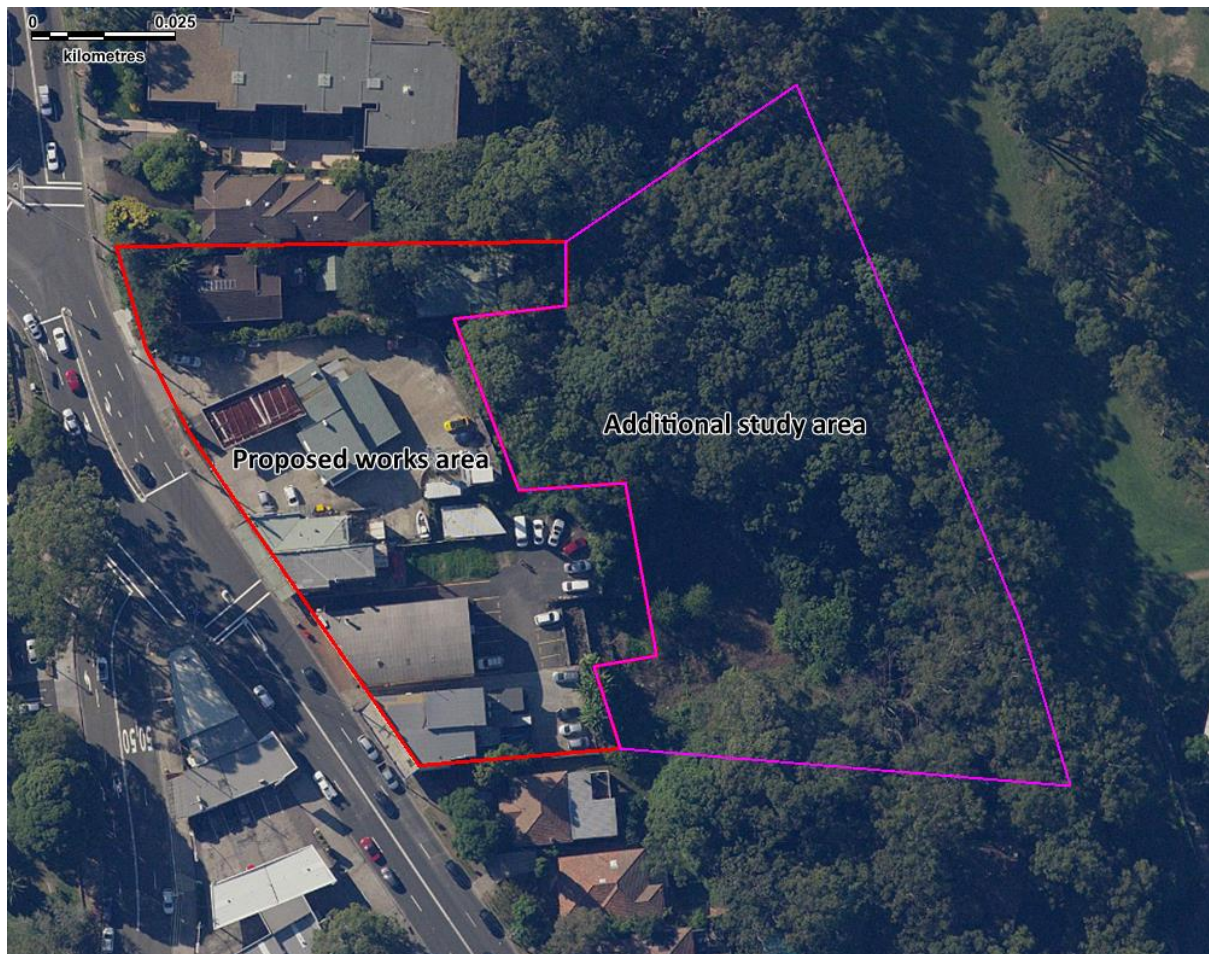
Figure 1 Site detail

The study site location and context are shown in Figures 1 and 2. The site is located in the suburb of Lane Cove with access from Northwood Road within the Lane Cove Council LGA.

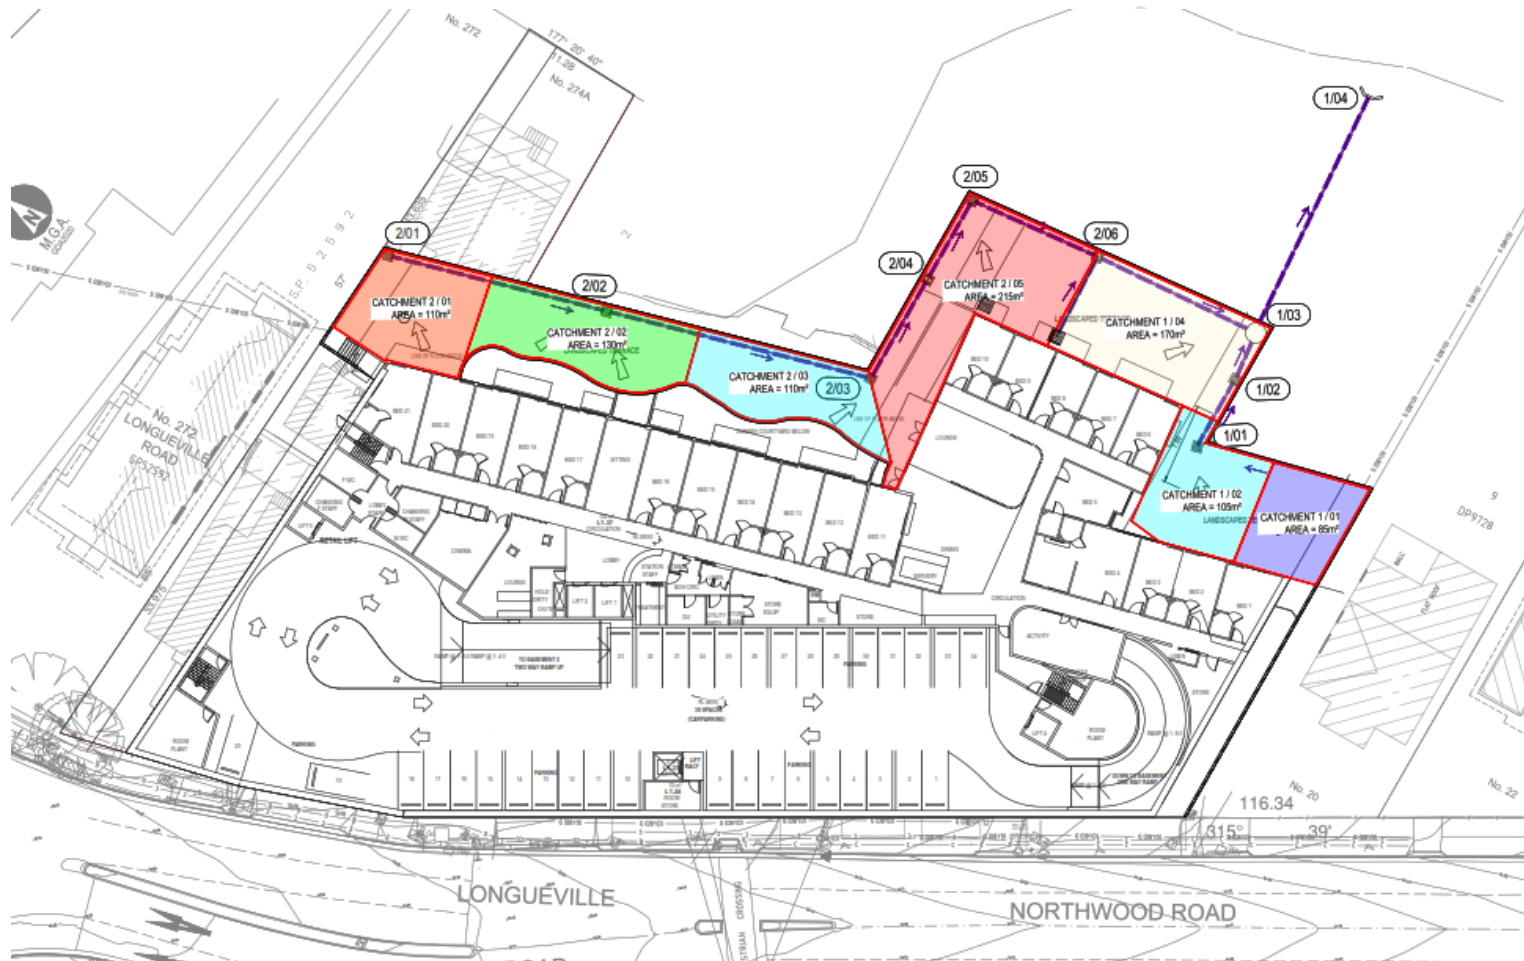
Figure 5 Stormwater catchment plan (Acor 2020)

The location of the stormwater infrastructure is not clear in the site landscape plans (Figure 3) and is provided separately (Figure 5).

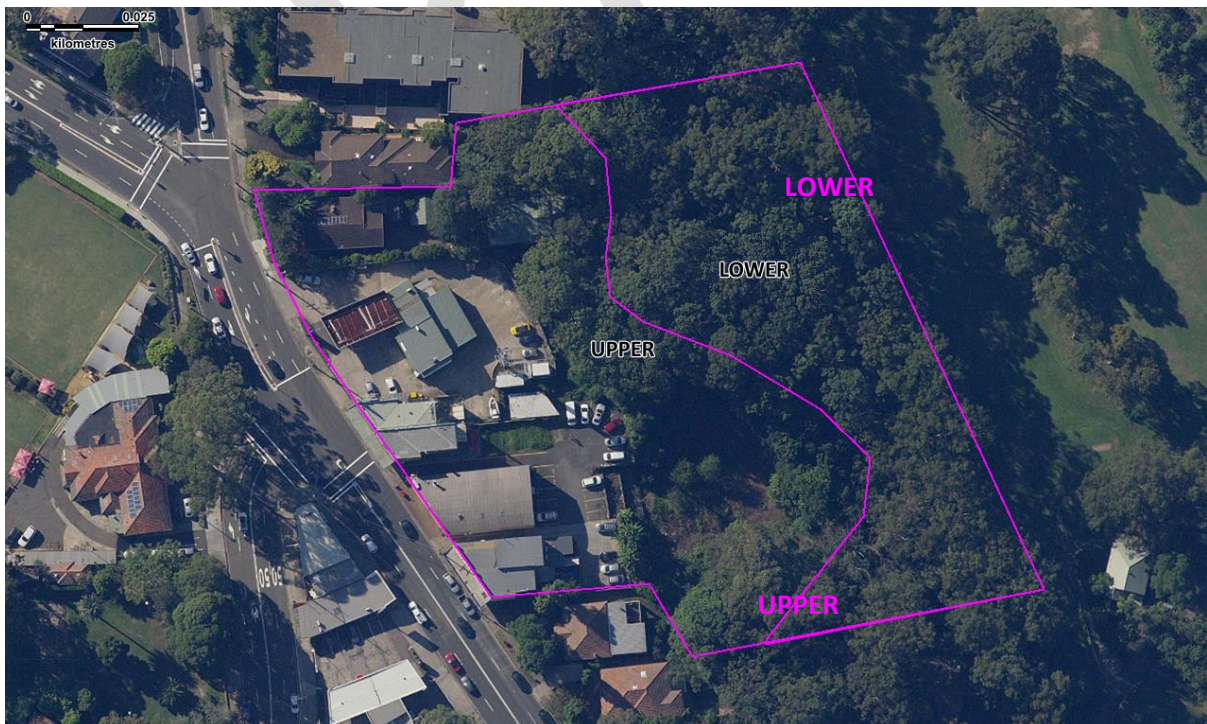
Figure 7 Survey zones used for flora surveys on the subject site at 4 Northwood Rd in February 2021

The subject site for the proposed development at 4 Northwood Rd, Lane Cove was divided into two zones based on condition of vegetation:

- Upper section, comprising the most degraded part of the site
- Lower section, mostly good quality bushland with some weeds

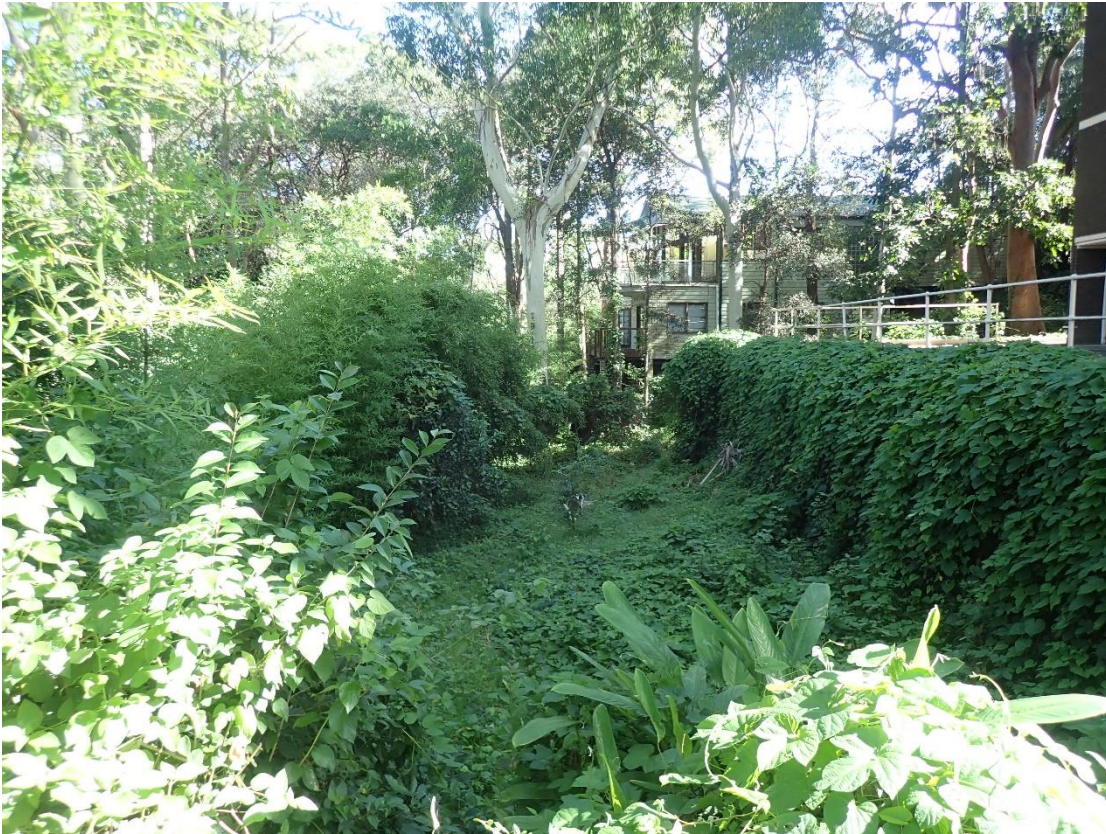
Figure 9 Vegetation behind adjoining buildings has been affected by shading and become quite weedy

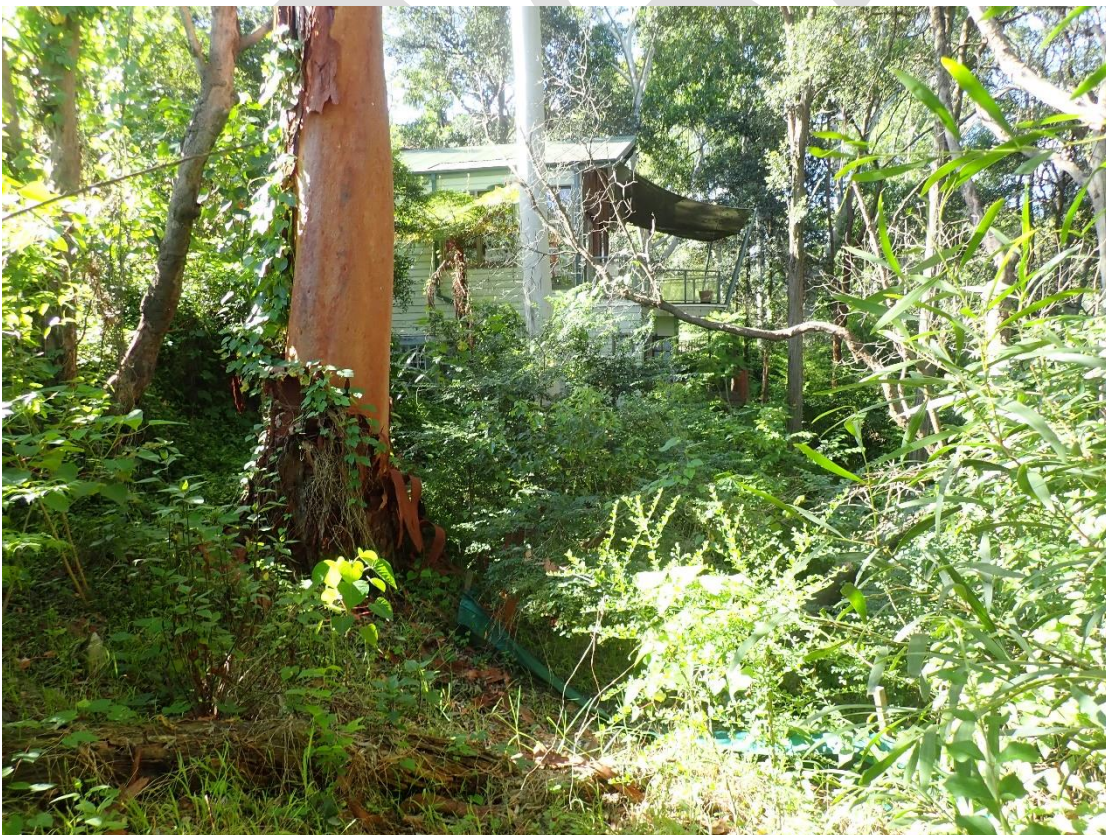
Figure 10 Mature canopy trees are still present along the edge of the proposed development site, and will be affected

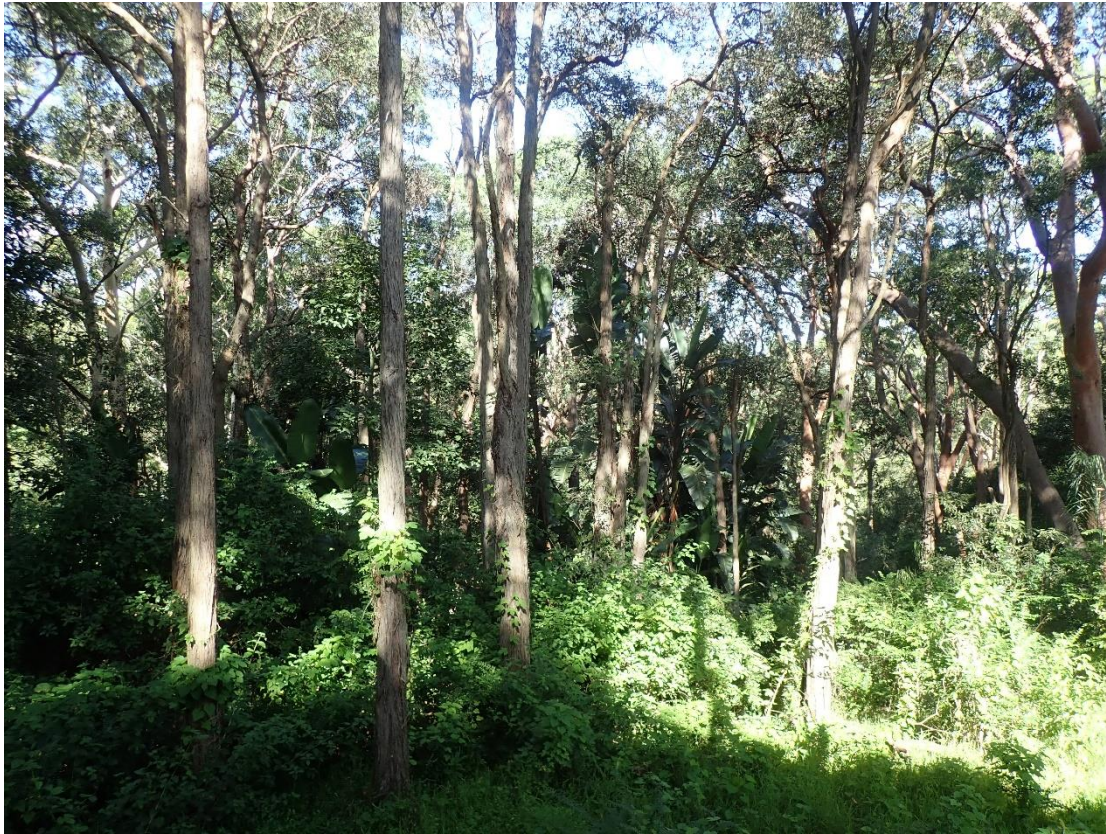
Figure 11 Areas of good quality native canopy trees are undergrown by weedy shrubs and vines

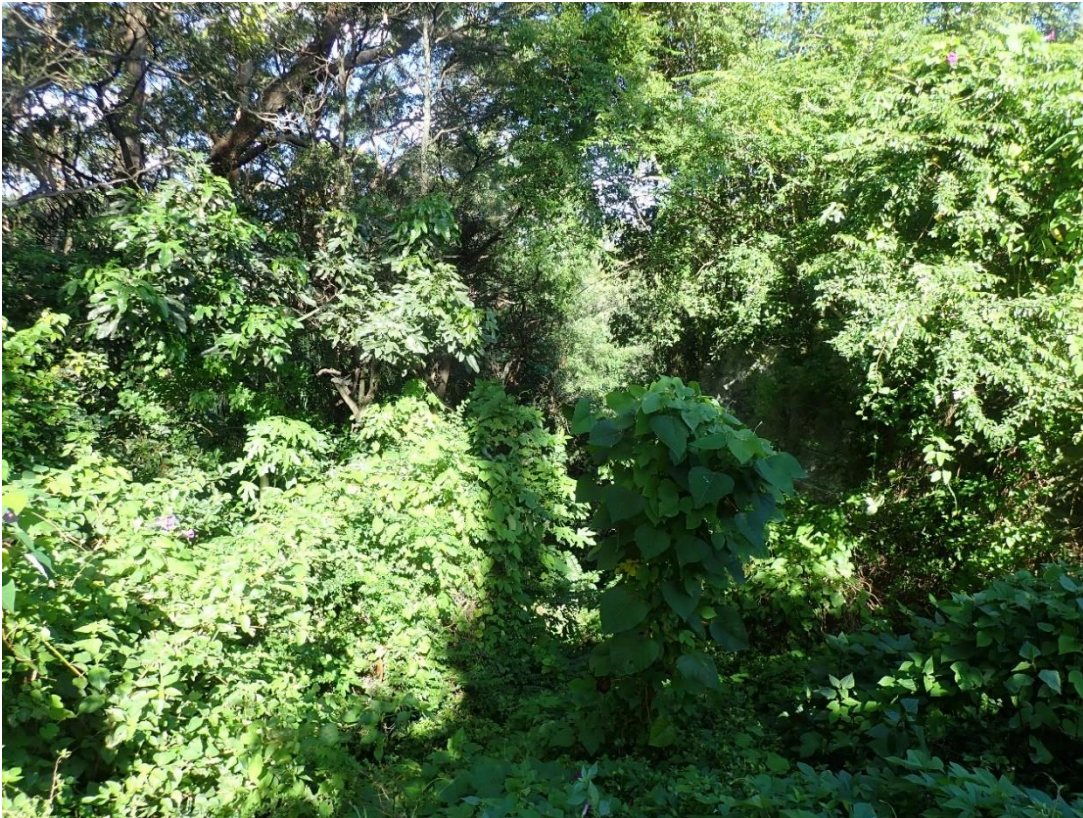
The land generally slopes steeply from immediately behind the commercial properties. These have retaining walls to stabilise and increase the usable area at the rear of the premises. Once the slope reaches the native soils it becomes much less steep, and the level of disturbance to vegetation is also less. The result is areas of good quality native canopy trees, including Turpentines (*Syncarpia glomulifera*) and Smooth-barked Apples (*Angophora costata*). The vegetation underneath is much weedier, with a dense shrub layer of woody weeds and vines (Figure 11). The contrast is quite obvious when viewed from the back of the commercial properties, especially where there has been some clearing of the native canopy (Figure 12).

Figure 12 Seen from above, there is a dense mid storey layer of weedy shrubs below the native canopy in the upper section

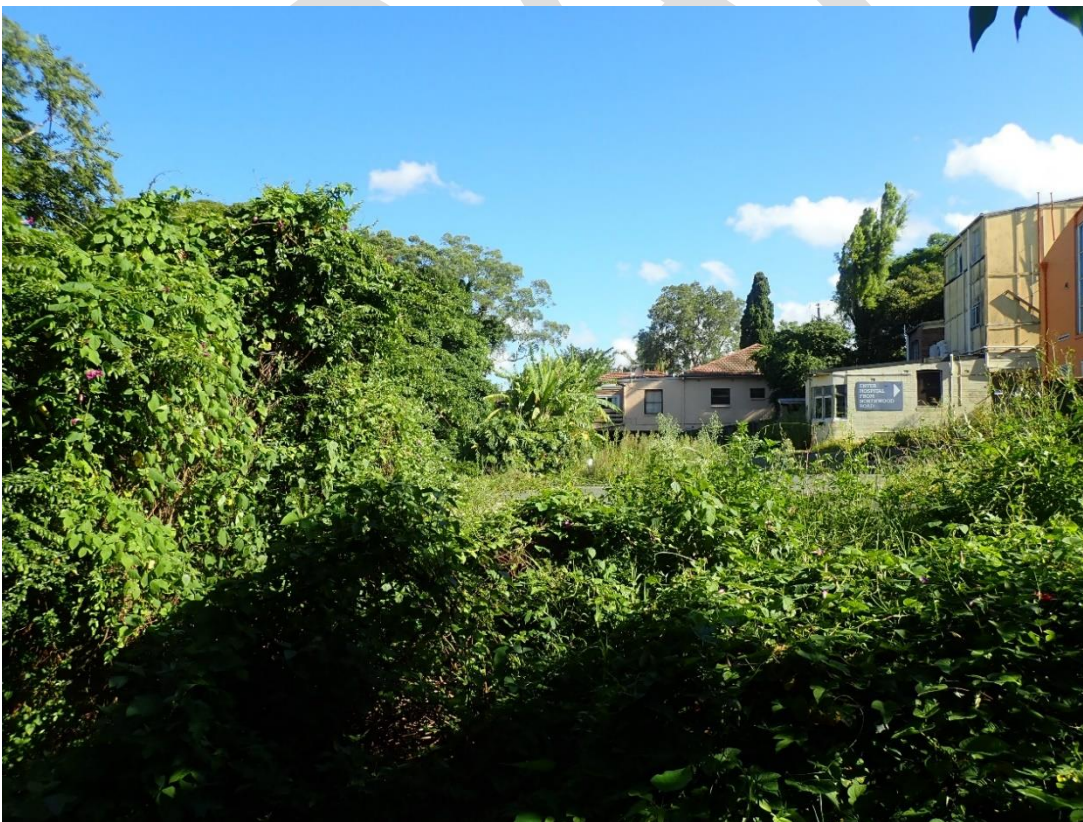
This type of vegetation – retained canopy with understorey dominated by weeds is quite typical of the upper survey zone, except where the canopy has been cleared for bushfire management or other reason. The result of clearing and modified soil levels is weedy vegetation, especially in the higher parts of the upper zone (Figure 13).

Figure 13 Most of the vegetation at the back of the proposed development site is very weedy and has impacted adjoining bushland

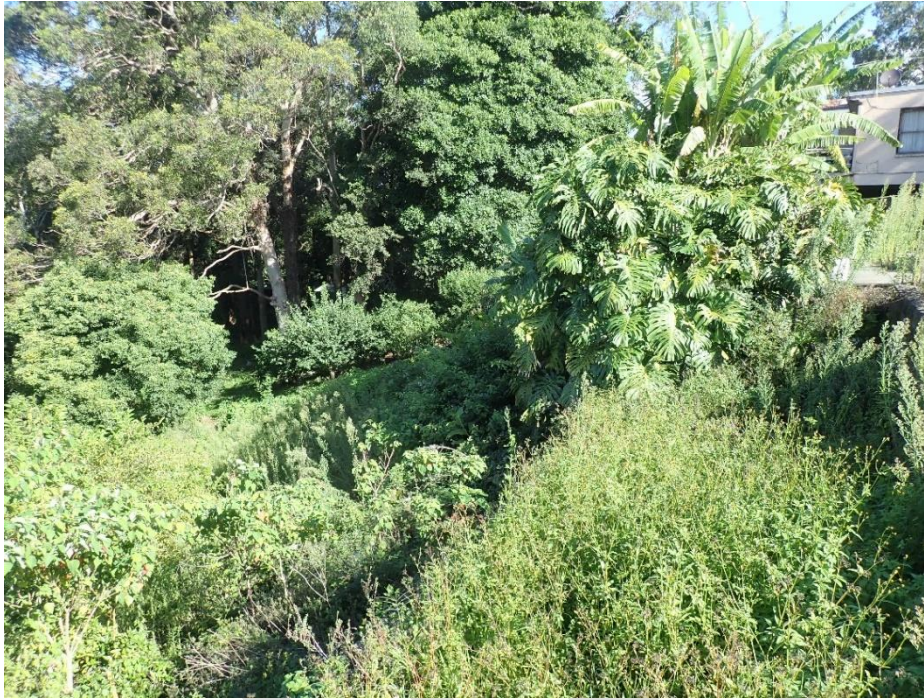
Behind the old animal hospital is an area that has been cleared of weeds, creating a gap in the thick midstorey layer of dense woody weeds (Figure 14). Access to this area is via a steep rocky slope that consists of poorly stabilised building debris and fill (Figure 15). The vegetation in this area has been affected by increased shading, modified soil levels and the introduction of weed propagules. The increased moisture and decreased light regimes have favoured the establishment of weeds over the native species and their seeds from the soil seedbank.

Figure 14 Downslope from the animal hospital car park is an area that has been cleared of weeds and replanted

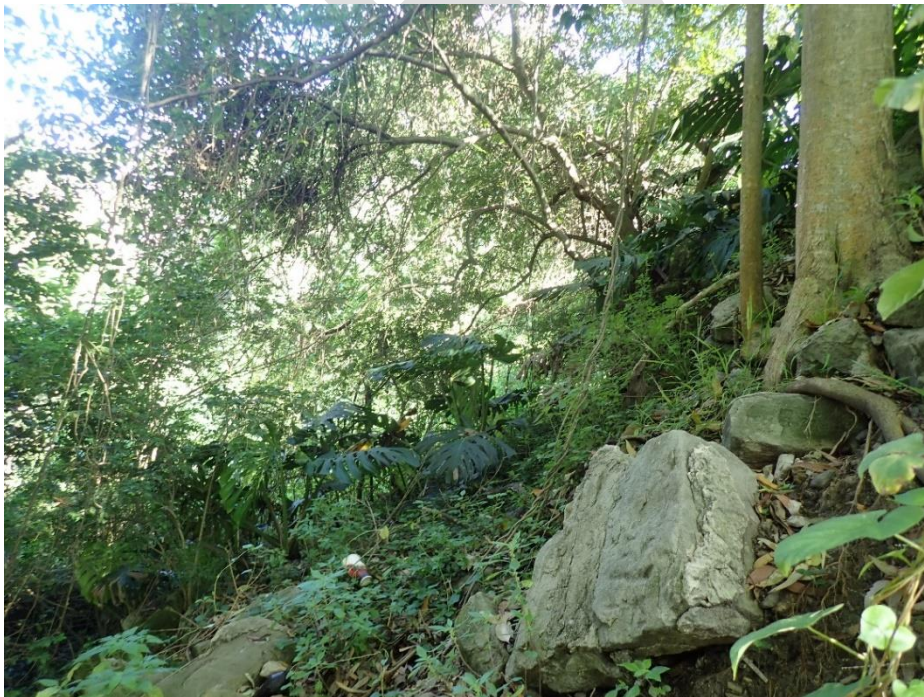
Figure 15 The slope consists of poorly stabilised building debris and fill, and is now deeply shaded and dominated by weeds

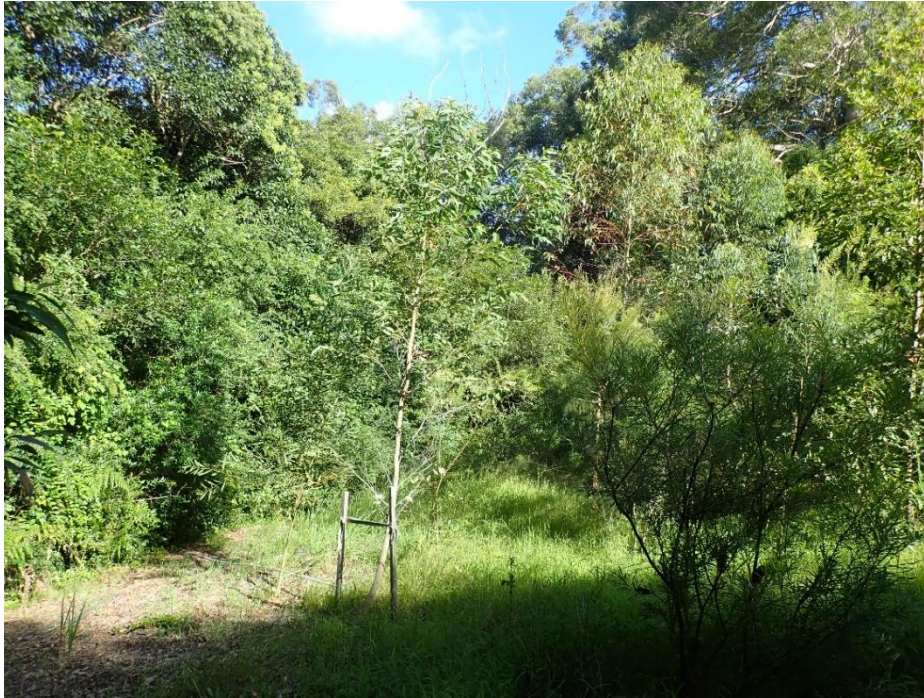
The revegetation area is at the base of this slope and has evidence of extensive weed control including removal of woody weeds and vines. The proposed stormwater pipe will run through this area, discharging from an outlet just below the edge of the clearing (Figure 16). The planting includes a number of mature saplings and shrubs. Considerable time and money have been invested in this revegetation (Figure 17). Nearly all the species are entirely appropriate for the extant vegetation community.

Figure 16 The revegetation area will be traversed by the proposed stormwater pipe, with the outlet below

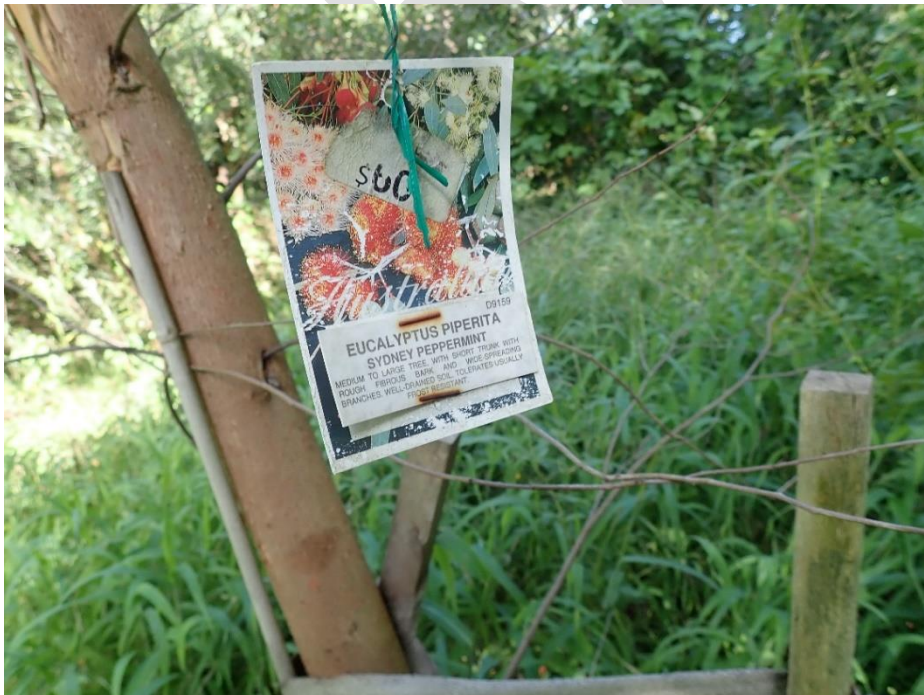
Figure 17 Considerable time and money has been invested in community appropriate species for replanting

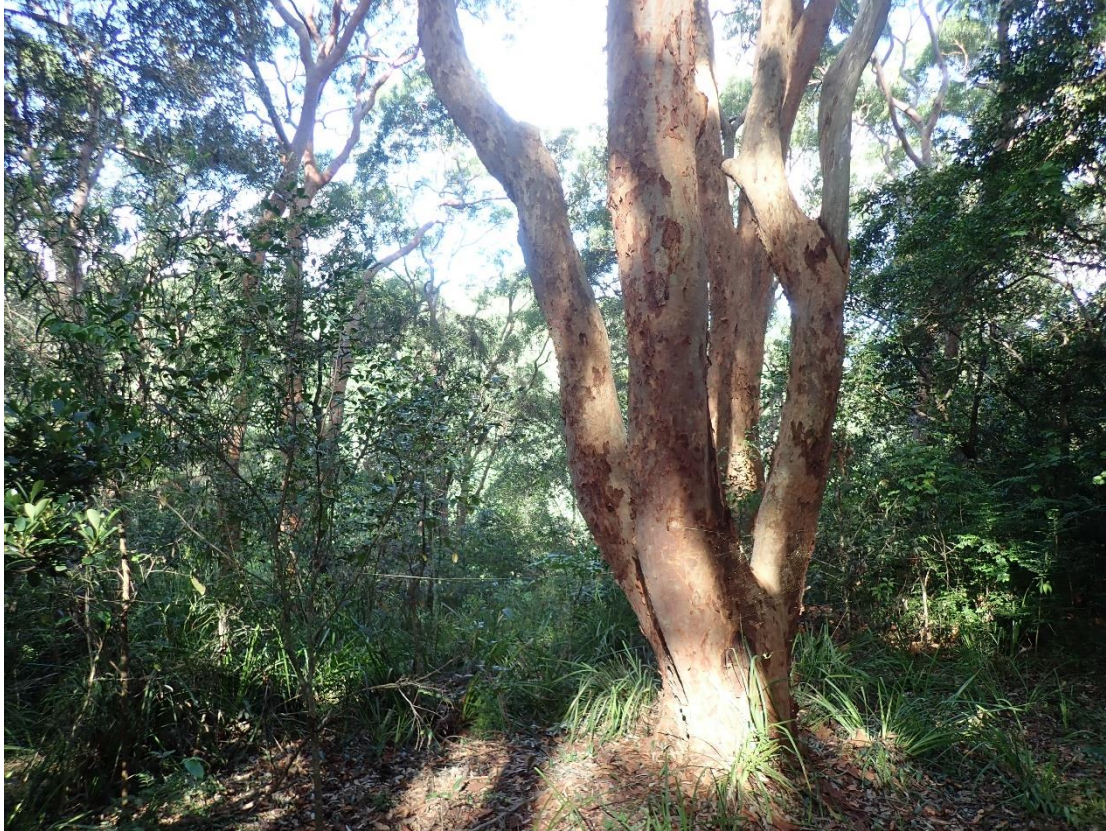
Vegetation condition in the lower zone is in much better condition (Figure 18). It is currently not adversely affected by shading, and there are only minor alterations to local moisture regimes and the resulting microclimate. Weeds have either been controlled in this area, or are yet to reach here, and the extant vegetation has a much lower weed burden than upslope.

Figure 18 Outside the area impacted by the existing development the vegetation is predominantly native

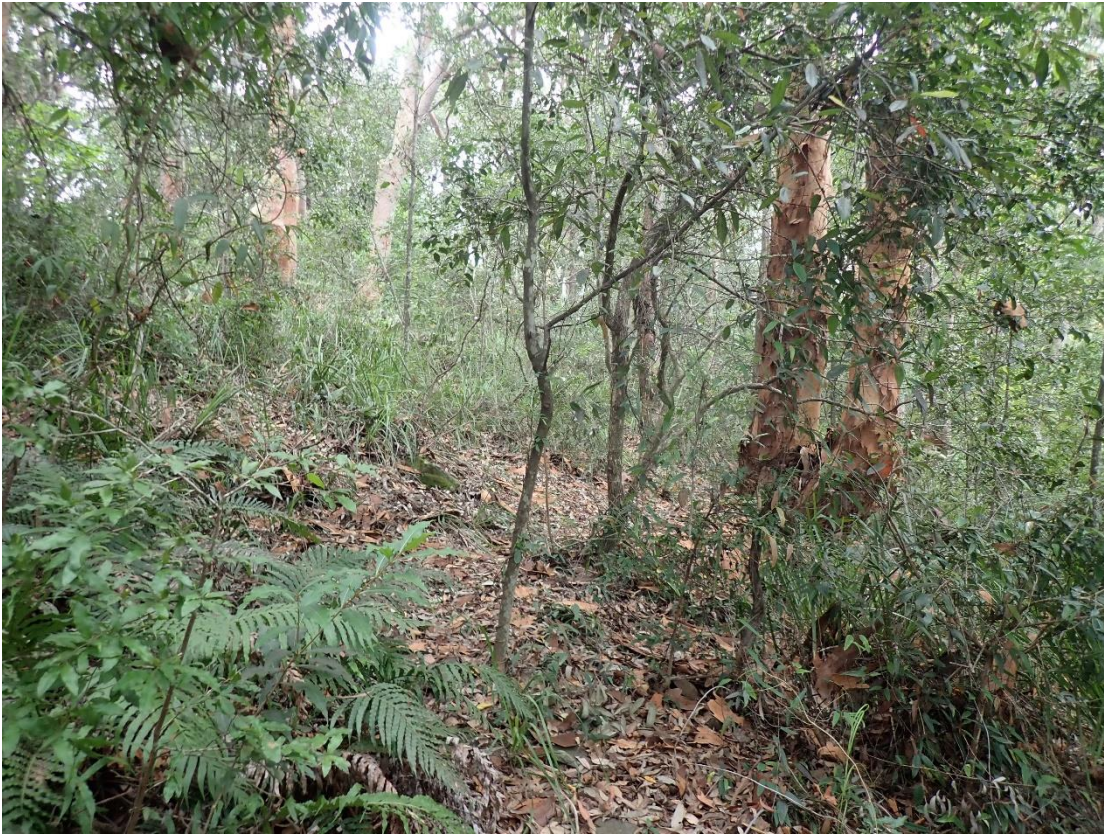
A band of good quality vegetation runs along the lower section of the slope behind properties on Northwood Rd (Figure 19). The proposed development will discharge stormwater from the site into this bushland, with the likely results similar to what can be seen further upslope – changed soil moisture and nutrient regimes, increased shading, introducing of water borne weed propagules, increasing cover by weeds, degradation of native vegetation, and so on. The current condition of bushland includes mature trees that have good habitat potential with a mix of midstorey and understorey species (Figure 20). Based on the modelled increase in shade from the proposed development, the impacts will immediately begin to affect the entire strip of bushland all the way to the fairway below on Lane Cove Golf Course (Figure 21), and during winter will shade the tennis courts and other facilities for a larger part of the day.

Figure 19 A band of good quality vegetation stretches along the lower section of the slope behind the existing properties

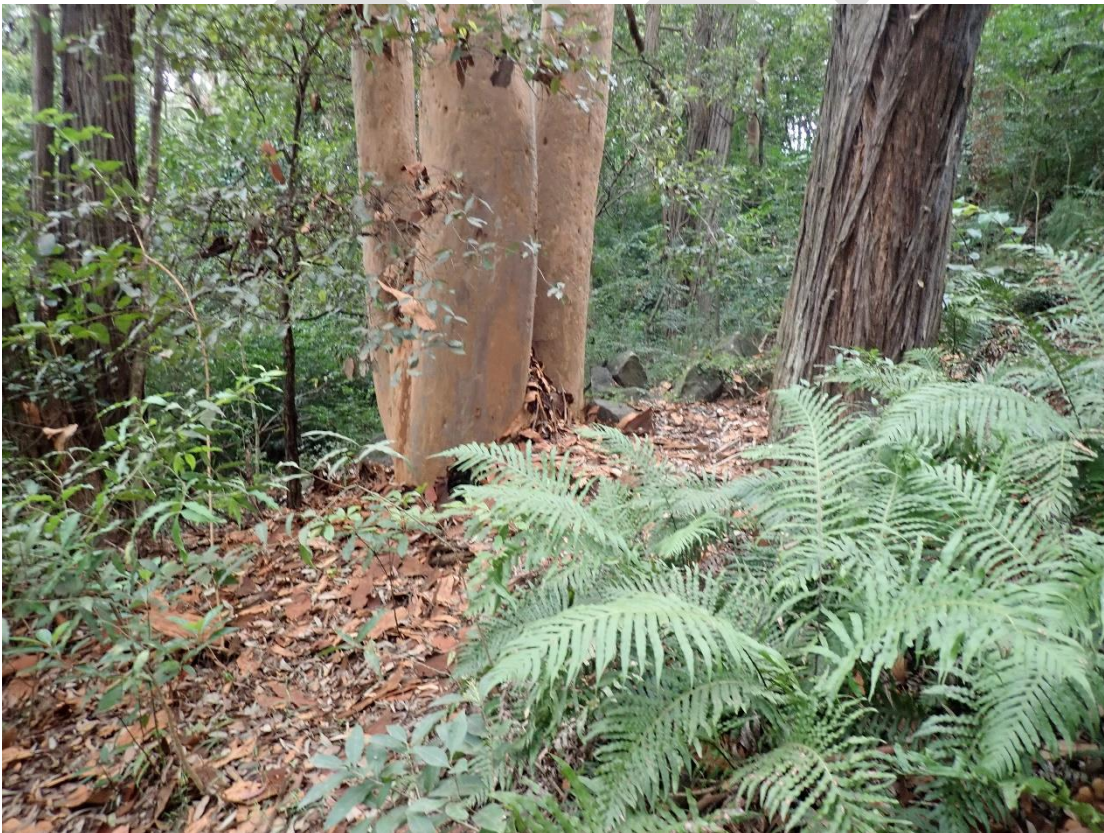
Figure 20 Mature native trees are present along with a mixture of native shrubs, ferns and grasses

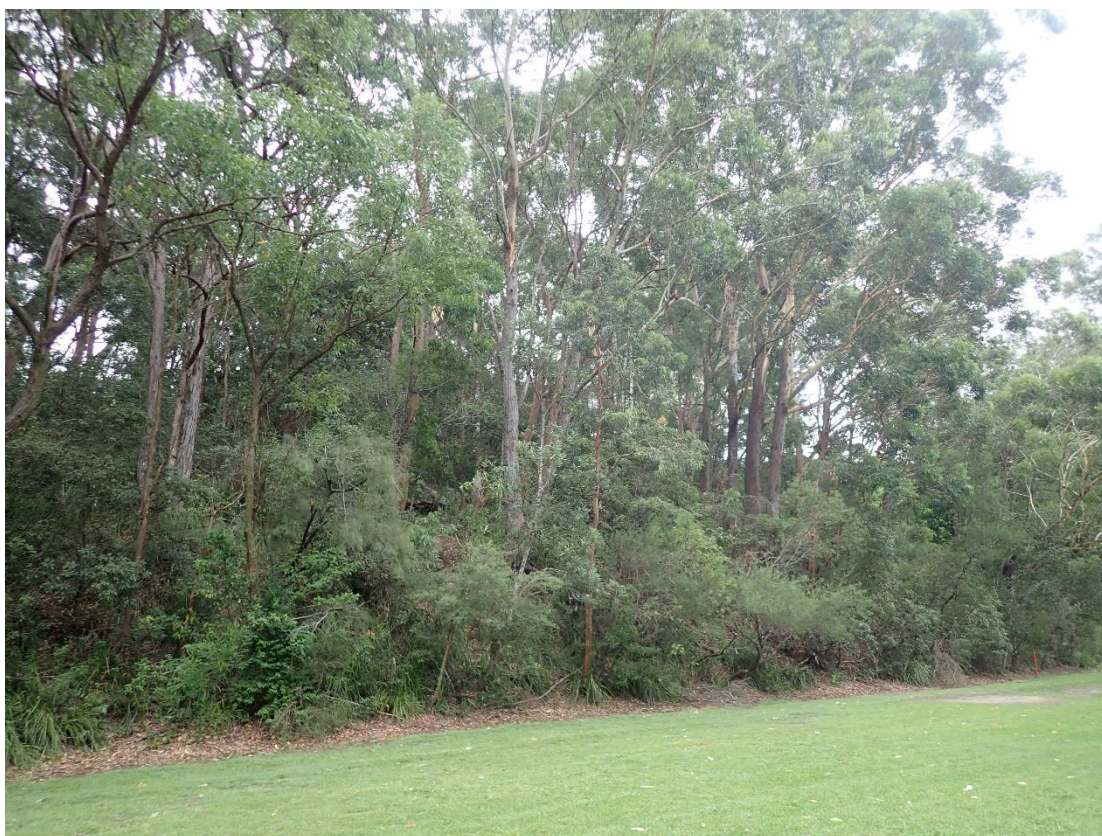
Figure 21 Shading from the new development will affect bushland all the way down to the fairway and tennis courts

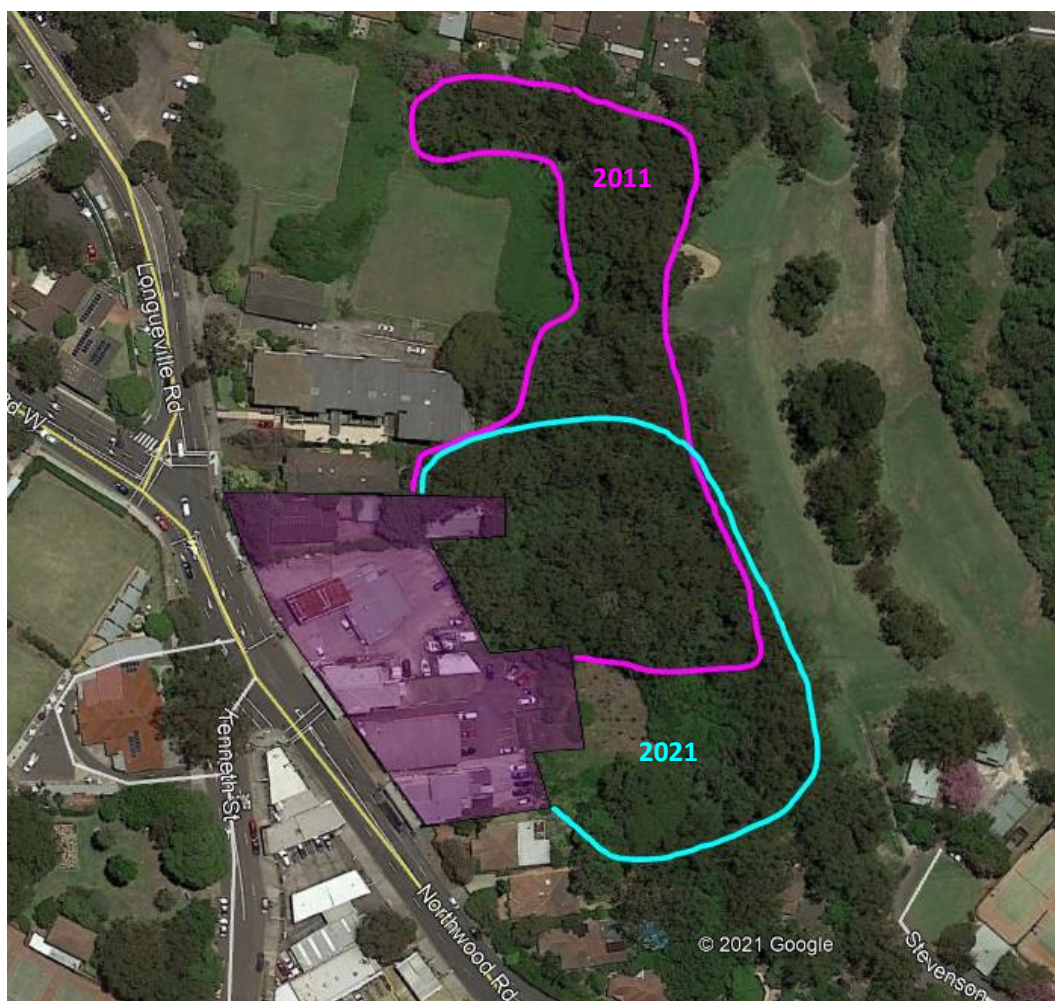
Figure 22 Areas included in 2021 surveys and 2011 surveys

A total of 6 hours was spent searching for fungi in the current survey. This current study was supplemented with results from a 2011 survey (Figure 22). This earlier field survey was undertaken on 22nd December 2011, totaling 10 hours of searching. This was used as a preliminary guide for the identification of fungi recorded during the current survey, which included opportunistic sightings during the flora and vegetation survey. Areas more likely to have species from the Hygrophoraceae family (ie. on soils) were specifically targeted during the current survey. Weather in the preceding days had been hot and showery providing conditions that permitted fruiting of some fungal species.

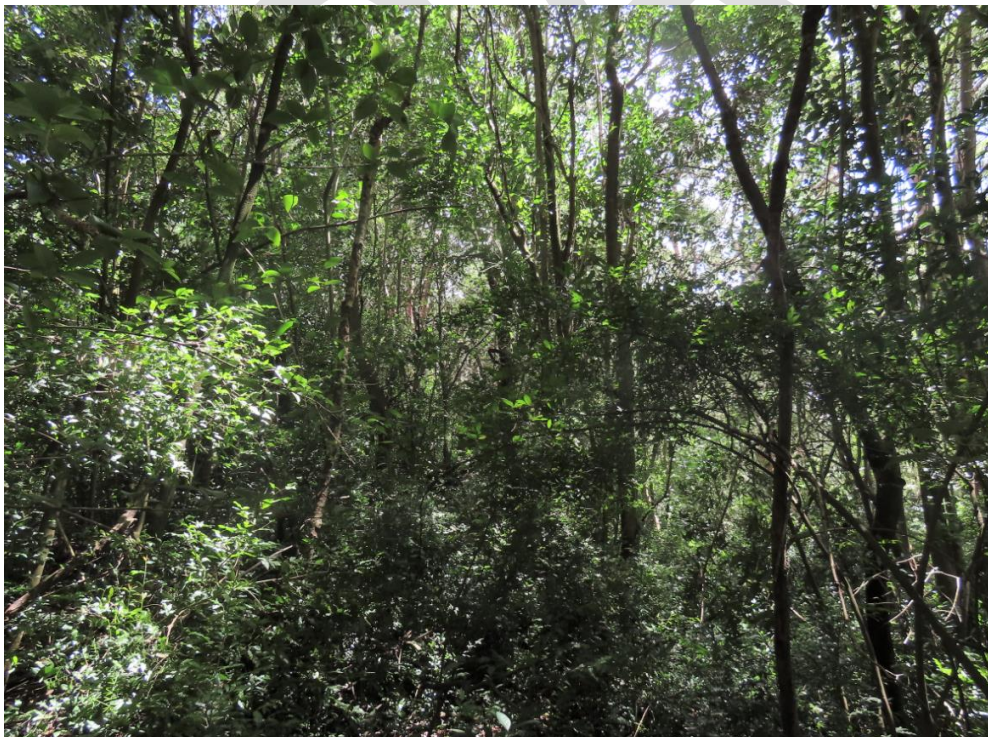
Figure 24 Dense weedy vegetation below the existing retaining wall.

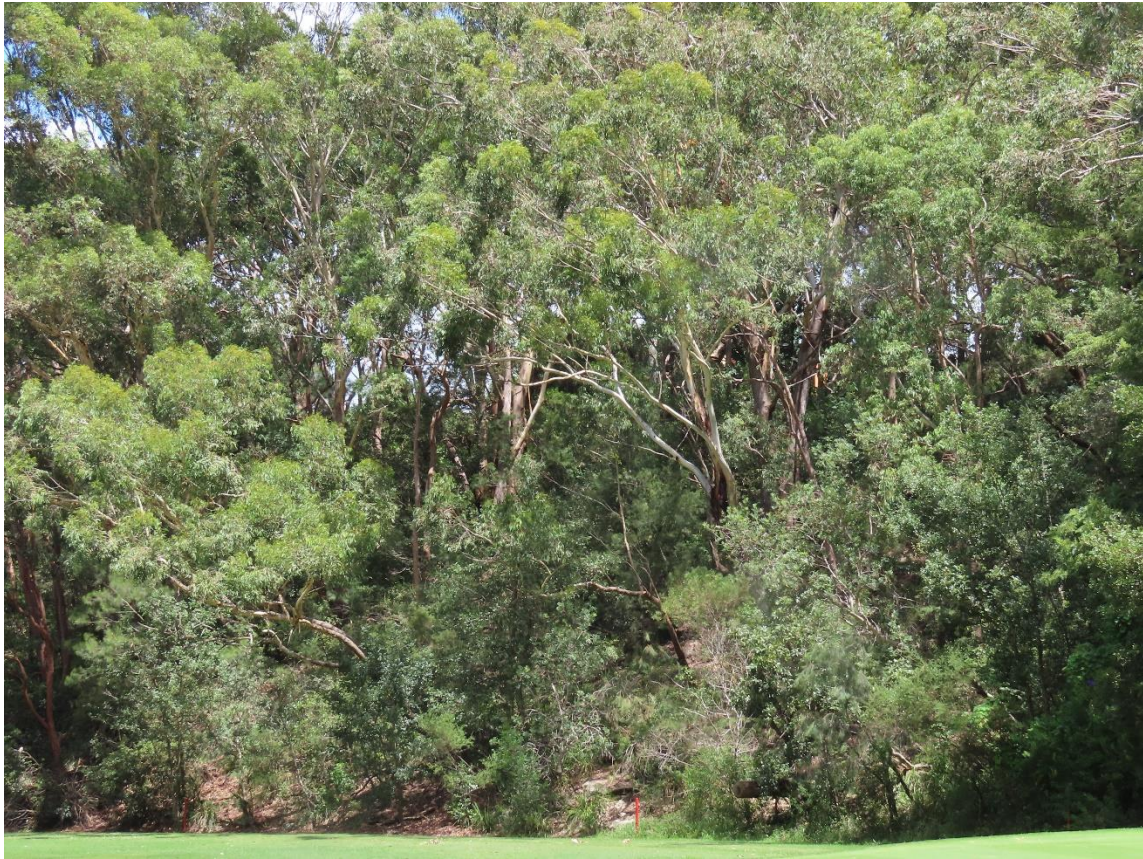
Figure 25 Bushland immediately adjoining the site viewed from the golf course.

The bushland adjoining the site is a mix of weedy mid and understorey species near the area of proposed works interspersed with mature native trees. The bushland becomes less weedy on a gradient to the toe of the bank where it abuts the manicured grass lawns of the Lane Cove Golf Course (Figure 25). Both the weedy vegetation (Figure 24) and the better native vegetation provide potential habitat for a range of species.

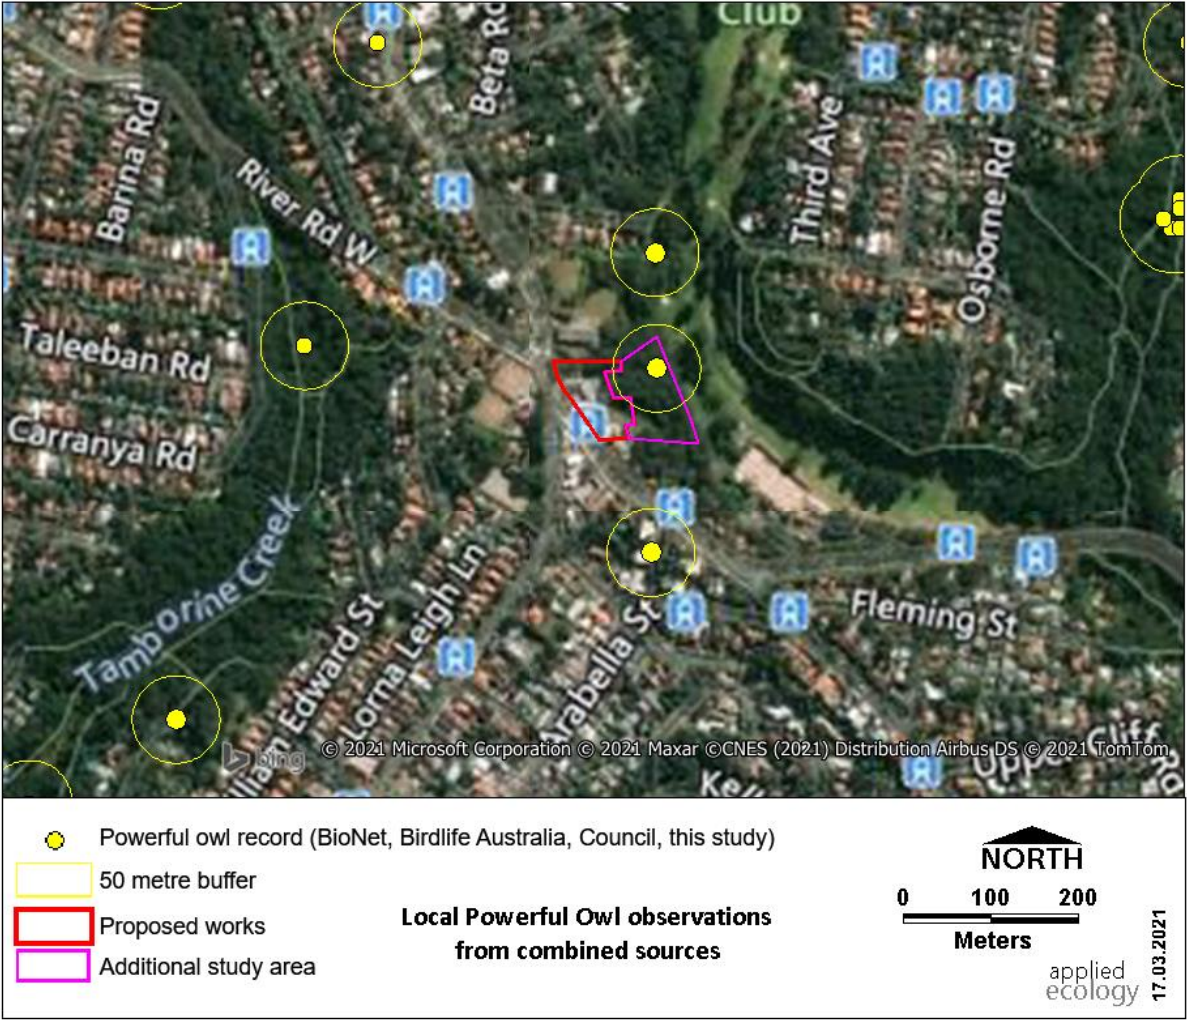
Figure 26 Powerful owl observations near the subject site

Powerful Owls are known to breed and roost nearby, and one was recorded calling on the site, or very close by on the 12th of February 2021. Other records are held by Council and these have been mapped in Figure 26 along with Birdlife and BioNet records for Powerful Owls. Habitat along the edge of the golf course may be important habitat for dispersing owls from both Warraroon Reserve/Tambourine Creek corridor, which is less than 250 metres to the west of the subject site, and the contiguous areas of bushland along Gore Creek including Lane Cove Bushland Park, Osbourne Park, Gore Creek Reserve and Lane Cove Golf Course. The subject site is located at the point where these two large areas of bushland are in closest proximity and it is potentially the easiest and safest area for wildlife to move between the two major corridors (Figure 27).

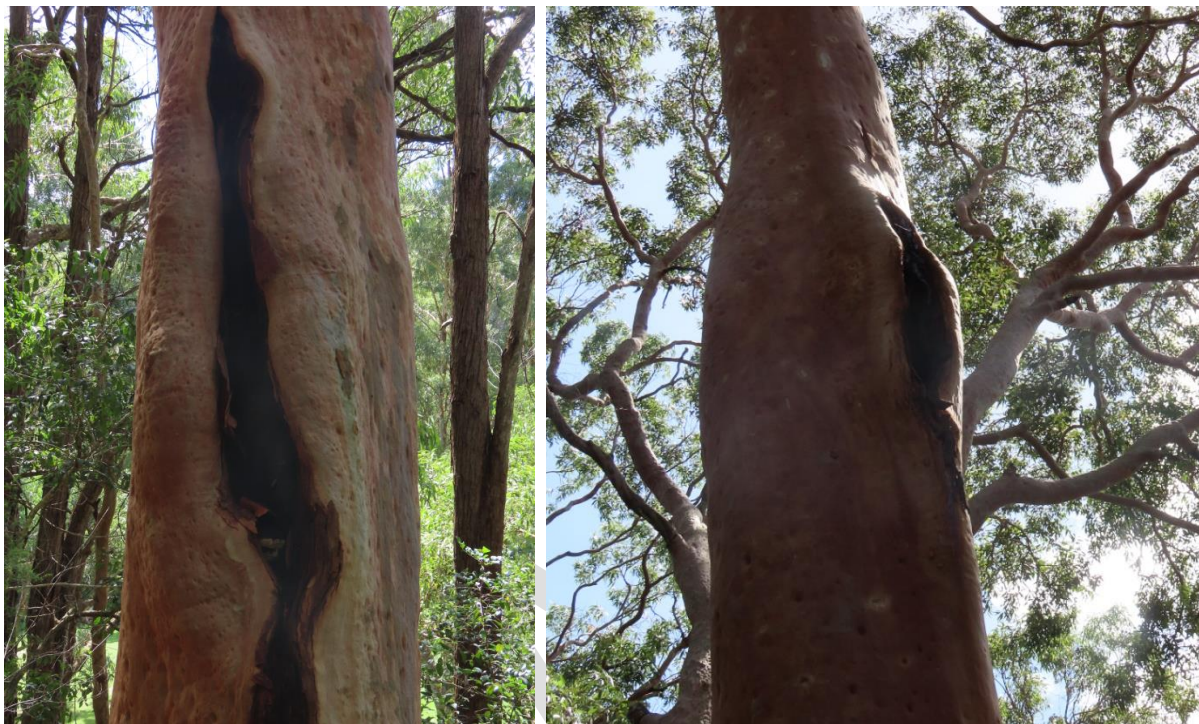
Several trees were observed to be potentially forming sizeable hollows (Figure 28).

Figure 28 *Angophora costata* with trunk hollows forming.

It is important to retain and protect hollow bearing trees within the LGA – both to maintain hollow dependent prey numbers for the Powerful owls and as potential breeding sites. Many threatened bat species recorded in the LGA are also hollow dependent.

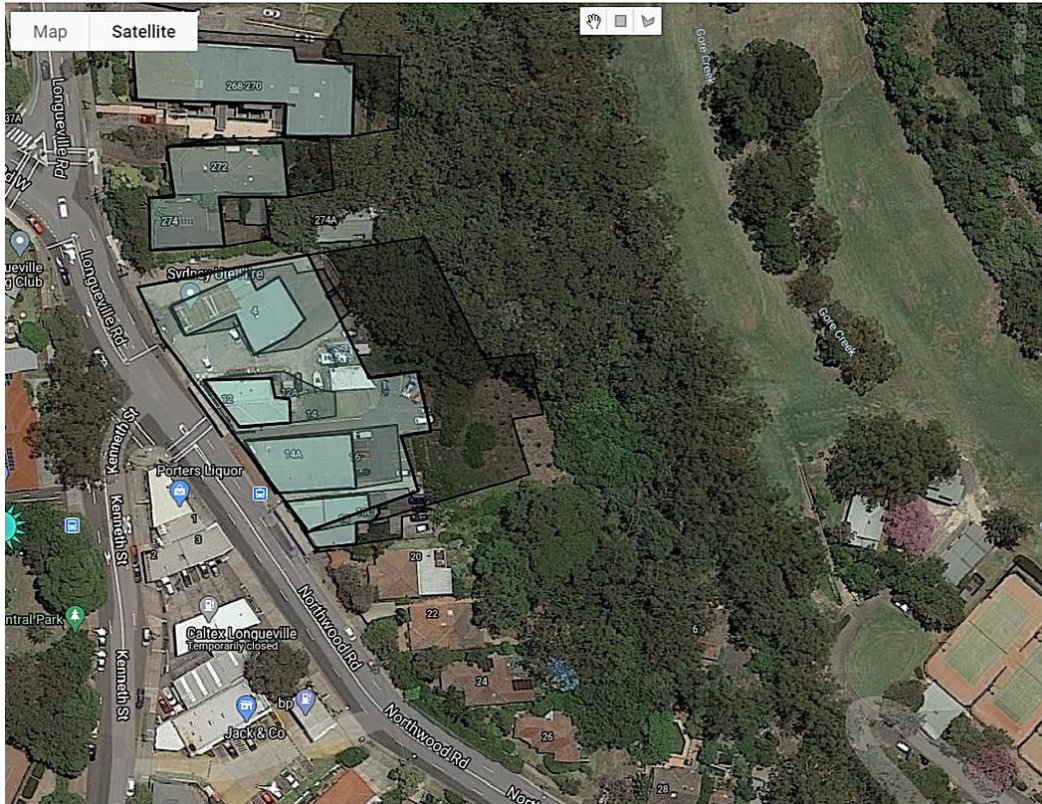
Figure 29 5.30pm midsummer – there currently is no shade impacts on bushland from buildings, but following the new development approximately one third of the site will be in shadow
