Environmental assessment

4-18 Northwood Rd & 274 & 274a

Longueville Rd, Lane Cove

Prepared for Lane Cove Council

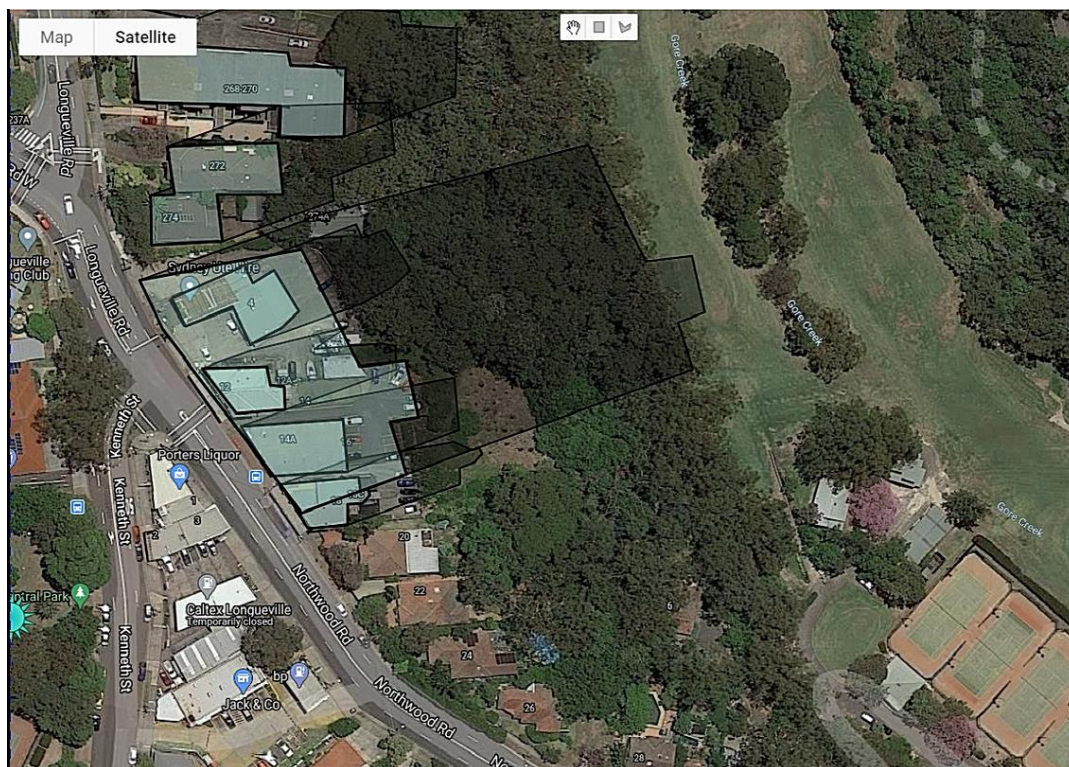
Figure 30 By 7pm in midsummer the new development will cast a shadow over the entire bushland patch, whereas it is currently only slightly impacted by shading

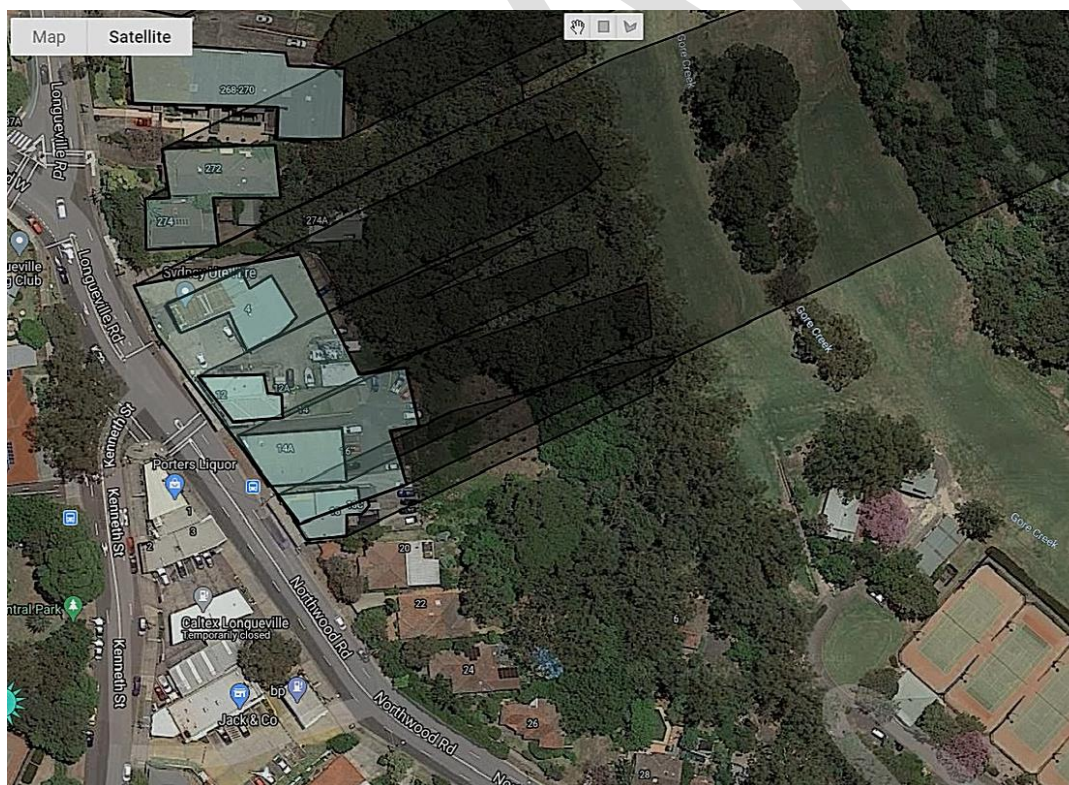
culminating around 7.45pm with the current patchy shading being replaced by total shading of the bushland, the fairway, and properties on the opposite side (Figure 31). In winter the impacts will be directed to the southeast. At 4.15 the site would normally be beginning to experience shadowing, but with the new development the whole bushland area will be in shade (Figure 32), and by 4.30pm the existing shadow would cover that bushland while the new shadow will affect the tennis courts and other parts of the golf course, as well as residential properties to the southeast on Northwood Rd (Figure 33).

Figure 31 By 7.45pm midsummer the new development will be casting shadows across the whole of the golf course and onto properties on the eastern side, whereas the existing buildings cast a shadow that doesn't reach the lowest edge of the bushland

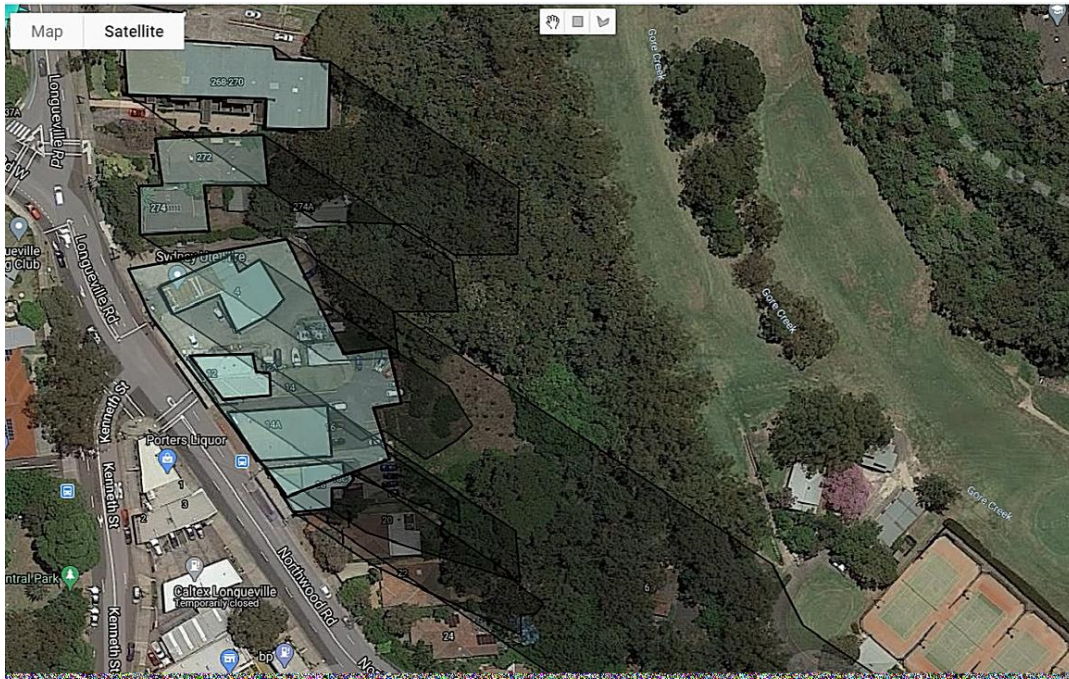
Figure 32 At 4.15pm in midwinter the existing buildings cast some shadow over bushland, while the proposed development will shadow an area towards the southeast that reaches beyond the bushland and will affect residences on Northwood Rd

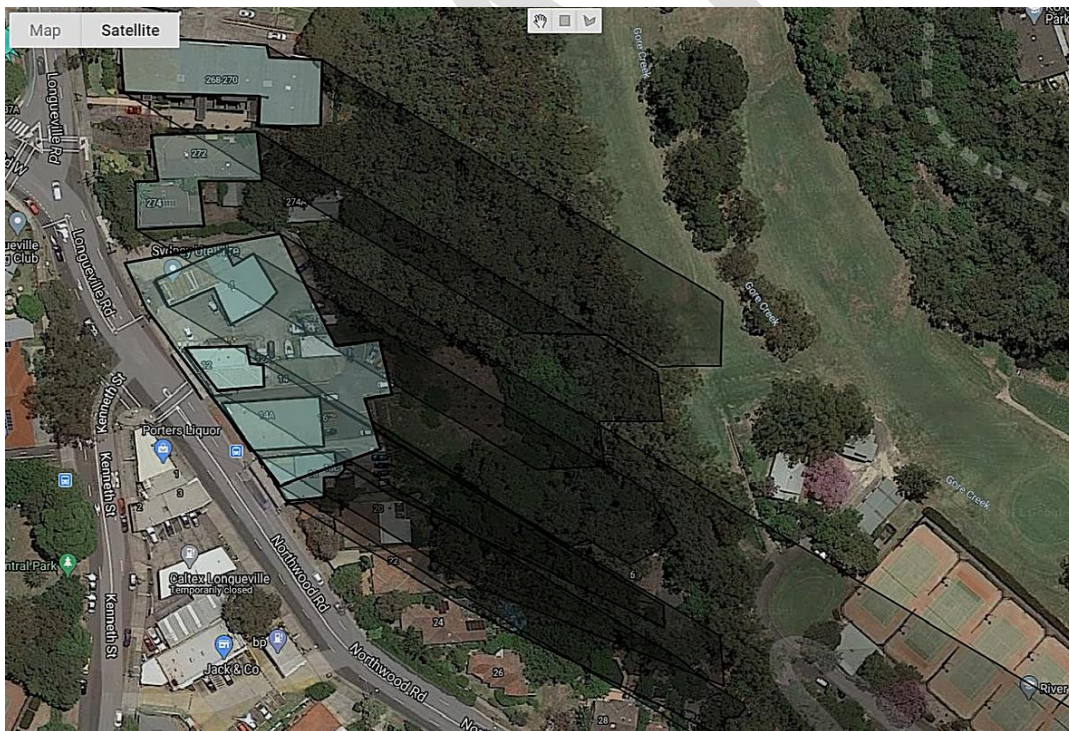
Figure 33 By 4.30pm midwinter the existing buildings cast shadows across the whole of the bushland strip, while the new development will overshadow the tennis courts and adjoining residential properties to the southeast
