Geotechnical Assessment Report

Project: Redevelopment of Aged Care Facility
St Columba's, Fig Tree Street, Lane Cove NSW.

REF: AG 20004B

GEOTECHNICAL INVESTIGATION REPORT

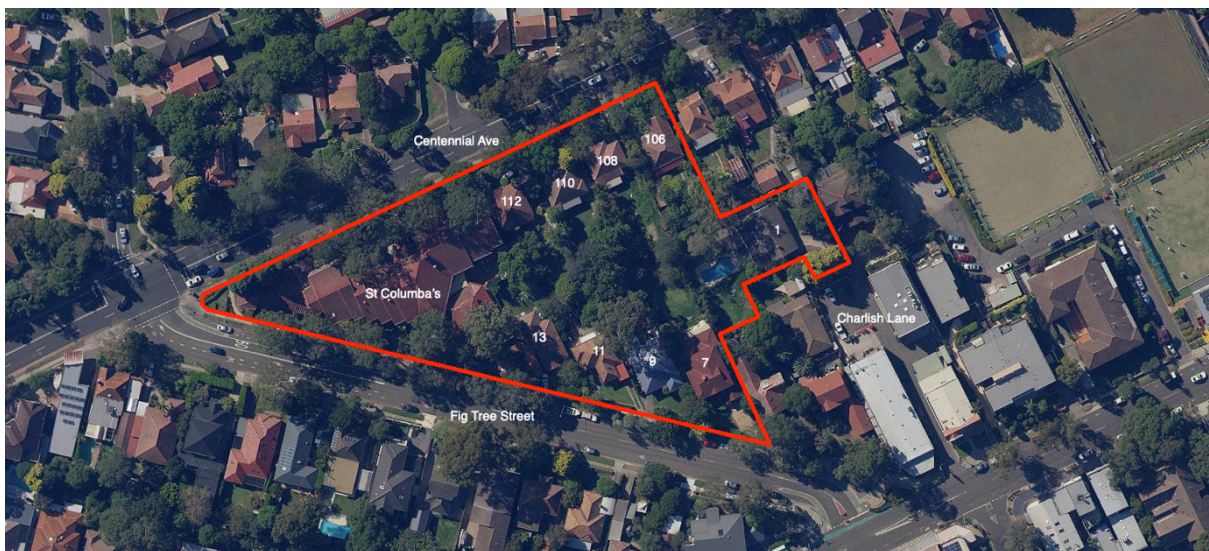
Image 1: Approximate redevelopment area – Red polygon (© SIX Maps NSW Gov)

A summary of site conditions identified at the time of our site visit is provided in the table below (Table 1). The site location is shown in Image 1.

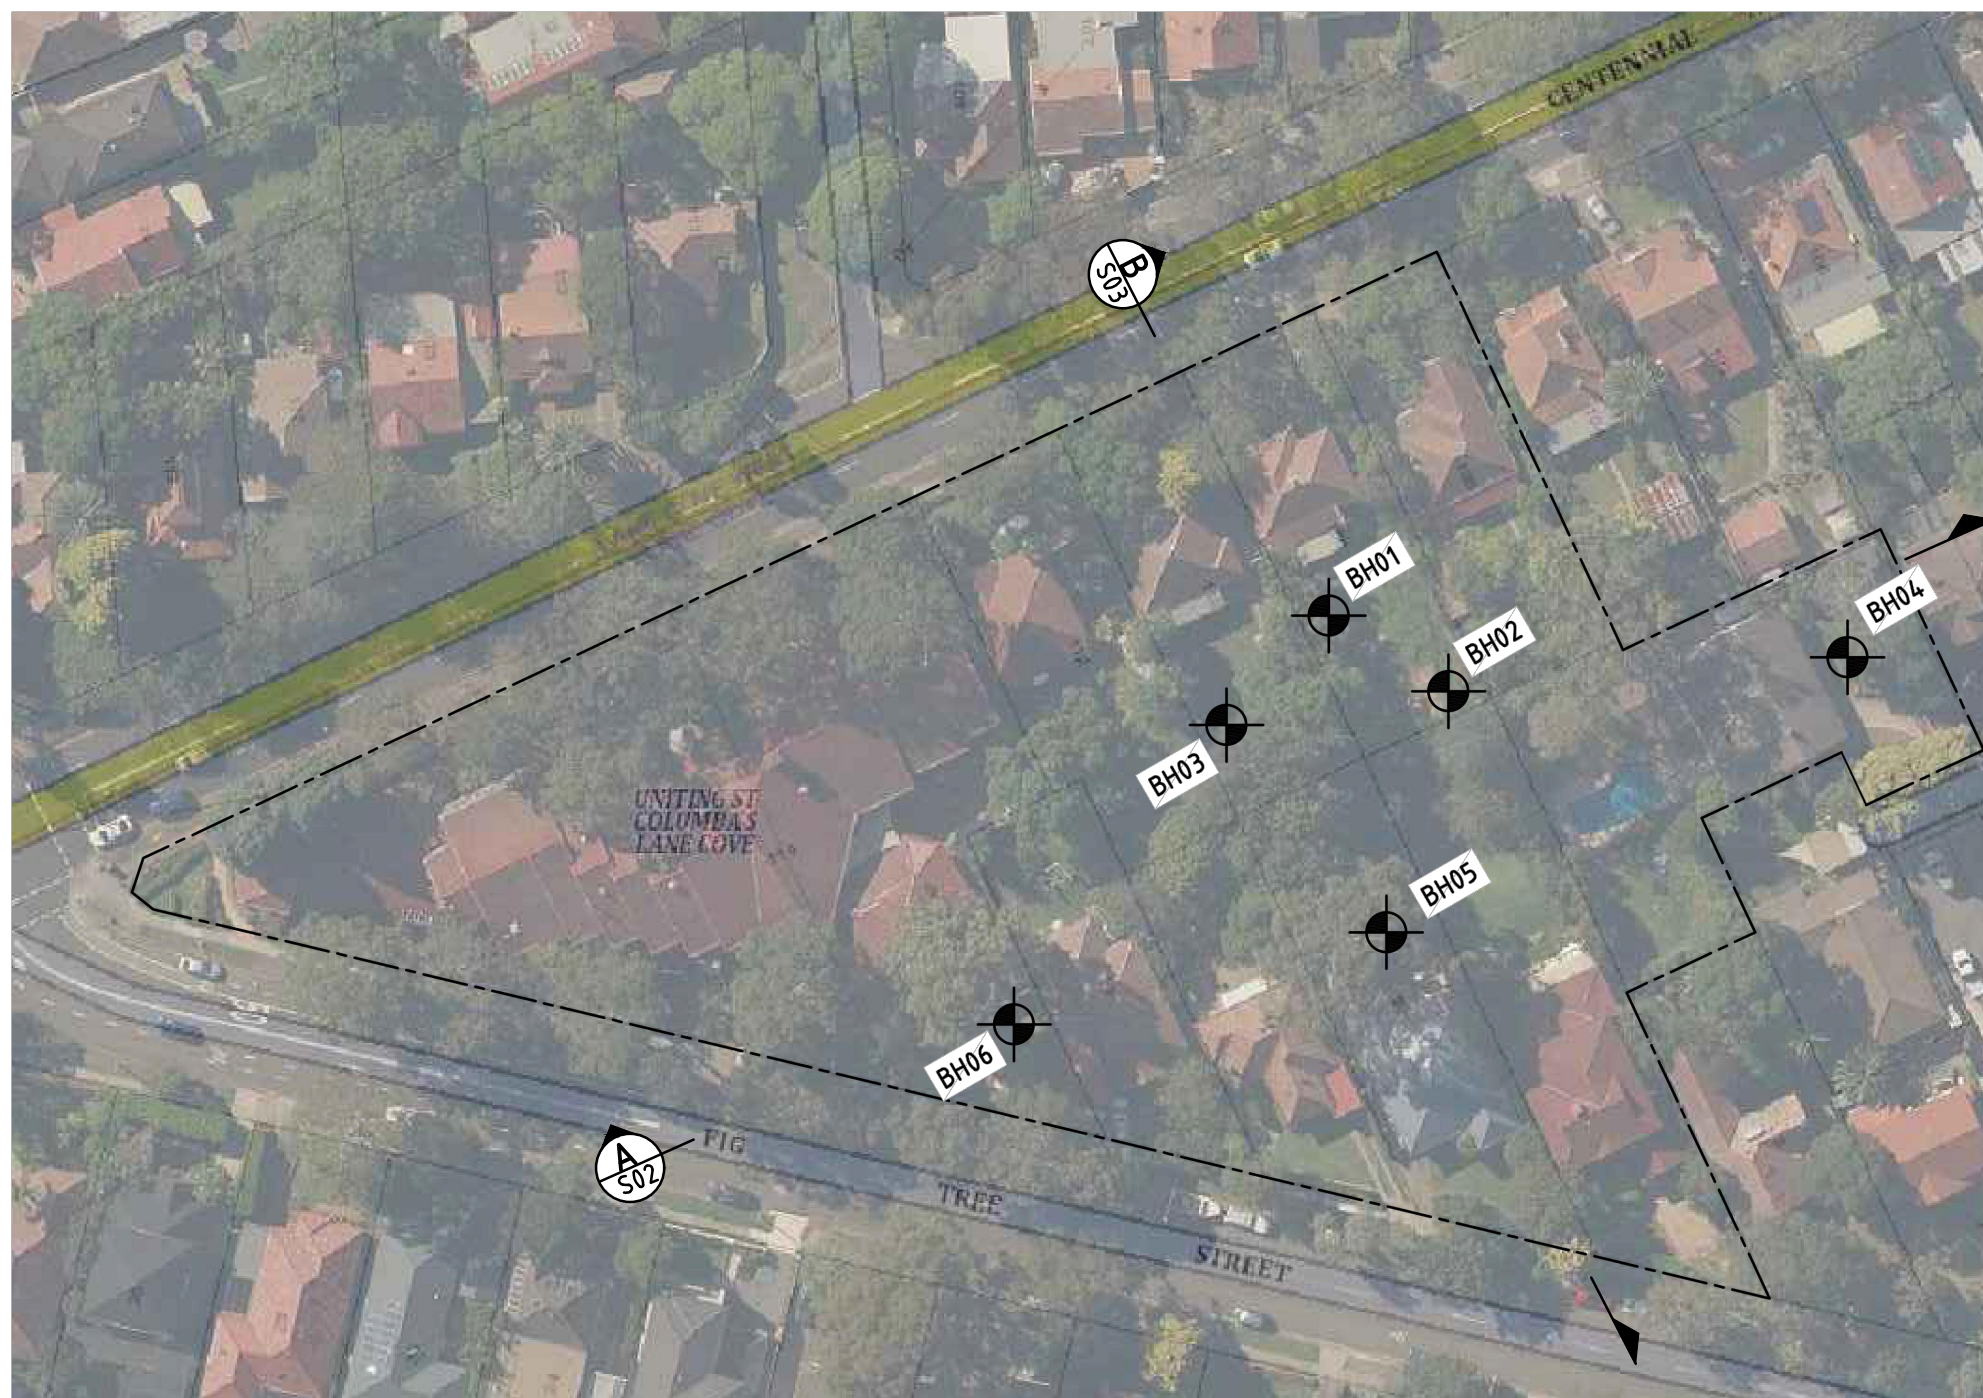
BOREHOLE LOCATIONS

GROUND TEST LOCATIONS

**GROUND TEST LOCATIONS FOR
UNITING'S ST COLUMBA'S
REDEVELOPMENT
FIG TREE STREET
LANE COVE NSW**

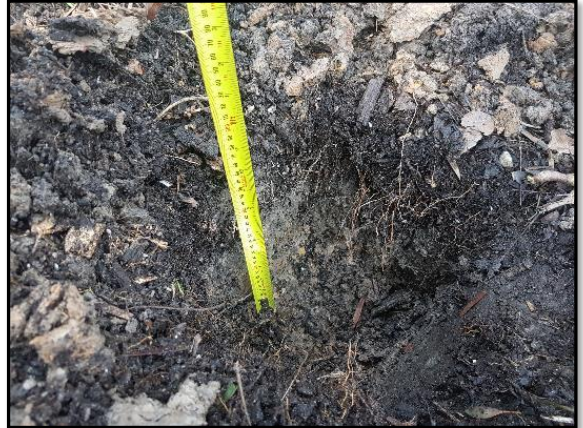
Photo 2: Image of TP01 with brown silty sand observed above grey sandy clay with red and orange mottling. Representative of sample TP01 0.2-0.3.

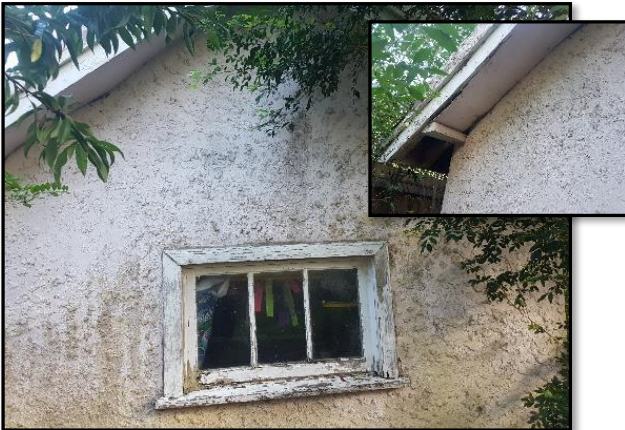
Photo 3: Image of additional structure observed at 106 Centennial Ave, with possible lead paint on window frame and (insert) suspected ACM eaves.

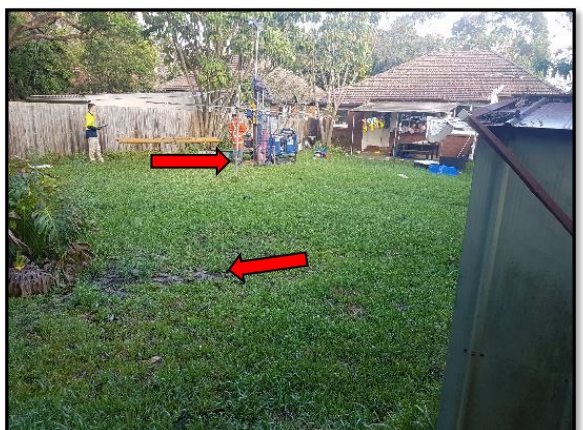
Photo 4: Image of site area at 108 Centennial Ave facing north, with BH01 visible in north west corner and brick footprint of possible former structure in south west corner.

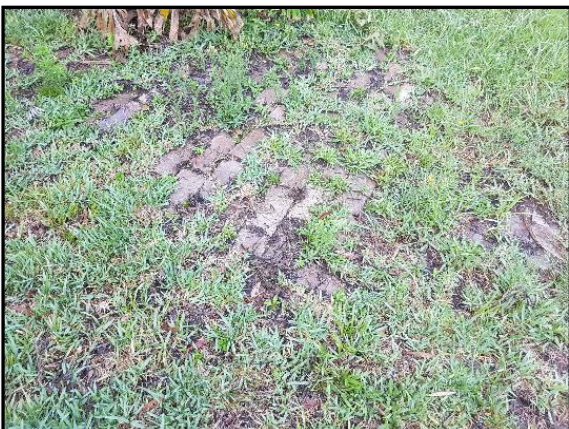
Photo 5: Image of brick footprint observed at 108 Centennial Ave and location of BH02.

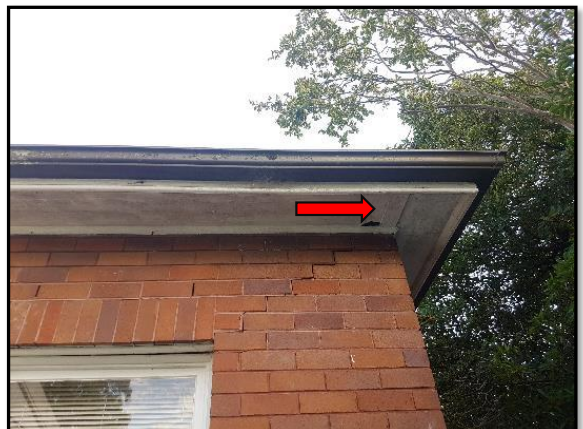
Photo 6: Image of suspected ACM eaves at 108 Centennial Ave on house.

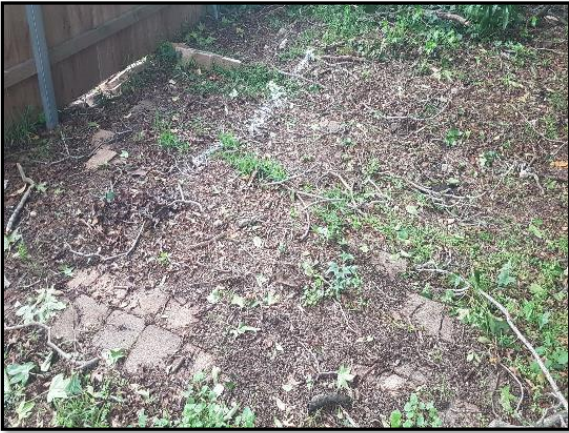
Photo 7: Image of brick footprint observed at 110 Centennial Ave behind shed.

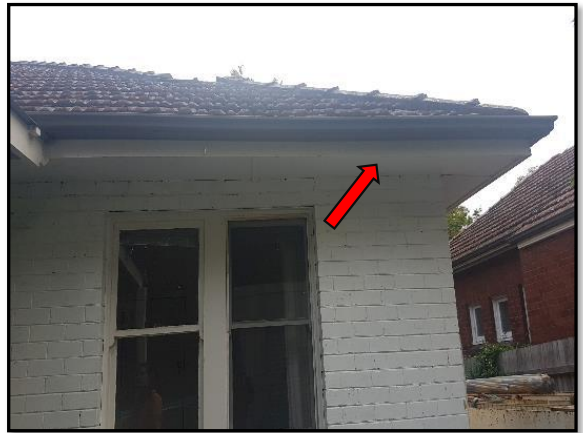
Photo 8: Image of house at 110 Centennial Ave, with suspected ACM eaves.

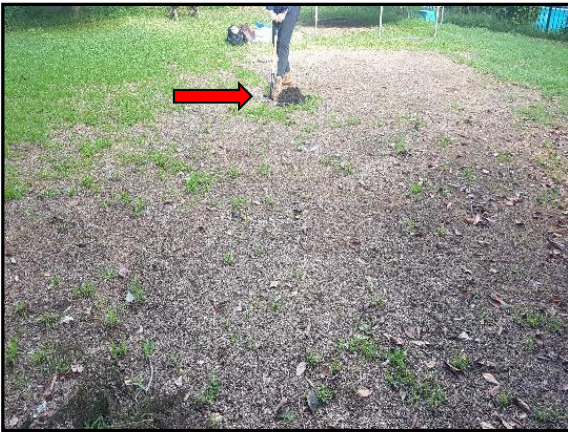
Photo 9: Image of minor grass dieback at 1 Charlish Lane, with TP02 visible at top of image.

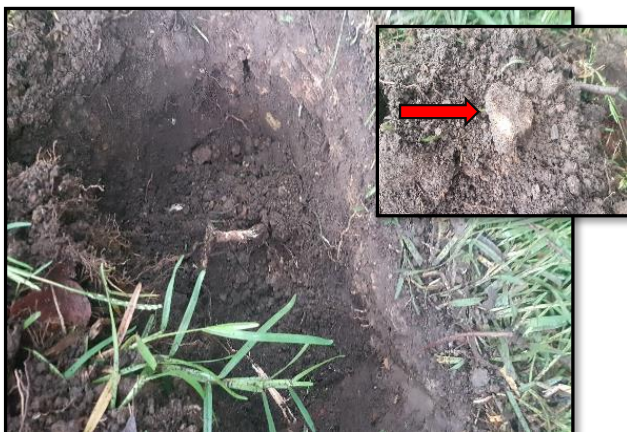
Photo 11: Image of TP03 located at 9 Fig Tree Street, with (insert) sandstone blocks observed within brown silty sand fill layer.

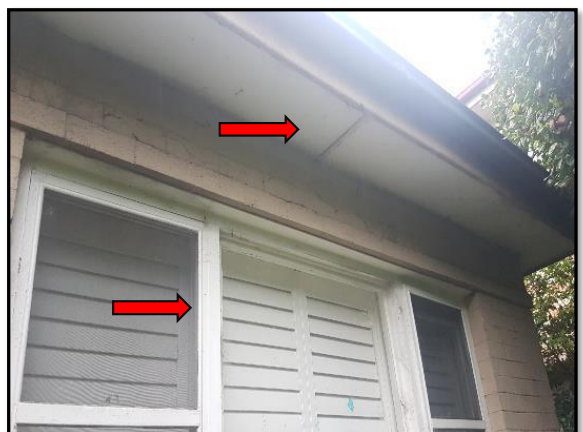
Photo 12: Image of potential lead paint and suspected ACM eaves at 9 Fig Tree Street.

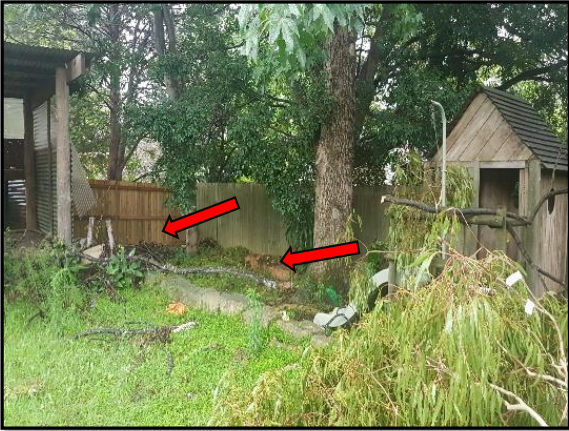
Photo 13: Image of stone ledge and approximate 0.5m drop at rear of property 9 Fig Tree Street. Brick and wood stockpiles are visible along fence line.

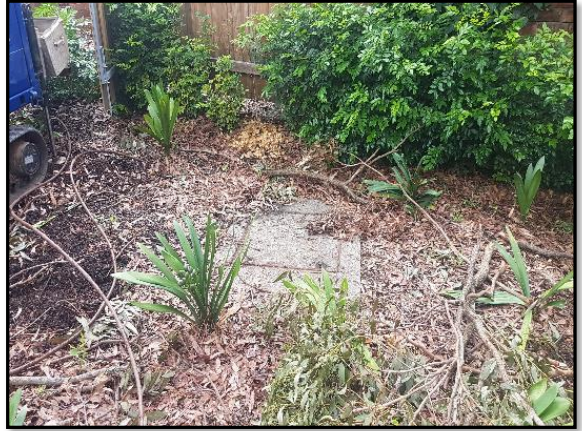
Photo 14: Image of landscaping observed at 15 Fig Tree Street, with mulch and leaf litter across surface, representative of BH05 location.

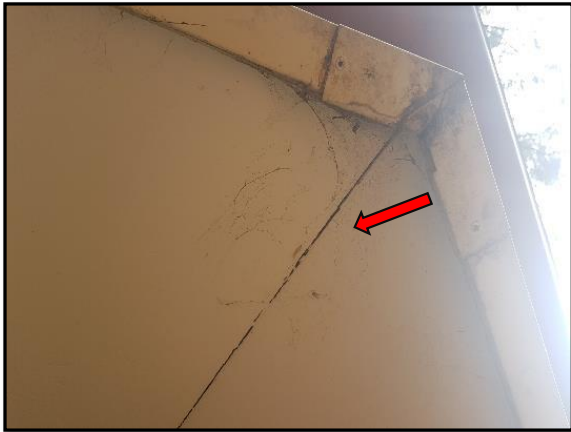
Photo 15: Image of suspected ACM eaves observed at 15 Fig Tree Street, near BH05.

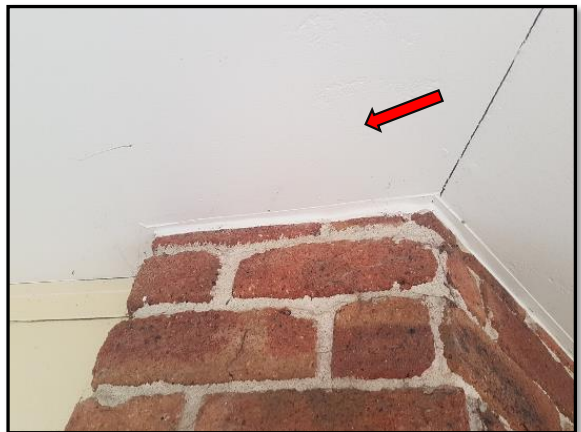
Photo 16: Image of potential ACM eaves observed at 15 Fig Tree Street, near BH05.
