# REPORT TO JDH ARCHITECTS

PRELIMINARY (STAGE 1) SITE INVESTIGATION (CONTAMINATION REPORT)

ST IVES INDOOR SPORTS COMPLEX

ST IVES HIGH SCHOOL, YARRABUNG ROAD, ST IVES, NSW

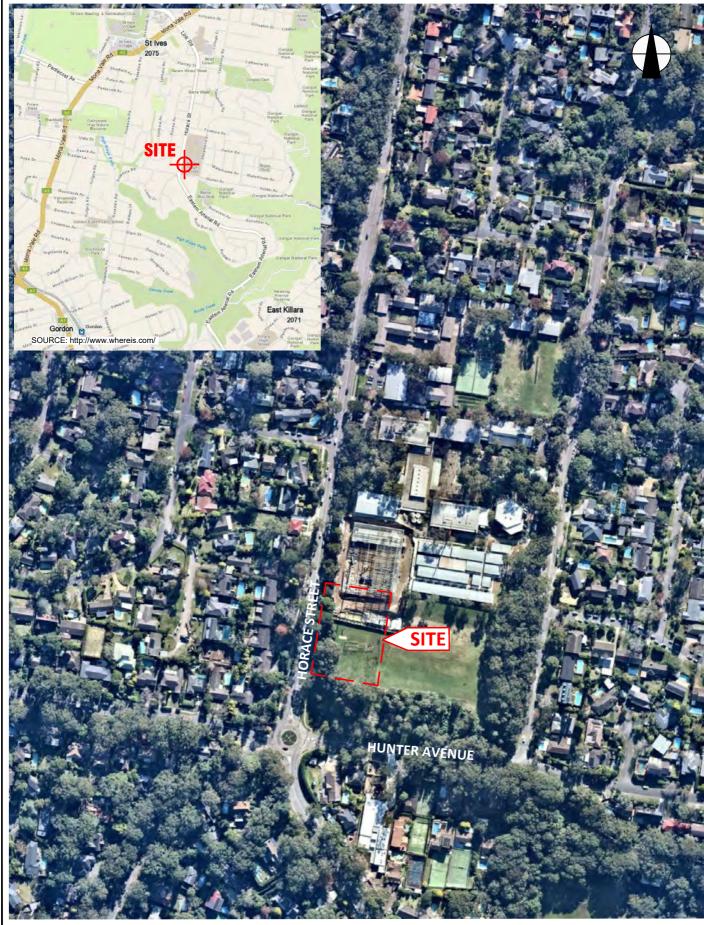
AERIAL IMAGE SOURCE: MAPS.AU.NEARMAP.COM **SITE LOCATION PLAN** ST IVES HIGH SCHOOL Location: ST IVES, NSW Project No: Figure No: E31754PT **JK**Environments

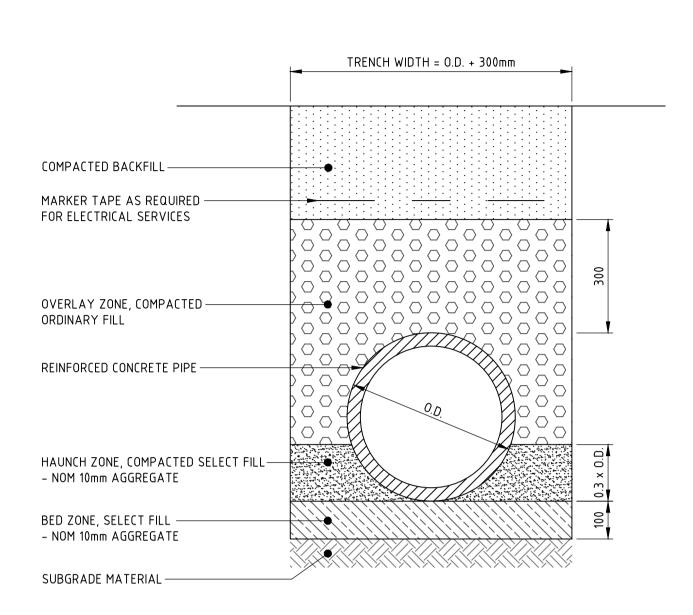
## TYPICAL PIPE TRENCH - GENERAL AREAS

- 1. TRENCH WIDTH MAY NEED TO BE INCREASED SUBJECT TO ACHIEVING COMPACTION. ENSURE MINIMUM 300mm CLEARANCE BETWEEN, WHEN USING MULTIPLE PIPES TO ACHIEVE ADEQUATE COMPACTION.
- 2. MINIMUM PIPE COVER NOT UNDER ROADS TO BE 300mm U.N.O.
- 3. THE CONTRACTOR SHALL ENSURE THAT SHORING OF TRENCHES IS INSTALLED AS
- REQUIRED BY STATUTORY REQUIREMENTS.
