# Geotechnical Site Investigation Report, St Leonards South

*18-32 Holdsworth Avenue & 21-41 Canberra Avenue*

18105360-006-R-Rev0

02 June 2021

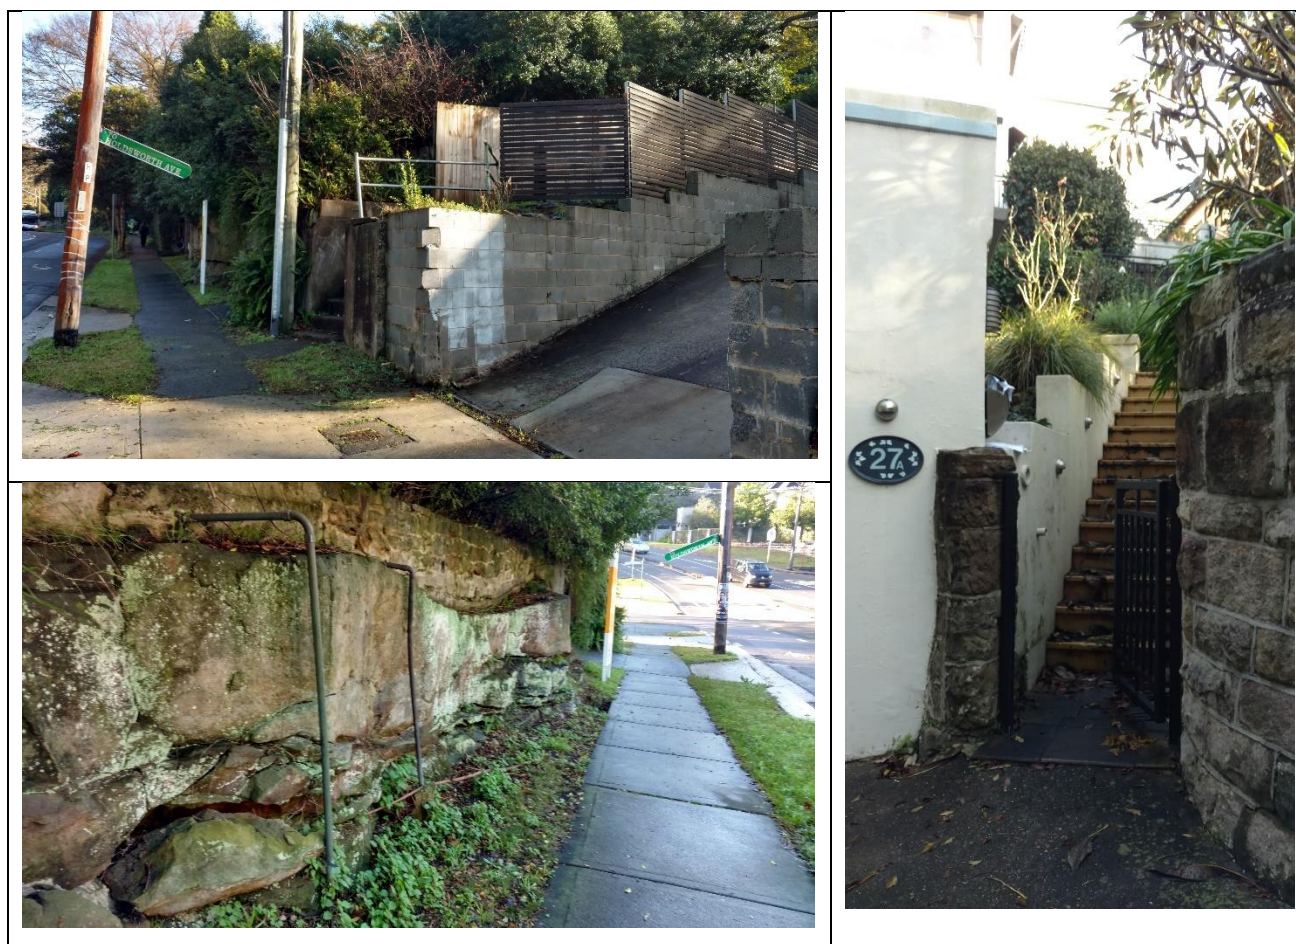
Figure 1: Stage 1 Site photographs (southern portions and 27 Holdsworth Avenue (right))

- The current residential houses are located on a south-eastern sloping hillside, which continues to a valley floor, close to the eastern boundary of the site. The topography across the south-eastern sloping hillside has a change in elevation of approximately 20 m across Stage 1 and 10 – 15 m across Stage 2;
- There are steep driveways/staircases and exposed rock outcrops along Canberra Avenue;
- No ponding of water was observed, it should be noted that no rainfall occurred on or in the days prior to conducting the site walkover;
- There are a number of retaining walls and sandstone outcrops along Canberra Avenue, suggesting the likely presence of some past filling.

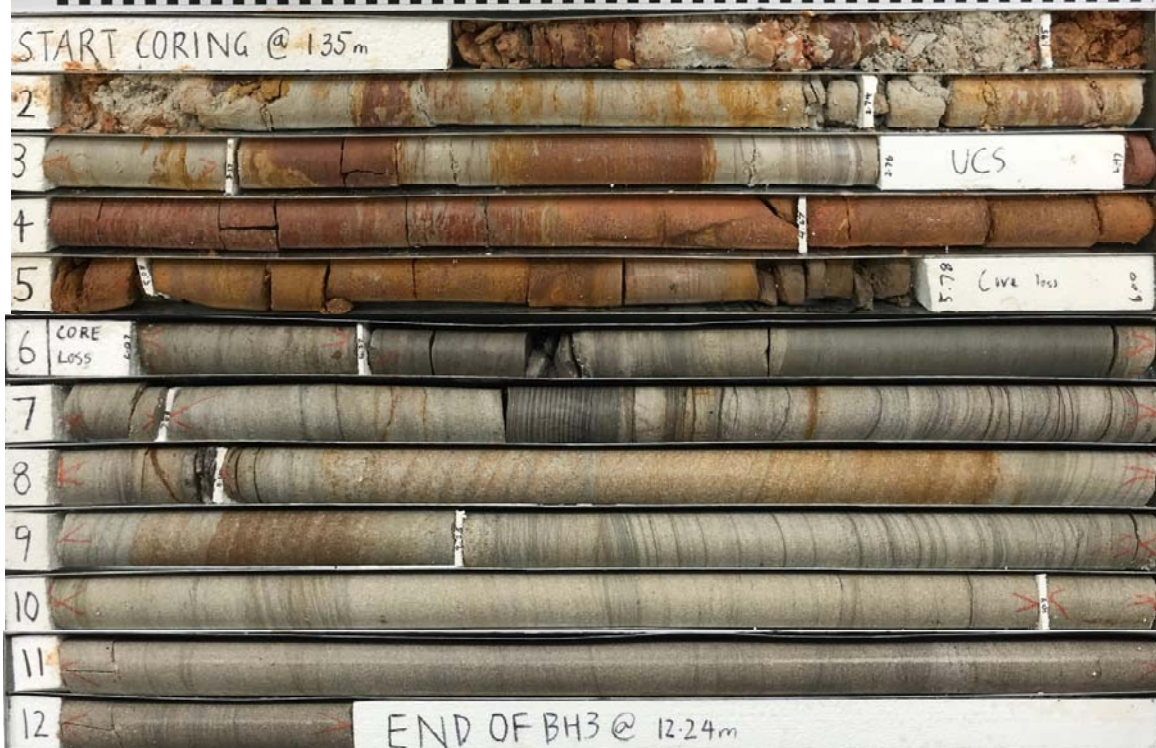
**JOB** St Leonards Development **DEPTH** 1.35 - 12.24 m **DATE**  
**BOREHOLE** BH3 **CORE TYPE** NMLC 3/09/2018

| Unit | General Description | Typical Depth Encountered (m) | Typical Thickness (m) |
|---|---|---|---|
| <b>Weathered Sandstone</b> | Extremely low to low strength sandstone, red to orange brown, with some clay seams typically up to 100 mm thick. A clay layer 0.9 m thick was observed in BH2. | 0.4 to 2.2 | 0.4 to 2.0, but up to 5m in BH3 |

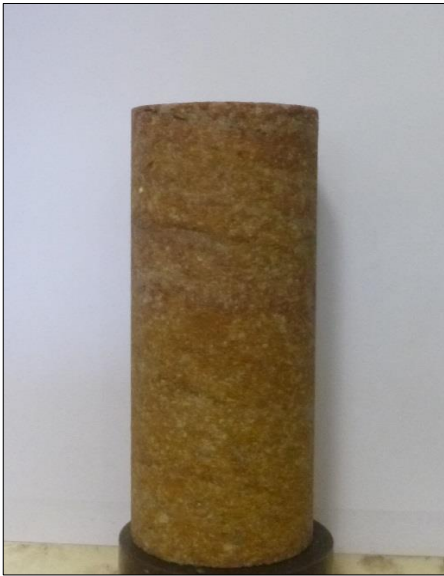
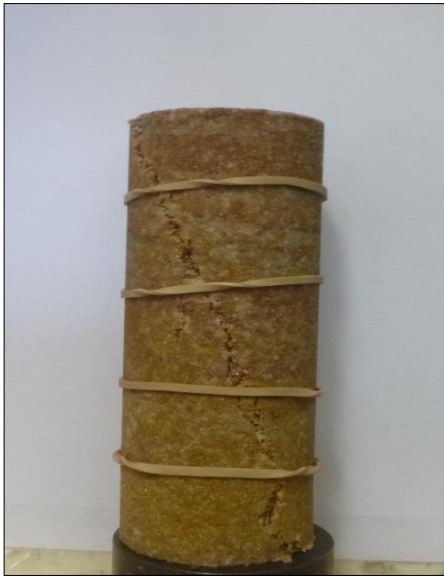
| Uniaxial Compressive Strength | | | |
|---|---|---|---|
| <b>Uniaxial Compressive Strength      27      MPa</b> | | | |

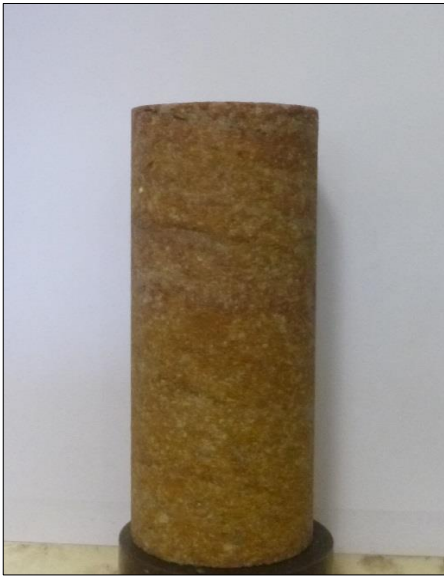
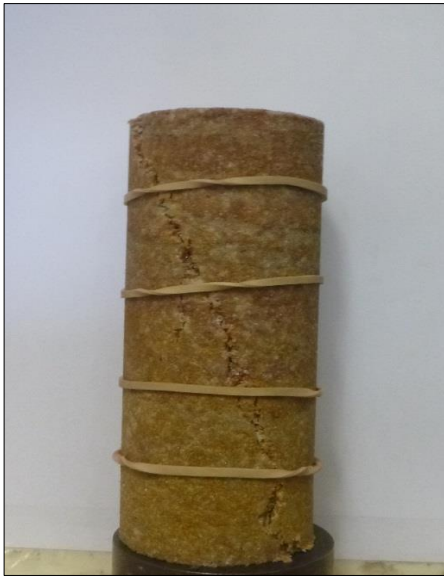
| Uniaxial Compressive Strength | | | |
|---|---|---|---|
| <b>Uniaxial Compressive Strength      4.2      MPa</b> | | | |

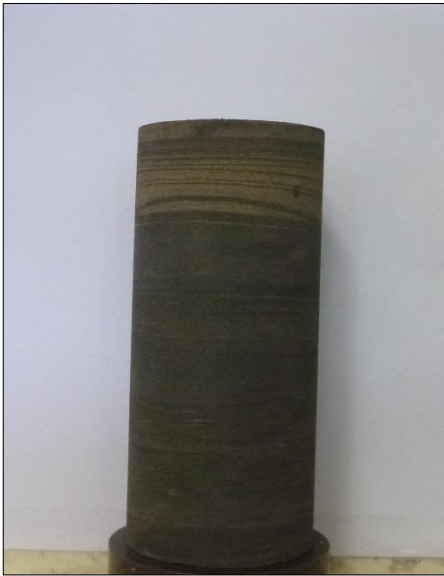
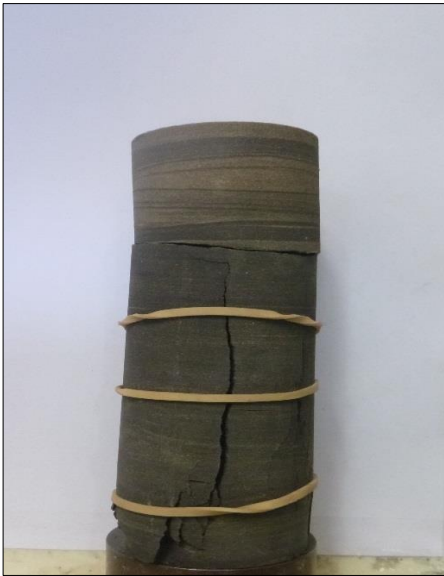
| Uniaxial Compressive Strength | | | |
|---|---|---|---|
| <b>Uniaxial Compressive Strength      9.3      MPa</b> | | | |

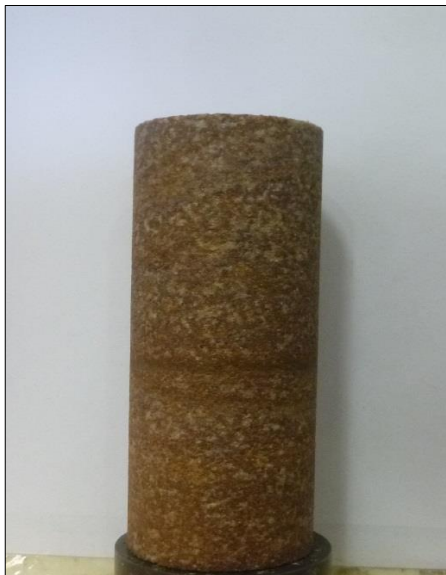
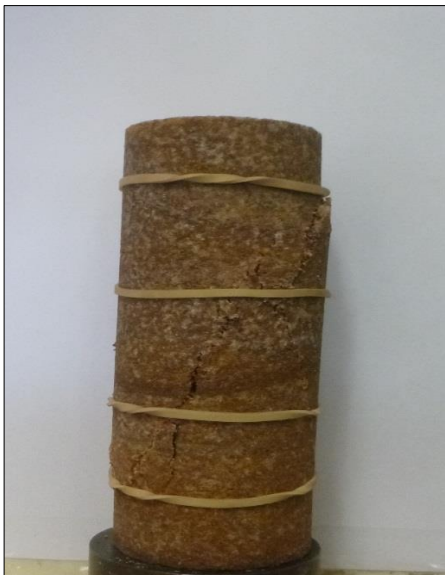
| Uniaxial Compressive Strength | | | |
|---|---|---|---|
| <b>Uniaxial Compressive Strength      15      MPa</b> | | | |

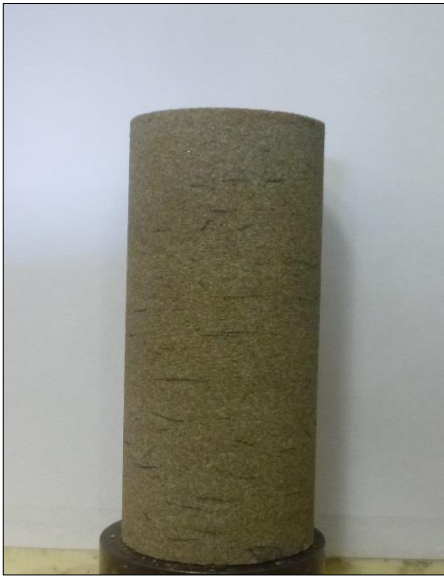
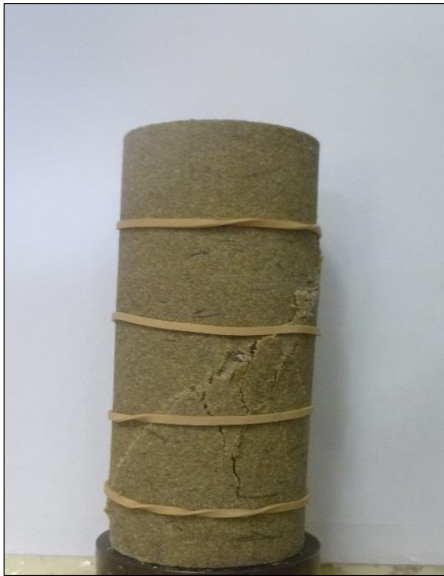
| Uniaxial Compressive Strength | | | |
|---|---|---|---|
| <b>Uniaxial Compressive Strength      17      MPa</b> | | | |
