**RE: DA-2019/247: 26 CRABBES AVENUE AND 243-255 PENSHURST STREET. NORTH WILLOUGHBY, NSW (CLUB WILLOUGHBY)**

This letter has been prepared to respond to the record of deferral letter issued by the Sydney North Planning Panel on 3<sup>rd</sup> November, 2020 specifically in the response to the following request by the panel:

The attached Annexures outline both the method and likely impacts for three drainage work options.

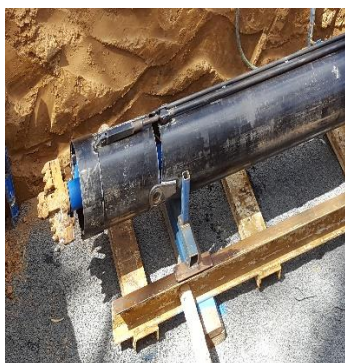
Cutter head and horizontal steering head  
ground

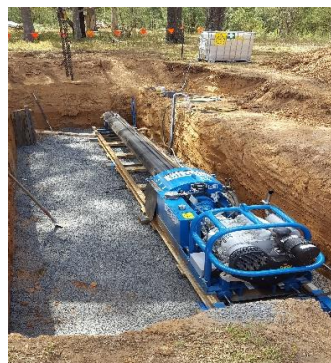
Machine set up on rails

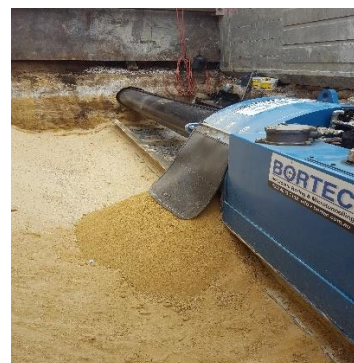
Steel sleeve entering

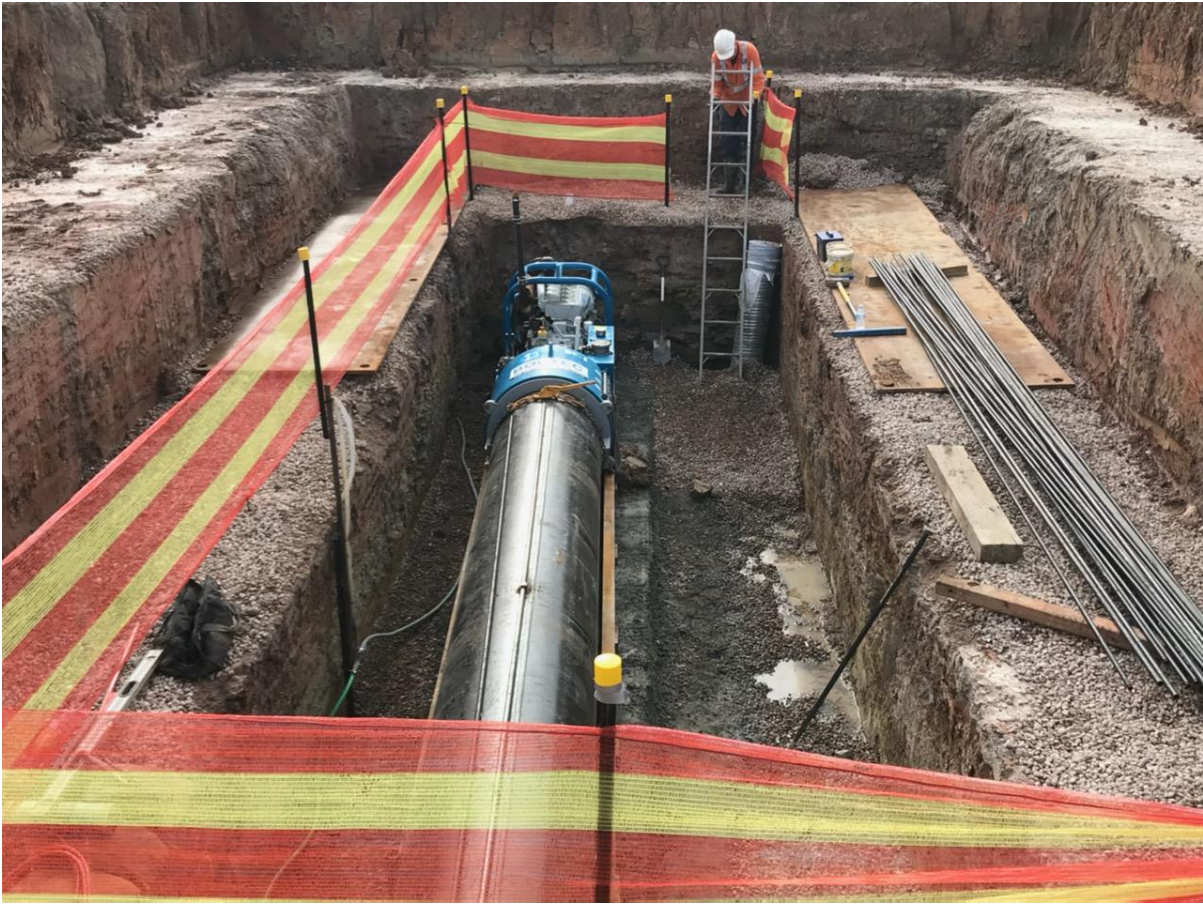
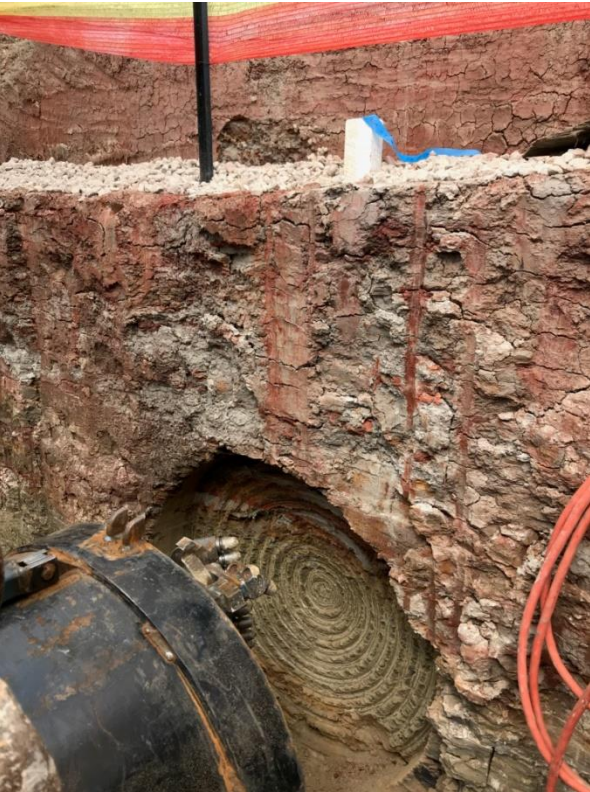
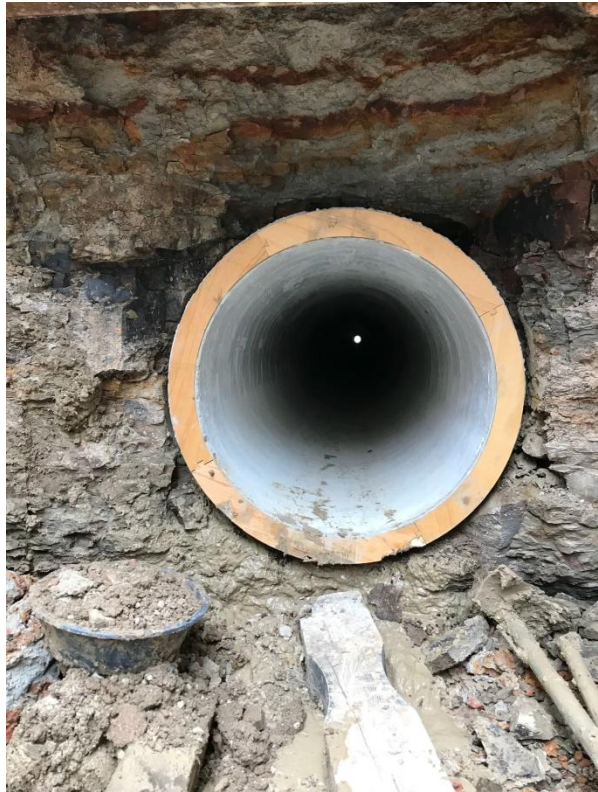
FIGURE 1.2 – REFERENCE IMAGES OF 'BORTEC' BORING MACHINE

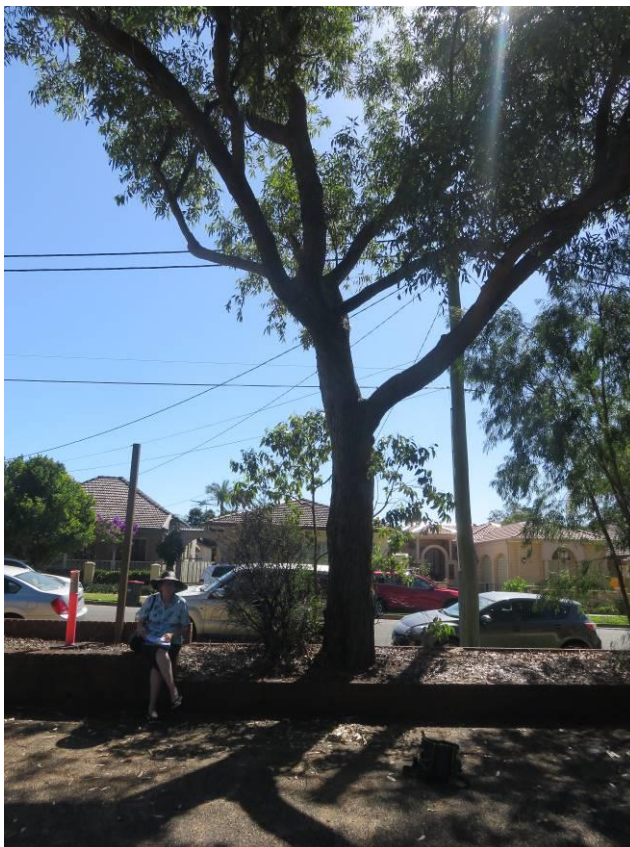
Figure 5. Tree 20 major encroachment of the TPZ and SRZ due to removal of low retaining walls, pedestrian access to Crabbes Ave and underground parking.

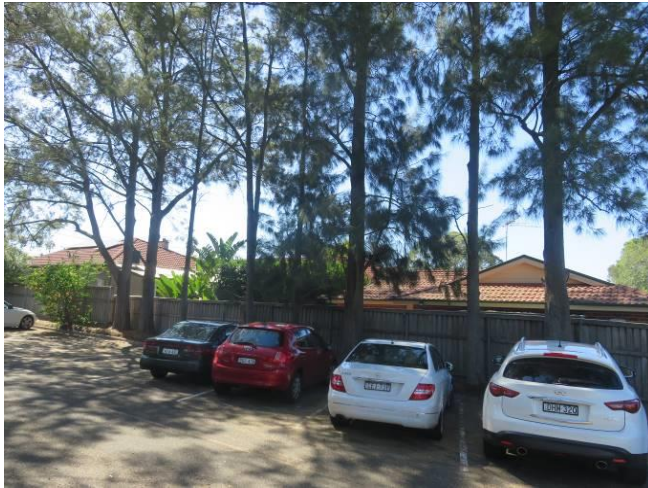
**Figure 65. Trees 25 – 32 removal of bitumen, kerb & ripping of subsoil proposed within TPZ**

- 4.4.4 **Trees 26, 27, 29, & 31 & 32** works within the TPZ and SRZ include demolition of the existing kerb, bitumen carpark and ripping the sub grade to facilitate new plantings. Fine or feeder roots, which are responsible for water and nutrient absorption, occur primarily within the upper 10 – 20cm of the soil profile. Therefore, lowering the grade even by a few centimetres will cause extensive root damage and a progressive decline over a period of several months to several years. In addition, pruning to achieve hoarding clearances is likely to be required to Tree 32. The demolition of the kerb, bitumen and ripping of the sub grade falls within the SRZ and is a major encroachment of > 40% of the TPZ. The proposed works will significantly reduce the trees life expectancy.

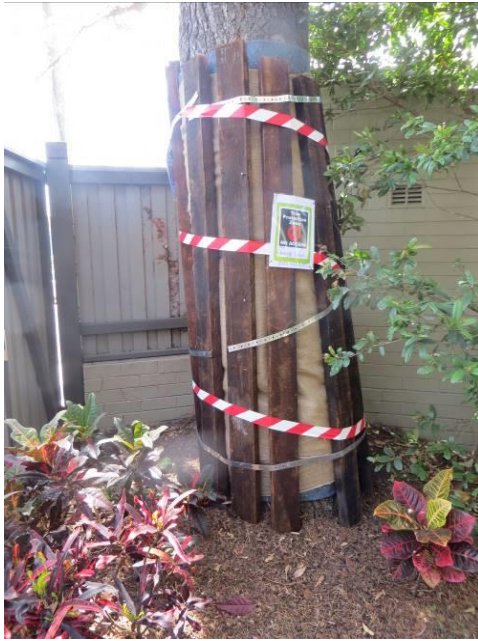
**Figure 9. Example of trunk protection**

- 6.2.2 Trunk Protection shall be achieved by strapping hessian or carpet underlay around the trunk followed by placing 1.5 – 2.0m lengths of timbers (100 x 50mm) spaced at 100mm intervals and secured together with galvanised wire. The timber slats shall be strapped around the trunk to avoid mechanical injury or damage. No wire/nails or securing devices shall damage or contact the trunk.

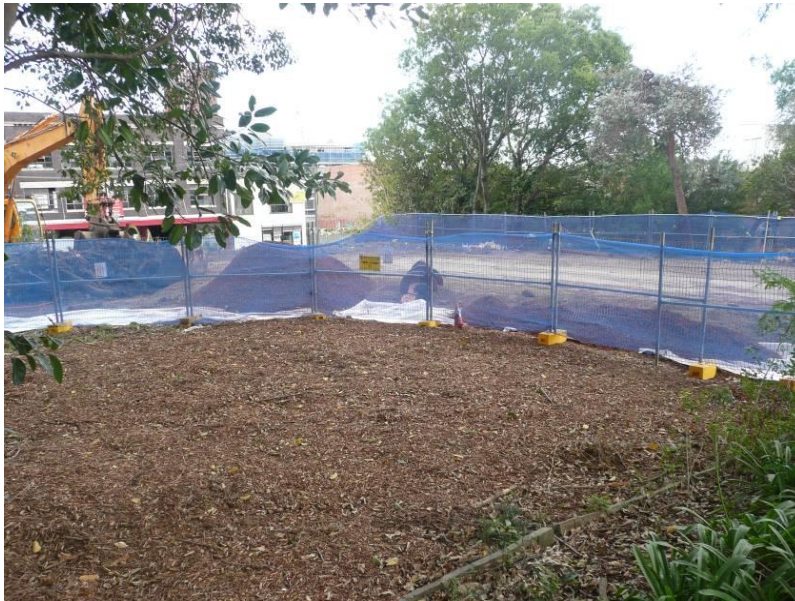
**Figure 10. Example of Tree Protection Fencing & mulching requirements**

- 6.2.9 Mulch shall be spread within the TPZ's of the retained trees or as instructed by the project Arborist. The mulch shall consist of mixed leaf and fine woodchip mulch as certified to AS4454:2012 Composts, Soil Conditioners and Mulches. Mulch shall be spread to a depth of 75mm and maintained at this depth for the duration of works.
