GEOTECHNICAL INVESTIGATION

NEW GOLDEN ST LEONARDS PTY LIMITED

3 Holdsworth Avenue, St Leonards

Report No: 21/2493_Rev2

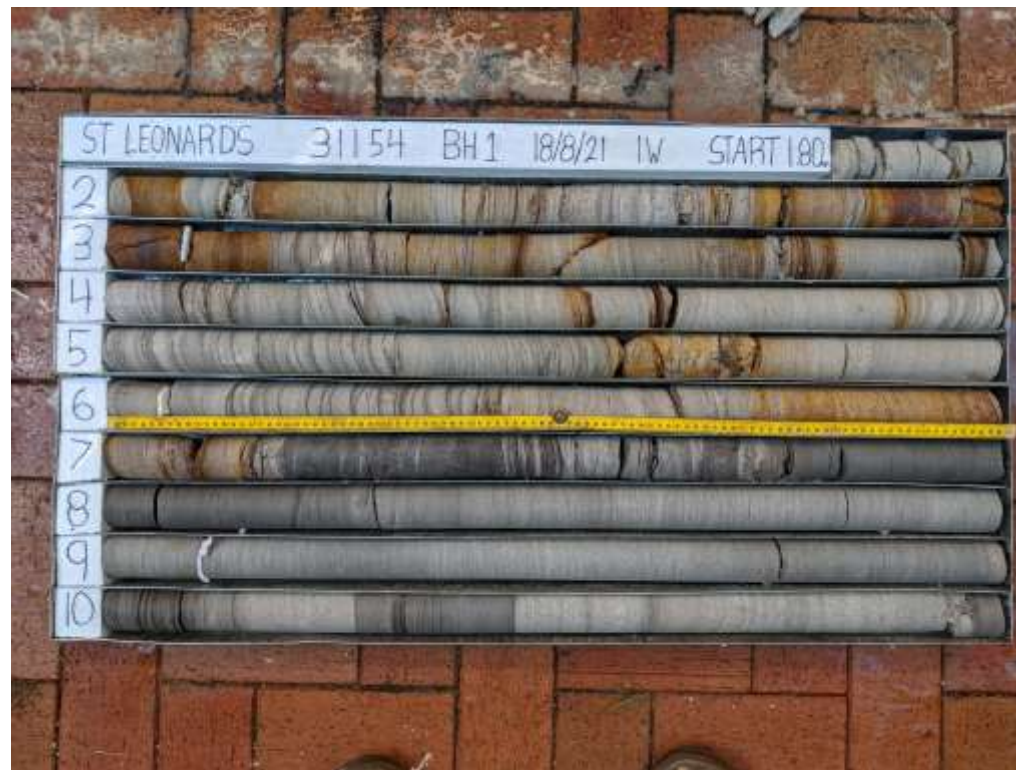
BOX 1-2 OF 5

DEPTH (m) START 1.8m - 23.85m END

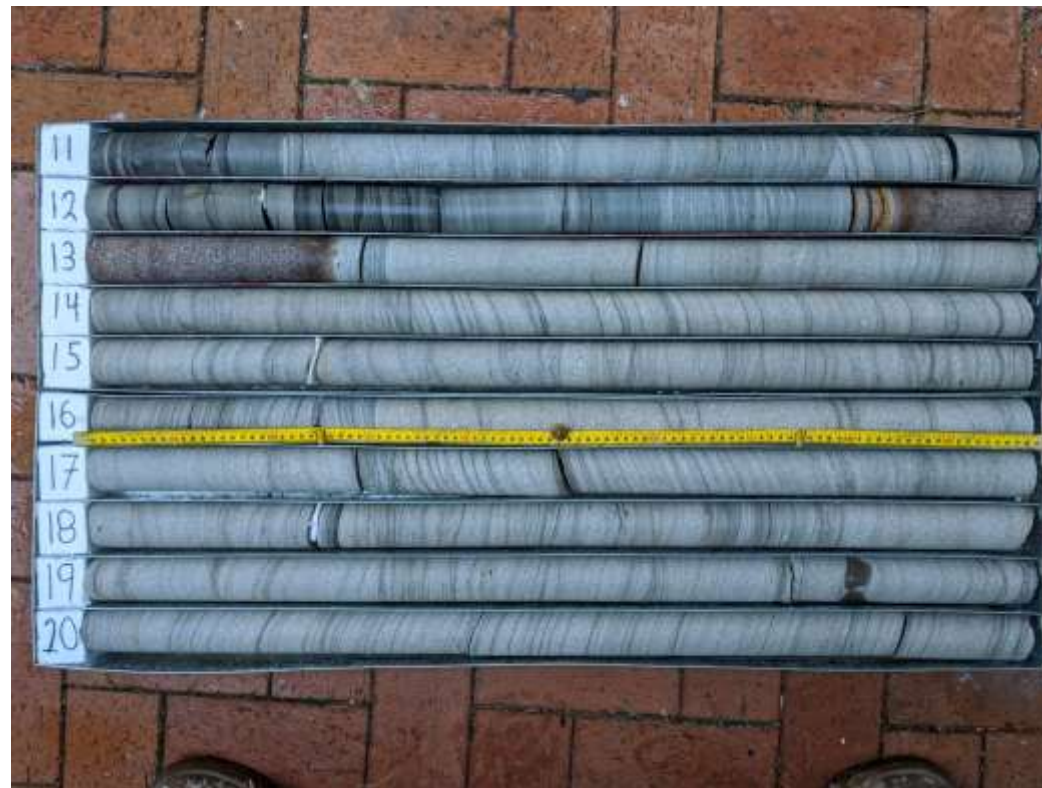
BOX 3-4 OF 5

DEPTH (m) START 1.8m - 23.85m END

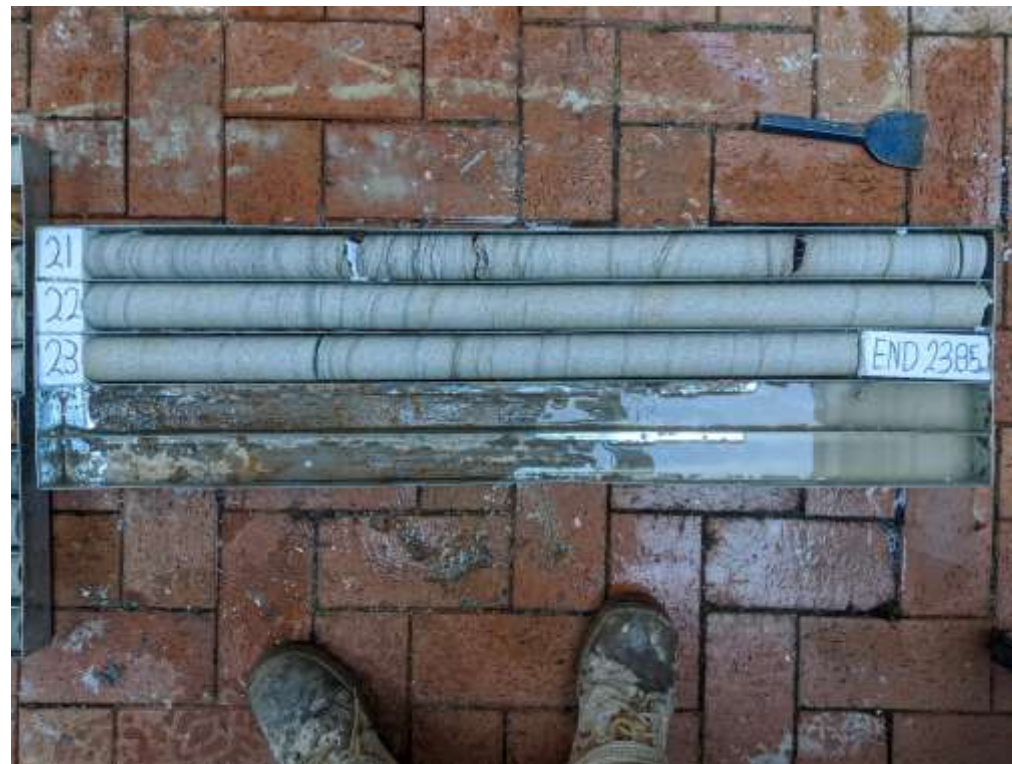
BOX 5 OF 5

DEPTH (m) START 1.8m - 23.85m END

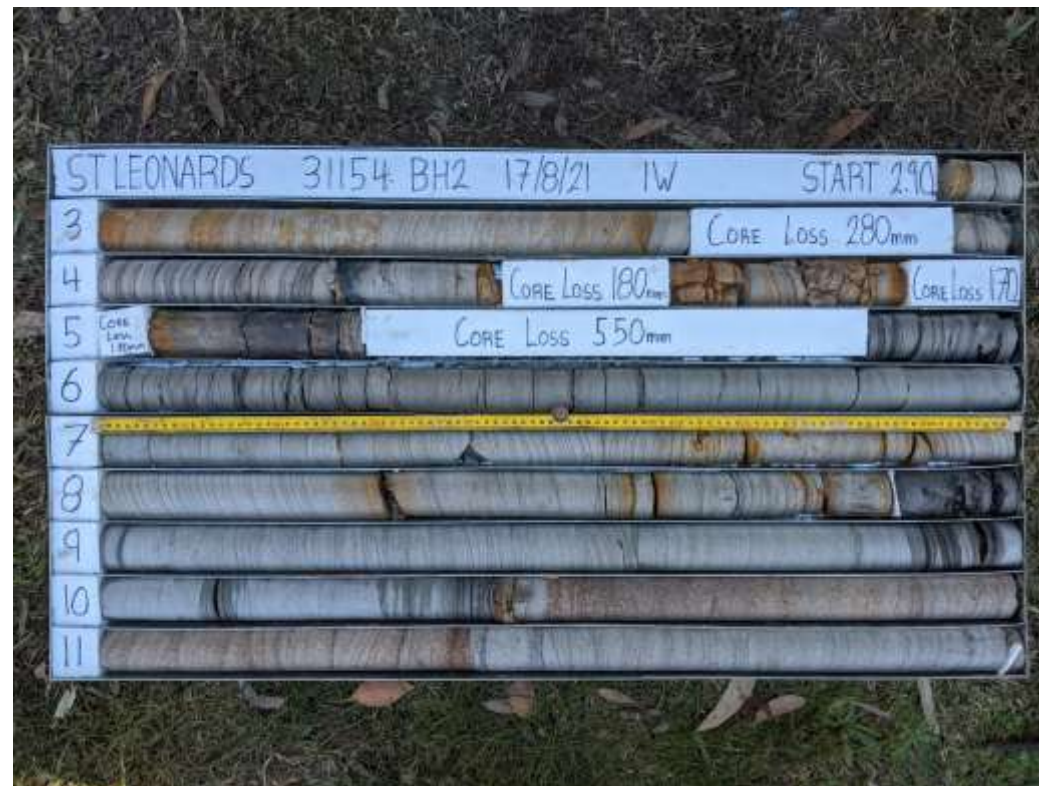
BOX 1-2 OF 4

DEPTH (m) START 2.9m - 21.5m END

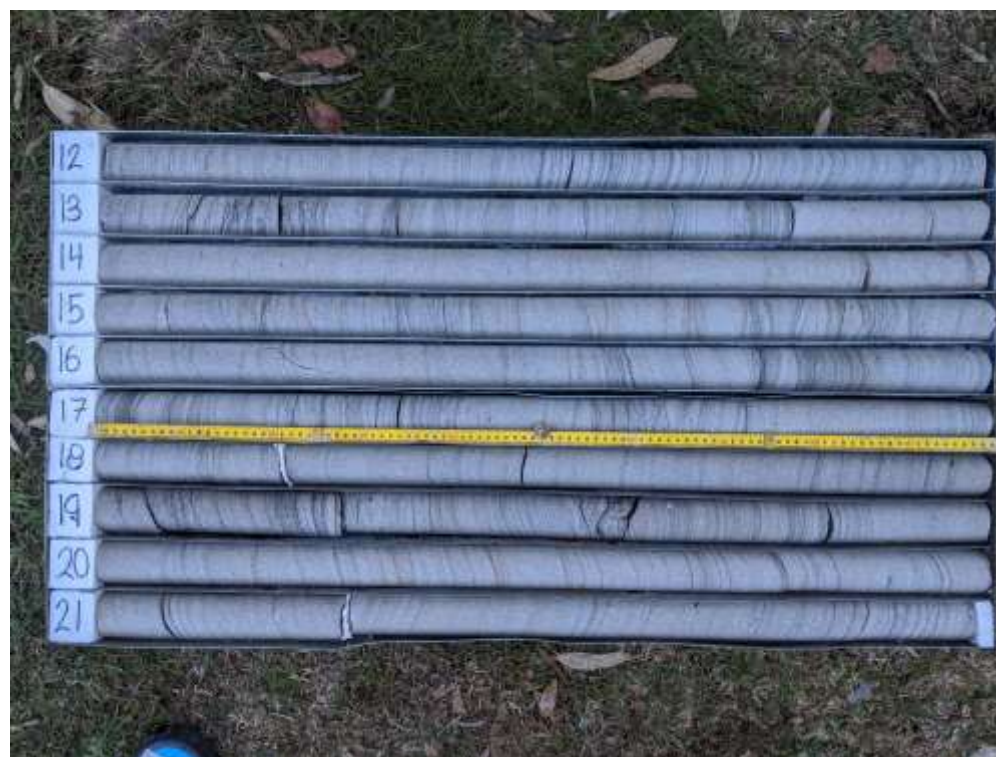
BOX 3-4 OF 4

DEPTH (m) START 2.9m - 21.5m END

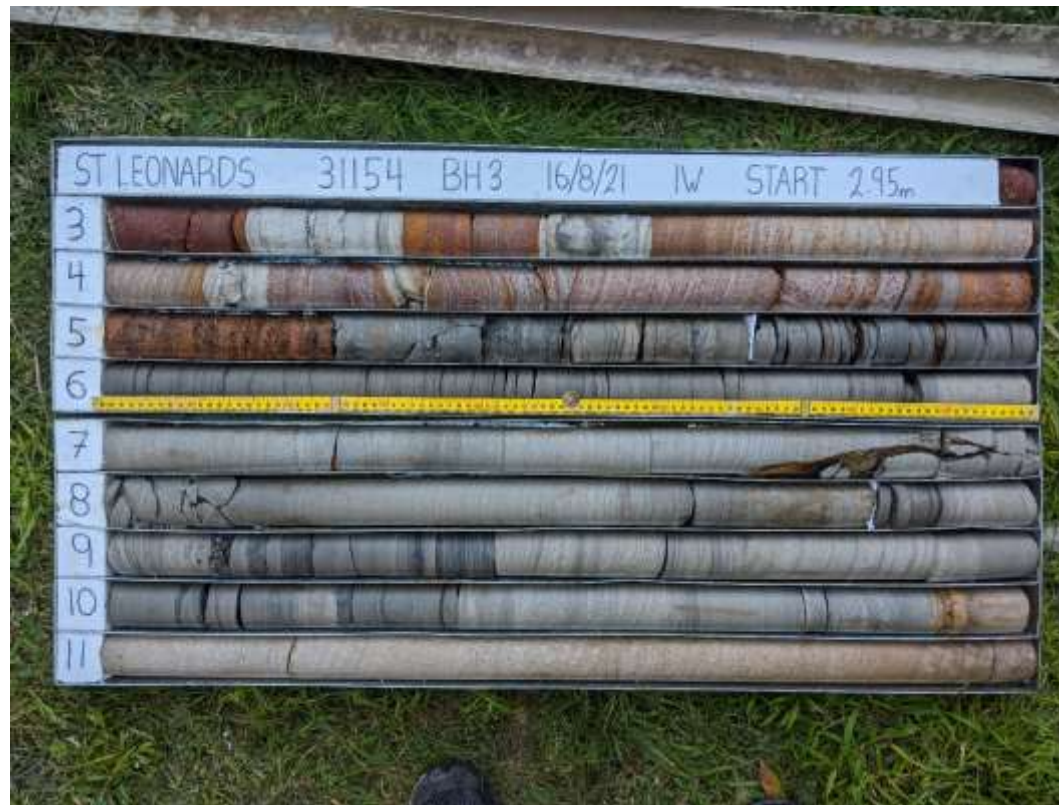
BOX 1-2 OF 4

DEPTH (m) START 2.95m - 21.18m END

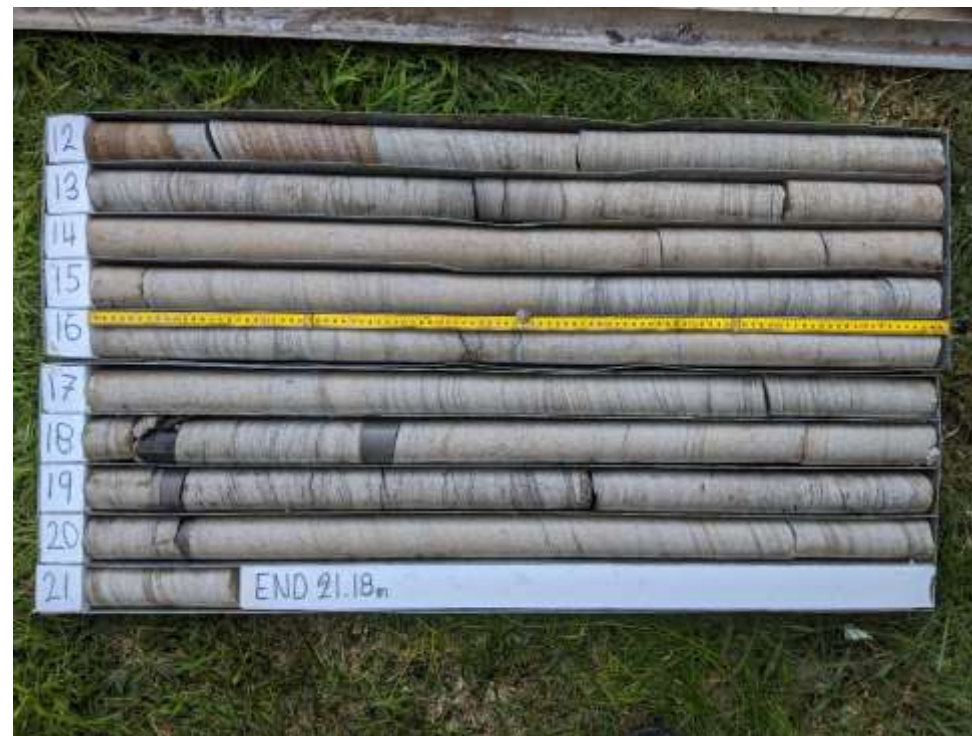
BOX 3-4 OF 4

DEPTH (m) START 2.95m - 21.18m END
