Arborist Report

ARBORICULTURAL IMPACT ASSESSMENT
&
TREE PROTECTION SPECIFICATION

REF: L&Co2021021 | 10 May 2022 | v.1.2

SITE ADDRESS | 22,24,26,28,30, 32, 34 Berry Road, 21, 23, 25, 27, 29 & 31 Holdsworth Avenue and 42,
44 & 46 River Road, St Leonards

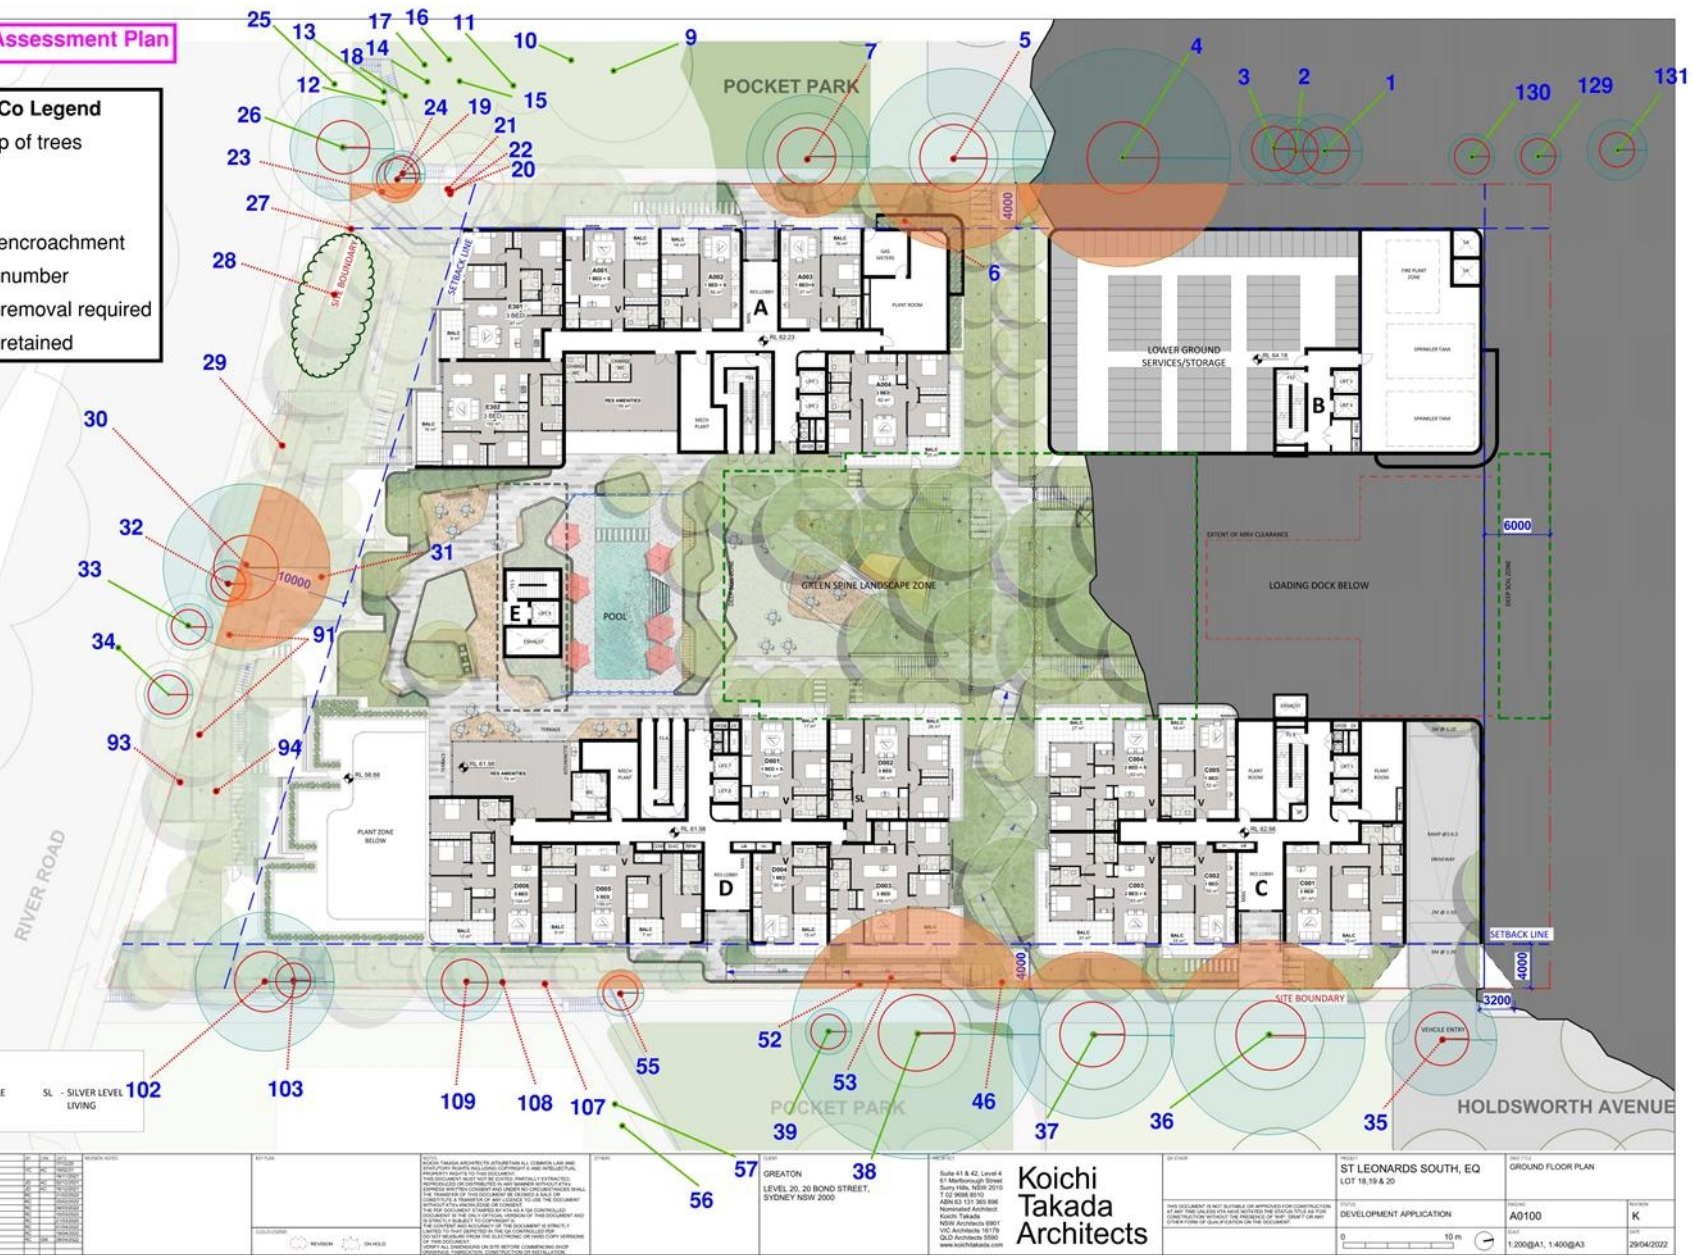
L&Co Legend

- Group of trees
- SRZ
- TPZ
- TPZ encroachment
- Tree number
- Tree removal required
- Tree retained

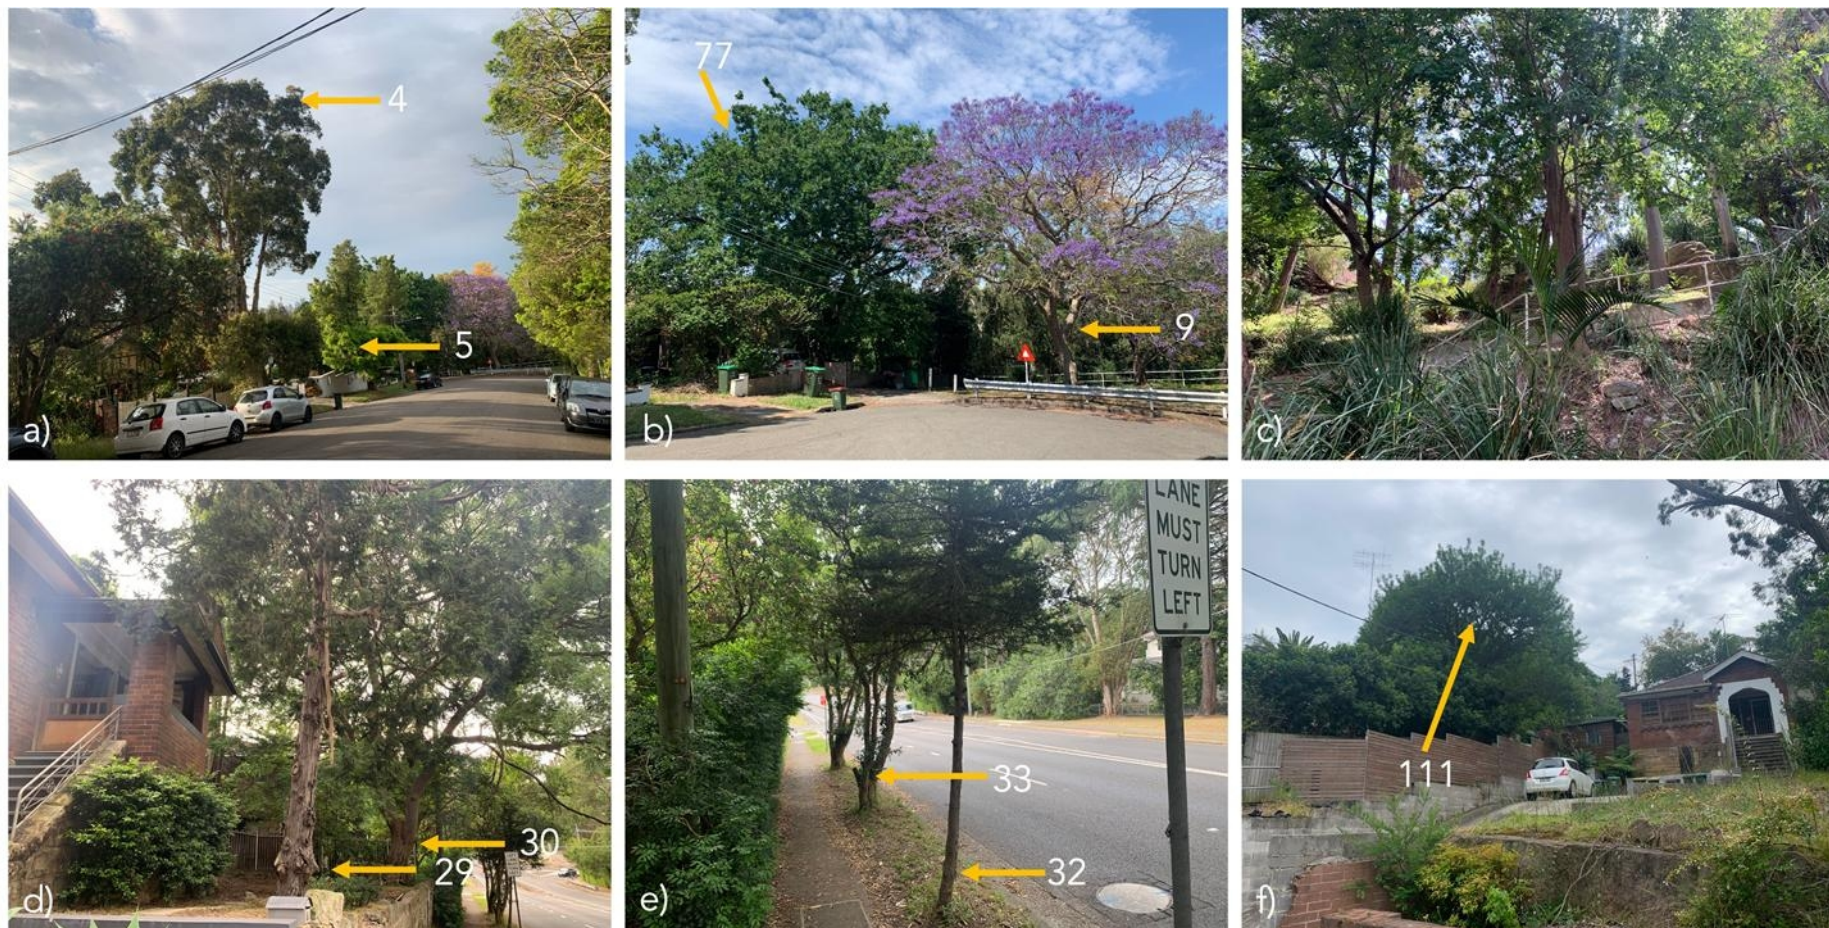
14.0 APPENDIX 9 | PLATES

a) Showing Trees 4 & 5 from Berry Road. b) Showing Trees 9 & 77 from the Berry Road Proposed Park Area. c) Trees in the Reserve between River Road and Berry Road. d) Showing Trees 29 & 30. e) Showing Trees 32 & 33. g) Showing Tree 111.

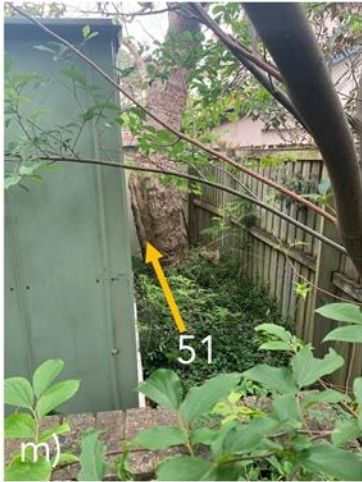
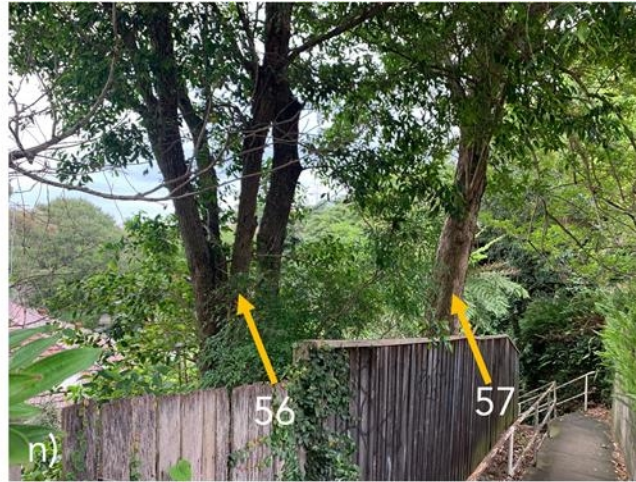
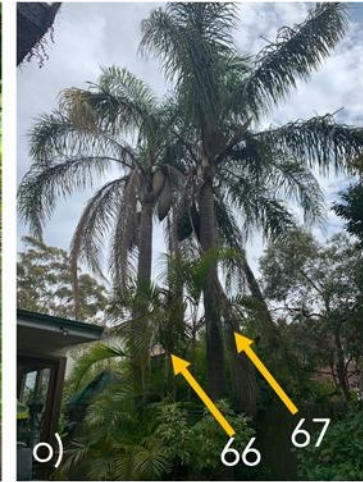
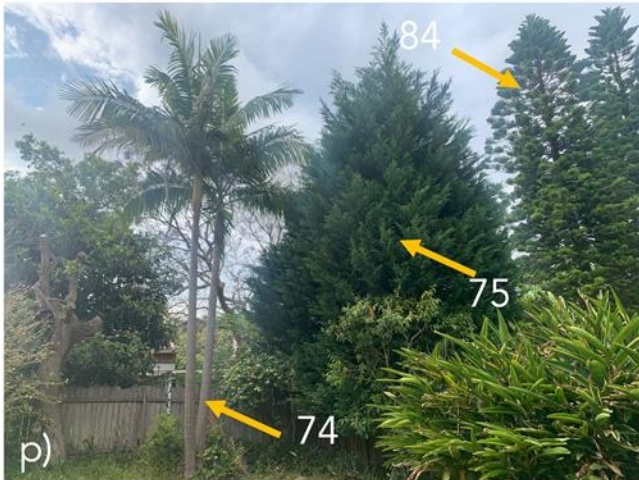
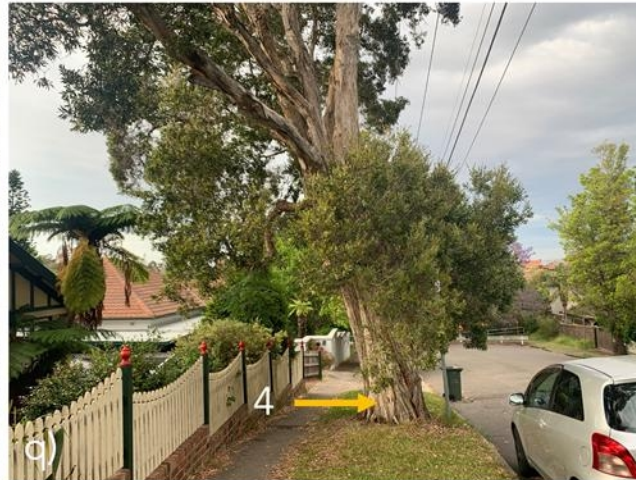
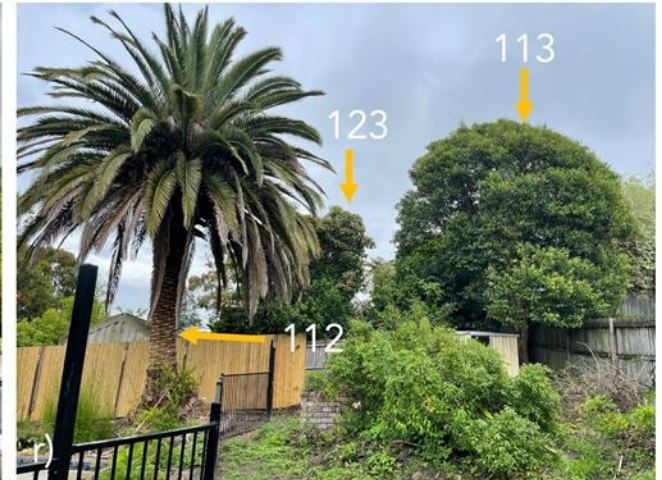
g) Showing example of lopped trees on Holdsworth Avenue. h) Showing Tree 42 in the Green Spine Deep Soil Section. i) Showing examples of trees with Low Landscape Significance Values. j) Showing Tree 45. k) Showing Tree 49. l) Showing Tree 51.

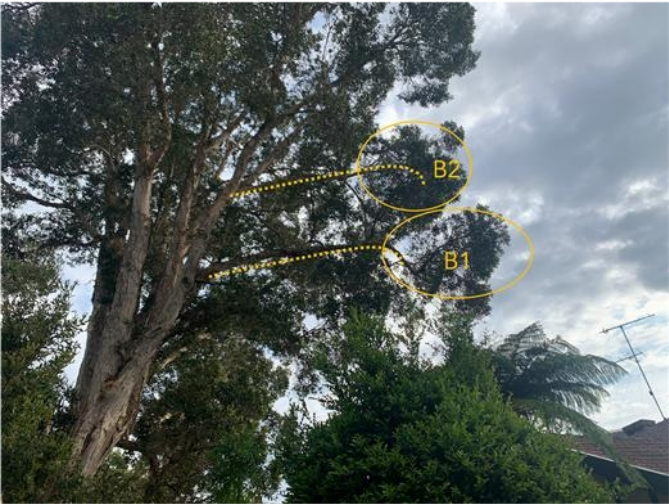
Tree No. 4	BRANCH Ø	BRANCH ORDER	AS4373 CODE	ORIENTATION	HEIGHT ABOVE GRADE (m)	Crown Encroachment (%)
Branch 1 (B1)	100	Second	Selective Thinning (S)	East	6m	5%
Branch 2 (B2)	100	Second	Selective Thinning (S)	East	8m	5%

- 1.6 The crowns of Trees 4, 36 & 38 are likely to be impacted by the proposed apartment blocks. The branches should be retained where possible, but a Pruning Specification is provided if this is not achievable.

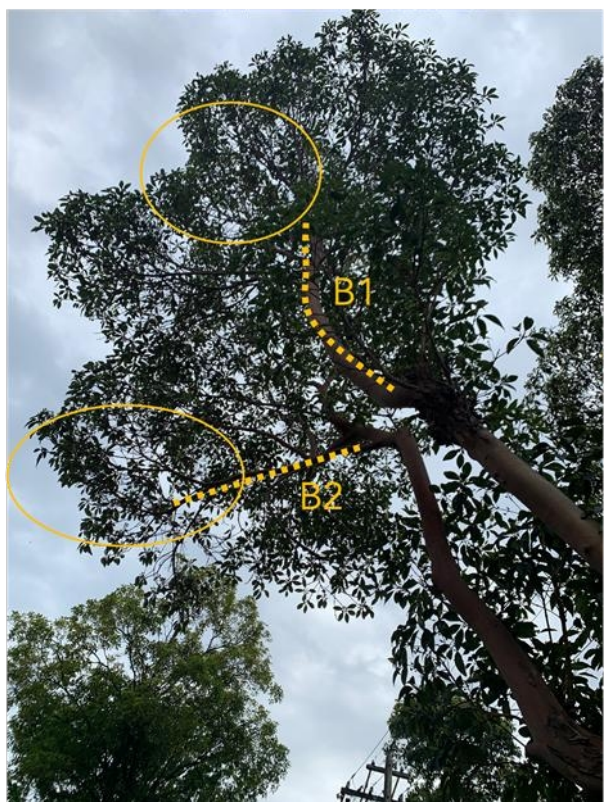
Tree No. 36	BRANCH Ø	BRANCH ORDER	AS4373 CODE	ORIENTATION	HEIGHT ABOVE GRADE (m)	Crown Encroachment (%)
Branch 1 (B1)	75	First	Reduction Pruning (R)	West	4m	8%
Branch 2 (B2)	50	Third	Reduction Pruning (R)	West	4m	2%

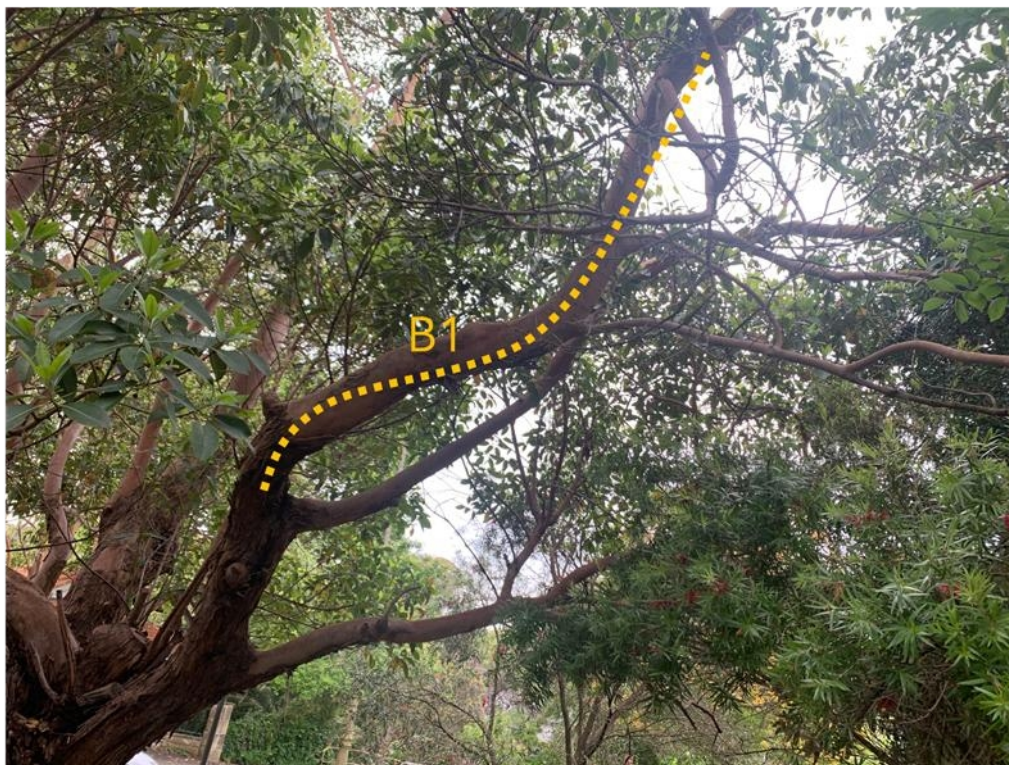
Tree No. 38	BRANCH Ø	BRANCH ORDER	AS4373 CODE	ORIENTATION	HEIGHT ABOVE GRADE (m)	Crown Encroachment (%)
Branch 1 (B1)	225	Second	Selective Thinning (S)	West	3	12%
