RESIDENTIAL DEVELOPMENT

4-8 MARSHALL AVENUE, 1-5 CANBERRA AVENUE, & 2-8 HOLDSWORTH AVENUE, ST LEONARDS NSW

Reference: P2160_02

16 February 2022

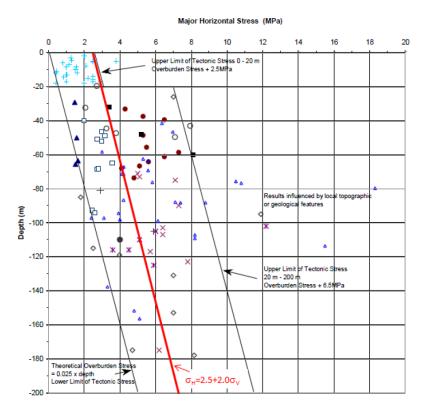
Figure 1: Plot of insitu stress to depth reproduced from McQueen (2004) and Bertuzzi (2014)

Bertuzzi's paper presents Sandstone and shale parameters for tunnel design. It is relevant to locked in stresses which can develop at depth, but not accurate for near surface effects. As can be seen from the

Bertuzzi (2014) reproduces the relationship shown in McQueen (2004) as

$$\sigma_{H} = 2.0\sigma_{V} + 2.5 \text{ MPa}$$

An in situ stress function of σ_V + 1.0 MPa encapsulates 15 of the 19 test results (approx. 80%) presented in the depth range relevant to excavation at the site. It is therefore considered a reasonable model of in situ stress conditions for modelling
