## Arboricultural Impact Appraisal and Method Statement

57-69 Strathallen Avenue  
Northbridge, NSW

Prepared for  
SJD NB Pty Ltd

19 October 2023

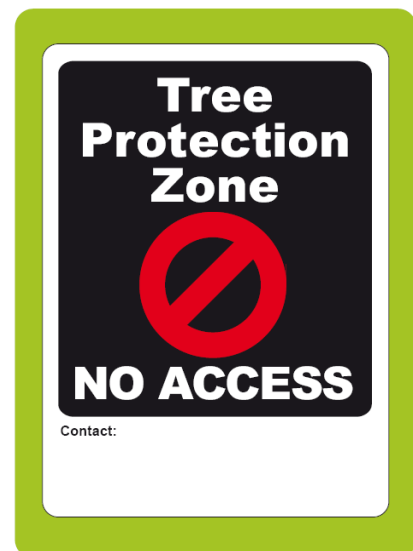
Signage example:

Shade cloth or similar should be attached to reduce the transport of dust, other particulate matter and liquids into the protected area and signage must be attached to outside of fencing.

**Signage:** All signs are to provide clear and readily accessible information to indicate that a TPZ has been established. Signage identifying the TPZ must be attached to outside of fencing and be visible from within the development site.

1. Chain wire mesh panels with shade cloth (if required) attached, held in place with concrete feet.
2. Alternative plywood or wooden paling fence panels. This fencing material also prevents building materials or soil entering the TPZ.
3. Mulch installation across surface of TPZ (at the discretion of the project arborist). No excavation, construction activity, grade changes, surface treatment or storage of materials of any kind is permitted within the TPZ.
4. Bracing is permissible within the TPZ. Installation of supports should avoid damaging roots.

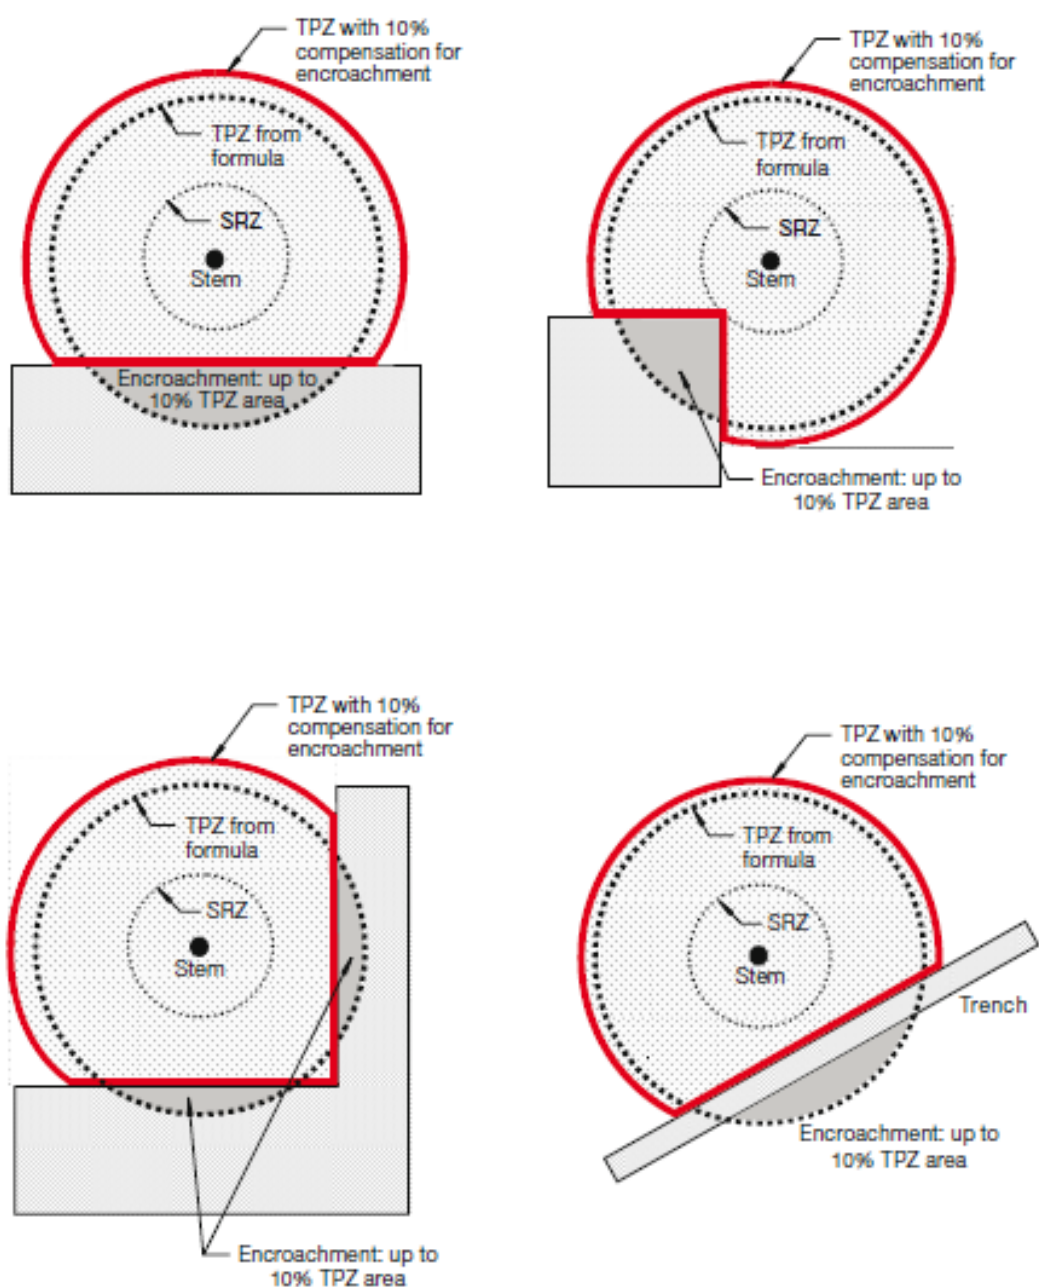
#### Major Encroachments

The proposed encroachment exceeds 10% of the TPZ or inside the SRZ. The area lost to this encroachment should be compensated for elsewhere and contiguous with the TPZ. This may require root investigation by non-destructive methods.

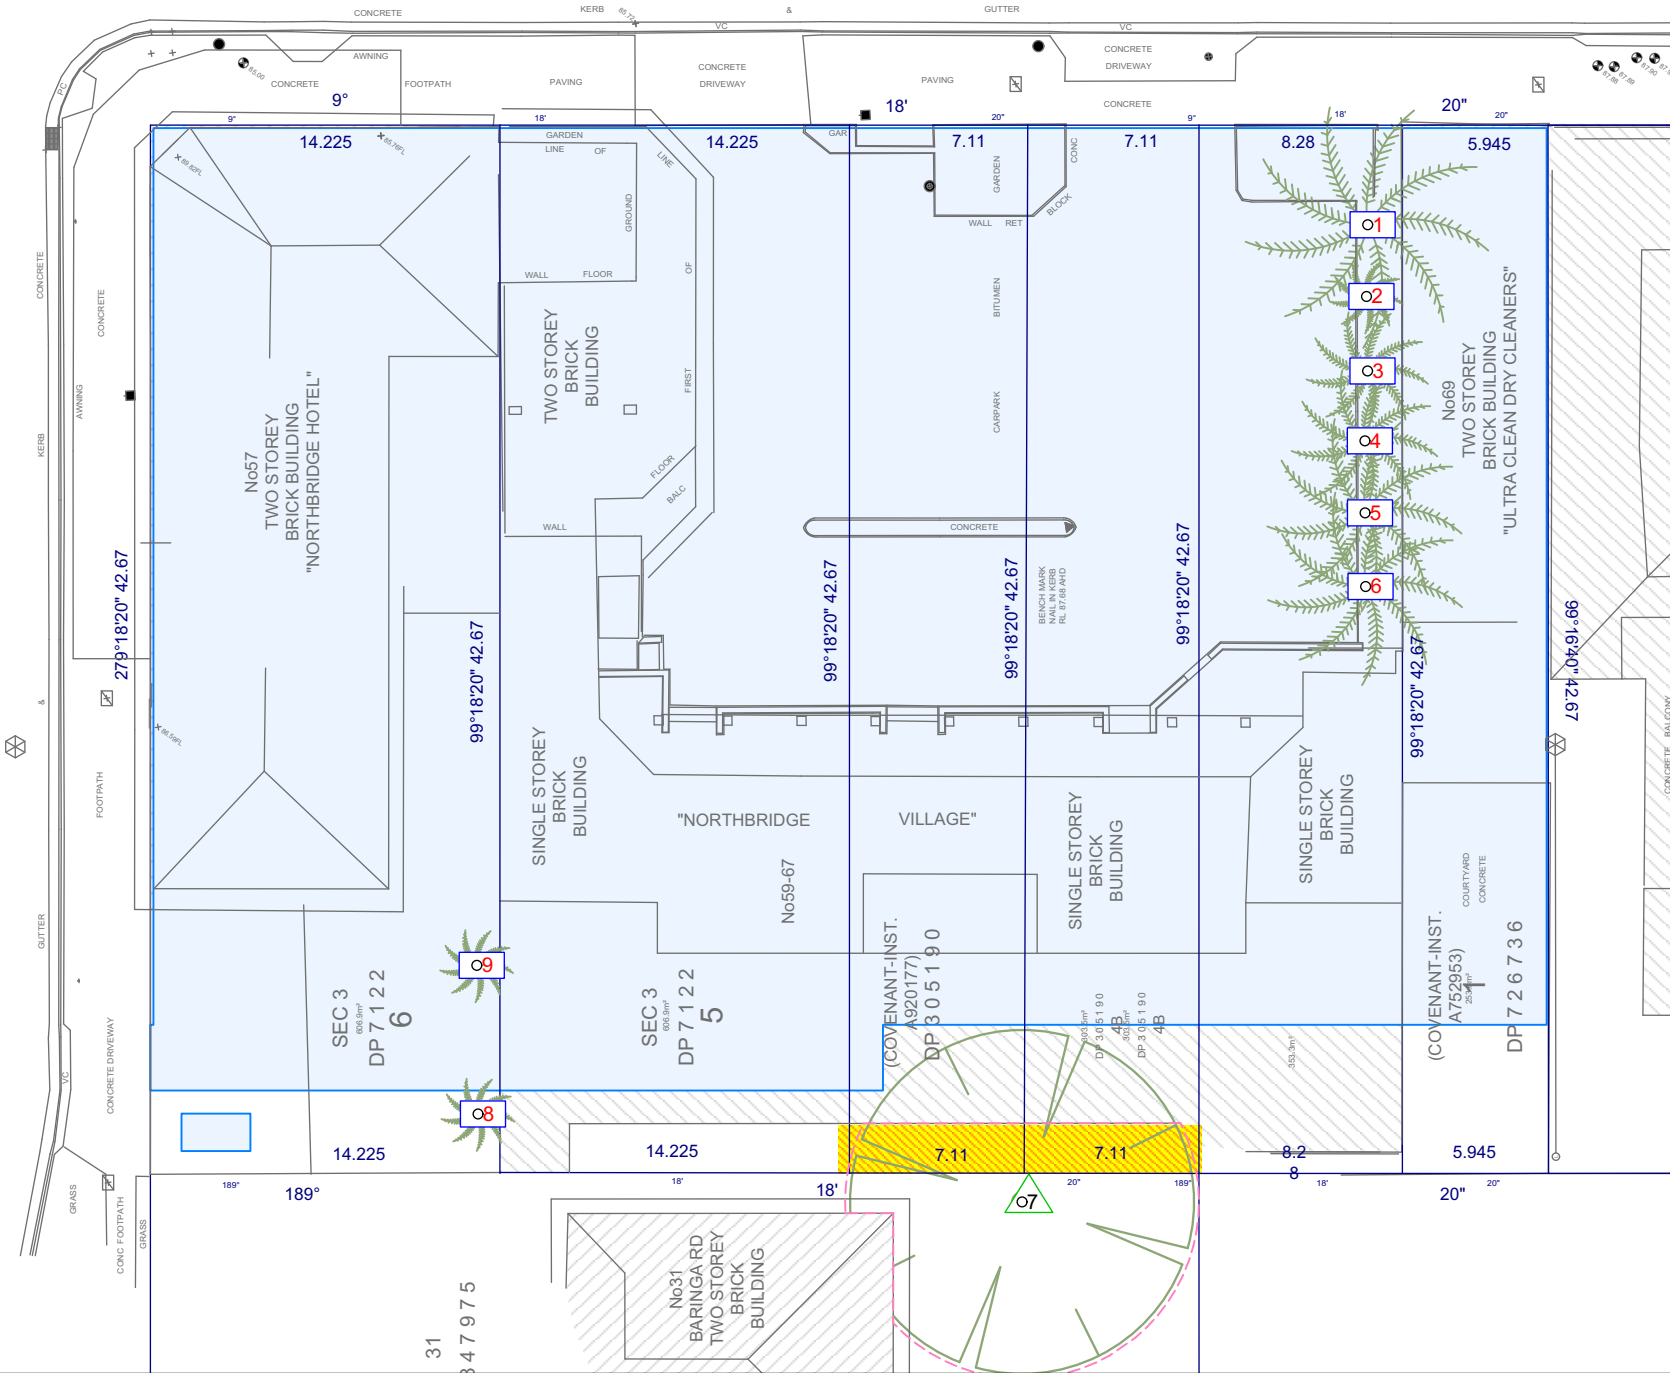
ISSUE	DATE	REVISION
<b>NOTE</b> DO NOT SCALE FROM DRAWING. USE FIGURED DIMENSIONS ONLY. CHECK ALL DIMENSIONS ON SITE BEFORE ANY MANUFACTURE OR CONSTRUCTION		
<b>PROJECT</b> 57-69 Strathallen Ave, Northbridge		
<b>CLIENT</b> SJD NB Pty Ltd		
<b>DRAWING</b> Tree Management Plan

- 2.2.4 **Identification and location of the trees:** I have illustrated the locations of the significant trees on the Tree Management Plan (Plan TMP01) included as Appendix 9. This plan is for illustrative purposes only and it should not be used for directly scaling measurements.

- 2.2.6 **Plan updates:** During my site visit, I noted three trees (Trees 7, 8 and 9) that were not shown on the land survey. I have illustrated their approximate locations on plan TMP01, but these positions have not been accurately surveyed. I do not consider that this has affected the conclusions of this report.

- 4.1.2 **Plan TMP01:** Plan TMP01 in Appendix 9 is illustrative and based entirely on provided information. This plan should only be used for dealing with the tree issues and all scaled measurements must be checked against the original submission documents. The precise location of all protective measures must be confirmed at the pre-commencement meeting before any demolition or construction activity starts. Its base is the existing land survey, which has the proposed layout superimposed so the two can be easily compared. It shows the existing trees numbered, with high categories (A) highlighted in green triangles and low categories (Z) highlighted in blue rectangles. It also shows the locations of the proposed protective measures.

- 4.2.2 **Ground protection:** Any TPZs outside the protective fencing must be covered in ground protection based on AS4970 recommendations until there is no risk of damage from the demolition and construction activity. An illustrative specification for this ground protection is included as Appendix 5. On this site, it must be installed near Tree 7 as illustrated on plan TMP01 before any demolition and construction starts.

- 4.3 **Precautions when working in TPZs:** Any work in TPZs must be done with care as set out in Appendix 7. On this site, special precautions must be taken near Tree 7 as illustrated on plan TMP01 and summarised below:

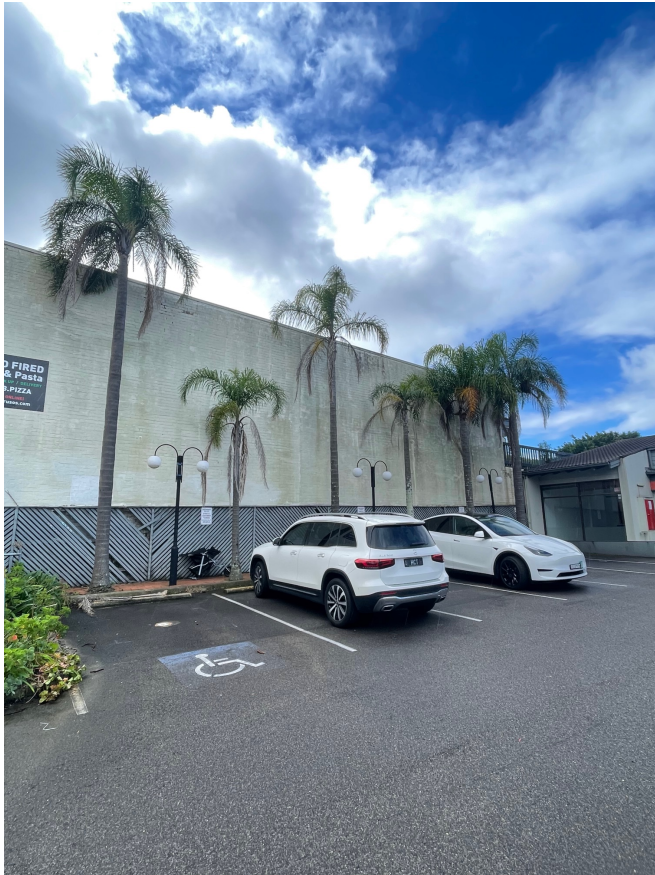
Trees 1 to 6 - *Syagrus romanzoffiana*

- 3.2.2 **Low category trees to be removed:** The proposed development will necessitate the removal of eight trees of low retention value. These include Trees 1, 2, 3, 4, 5, 6, 8 and 9. None of these trees are considered significant or worthy of special measures to ensure their preservation. It should be noted that Trees 1, 2, 3, 4, 5 and 6 are exempt from Willoughby Council's Tree and Vegetation Preservation Order 2012.

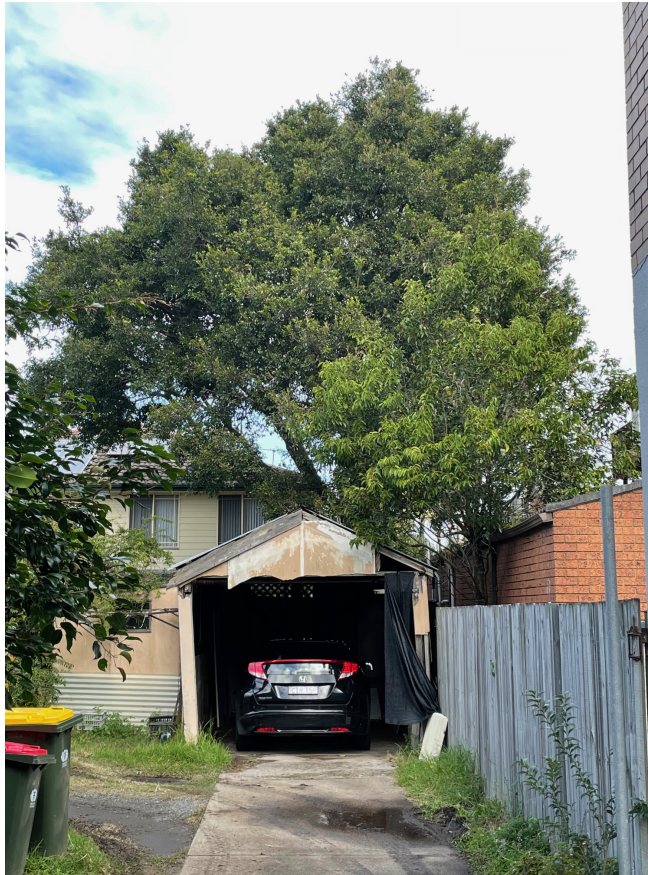
Tree 7 - *Acmena smithii*

- Tree 7: This is an important tree with a high potential to contribute to amenity so any adverse impacts on it should be minimised. The proposed works remain largely outside the TPZ of this tree and therefore direct impacts are not expected. It should be noted that the extent of the TPZ is restricted by the existing building foundations. I have reviewed the situation carefully and my experience is that these trees could be successfully retained without any adverse effects if appropriate protective measures are properly specified and controlled through a detailed arboricultural method statement.

- **Removal of existing surfacing/structures and replacement with new surfacing/structures:** Tree 7 may be adversely affected by the demolition and construction works or the installation of a small area of new surfacing. Any adverse impact must be minimised by following the guidance set out in Appendix 7.
