Report on  
Geotechnical Investigation

Proposed Shop Top Housing Development  
57-69 Strathallen Avenue, Northbridge

Prepared for  
SJD NB Pty Ltd

Project 221953.01  
May 2024

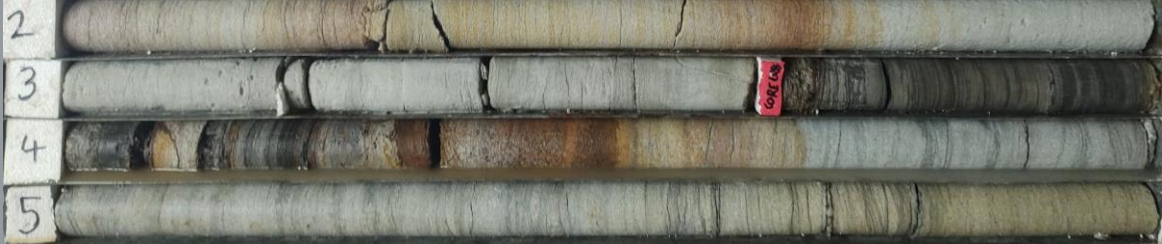
1.38-6.00m

NORTHBRIDGE BH 1  
221953.01 START 1.38m

BORE: BH1

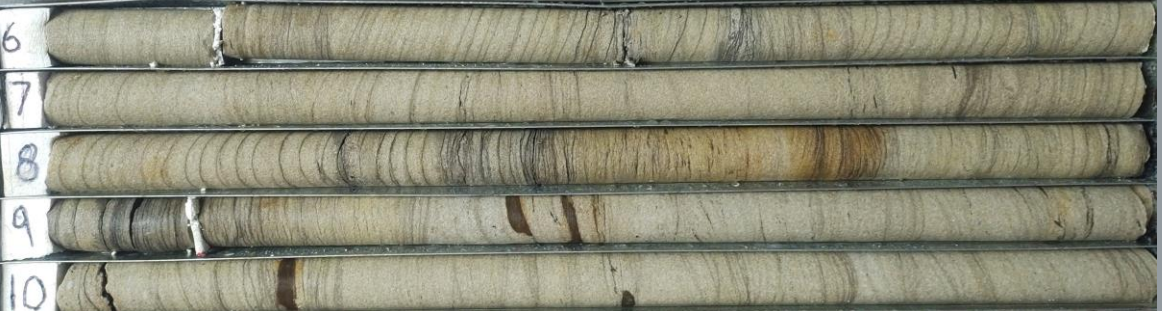
6.00-11.00m

Depth: 6.0m - 11.0m

Core Box No.: 2 of 3

BORE: BH1

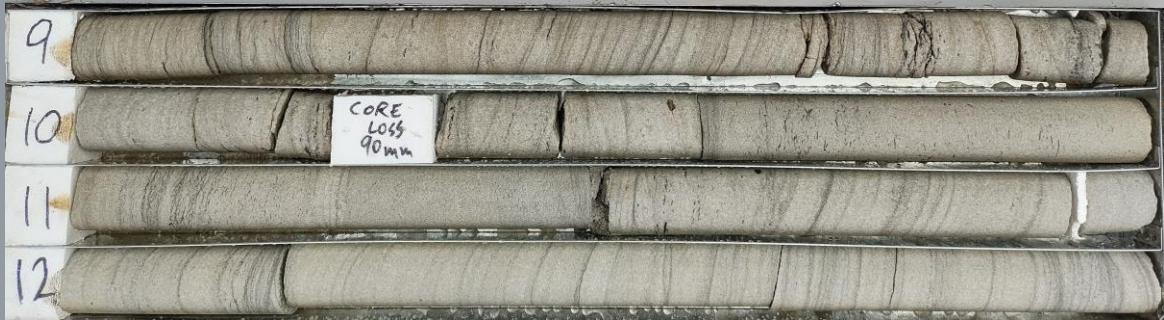
9.00-13.00m

Depth: \* 9.0m - 13.0m

Core Box No.: 3 of 4

BORE: BH3

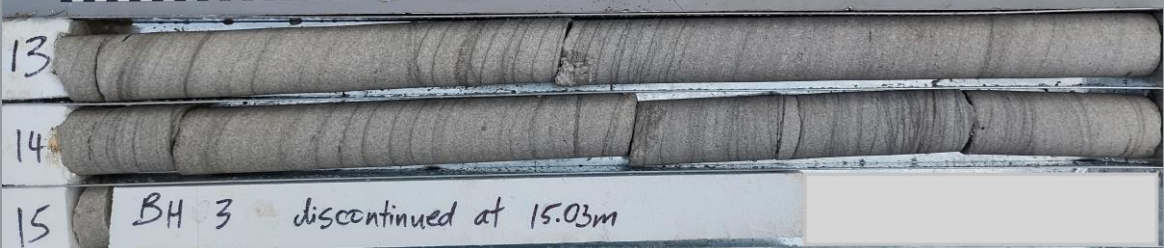
13.00-15.03m

Depth: \* 13.0m - 15.03m

Core Box No.: 4 of 4
