WINIM Developments Pty Ltd

Preliminary Site Investigation: 1 Gatacre Avenue and 5 Allison Avenue, Lane Cove, NSW

P2008014JR03V01
May 2021

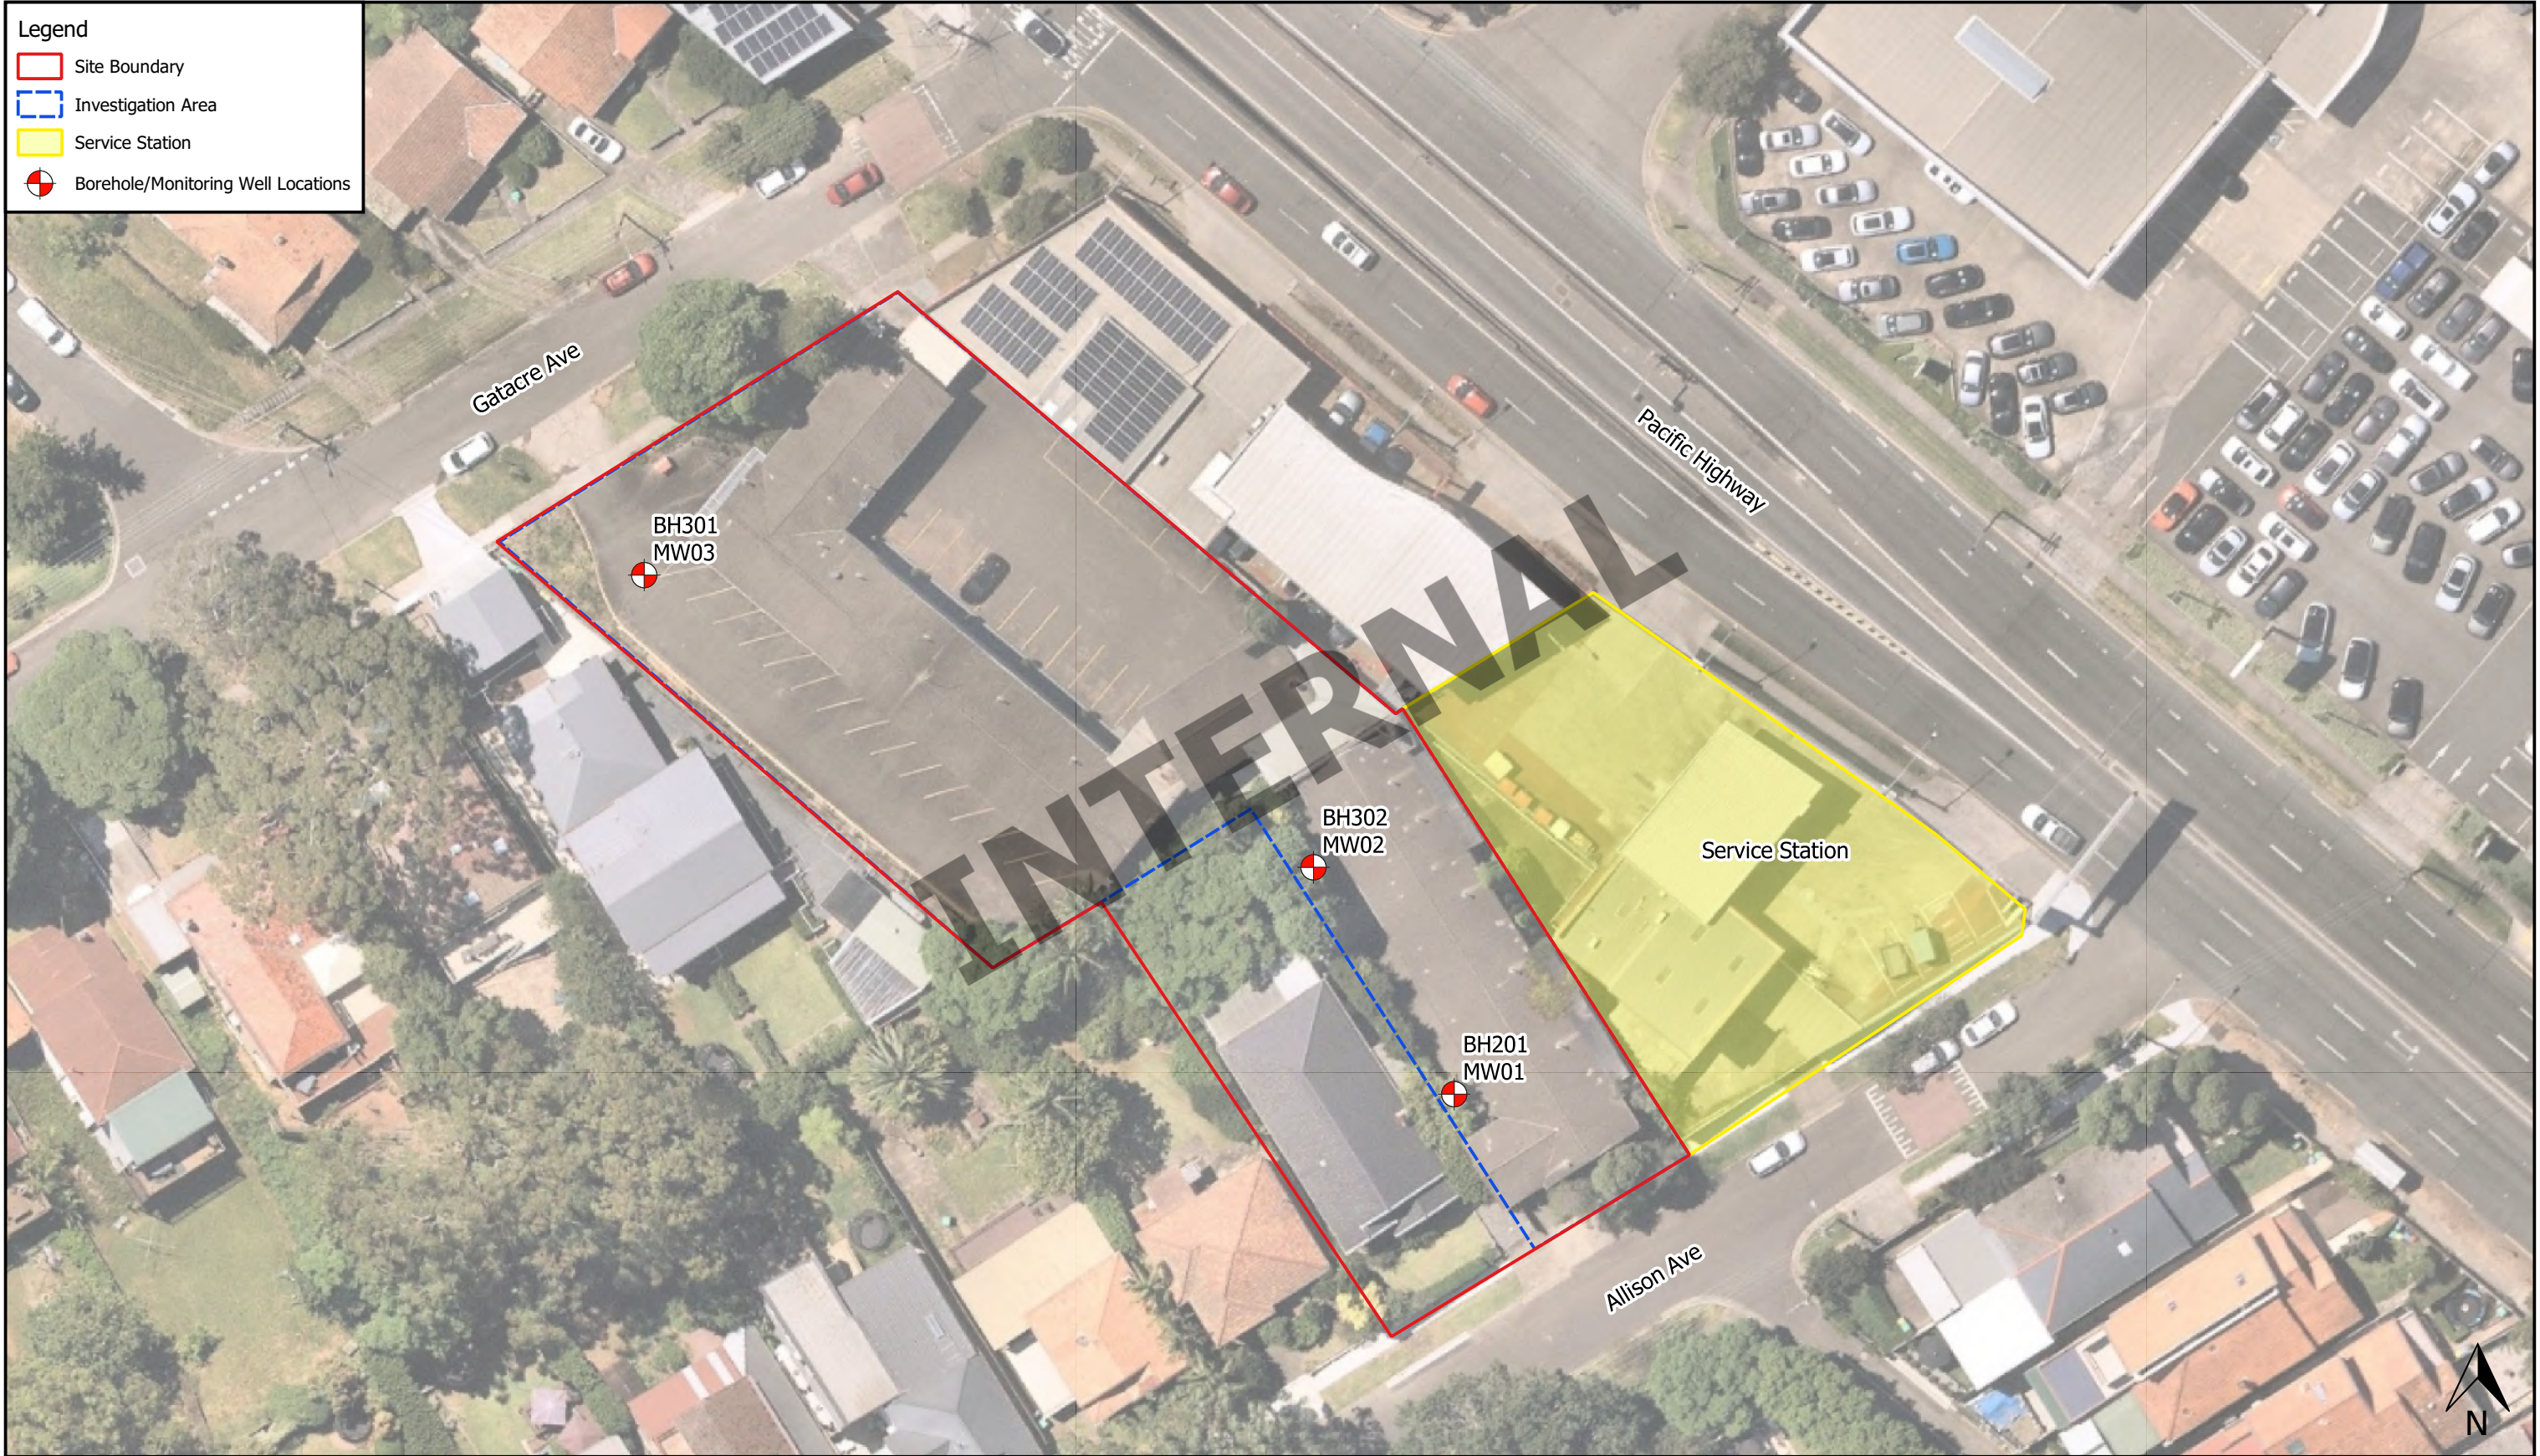
- Site Boundary
- Investigation Area
- Service Station
- Borehole/Monitoring Well Locations

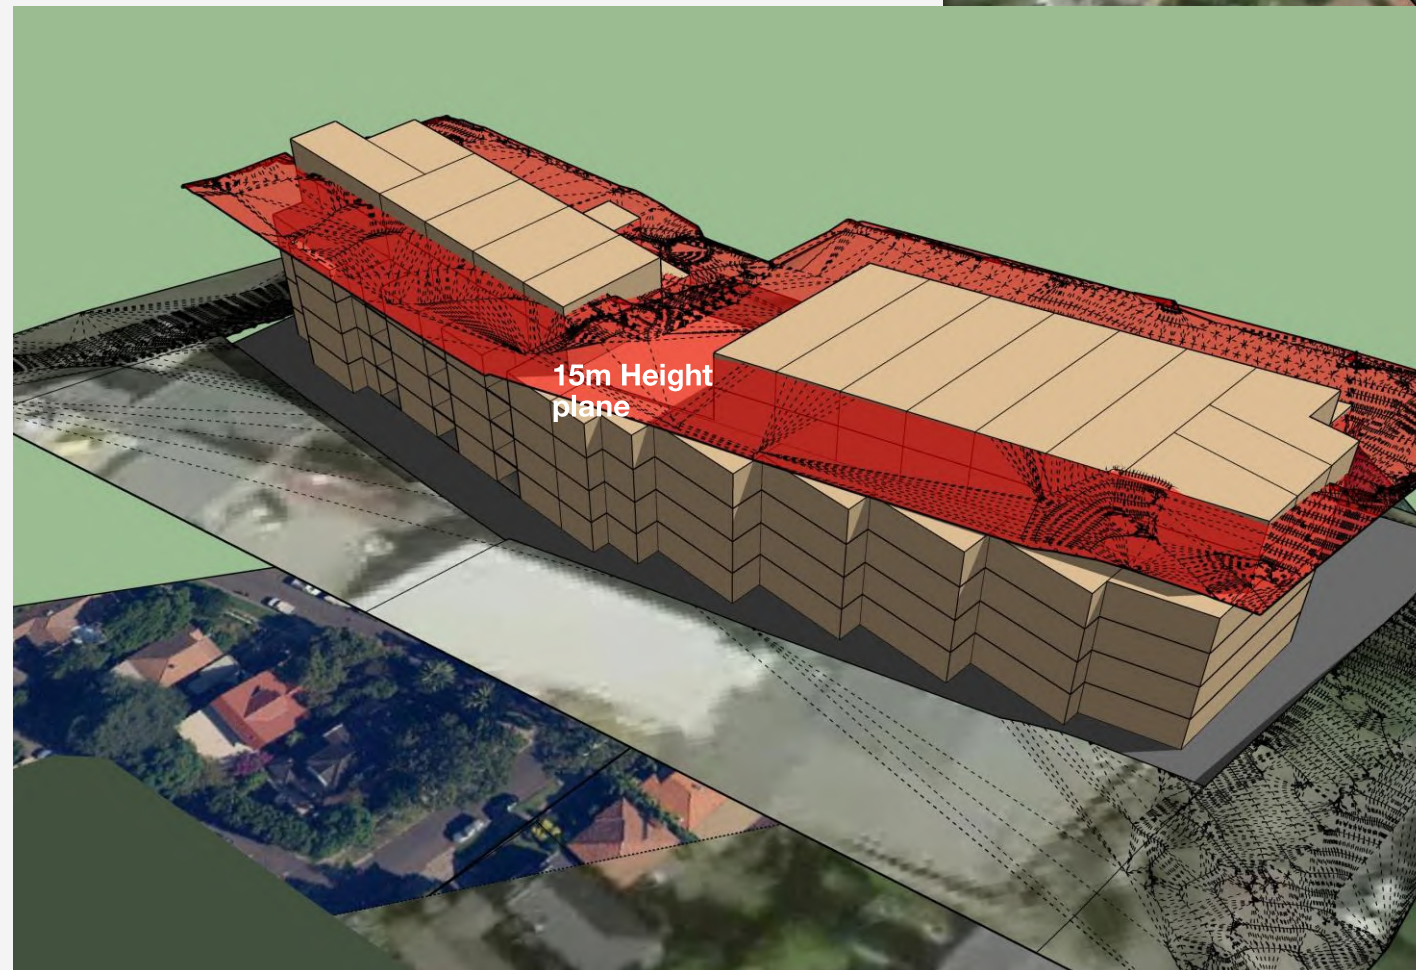
Overview 3

- To create visual break in form, area is redistributed to double storey apartments on the upper two levels.
- Protrusions through height plane partially setback from boundary further than required under ADG
- Upper level is bedroom floor (lower height)
- Can shape roof form as needed
- Portion of form above height plane approx. 850sqm.
- 300sqm of this is redistributed from level
- 150sqm is from increase in NSA
- A half floor on the basement level (circa 400sqm) would be required to regain this area

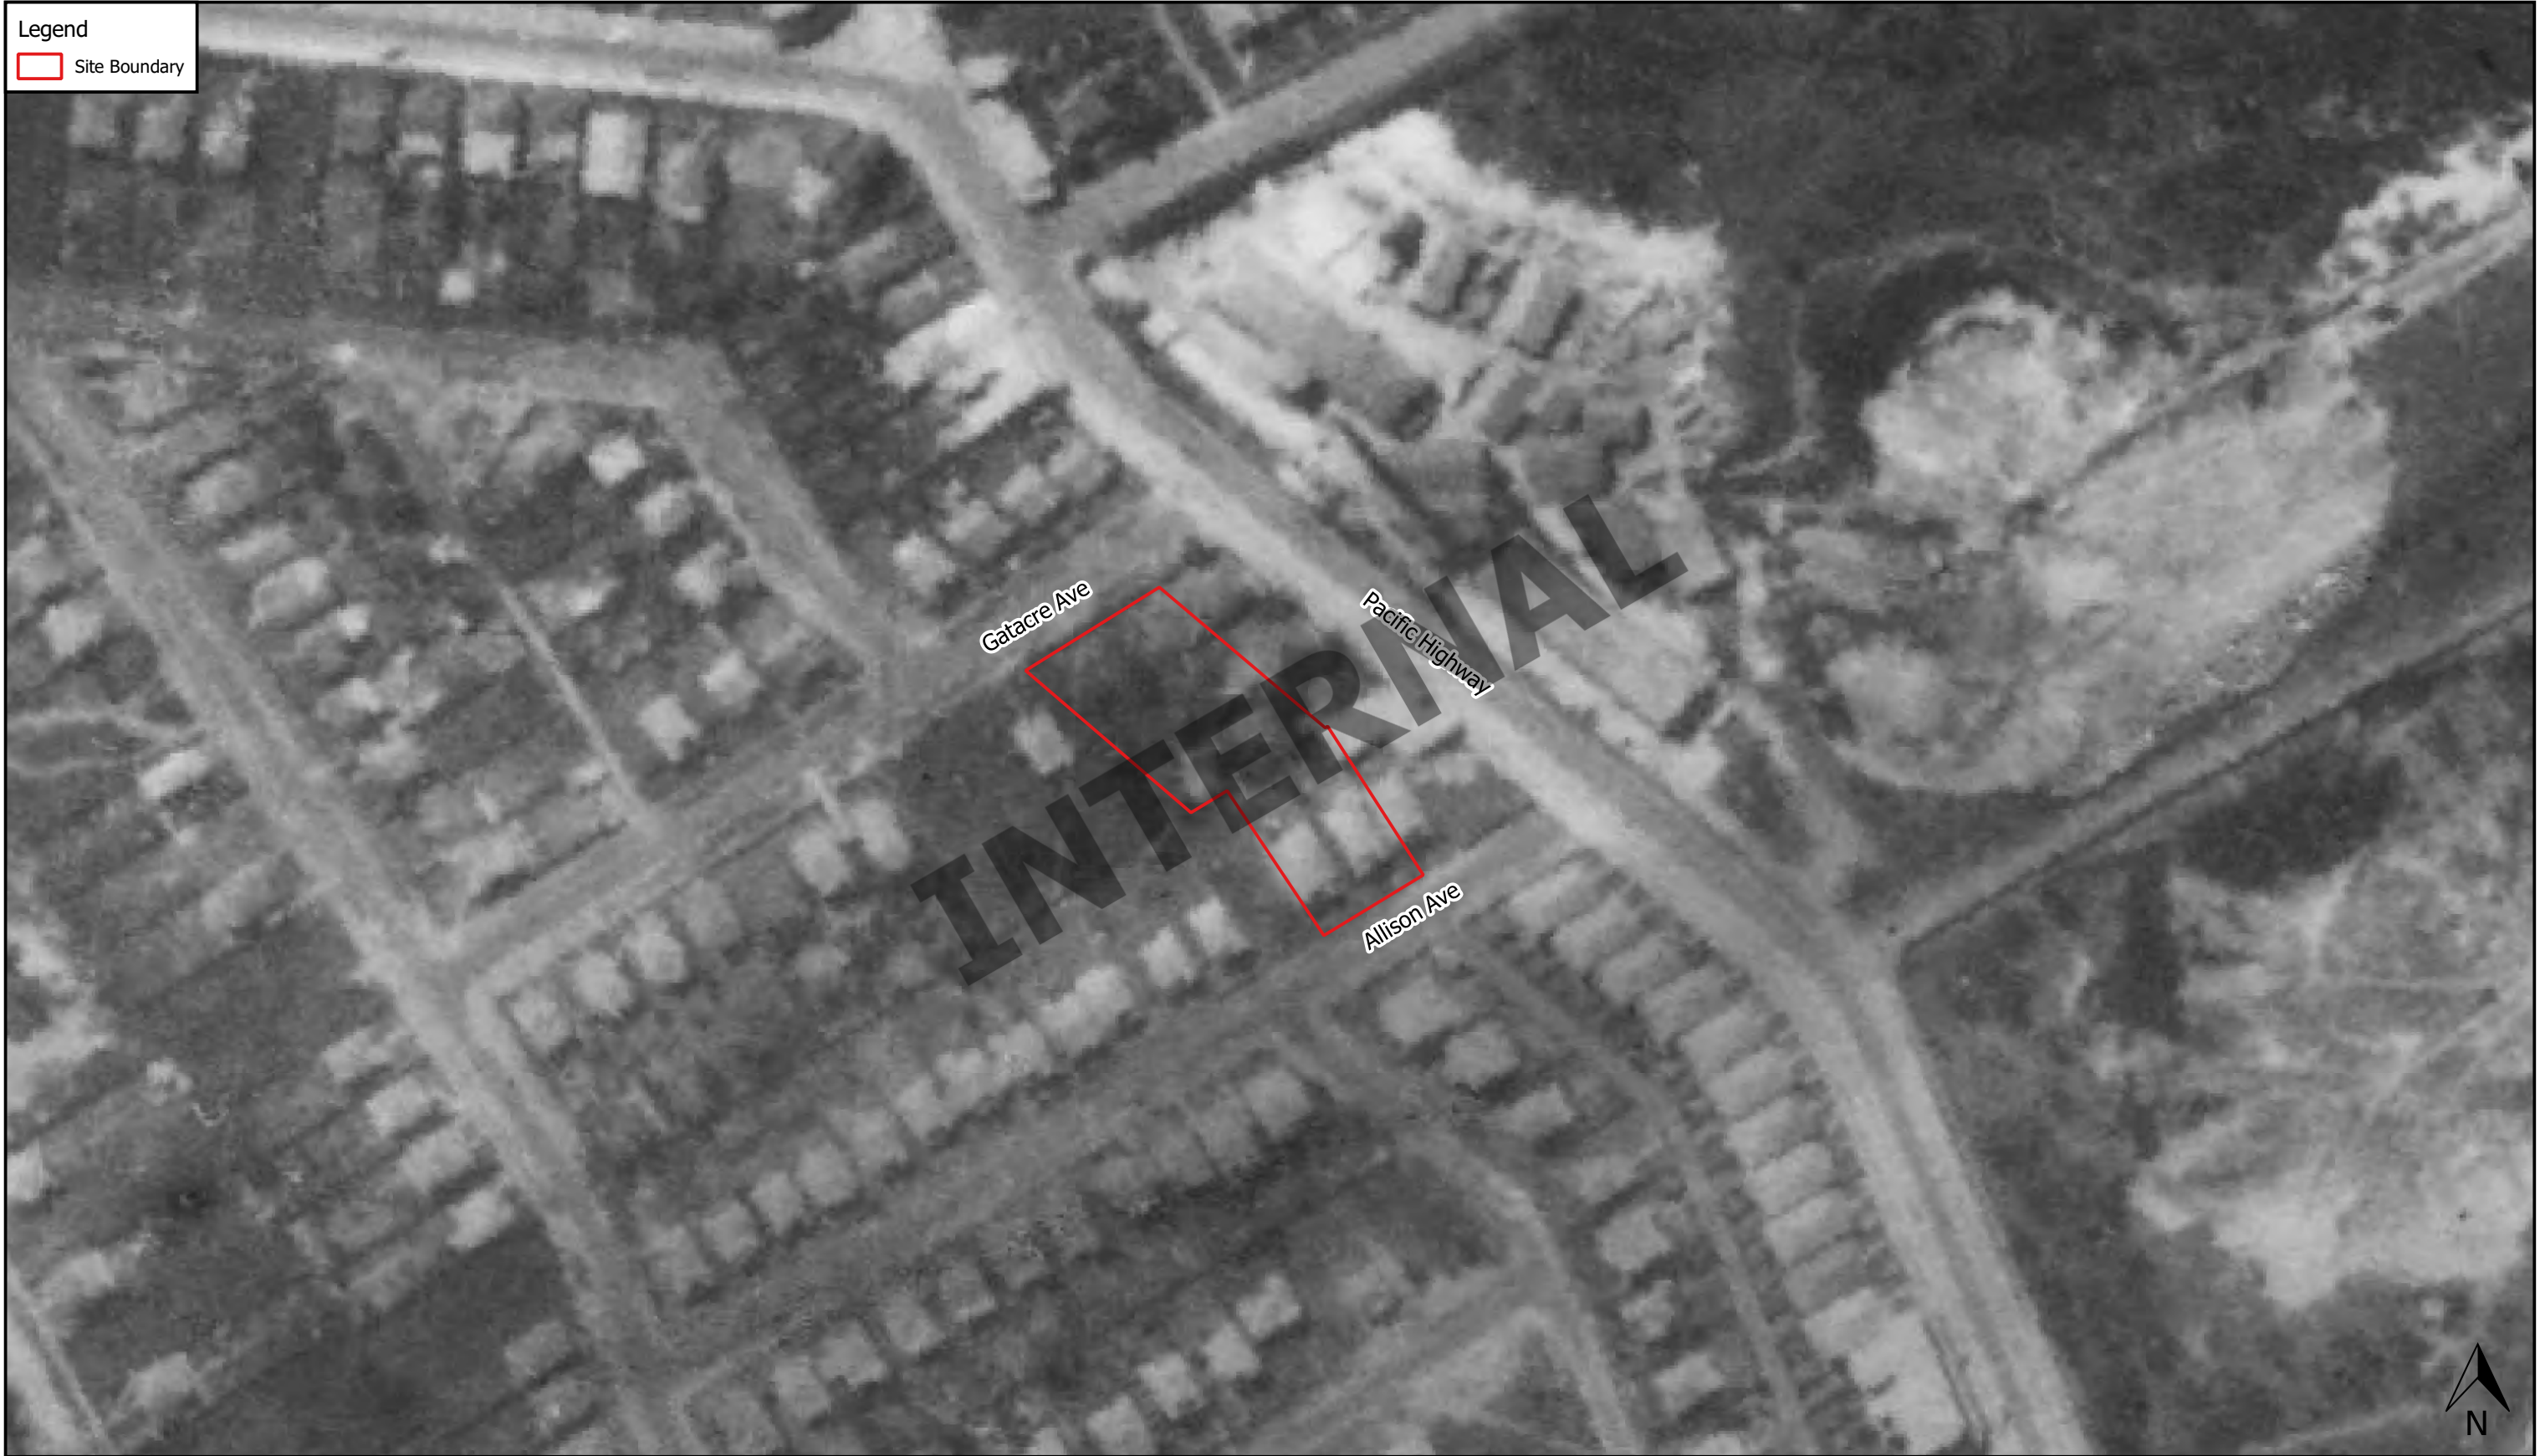
Map Title / Figure:
Aerial Photograph 1930

Year (Source)	Site Activity	Surrounding Land Use
1930 ¹	Residential dwellings observed at 1 Gatacre Avenue. Existing dwelling observed at 5 Allison Avenue.	Surrounding land consist of industrial buildings to the north east and low density residential in all other directions. Bulk earthworks observed to the east.
1951	Little to no change from previous.	Increase in low density residential dwellings to the north, west and south.
1978	Residential dwellings were demolished and existing motel development were observed.	Demolition of former commercial developments, and construction of existing commercial and industrial developments to the north east and east. High density residential developments constructed to the north and northwest. Petrol station constructed to the south east.
1983 ¹	Little to no change from previous.	Increase in commercial and industrial buildings to the east, otherwise little to no change from previous.

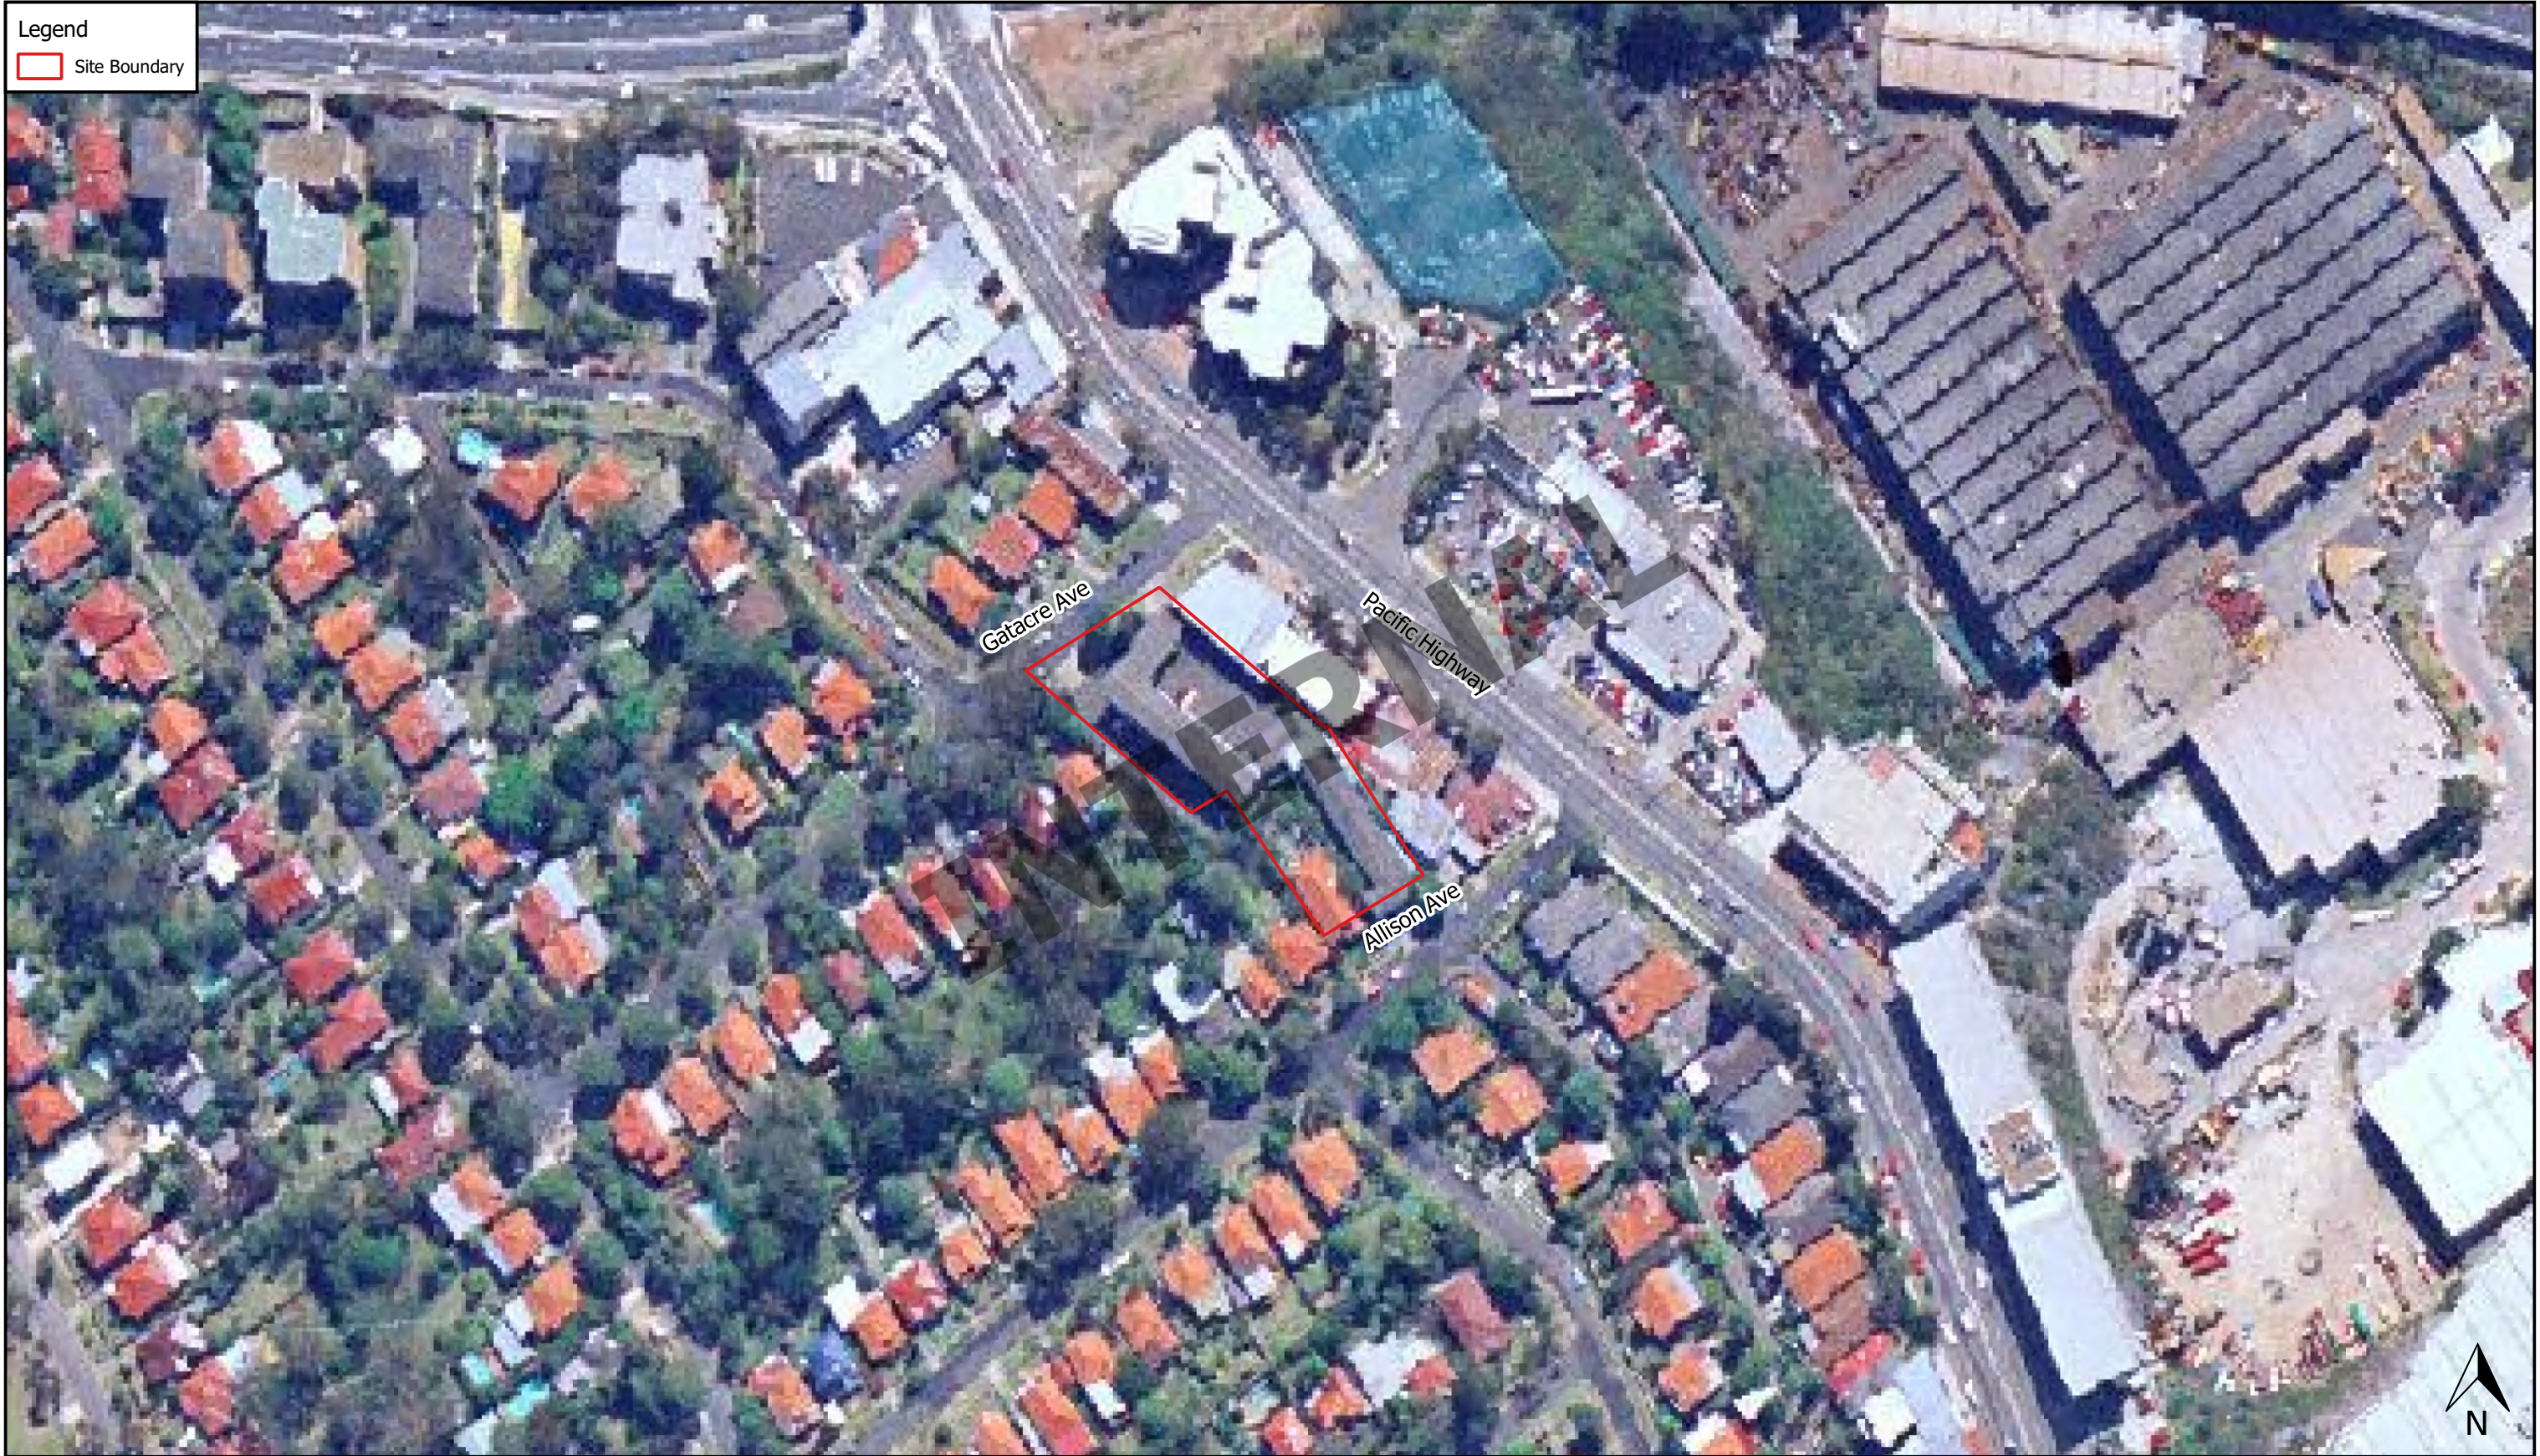
Map Title / Figure:
Aerial Photograph 1983

Map 05	Map
1 Gatacre Ave and 5 Allison Ave, Lane Cove, NSW	Site
Proposed Residential Development	Project
Preliminary Site Investigation	Sub-Project
WINIM Developments	Client
09/03/2021	Date

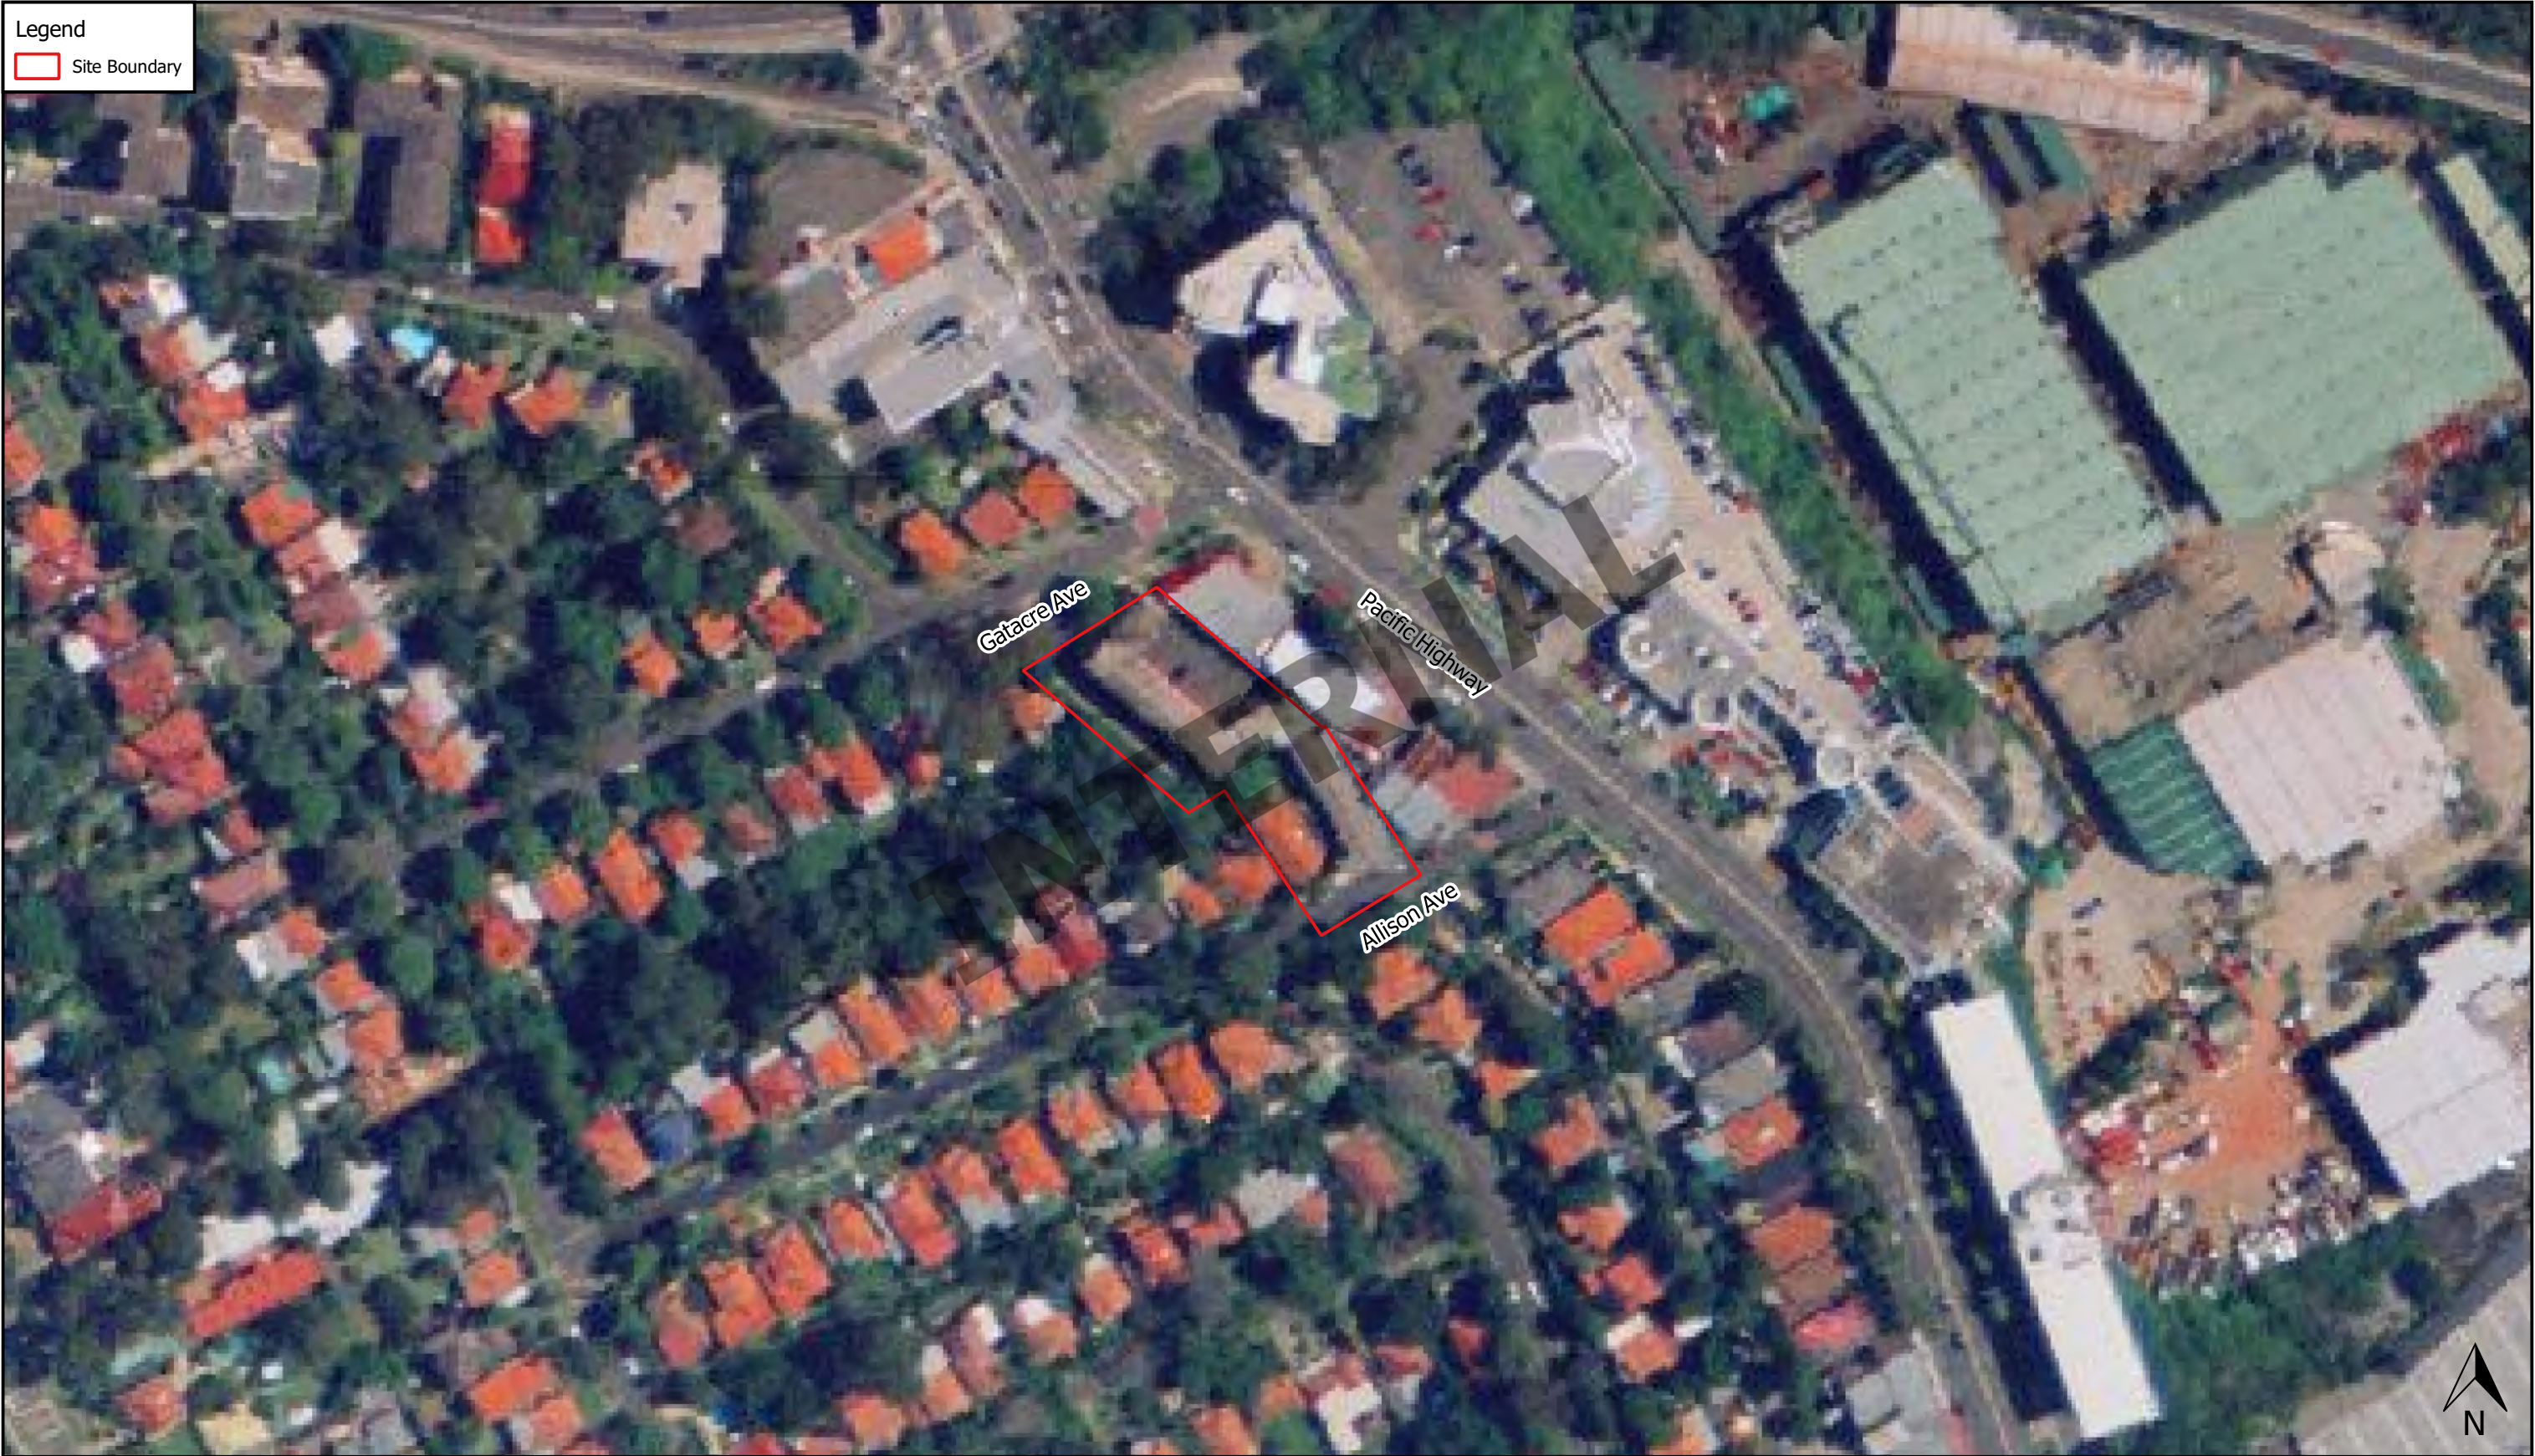
Aerial Photograph 1994

1994	Little to no change from previous.	Increase in commercial and industrial buildings to the east.
2002	Little to no change from previous.	Little to no change from previous.
2009	Little to no change from previous.	Increase in commercial and industrial buildings to the east.
2021	Little to no change from previous.	High density residential developments constructed to the north.
