# ARBORICULTURAL IMPACT ASSESSMENT

(EASEMENT ALIGNMENT TO BENT STREET)

3 & 3a Beaconsfield Parade,  
Lindfield NSW

Prepared 06 April 2025  
Our Ref: 2425114.3

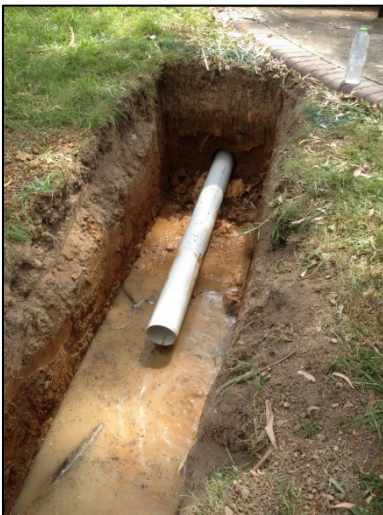
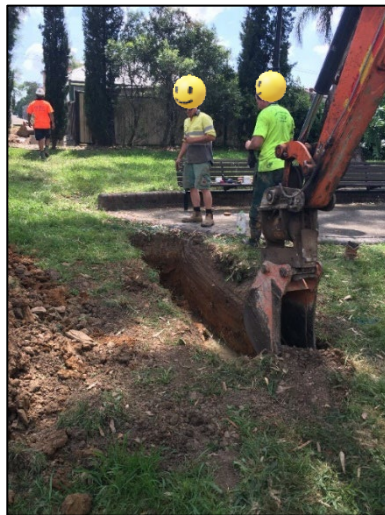
*“All services should be routed outside the TPZ. If underground services must be routed within the TPZ, they should be installed by directional drilling or in manually excavated trenches.*

*The directional drilling bore should be at least 600 mm deep. The project arborist should assess the likely impacts of boring and bore pits on retained trees.*

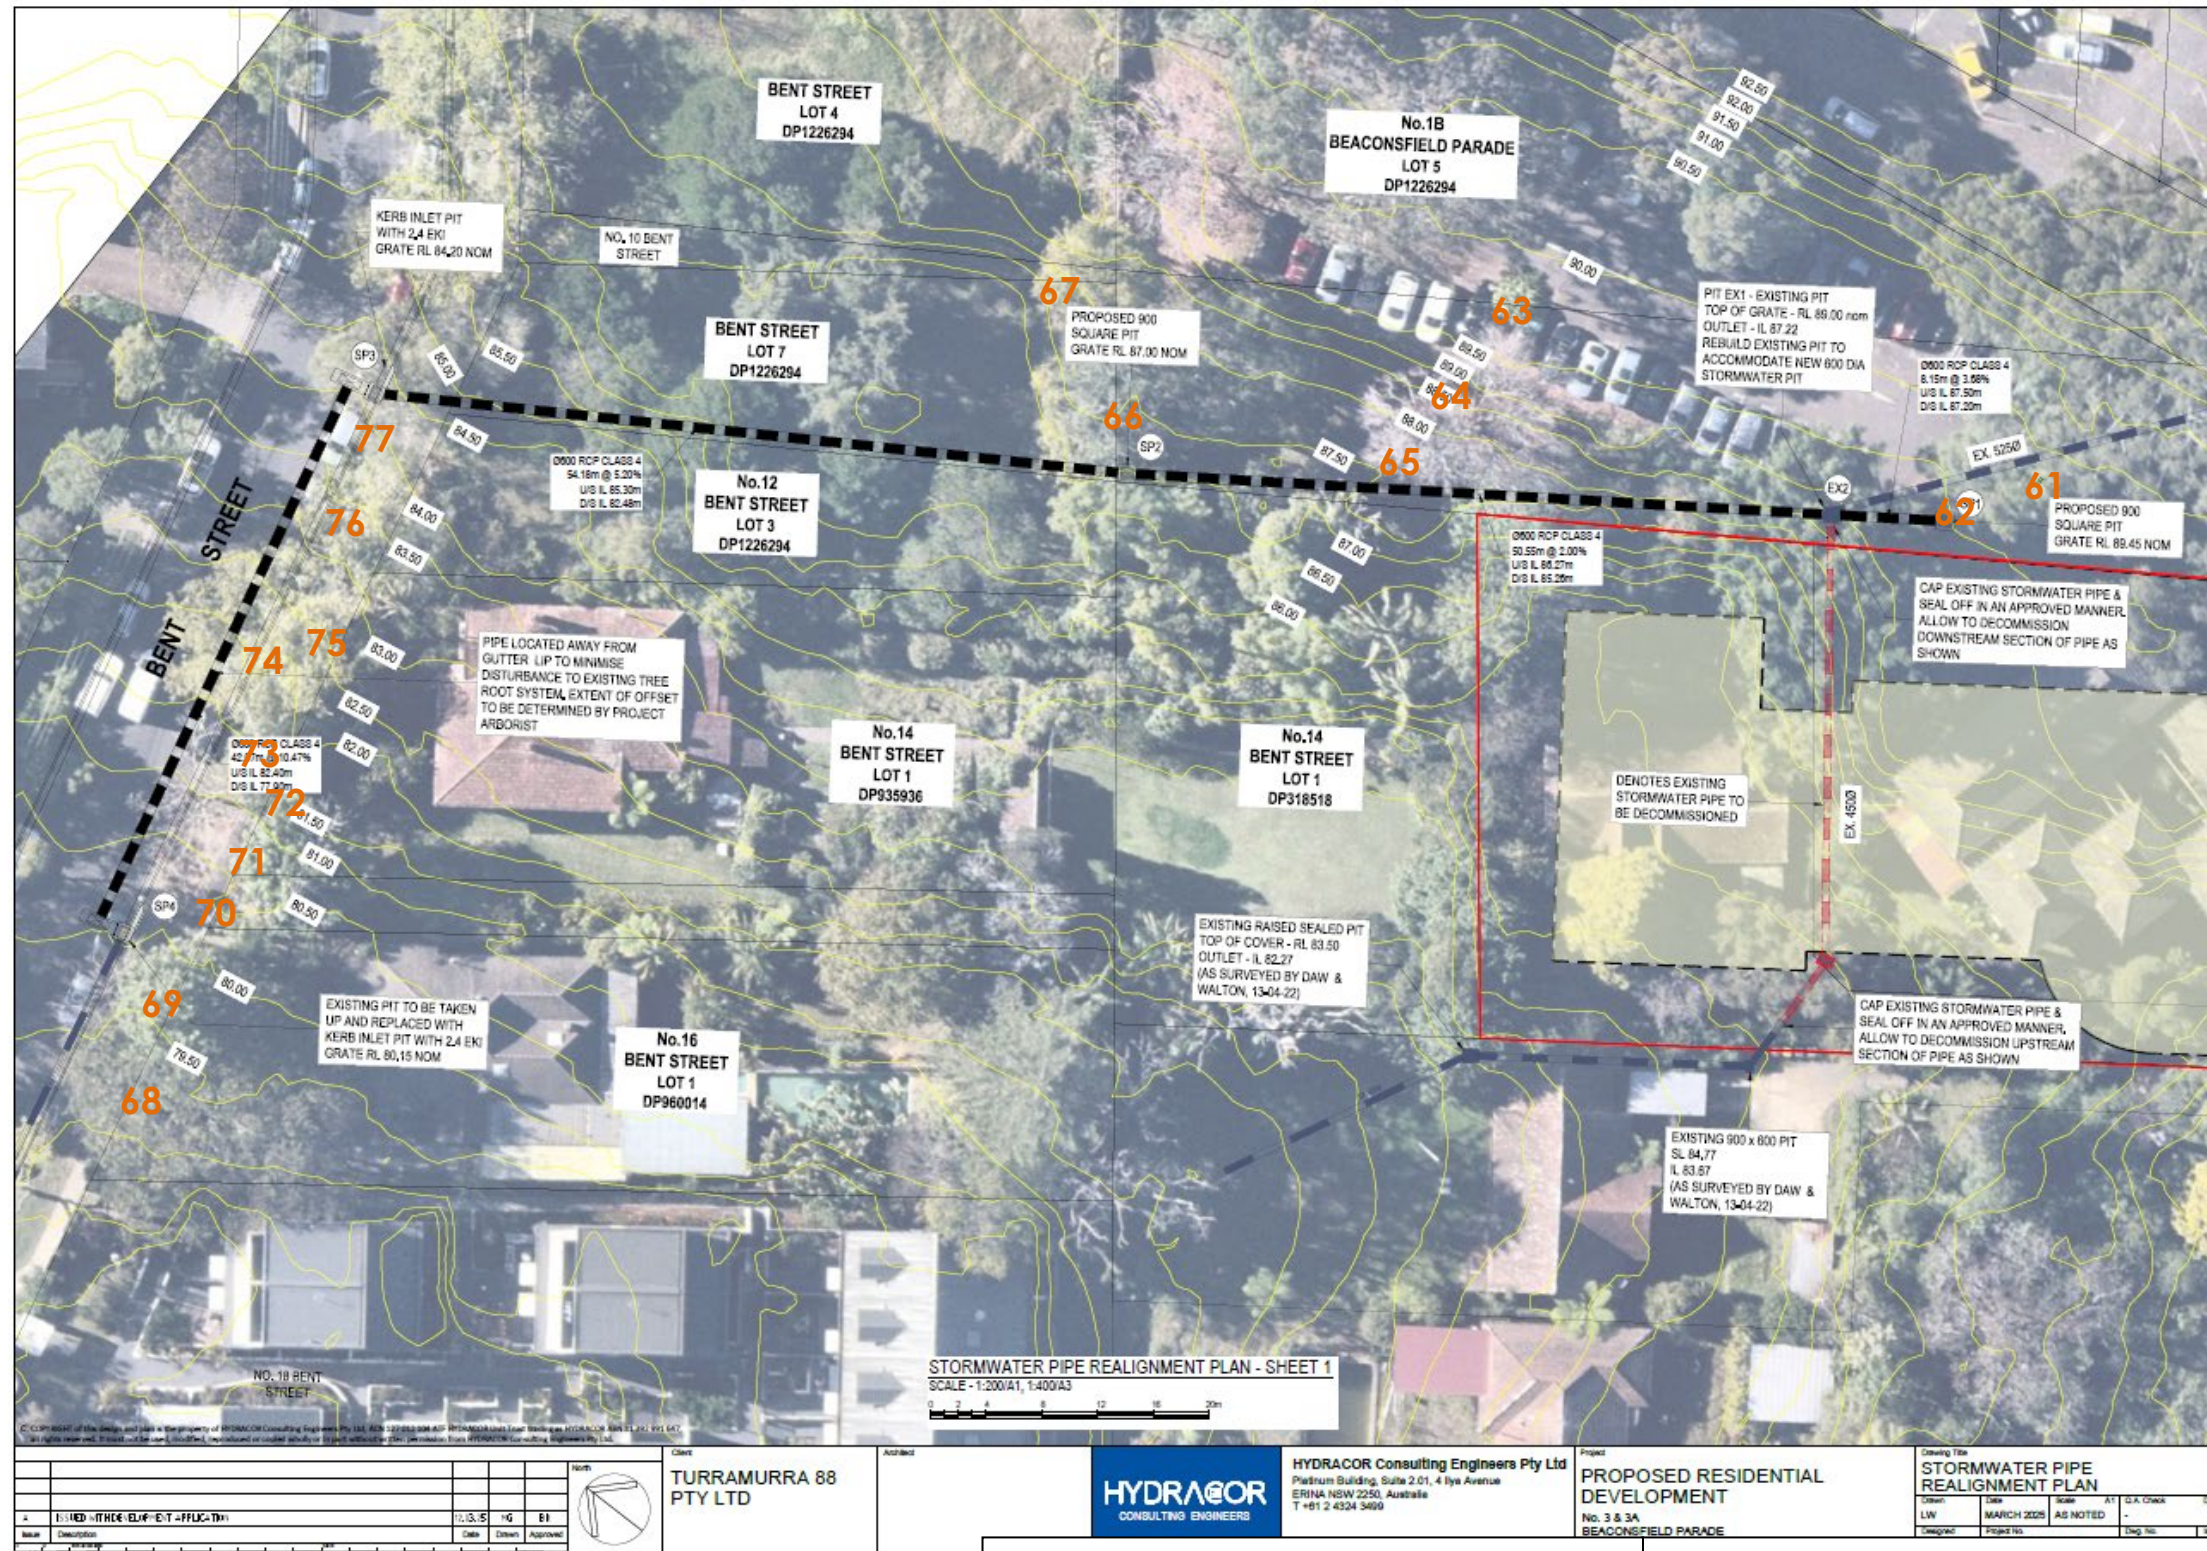
Plan reproduced by email and further reduced by electronic scanning and no longer to original scale. For other tree protection measures see sections 5.0 and 7.0.

All Tree Protection Zones are to be measured on site.
