## **GEOTECHNICAL INVESTIGATION REPORT**

2-10 Berry Road, 14-16 Marshall Avenue and  
5-9 Holdsworth Avenue, St Leonards NSW 2065

DASCO Property Development Services Pty Ltd

27 May 2025

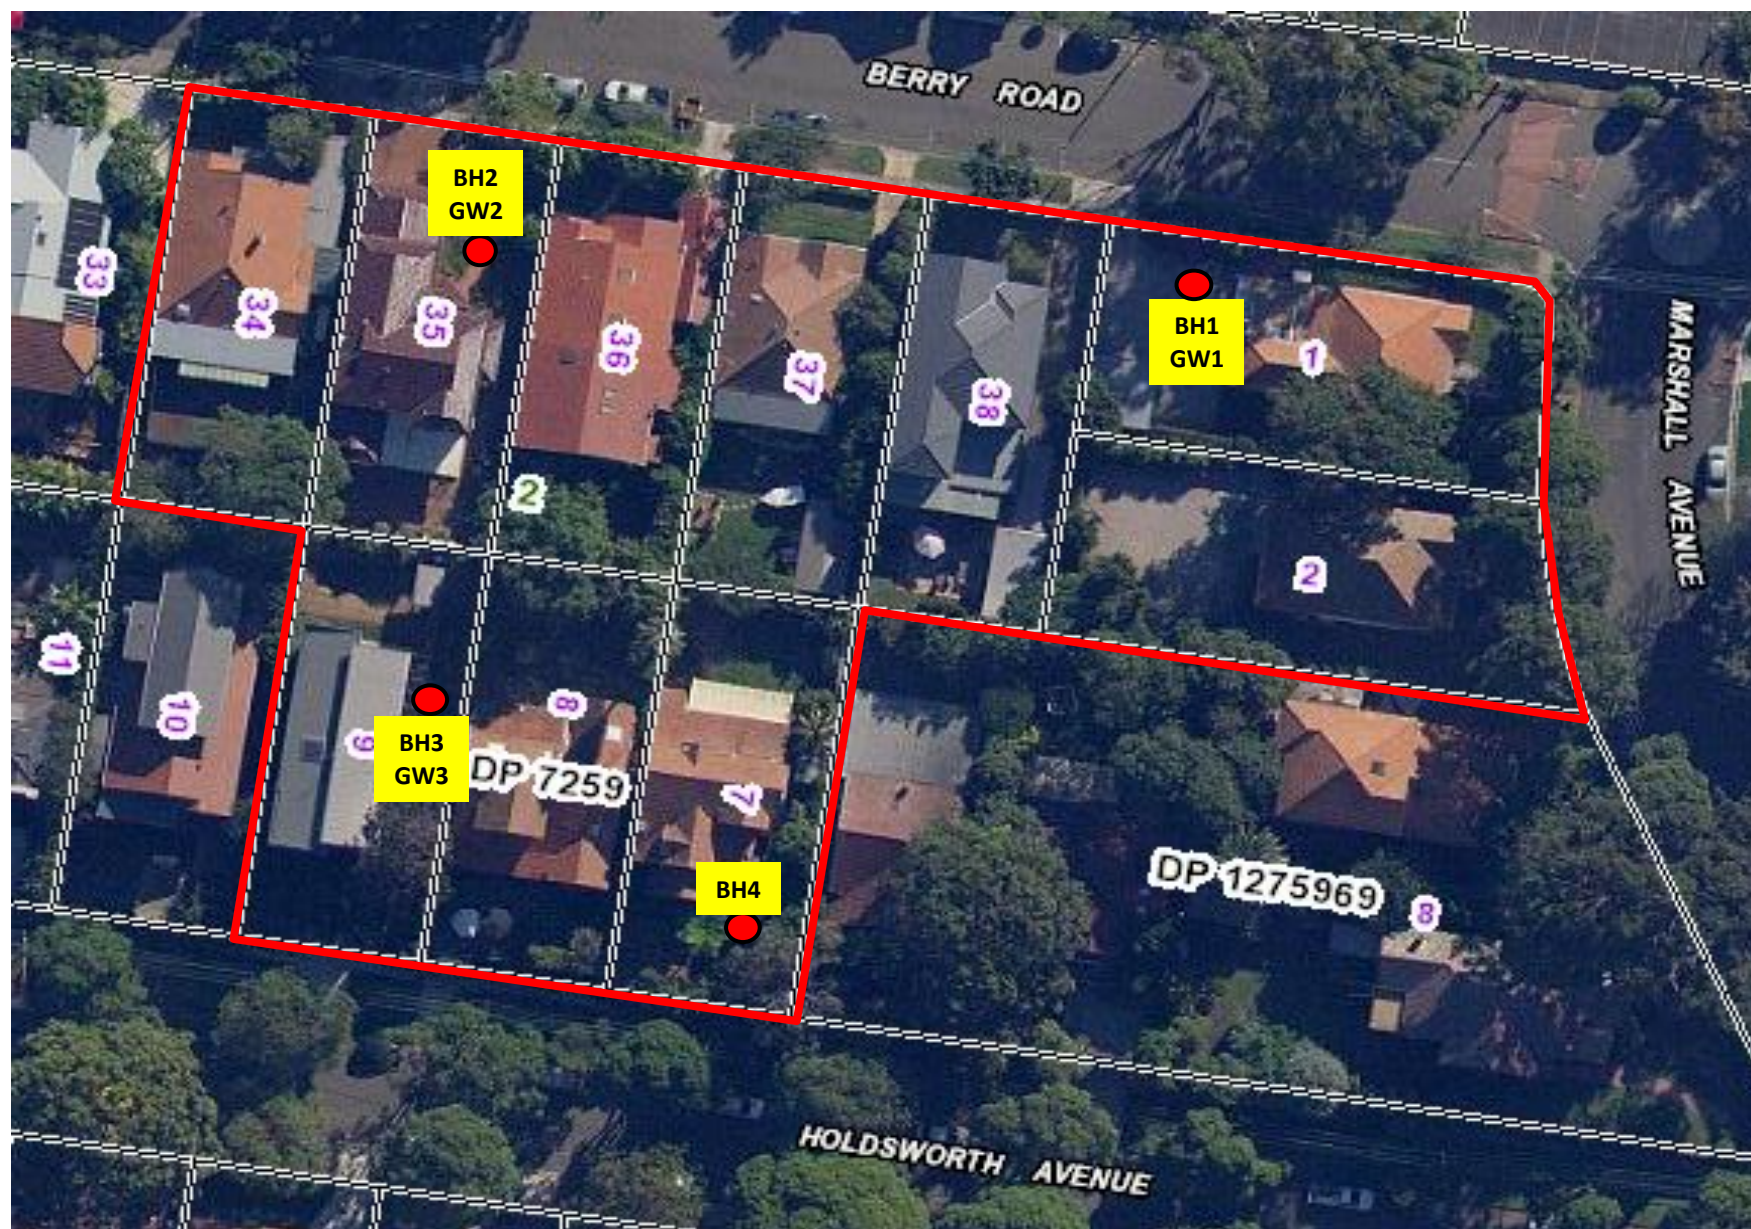
## Site Plan

● Approximate Test Locations

- Preparation of a Safe Work Method Statement (SWMS) tailored to the site conditions.
- Review of Before You Dig Australia (BYDA) plans and service locating.
- Mechanical drilling of four boreholes identified as boreholes BH1 to BH4.
- Standard Penetration Testing (SPT) within the augering of the boreholes.
- Installation of three groundwater wells identified as GW1 to GW3 within the boreholes BH1 to BH3, respectively.
- Subsequent field visit to the site to measure the standing groundwater level.
- Conduct following laboratory testing on the recovered soil and rock samples:
  - Point Load Index (PLI) tests.
  - Aggressivity and Salinity tests.

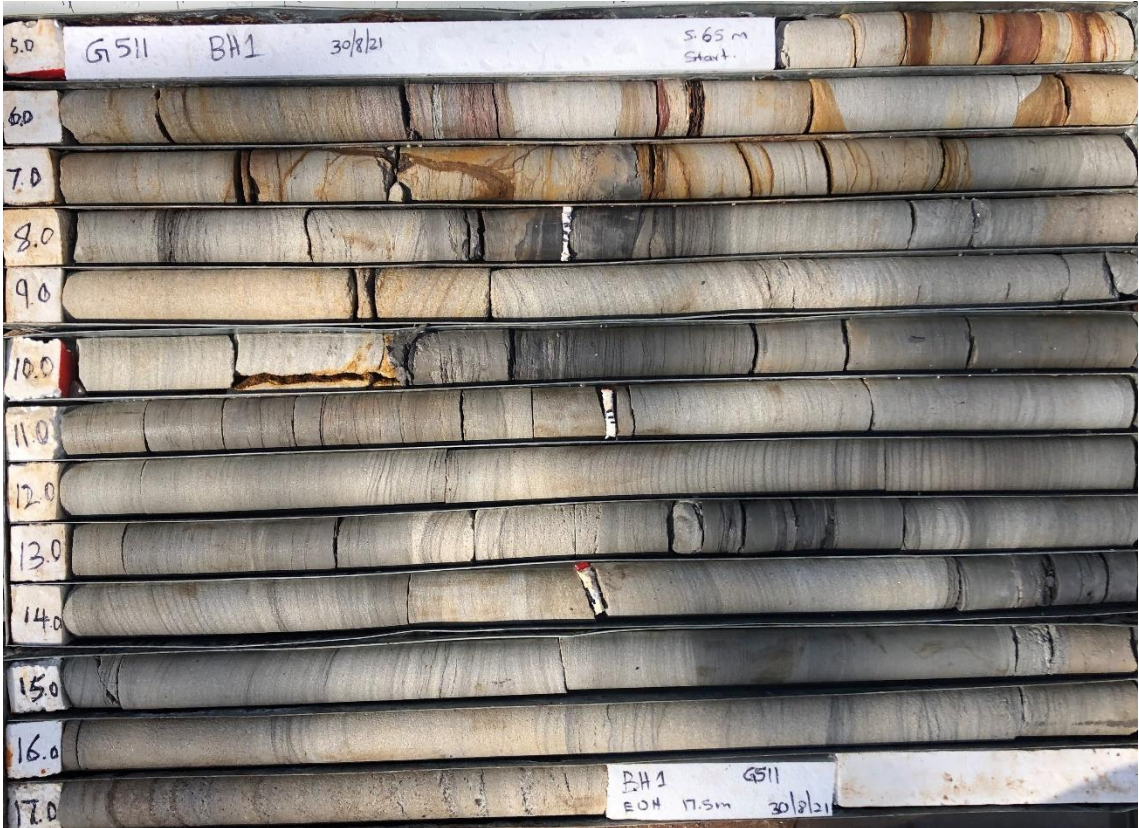
| Borehole | Drilled Date | Start Depth (m) | End Depth (m) |
|---|---|---|---|
| BH1 | 30/08/2021 | 5.65 | 17.75 |

| Borehole | Drilled Date | Start Depth (m) | End Depth (m) |

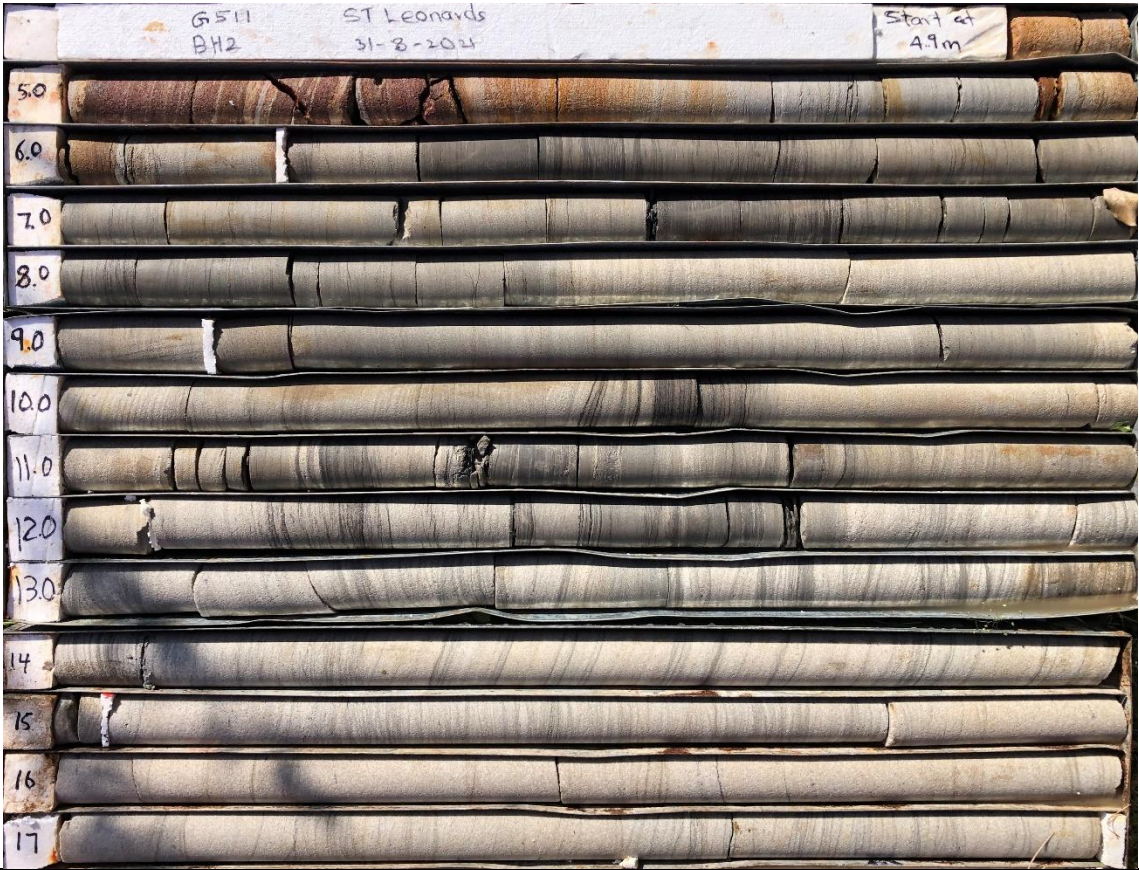
| Borehole | Drilled Date | Start Depth (m) | End Depth (m) |
|---|---|---|---|
| BH2 | 31/08/2021 | 4.90 | 17.98 |

| Borehole | Drilled Date | Start Depth (m) | End Depth (m) |

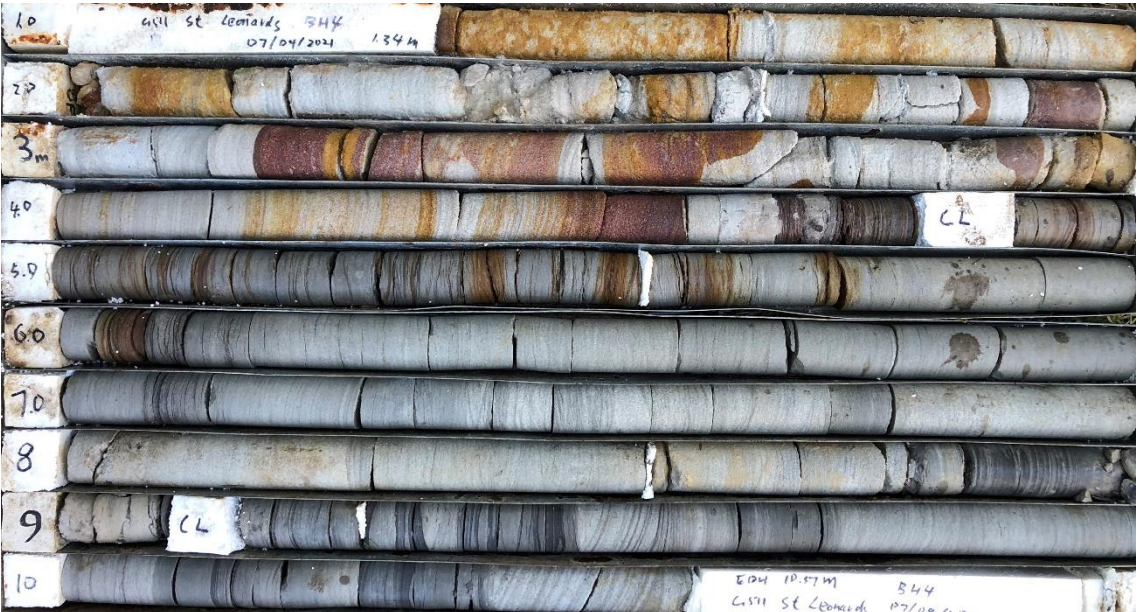
| Borehole | Drilled Date | Start Depth (m) | End Depth (m) |
|---|---|---|---|
| BH4 | 7/09/2021 | 1.34 | 10.57 |

| Borehole | Drilled Date | Start Depth (m) | End Depth (m) |
