24 July 2025
Ref. GR1558.1J

**Letter Support for Drained Basement
Proposed Affordable Housing Units
14-16 Marshall Avenue, 2-10 Berry Road & 5-9 Holdsworth Avenue Street, St
Leonard, NSW**

HYDROGEOLOGICAL INVESTIGATION REPORT

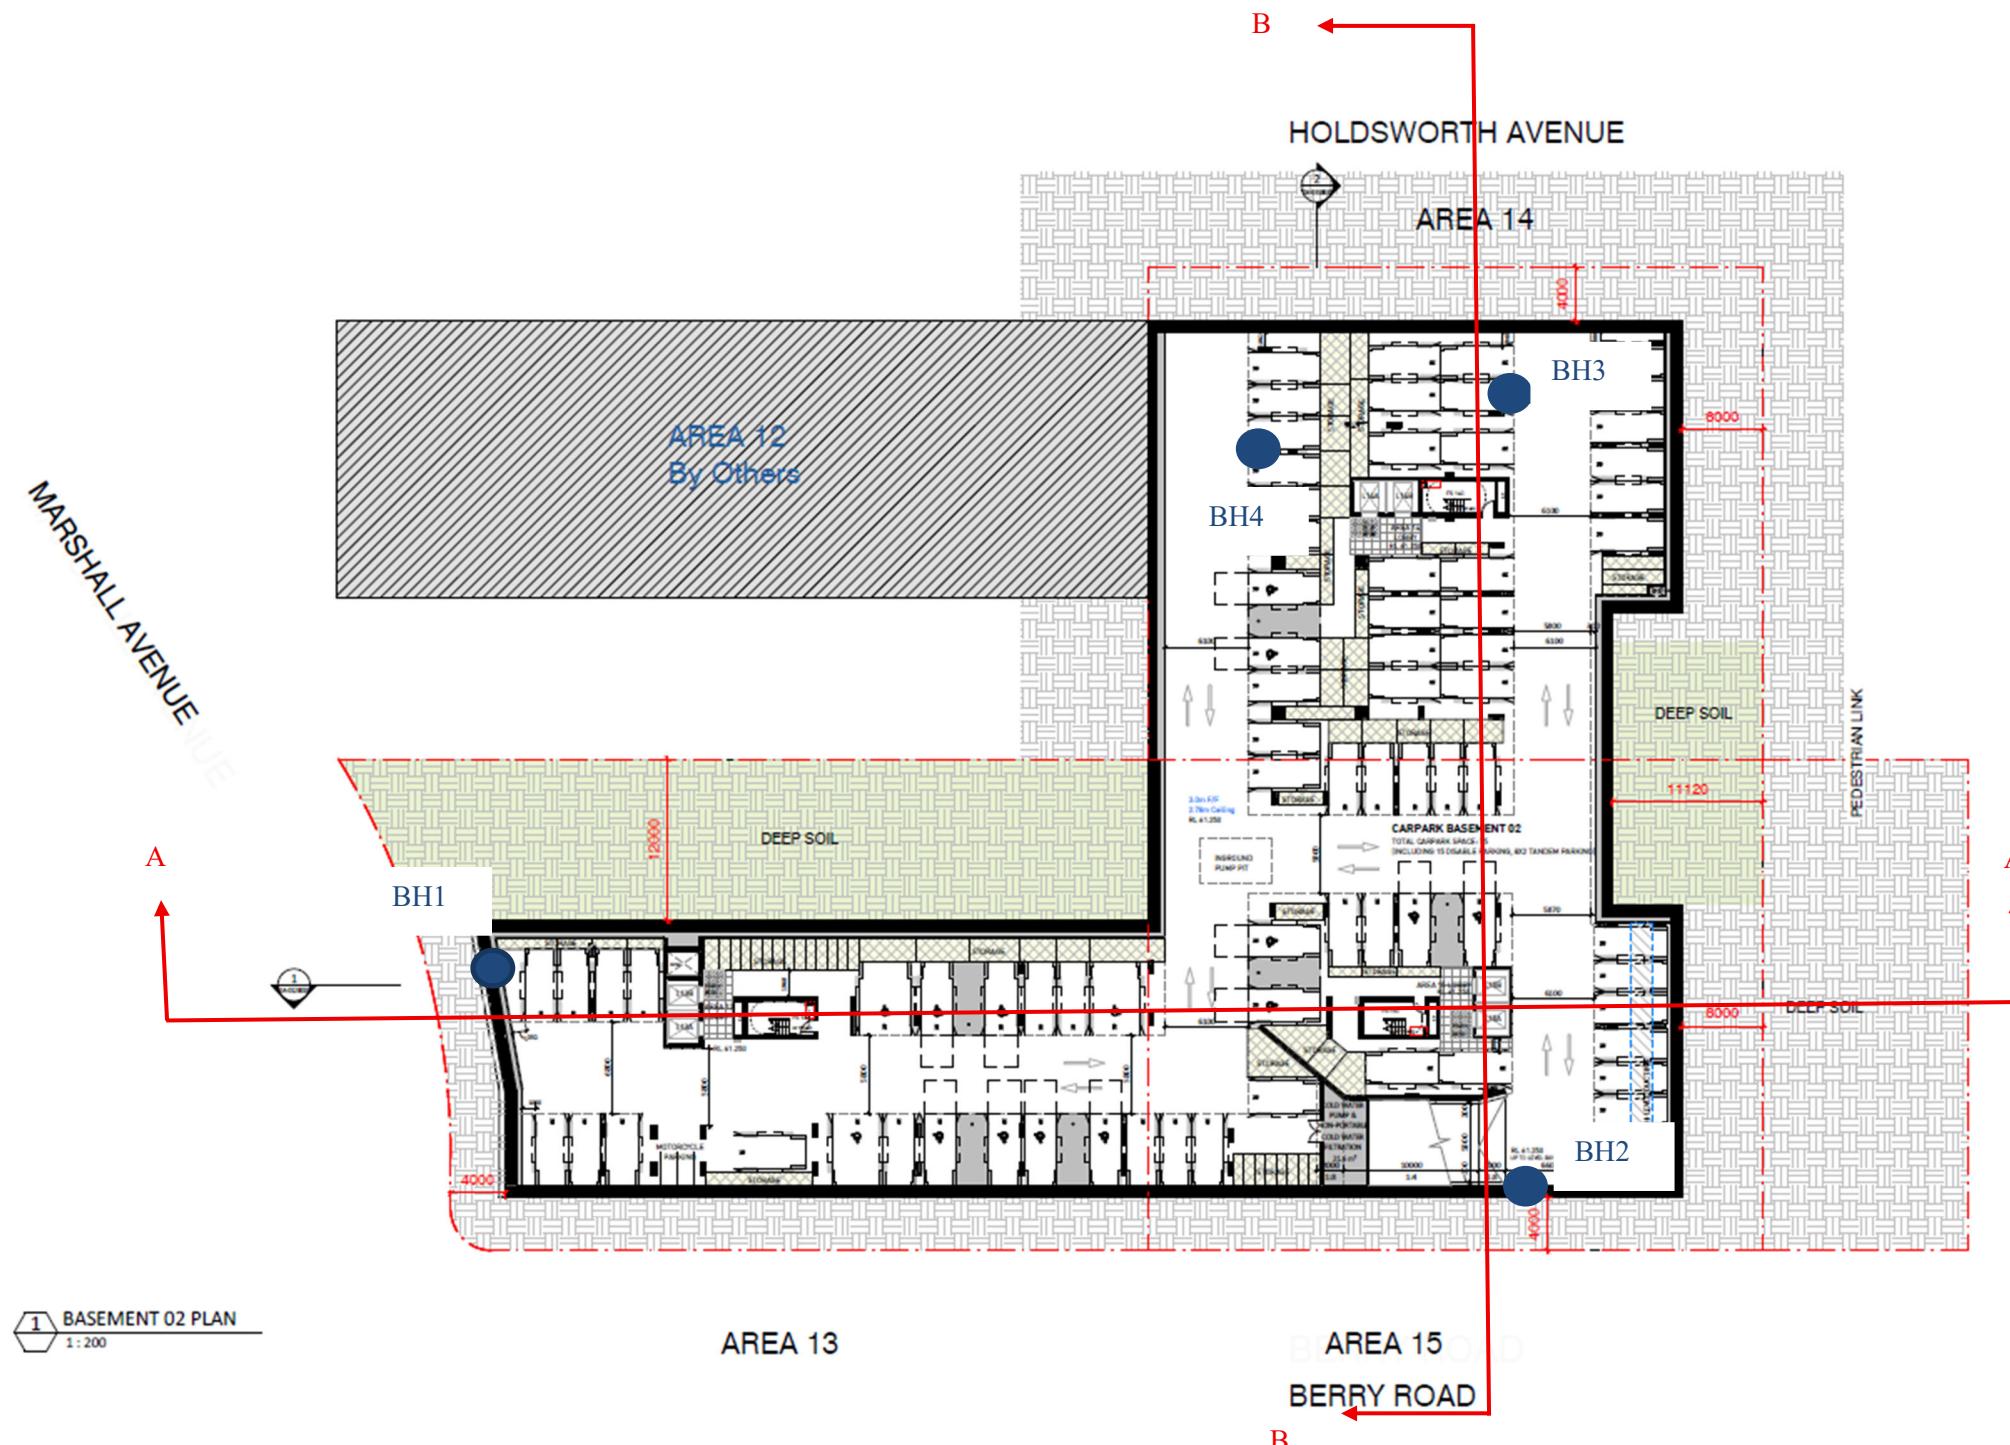
Location of Cross Section

For the purpose of this assessment, the subsurface conditions used in the analysis were based on data obtained from the FES 2023 geotechnical investigation. Due to the irregular geometry of the building, two geotechnical models were developed using representative cross-sections to adequately capture variations in subsurface conditions. Section A–A was derived from borehole BH1, while Section B–B was based on borehole BH3, selected to represent the worst-case scenario in terms of soil stratigraphy and groundwater conditions. The adopted geotechnical models (one is illustrated in Figure 2) were used in the seepage analysis to predict the expected groundwater inflow rates. The locations of the sections are shown in the attached Figure 1.

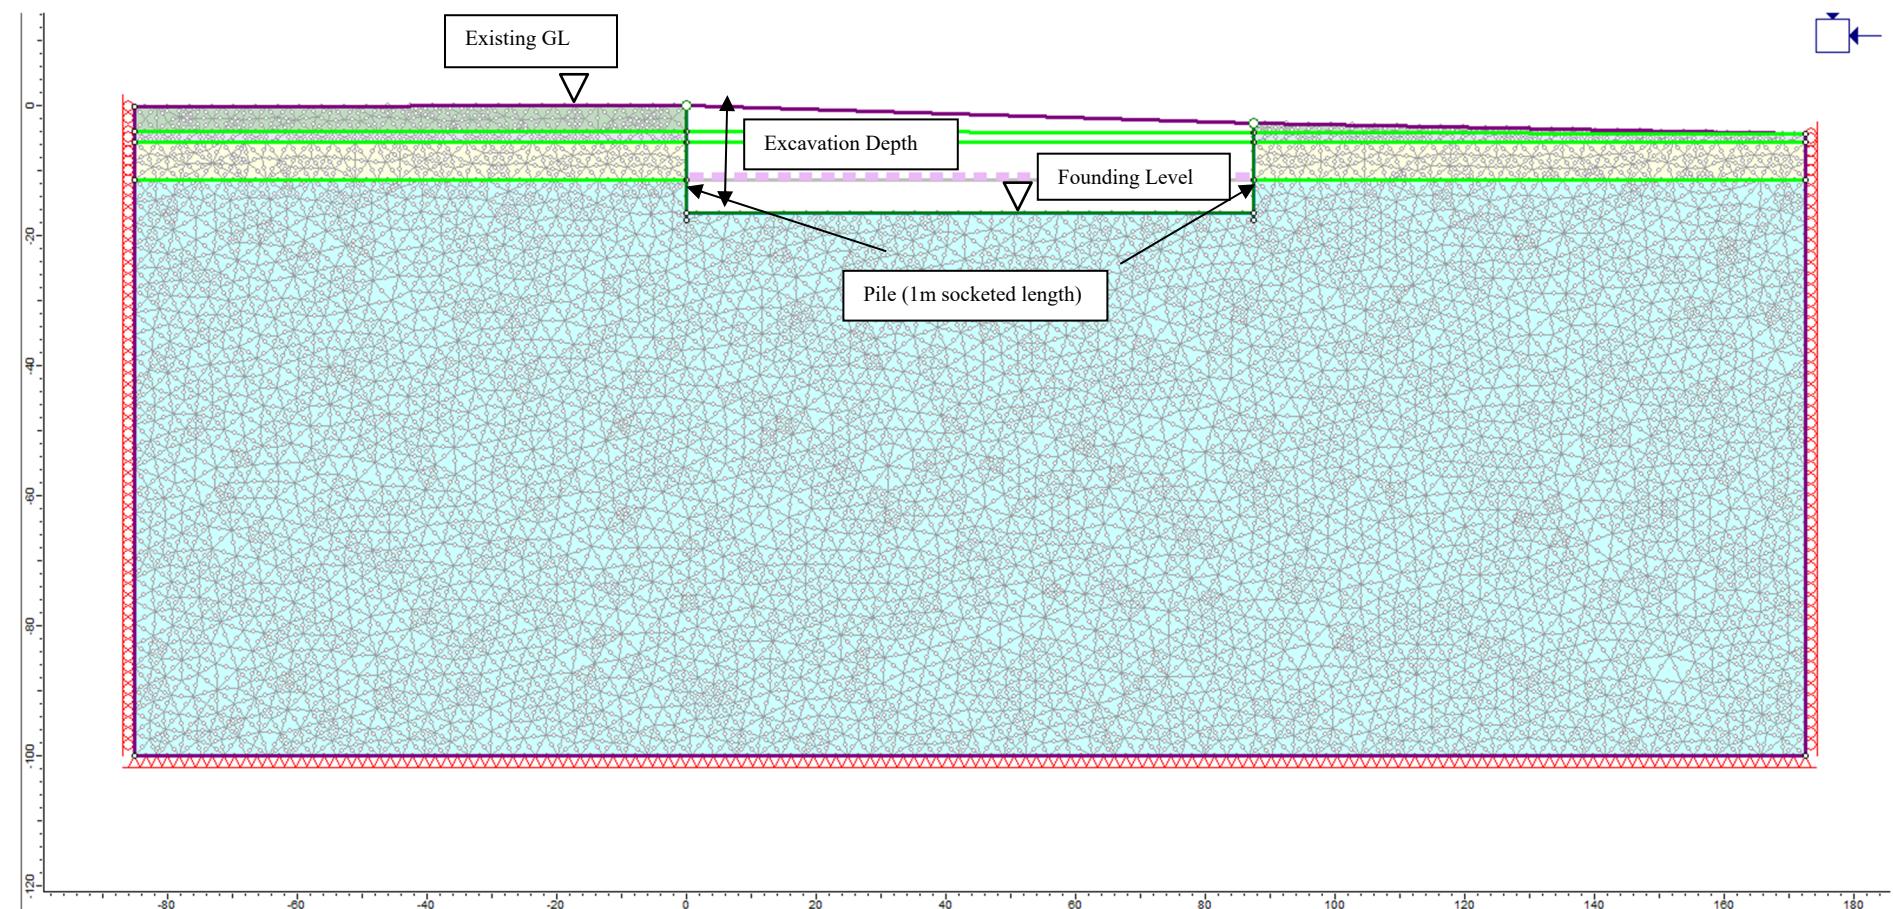
Geotechnics	Figure	2
Checked	JC			Title	Section A-A – Ground Model
Date	22/08/2025			Job No.	GM1558.1J
Scale	NTS

Material Name	Material colour	Initial Element Loading	Unit weight (kN/m ³)	Porosity Value	Initial Water Condition	Initial Pore water pressure (kPa)	Elastic Type	Young's Modulus (kPa)	Failure Criterion	Material Type	Peak Tensile Strength	Peak Friction Angle (degrees)	Peak cohesion (kPa)	Use Unsaturated Parameters	Material Behavior	K _s (m/s)	K ₂ / K ₁ (m/s)	K ₁ angle (degrees)	Soil Type
FILL/ RESIDUAL SOIL		Field stress and Body Force	23	0.5	Pore water Pressure	1	Isotropic	20000	Mohr-Coulomb	Elastic	0	35	10	No	Drained	1.0E-06	0.5	0	General
CLASS V SANDSTONE		Field stress and Body Force	20	0.5	Pore water Pressure	1	Isotropic	20000	Mohr-Coulomb	Elastic	0	29	10	No	Drained	1.0E-07	0.5	0	General
CLASS IV SANDSTONE		Field stress and Body Force	23	0.5	Pore water Pressure	1	Isotropic	50000	Mohr-Coulomb	Elastic	0	30	30	No	Drained	1.0E-07	0.5	0	General
CLASS III SANDSTONE		Field stress and Body Force	24	0.5	Pore water Pressure	1	Isotropic	80000	Mohr-Coulomb	Elastic	0	35	150	No	Drained	1.0E-08	0.5	0	General

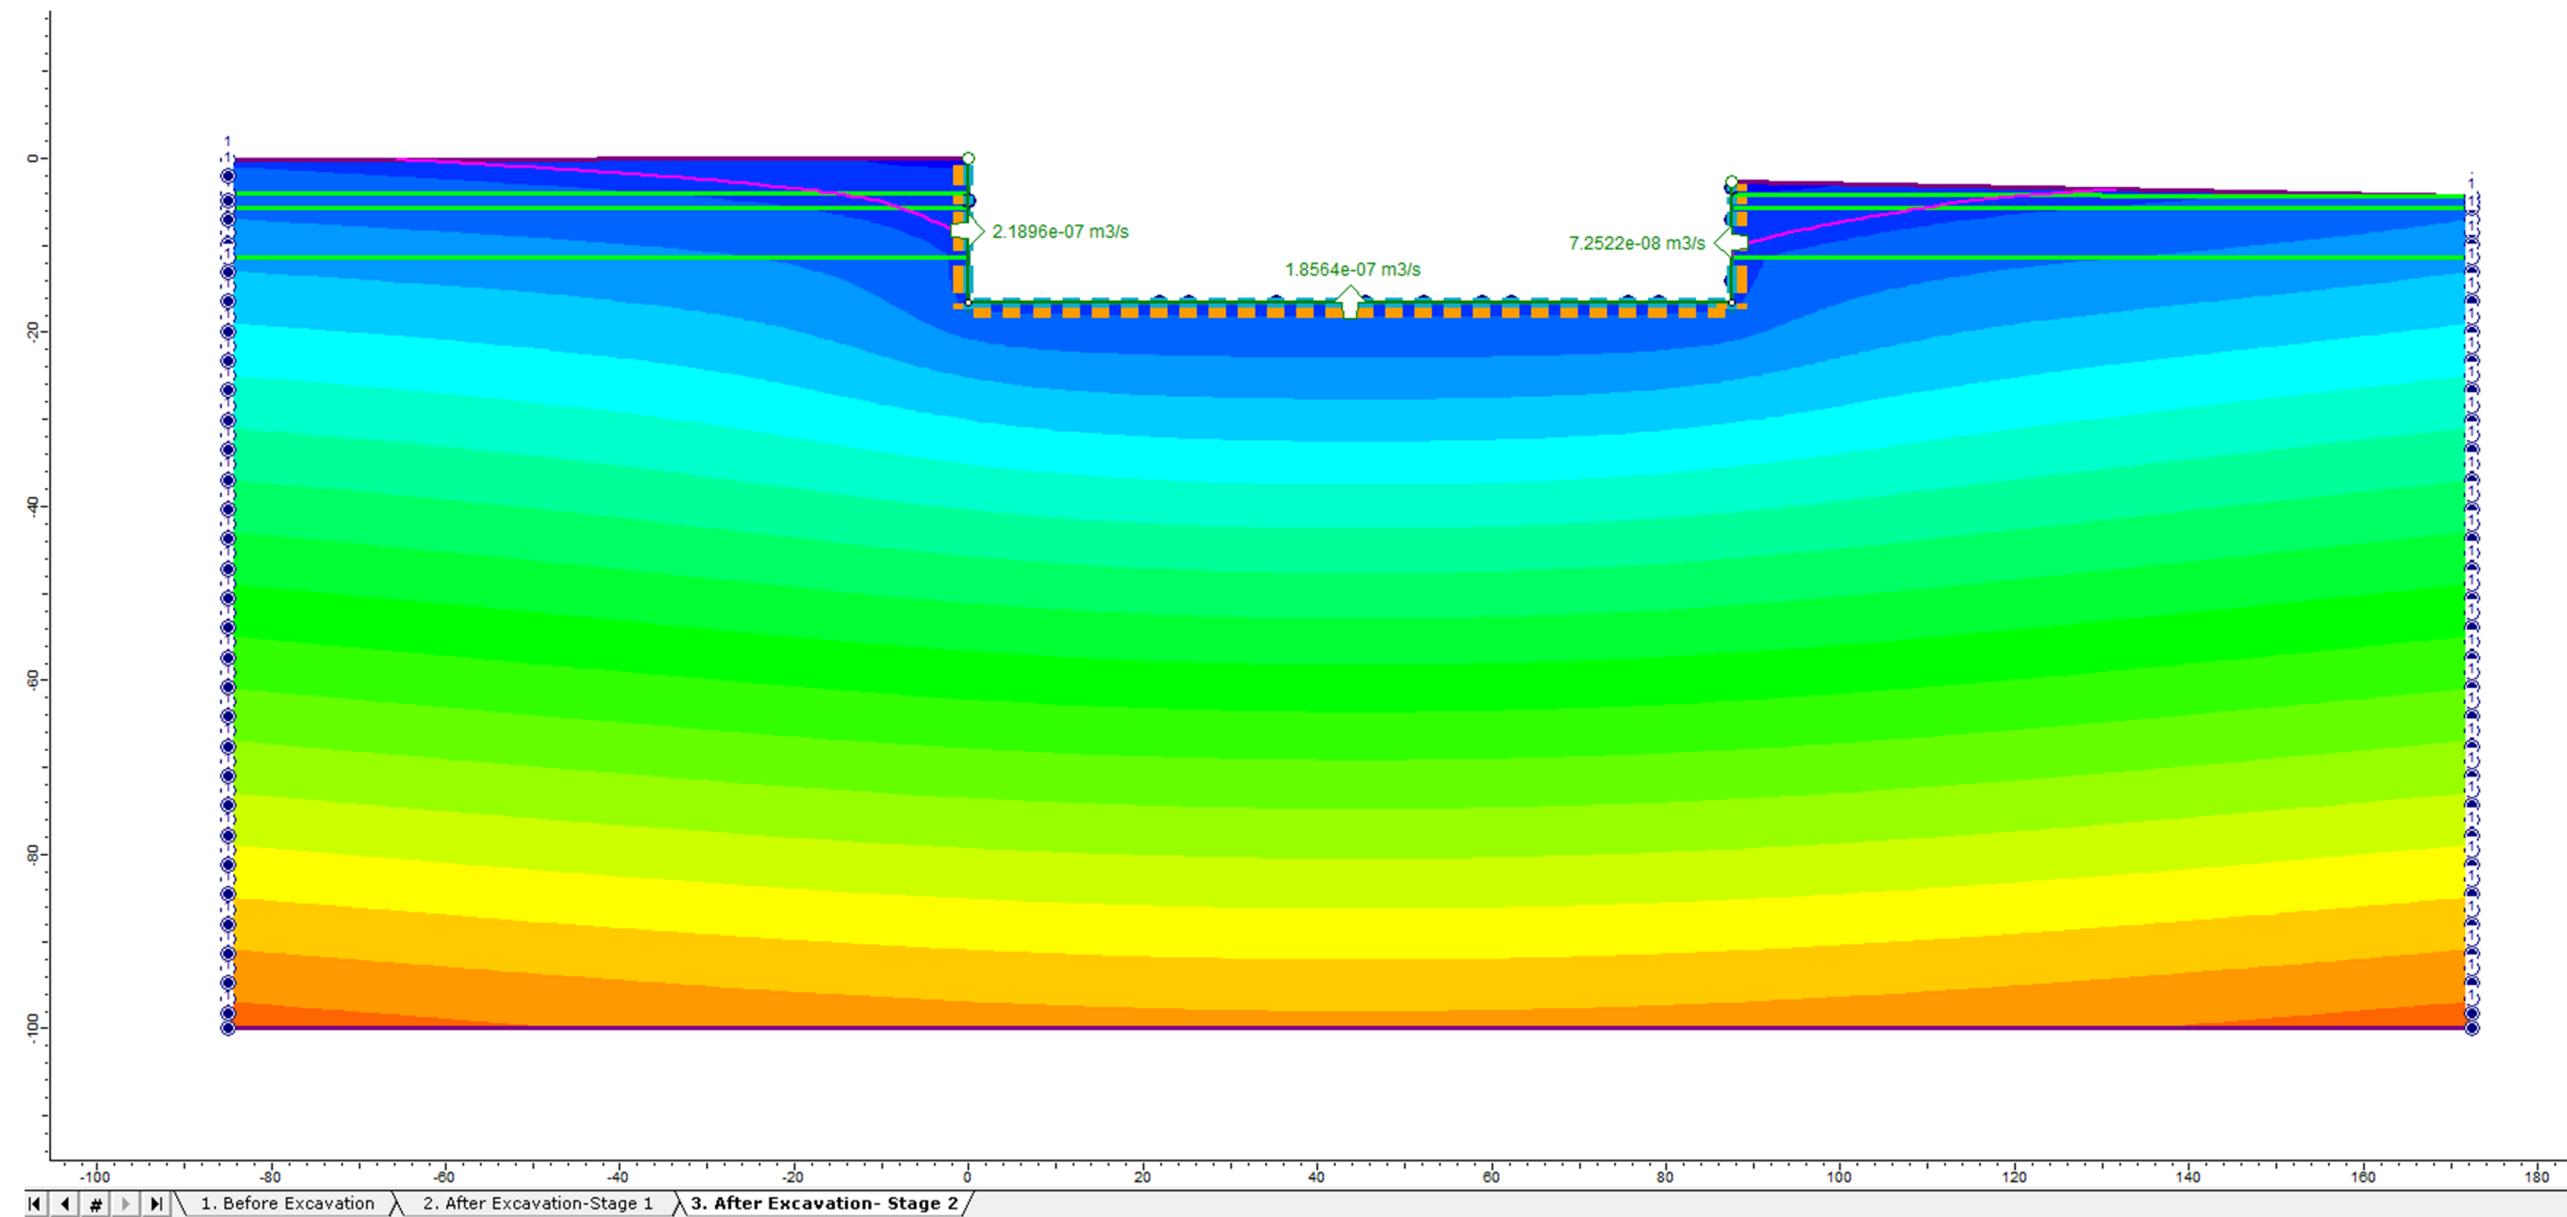
Seepage Analysis Result

Drawn	YS	Groundwater Seepage Analysis Proposed Affordable Housing Units 14-16 Marshall Avenue, 2-10 Berry Road & 5-9 Holdsworth Avenue Street, St Leonard, NSW, 2065	Figure	3
Checked	JC			
Date	22/08/2025		Title	Section A-A – Results
Scale	NTS		Job No.	GM1558.1J

Seepage volumes are minimal, with pump testing showing approximately 7,720 L/day during construction and around 7,220 L/day in long-term operation. These flows are well within the capacity of a standard drained basement system and are below the 3 ML/year threshold.

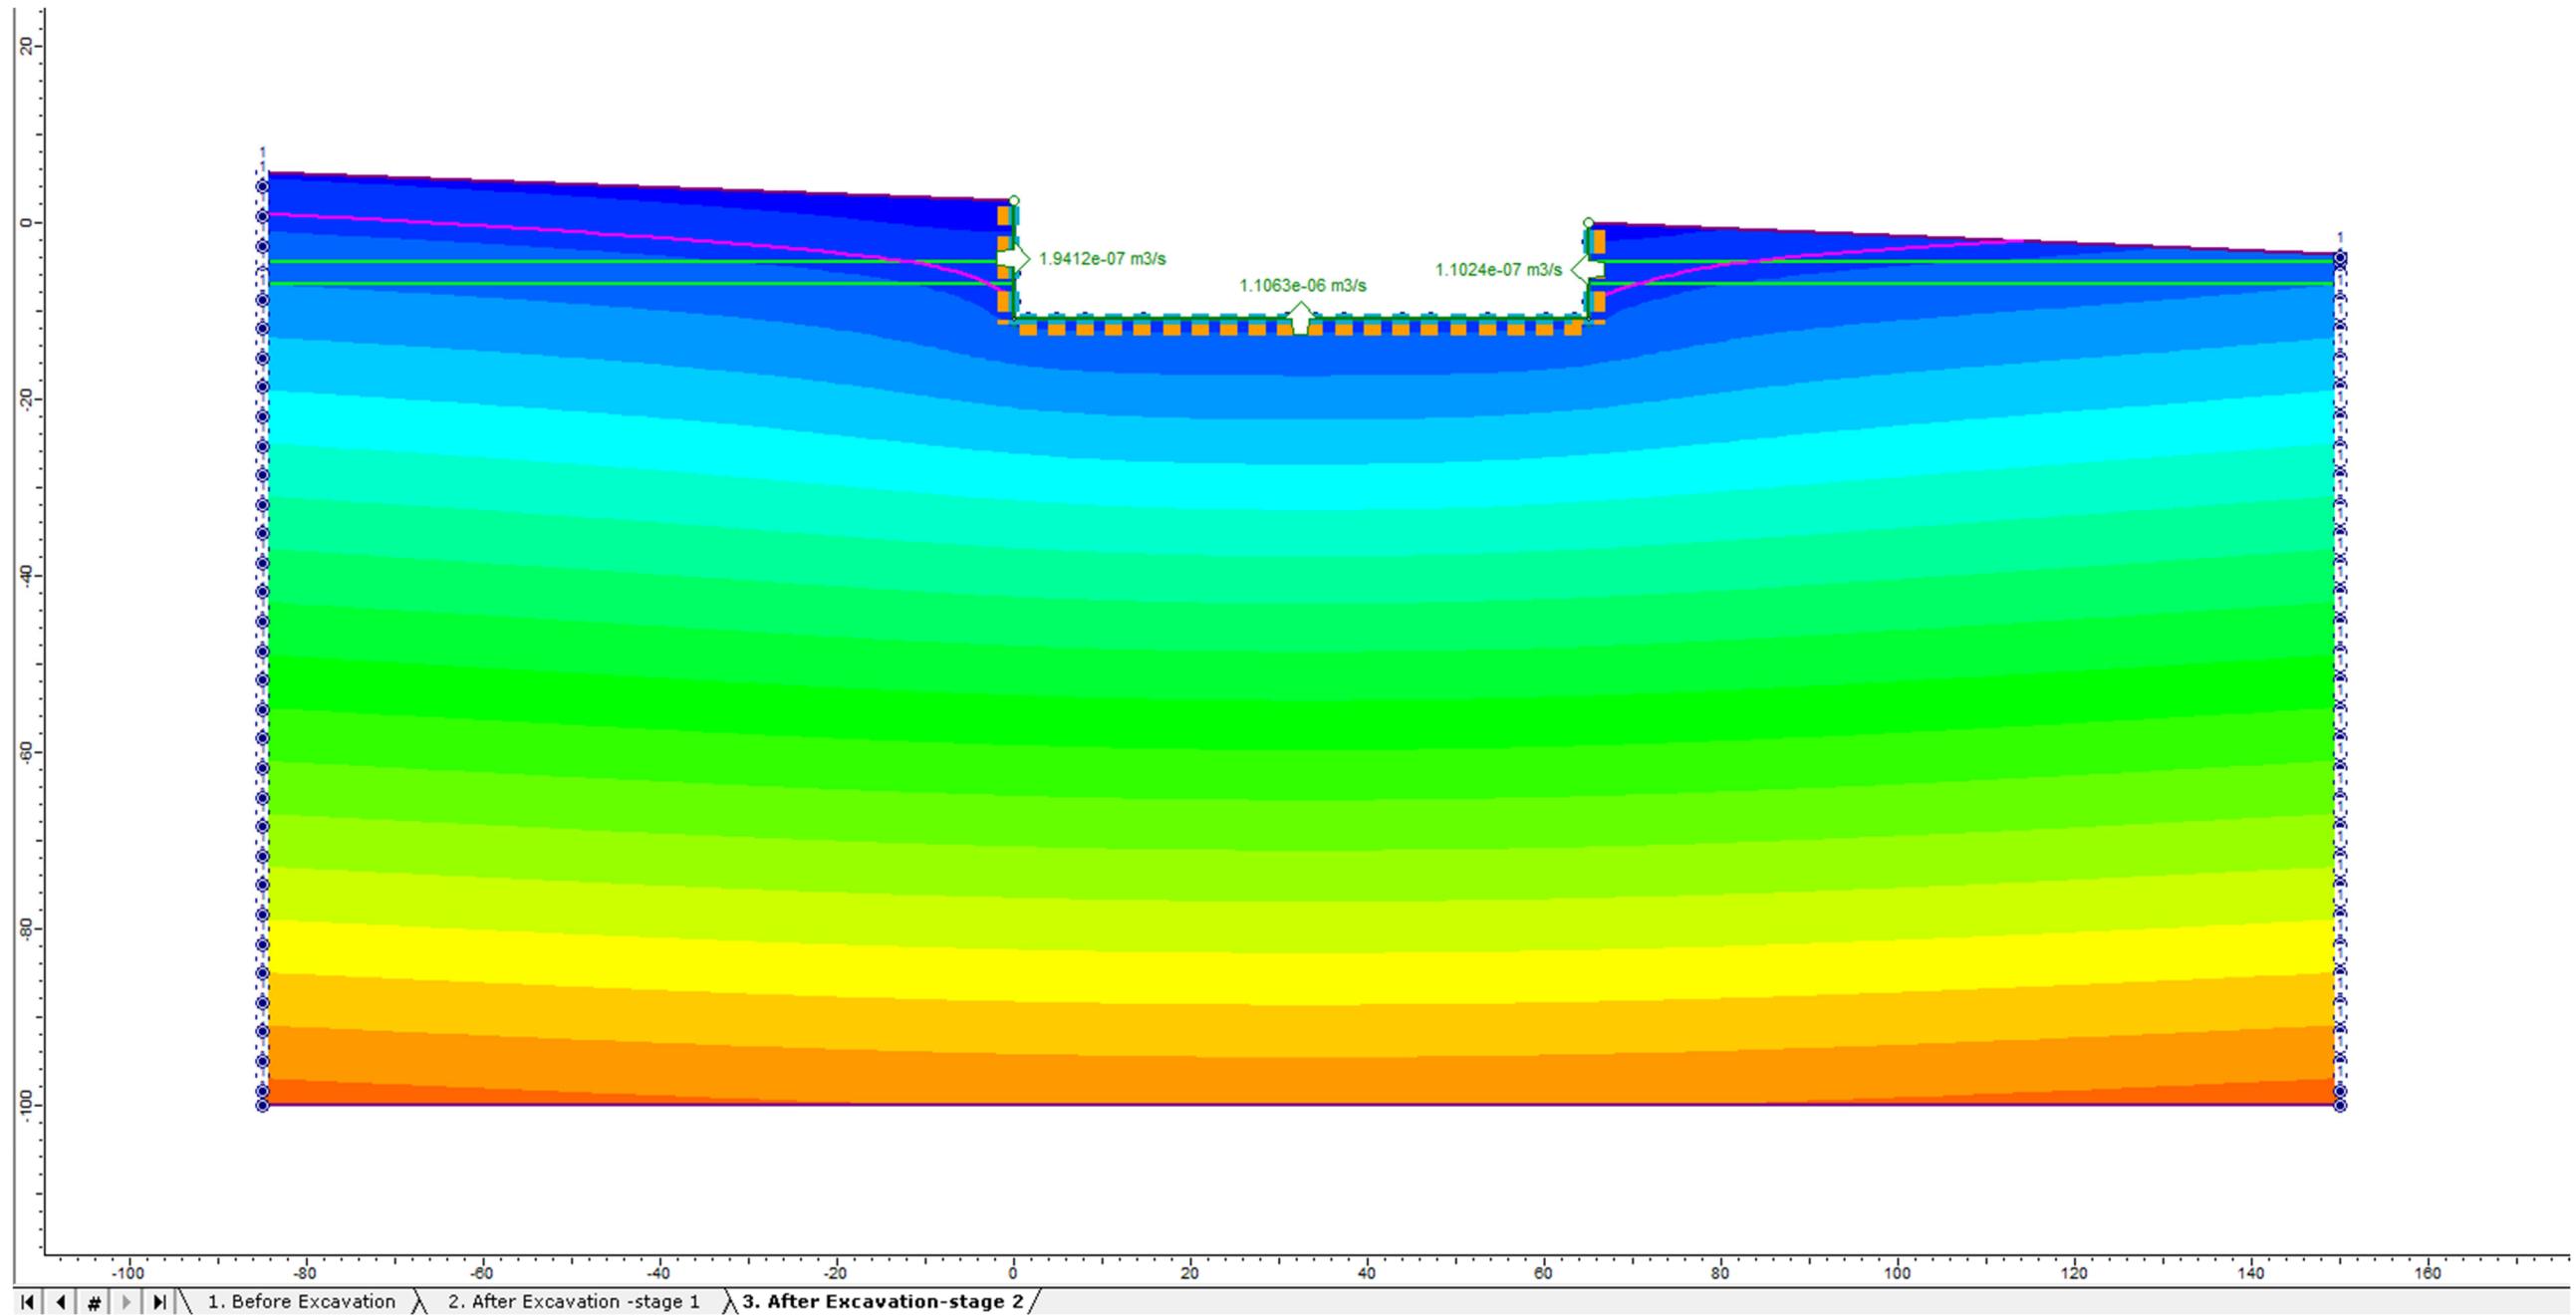
Drawn	YS	Groundwater Seepage Analysis Proposed Affordable Housing Units 14-16 Marshall Avenue, 2-10 Berry Road & 5-9 Holdsworth Avenue Street, St Leonard, NSW, 2065	Figure	4
Checked	JC			
Date	22/08/2025		Title	Section B-B – Results
Scale	NTS		Job No.	GM1558.1J

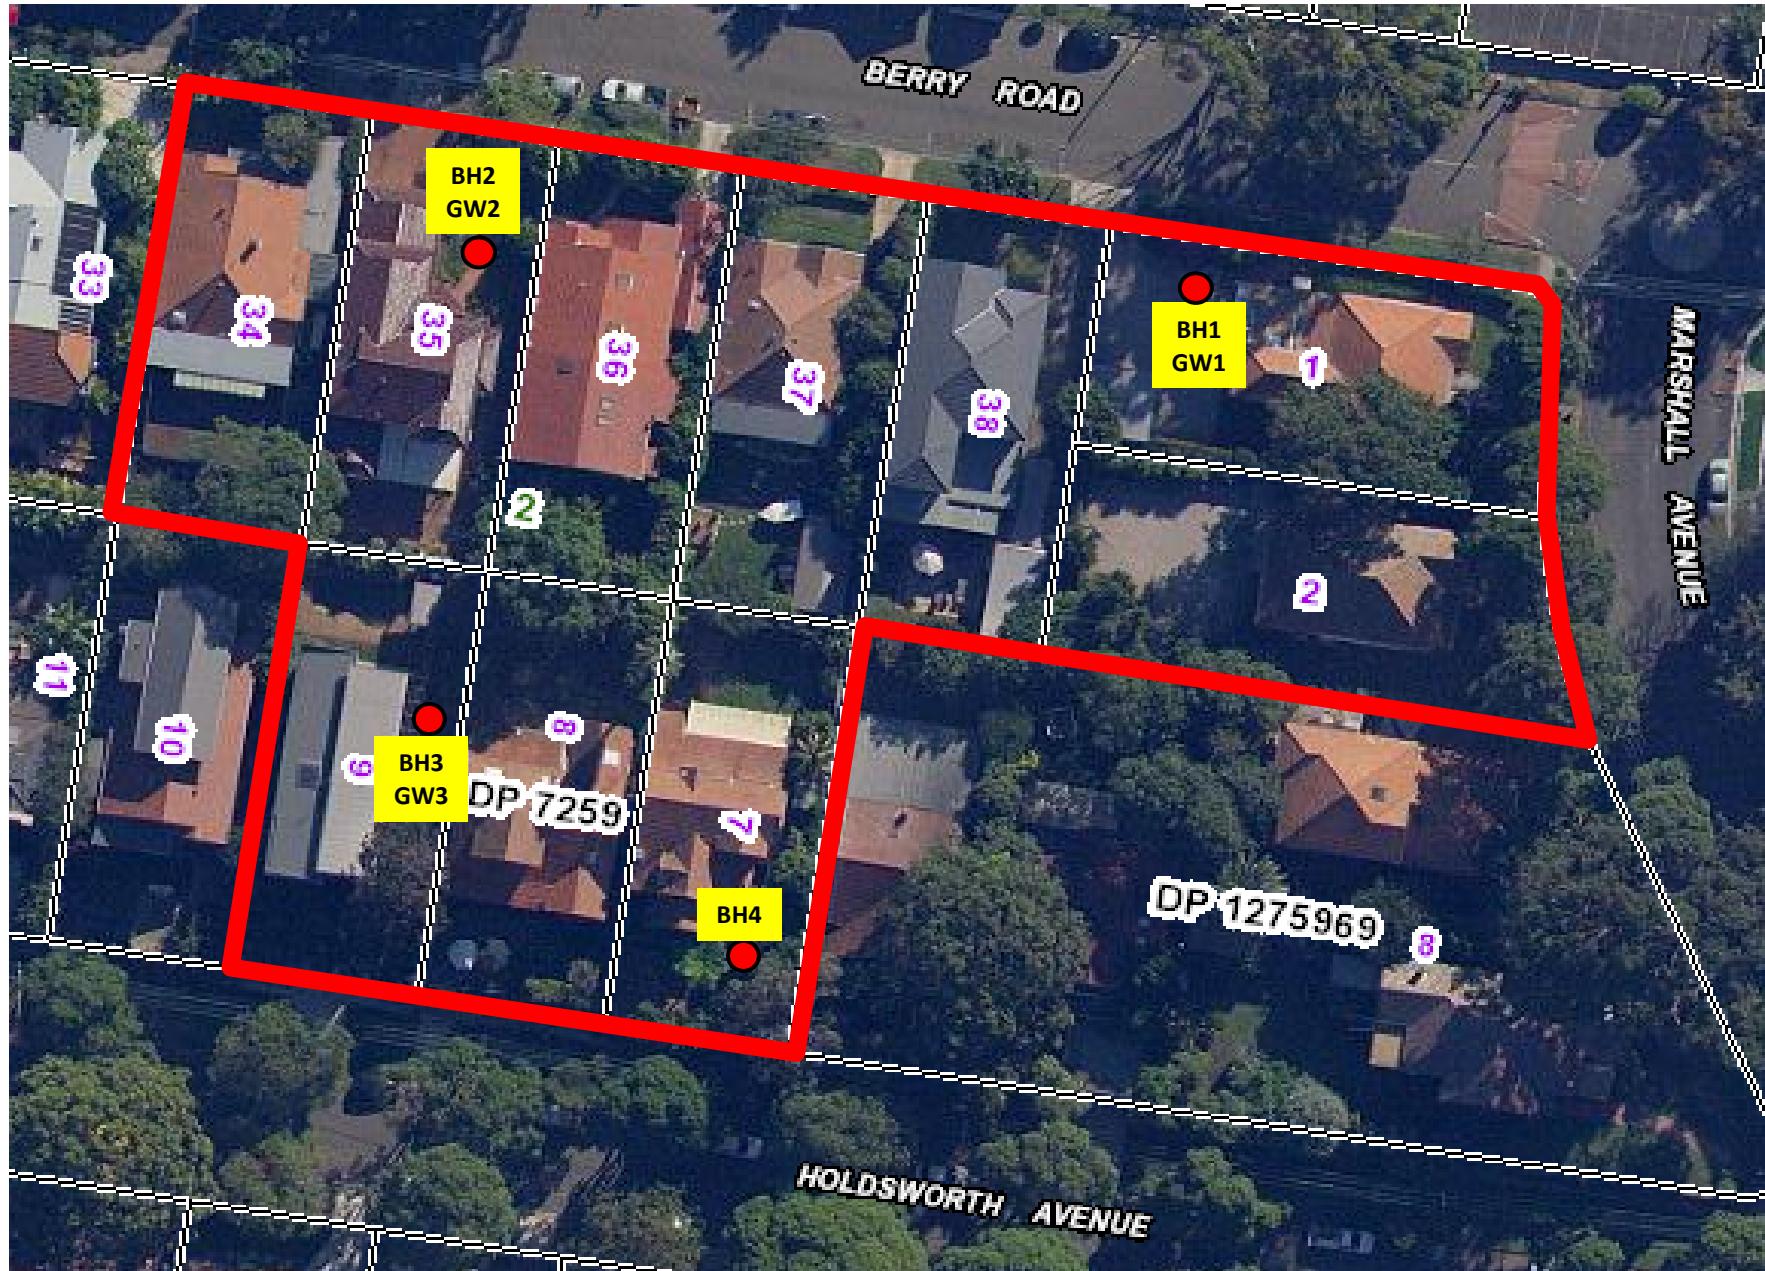
● Approximate Test Locations

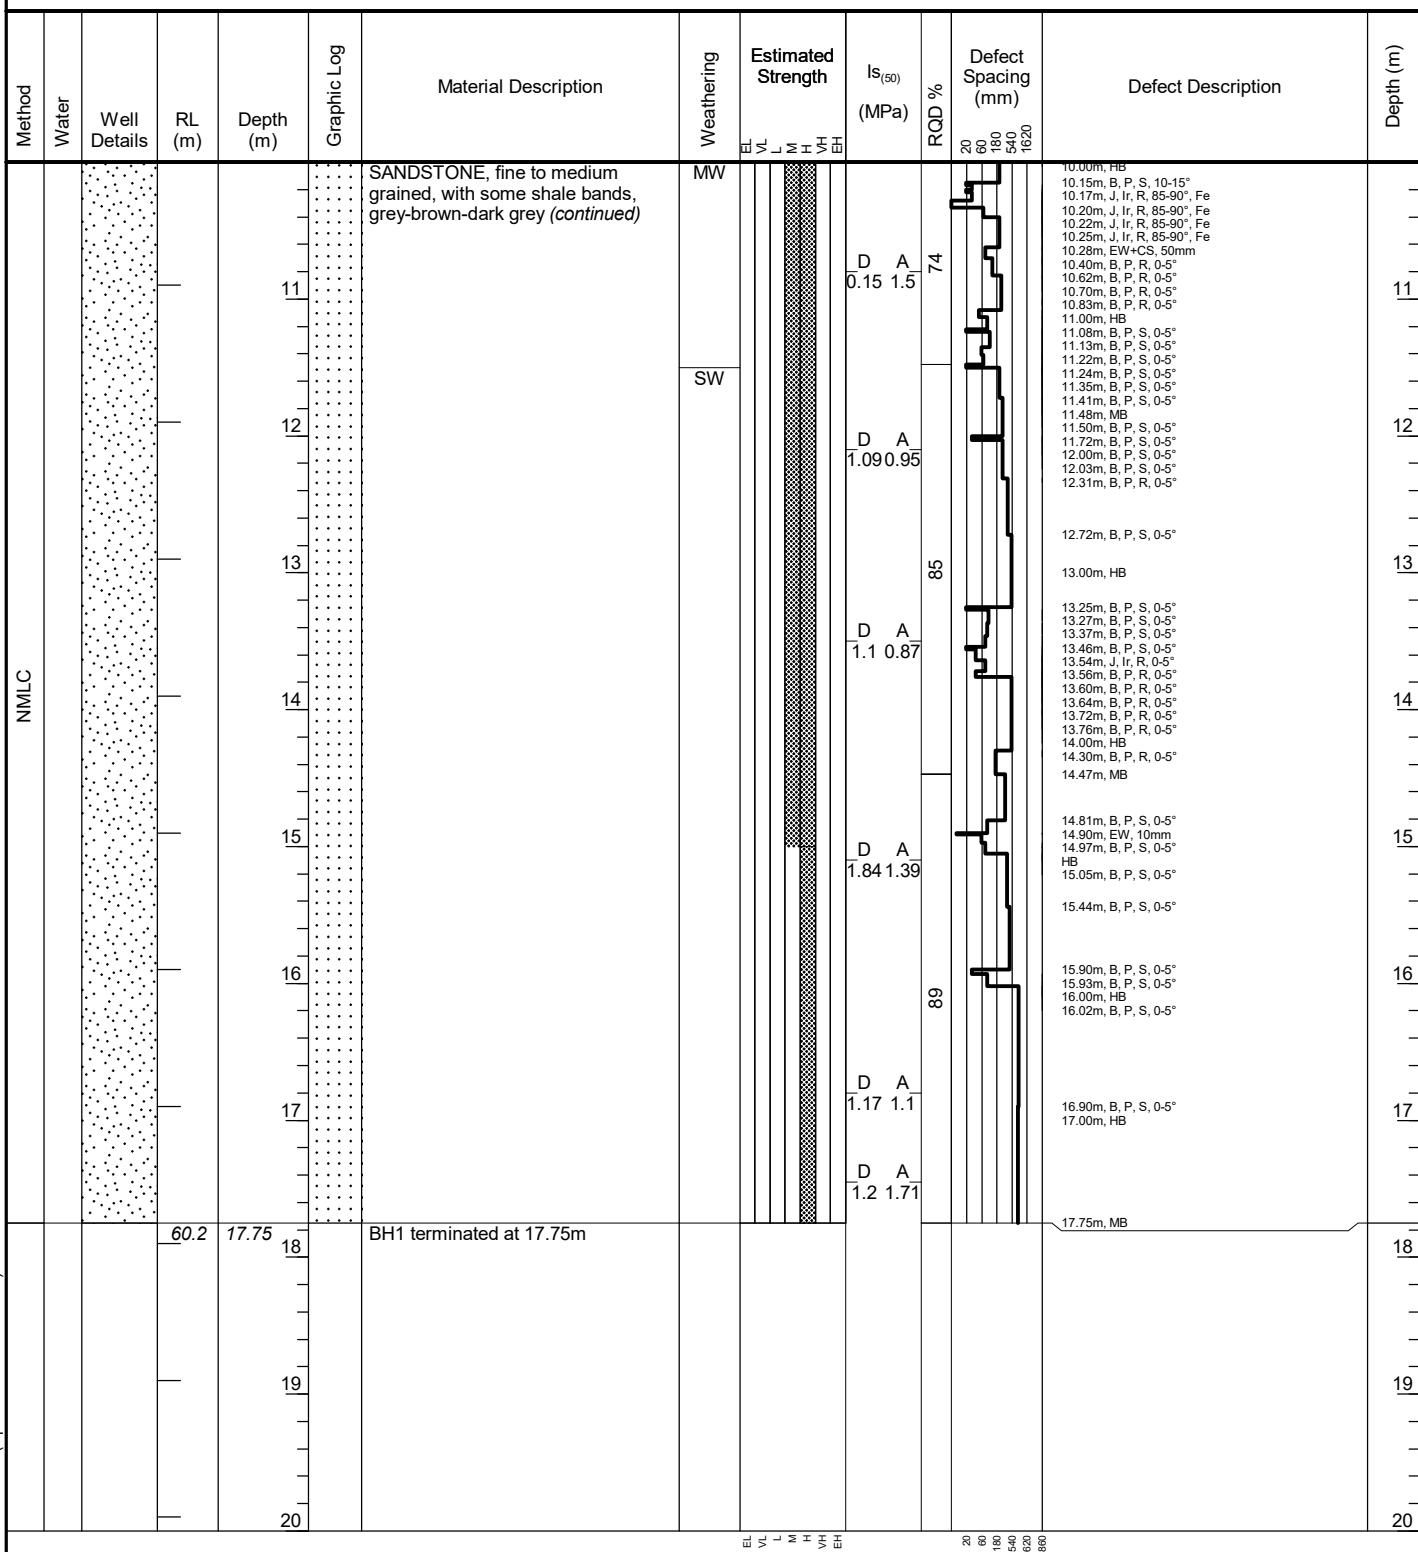
Borehole Location : Refer to Site Plan **Surface RL :** 77.9 **Datum :** m AHD

Equipment : Drilling Rig **Borehole Size :** 100mm **Slope :** -90°

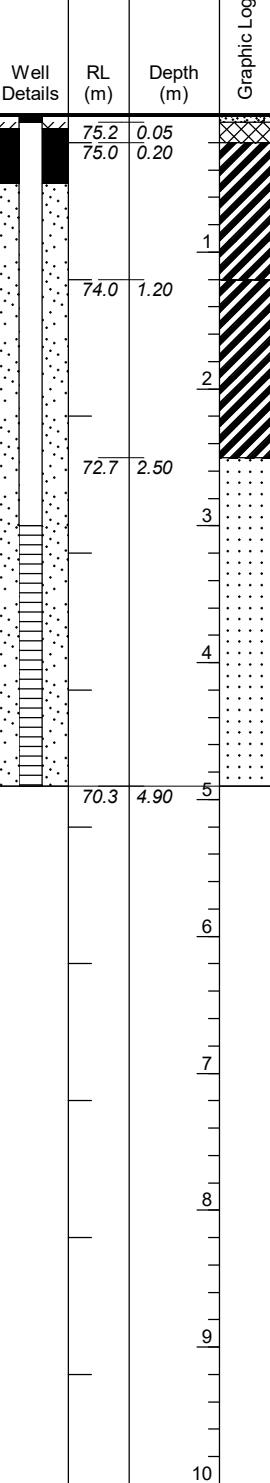
Brick Pavement, approximate thickness of 50mm FILL, gravelly silt, low plasticity, fine gravel, dark brown-dark grey Silty CLAY, medium to high plasticity, grey with red mottling	M M	F St-VSt		Fill Residual Soils SPT 3, 6, 9 N=15	1
			75.0	0.20								
			74.0	1.20								
			72.7	2.50								
			70.3	4.90

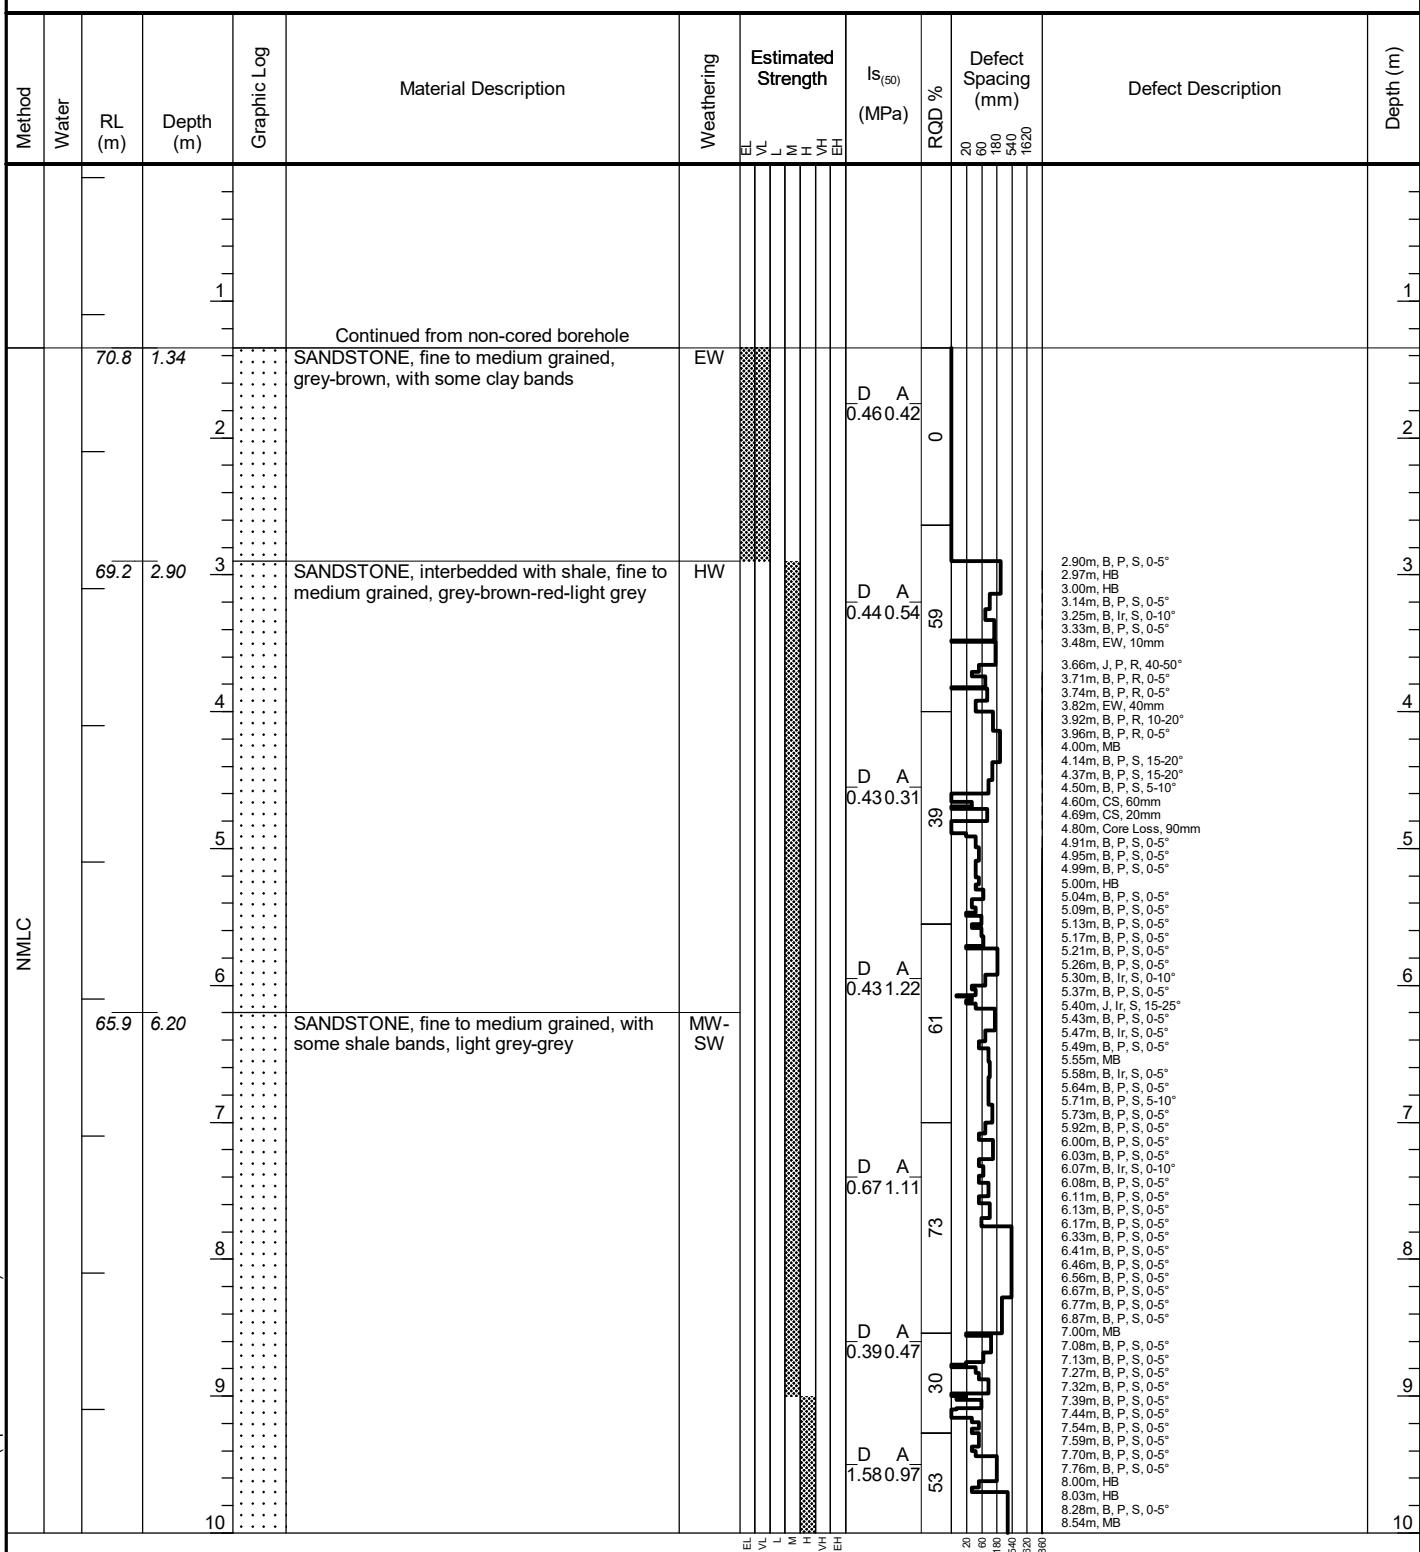
Borehole Location : Refer to Site Plan Surface RL : 72.1 Datum : m AHD

Equipment : Drilling Rig Borehole Size : 100mm Slope : -90°
