**REPORT TO  
SHIRE CHRISTIAN SCHOOL**

**ON  
REMEDIATION ACTION PLAN**

**FOR  
PROPOSED BASEMENT CARPARK**

**AT  
16A ALLIES ROAD, BARDEN RIDGE, NSW**

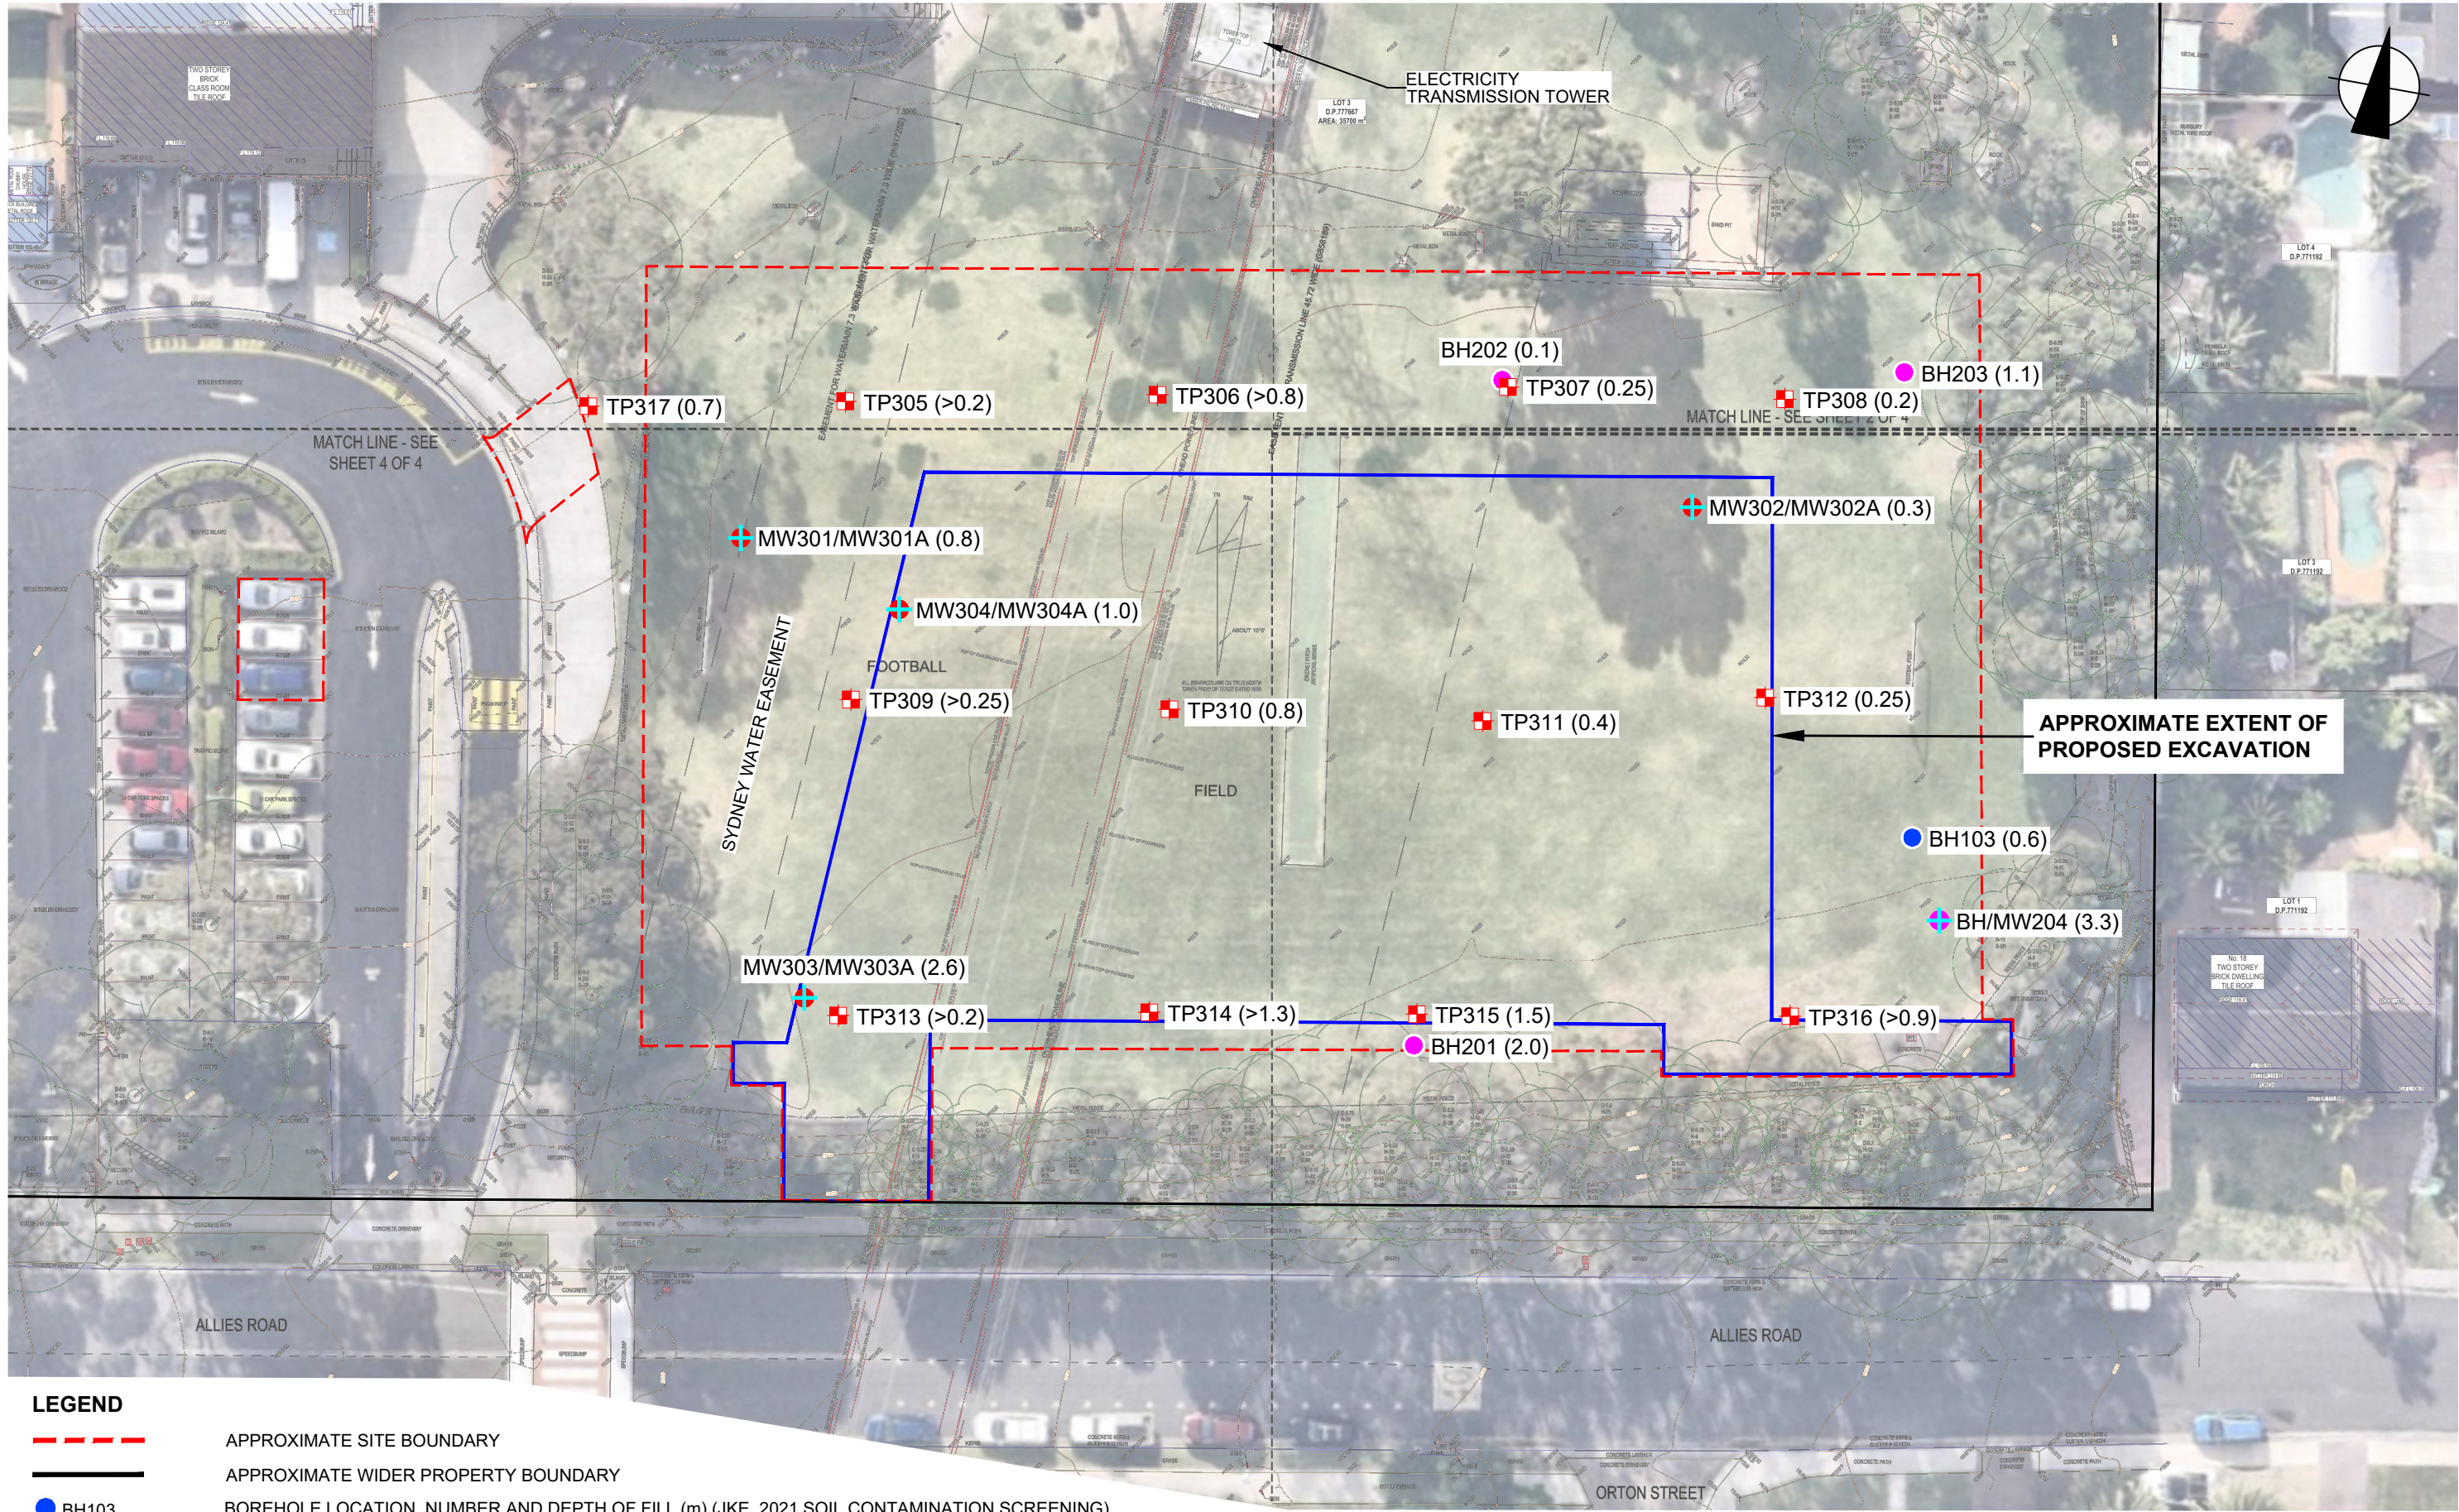
- APPROXIMATE SITE BOUNDARY
- APPROXIMATE WIDER PROPERTY BOUNDARY
- BH103 BOREHOLE LOCATION, NUMBER AND DEPTH OF FILL (m) (JKE, 2021 SOIL CONTAMINATION SCREENING)
- BH203 BOREHOLE LOCATION, NUMBER AND DEPTH OF FILL (m) (JKE, 2022 PSI)
- BH/MW201 BOREHOLE AND GROUNDWATER MONITORING WELL LOCATION, NUMBER AND DEPTH OF FILL (JKE, 2022 PSI)
- TP301 TEST PIT LOCATION, NUMBER AND DEPTH OF FILL (m) (JKE, 2023 DSI)
- 304 BOREHOLE LOCATION, NUMBER AND DEPTH OF FILL (m) (JKE, 2023)
- MW301 GROUNDWATER MONITORING WELL LOCATION AND NUMBER (JKE, 2023 DSI)

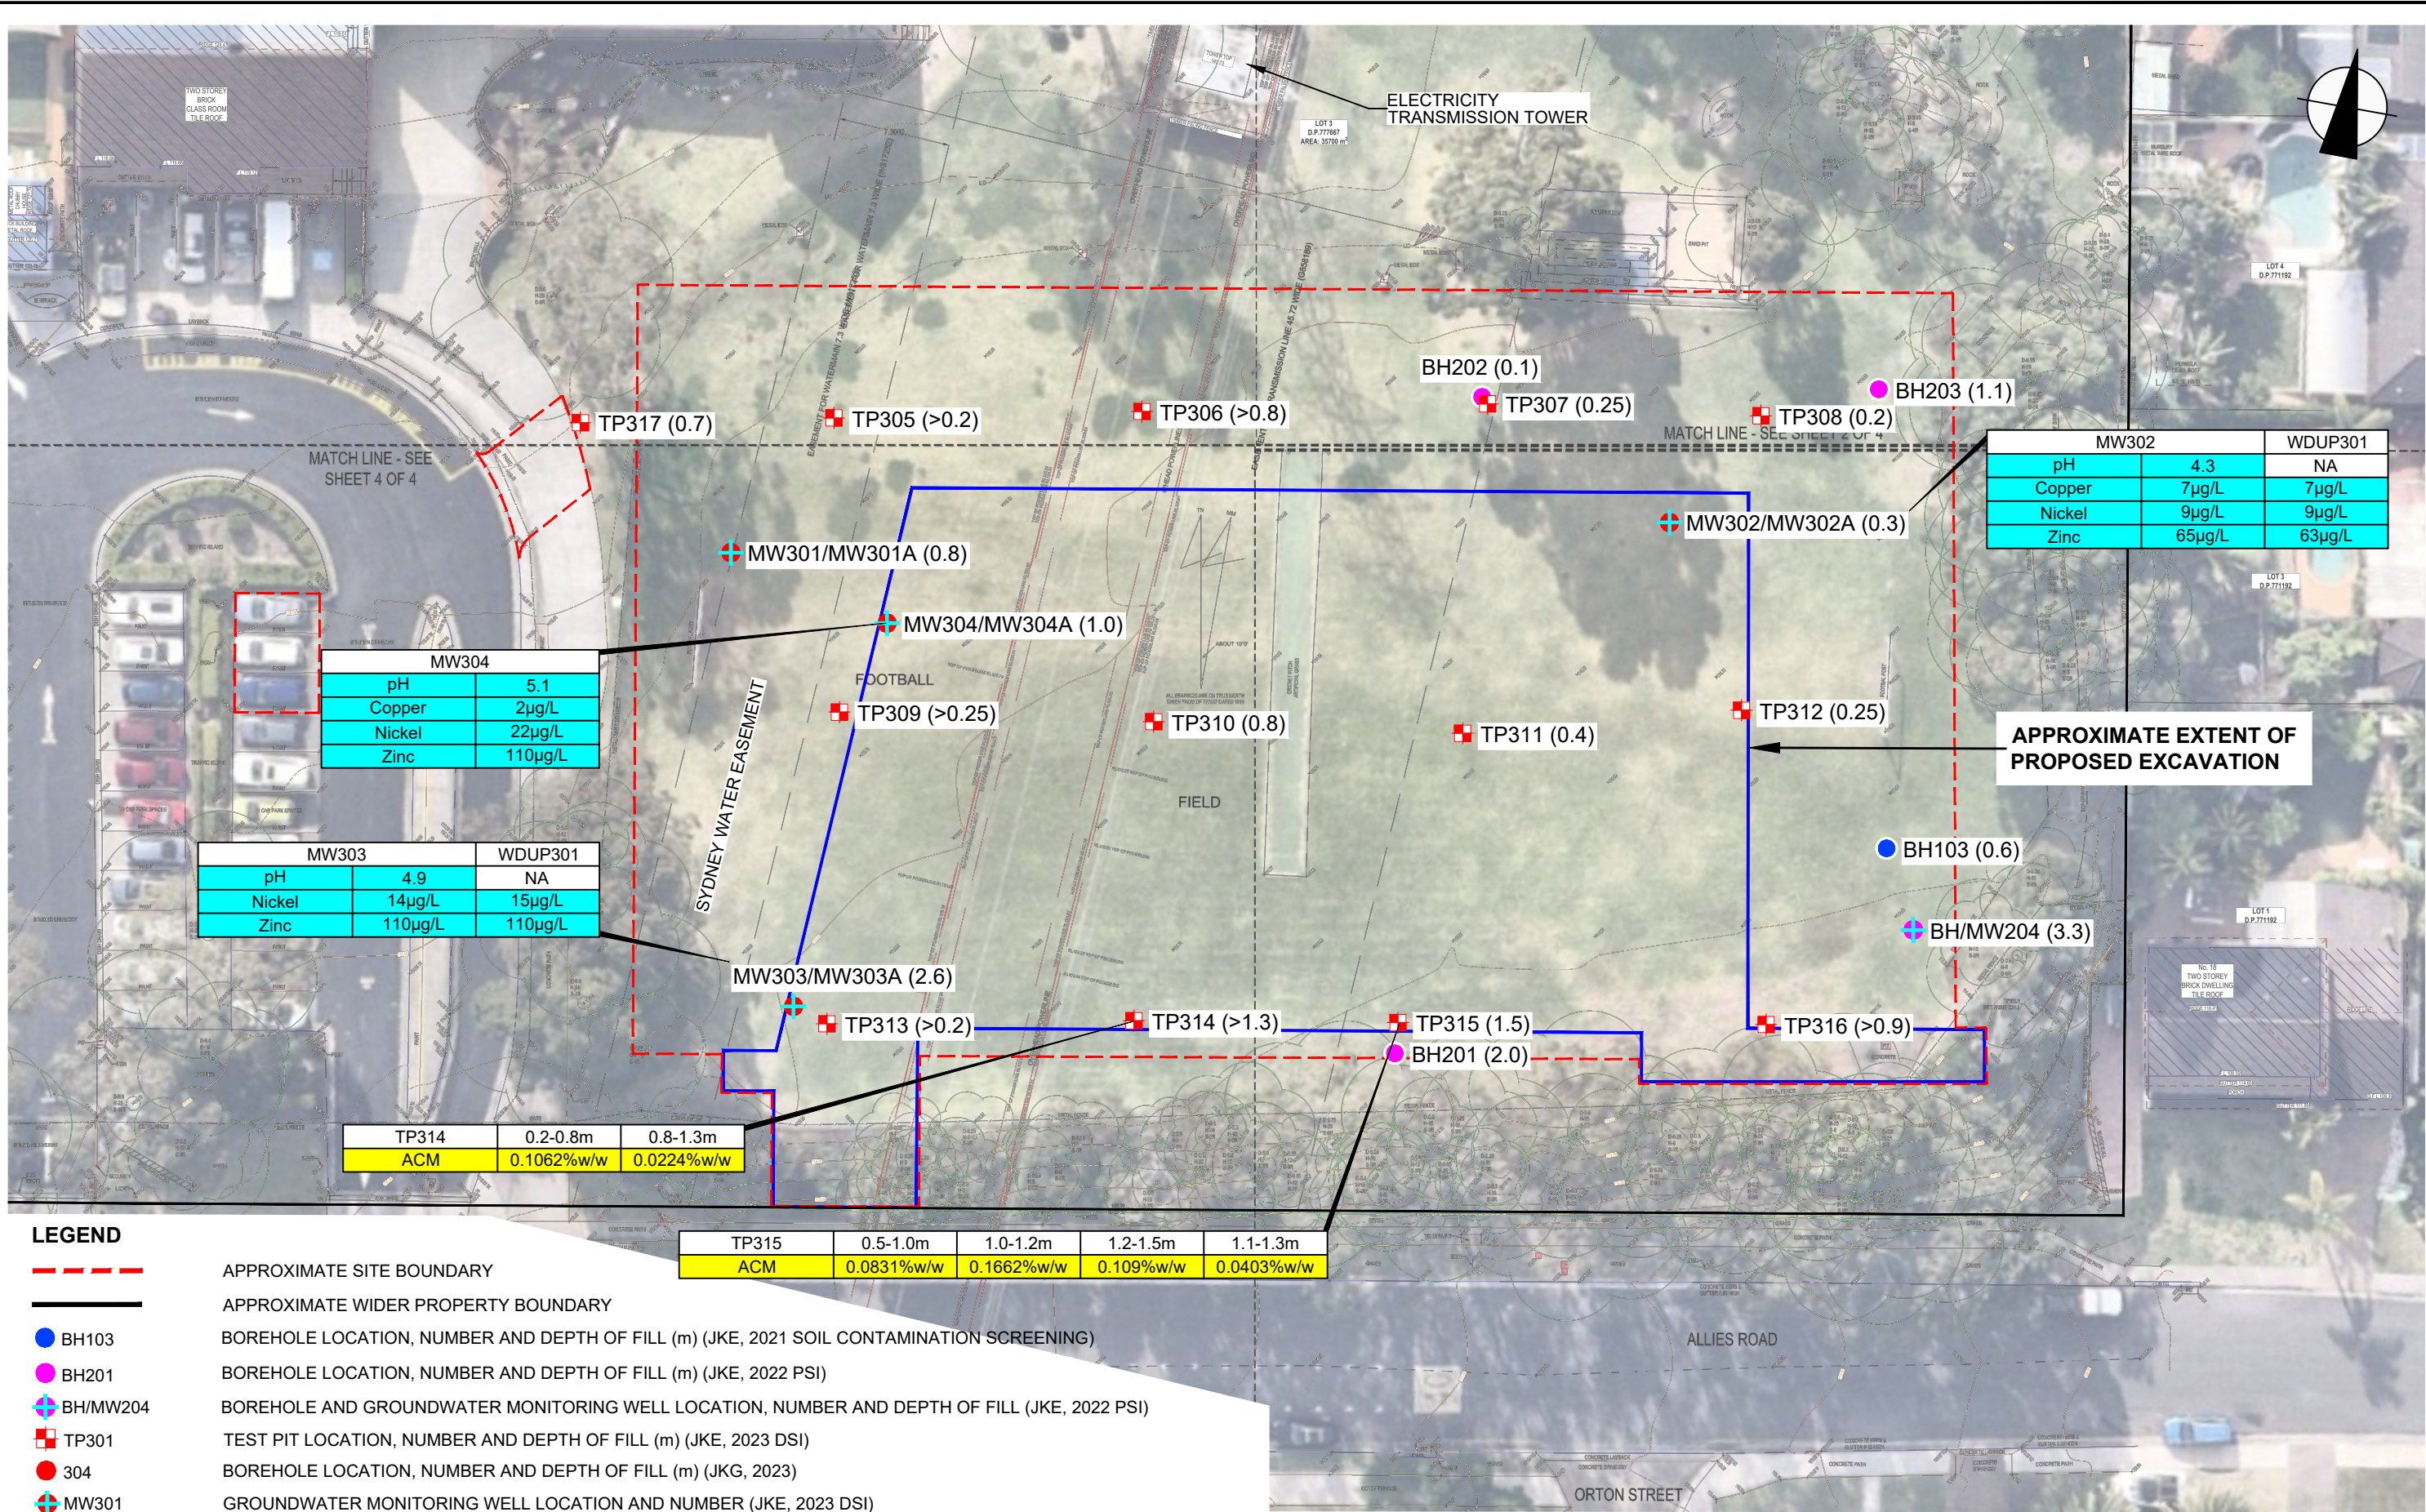
- APPROXIMATE SITE BOUNDARY
- APPROXIMATE WIDER PROPERTY BOUNDARY
- BH103 BOREHOLE LOCATION, NUMBER AND DEPTH OF FILL (m) (JKE, 2021 SOIL CONTAMINATION SCREENING)
- BH201 BOREHOLE LOCATION, NUMBER AND DEPTH OF FILL (m) (JKE, 2022 PSI)
- BH/MW204 BOREHOLE AND GROUNDWATER MONITORING WELL LOCATION, NUMBER AND DEPTH OF FILL (JKE, 2022 PSI)
- TP301 TEST PIT LOCATION, NUMBER AND DEPTH OF FILL (m) (JKE, 2023 DSI)
- 304 BOREHOLE LOCATION, NUMBER AND DEPTH OF FILL (m) (JKG, 2023)
- MW301 GROUNDWATER MONITORING WELL LOCATION AND NUMBER (JKE, 2023 DSI)

- Inspection and soil sampling from a minimum of 10 test pit locations (TP401-TP410) as shown on Figure 5 in Appendix A. Prior to sampling, the locations must be checked and cleared for any underground services;
- The test pits must be extended to the base of the fill;
- Bulk (10L) field asbestos quantification sampling must occur from the 10 (minimum) test pit locations, in accordance with the endorsed methods in the NEPM 2013. Any identified fibre cement fragments (FCF) are to be weighed/recorded and analysed for asbestos. If the field assessment of any FCF indicates that the FCF is degraded and can be crushed/pulverised to a powder by hand pressure, a separate 500ml sample must be collected from the soil at any location where such FCF is identified and must be analysed for asbestos using the NEPM 2013 quantification method.
