Aliro Trusco 1 Pty Ltd  
care of  
Aliro Management Pty Ltd

Masterplan Remedial Action Plan  
13 Endeavour Road, Caringbah, NSW

11 October 2024

64957/153694 Rev 2

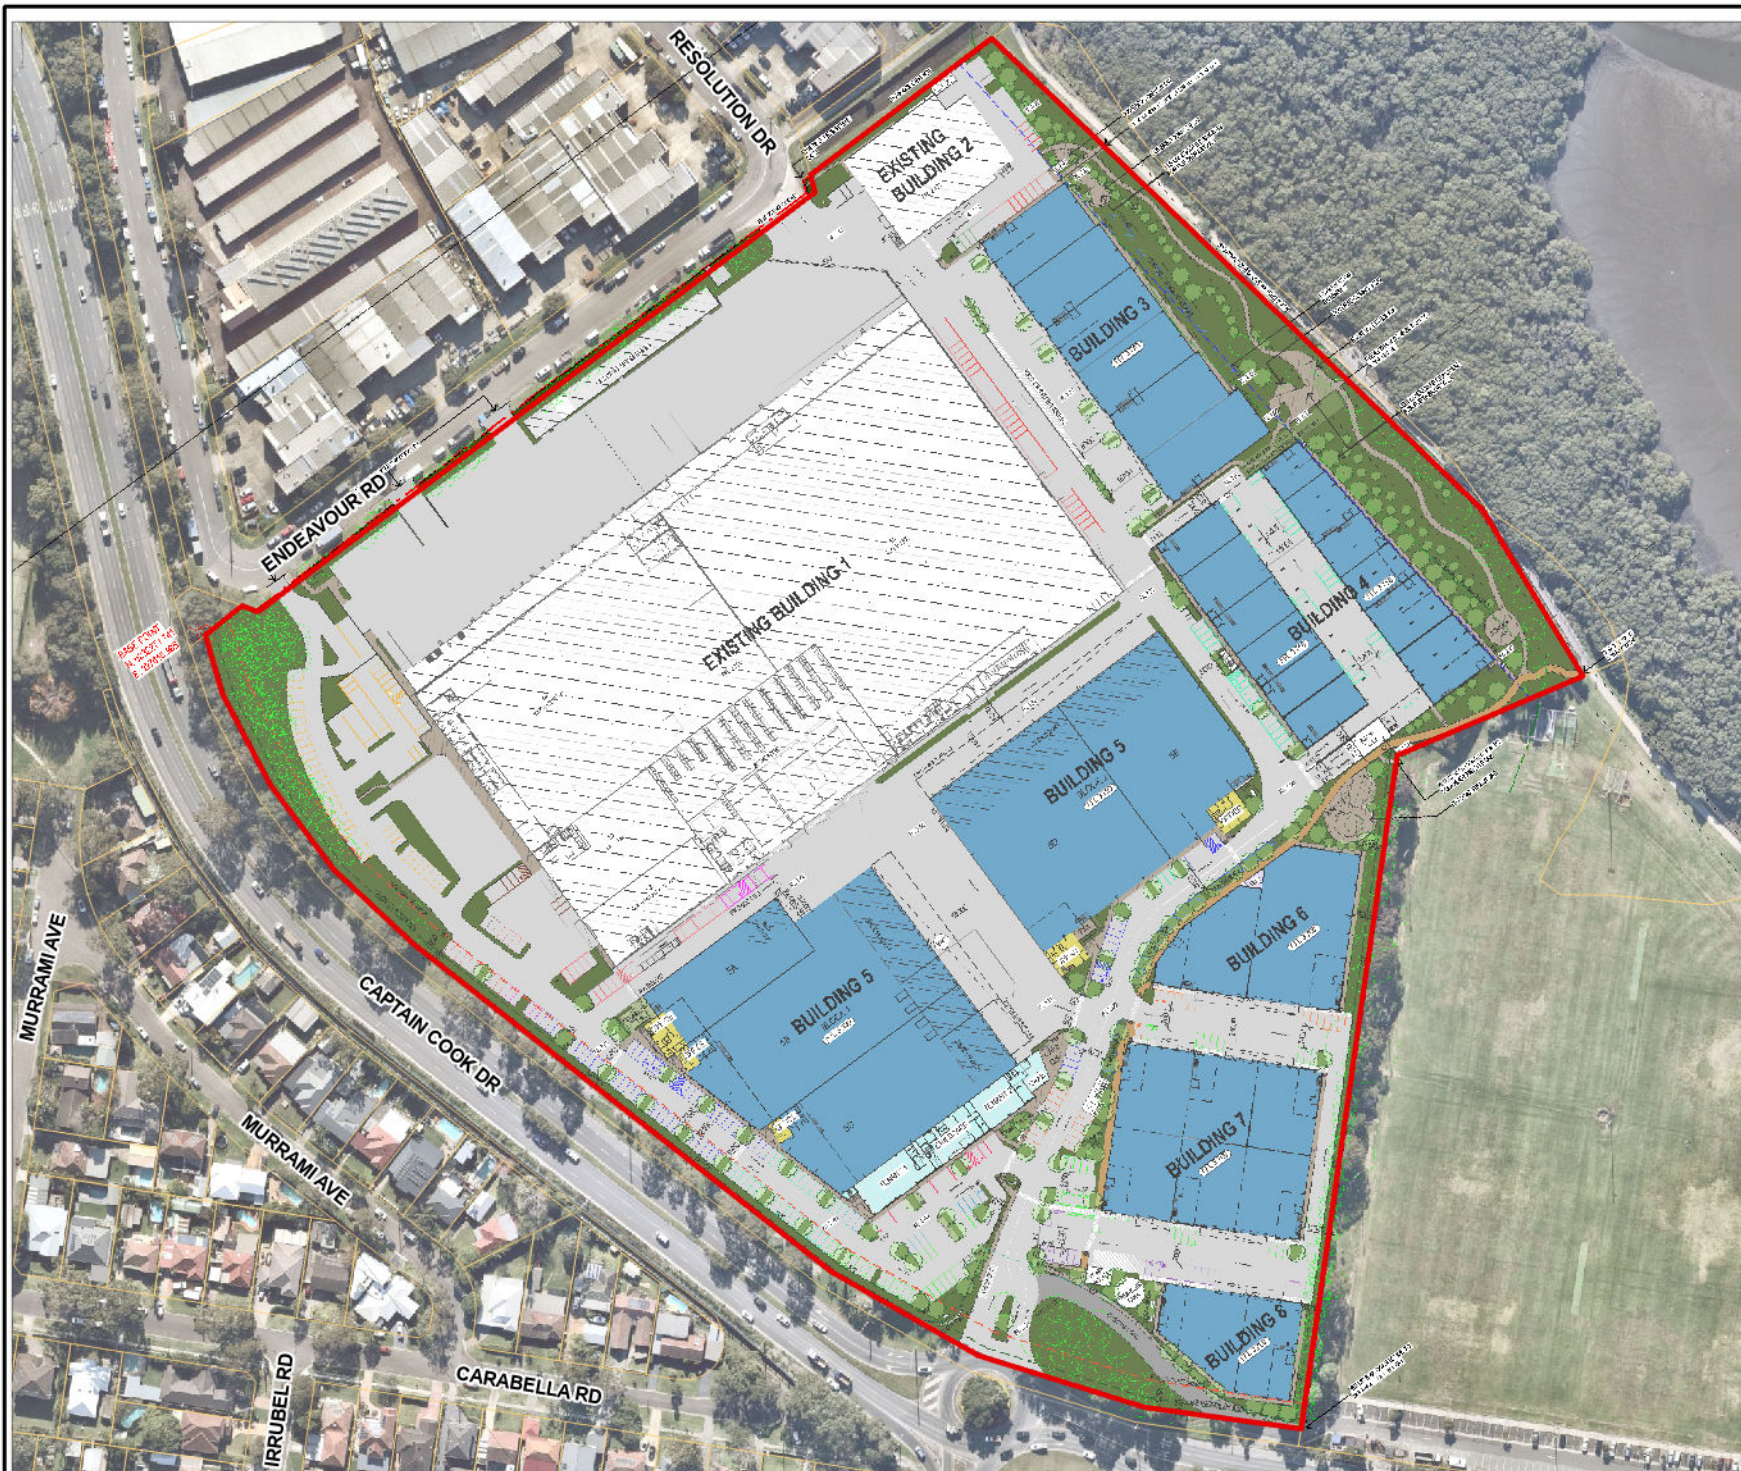
**FIGURE 2**

**PROPOSED SITE LAYOUT**

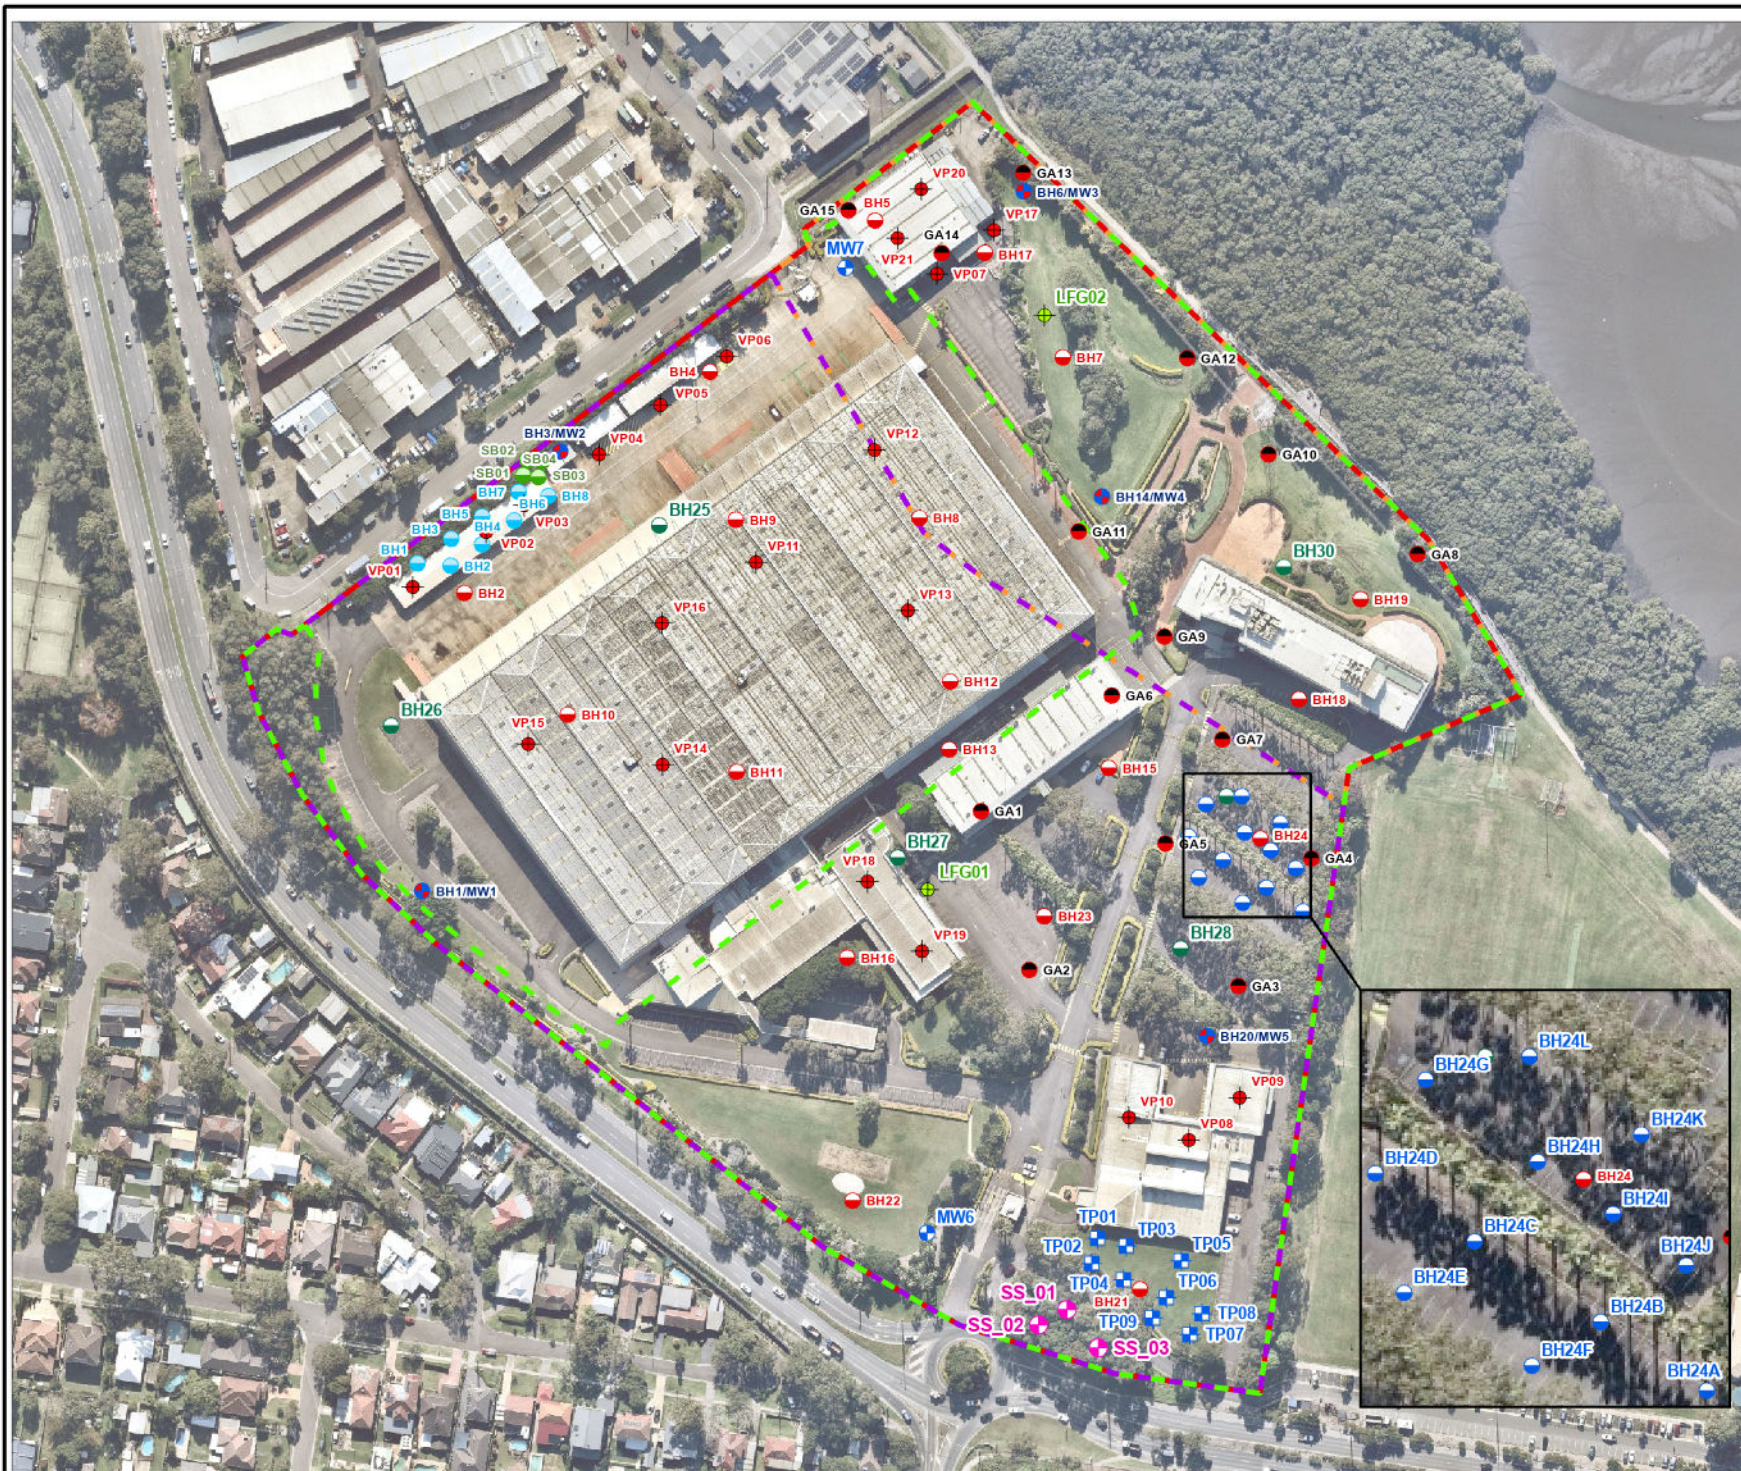
**FIGURE 4**

- Legend**
- Approximate Site Boundary
  - Stage 2 TripleTwoNine Masterplan Development
  - Northern Portion of the Site: Reclaimed Tidal Mangrove Swamp
  - Southern Portion of the Site: Reclaimed Tidal Mangrove Swamp
- Historical Sample Locations**
- Borehole Location, AECOM 2019
  - Borehole Location, CES 2005
  - Borehole/Groundwater Monitoring Well Location, AECOM 2019
  - Sample Location, Noel Arnold & Ass. 2012
  - Test Pit Location, Golder 1998
- Sample Locations - JBS&G 2019**
- Borehole Location, JBS&G 2019
  - Groundwater Monitoring Location, JBS&G 2019
  - Soil Vapour Sample Location, JBS&G 2019
- Sample Locations (2020)**
- Borehole Location
  - Ground Gas Monitoring Wells
- Sample Locations (2022)**
- Soil Sample
  - Testpit

**HISTORICAL SAMPLE LOCATIONS**

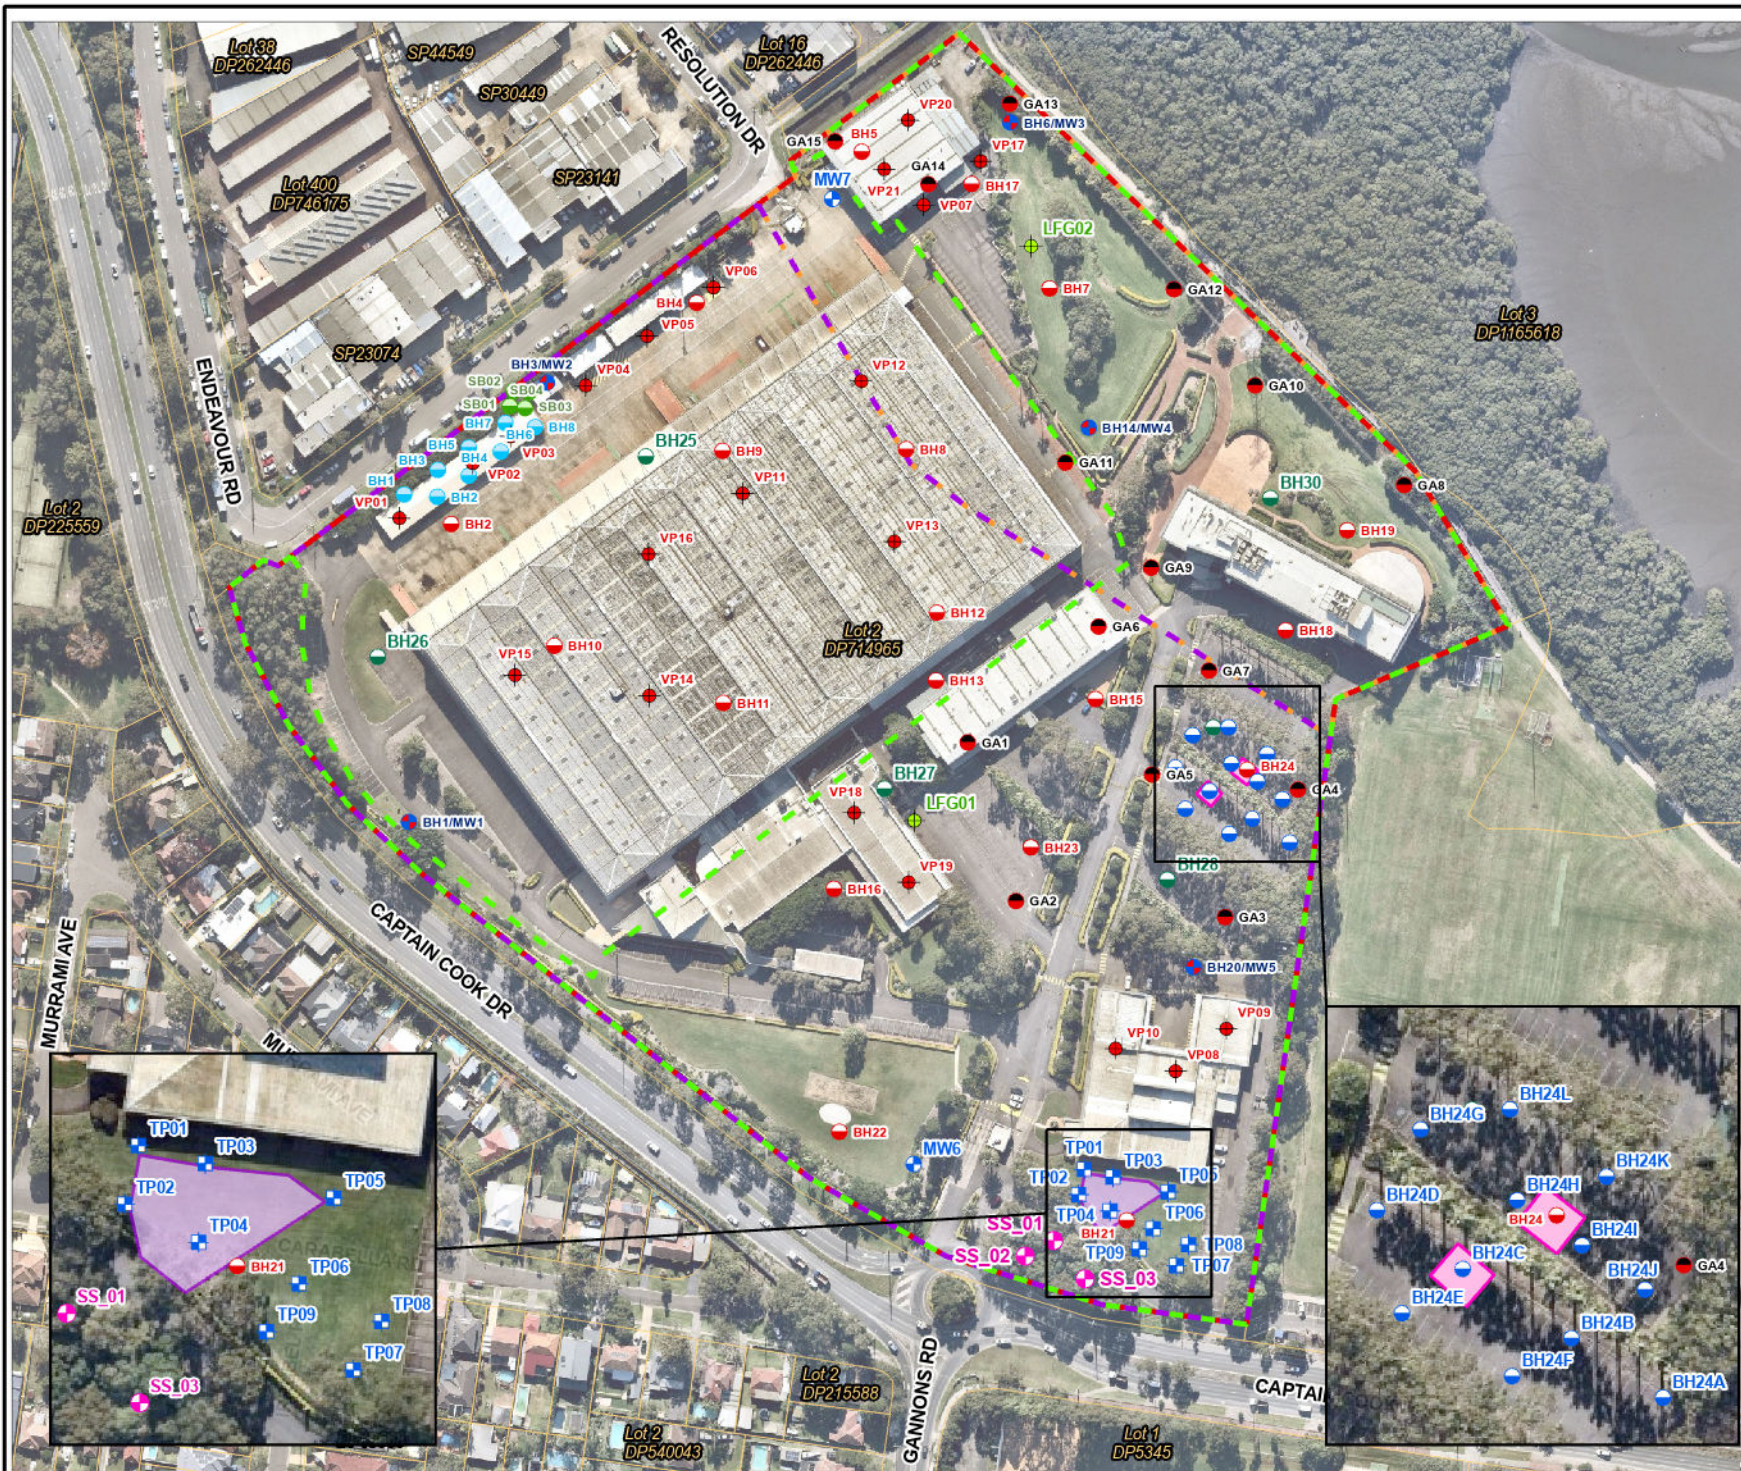
**FIGURE 5**

- Approximate Site Boundary
- NSW Cadastre
- Bonded ACM Impact Area
- ACM Impact Area
- Stage 2 TripleTwoNine Masterplan Development
- Northern Portion of the Site: Reclaimed Tidal Mangrove Swamp
- Southern Portion of the Site: Reclaimed Tidal Mangrove Swamp
