Geotechnical Investigation

1 Veno Street, Heathcote

Report Title: Geotechnical Investigation, 1 Veno Street, Heathcote

Report No: E26160.G03

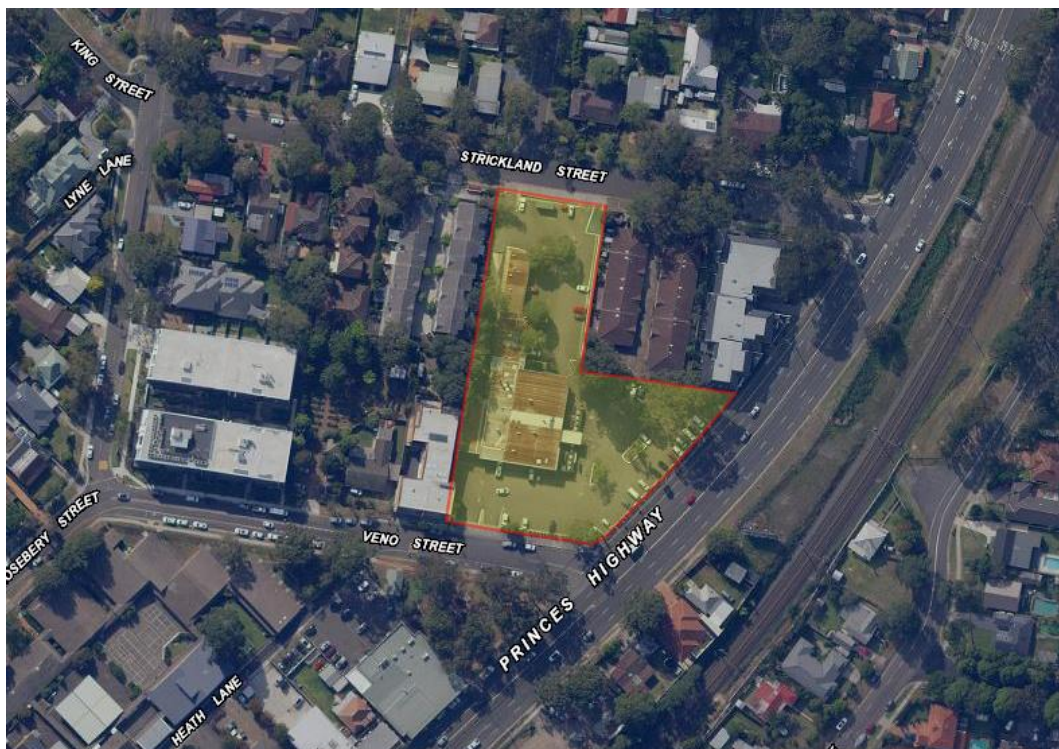
Plate 1: Aerial photograph of the site (source: SixMaps, accessed 25/9/2023)

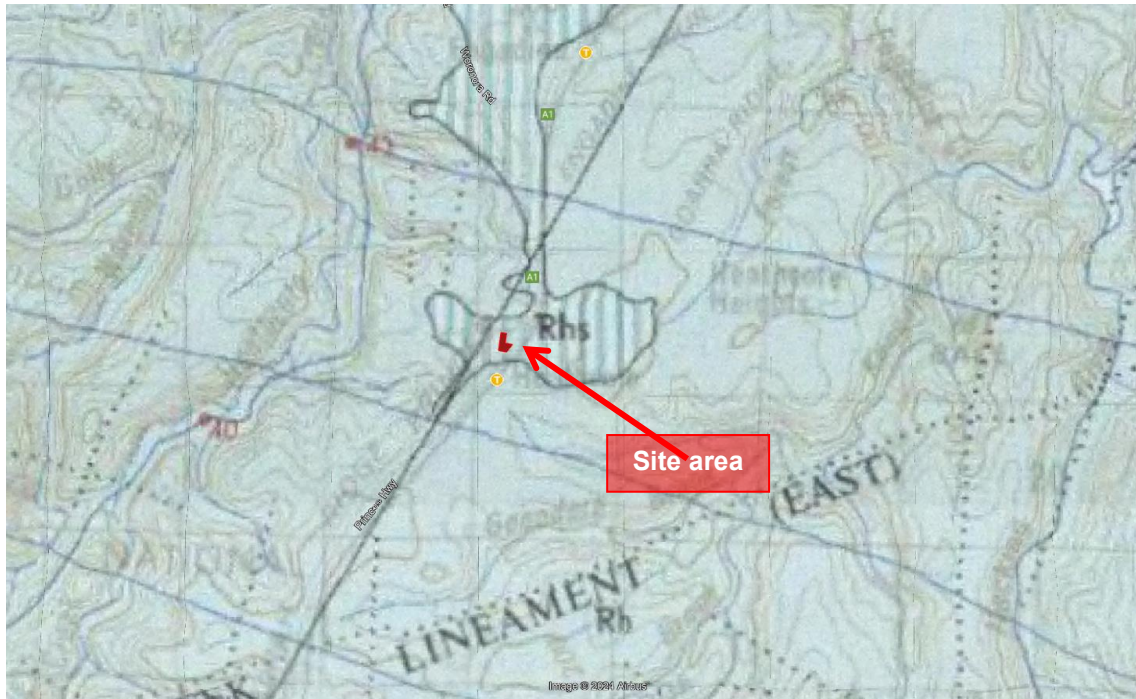
Plate 2: Excerpt of geological map showing location of site.

Attribute	Description
Topography	<p>The site is located on the low north side of Veno Street within gently (0° to 4°) north dipping topography with site levels varying from about RL192.9m AHD along the Veno Street frontage to about RL184.68m AHD at the northwest site corner.</p>
Regional Geology	<p>Information on regional sub-surface conditions, referenced from the Department of Mineral Resources Geological Map Wollongong-Port Hacking 1:100,000 Geological Series Sheet 9029-9129 (DMR 1985) indicates the site to be underlain by the (Rhs) subgroup of Hawkesbury Sandstone, which typically comprises of claystone, siltstone, and laminite ("Shale lenses").</p> <p>EI notes that the site lies on the boundary between Rhs and Hawkesbury Sandstone (Rh) group, Hawkesbury Sandstone (Rh) is described typically as comprising medium to coarse-grained quartz sandstone with very minor shale and laminite lenses.</p>

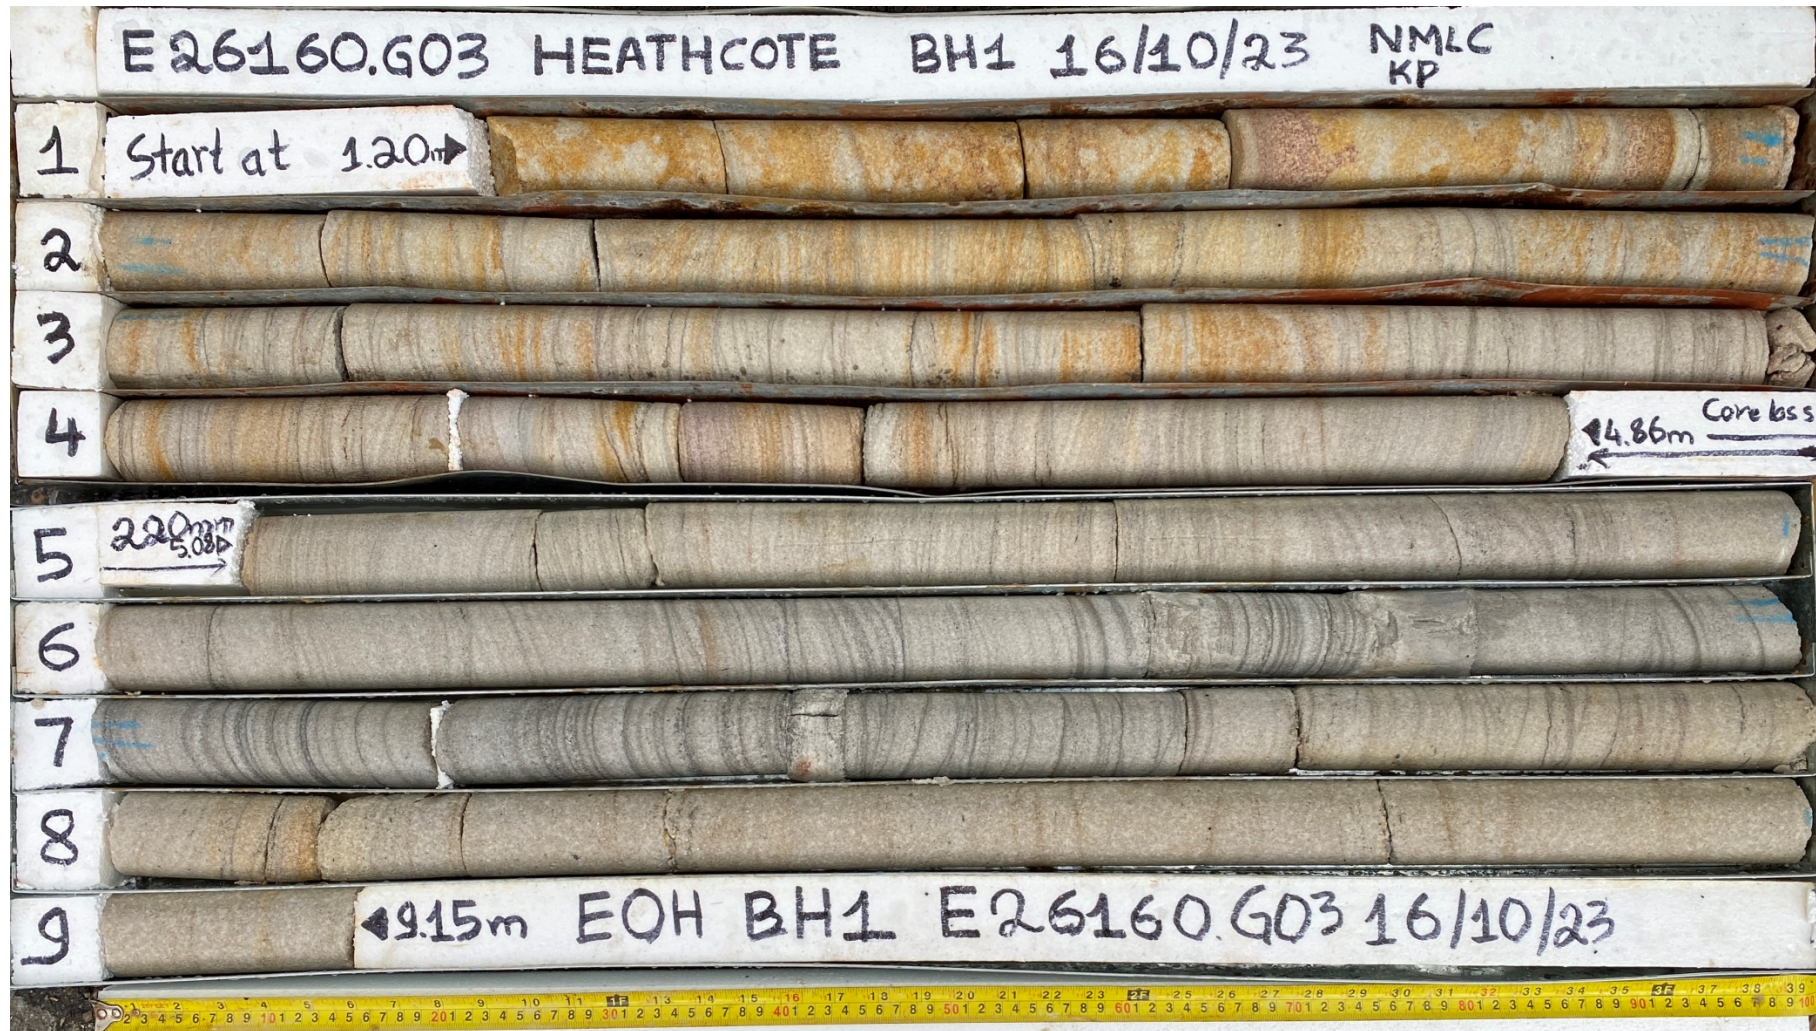
CORE PHOTOGRAPH OF BOREHOLE: BH1

Project	Proposed Mixed Use Development	East	316297.1206	Depth Range	1.2m to 9.15m BEGL		
Location	1 Veno Street,Heathcote, NSW	North	6226616.8570	Contractor	Geosense Drilling & Engineering Pty Ltd		
Position	See Figure 2	Surface RL	≈ 185.5m	Drill Rig	Comacchio Geo 205		
Job No.	E26160.G03	Inclination	-90°	Logged	KP	Date	16/10/2023
Client	Duffy Kennedy Constructions	Box	1 & 2 of 2	Checked	JS	Date	07/11/2023

Unit	Material ²	Depth to Top of Unit (m BEGL) ¹	RL of Top of Unit (m AHD) ¹	Observed Thickness (m)	Comments
					bedding partings, sub-vertical joints, and fractured/decomposed zones. Core loss was encountered in BH1 between depths of 4.86m and 5.08m.

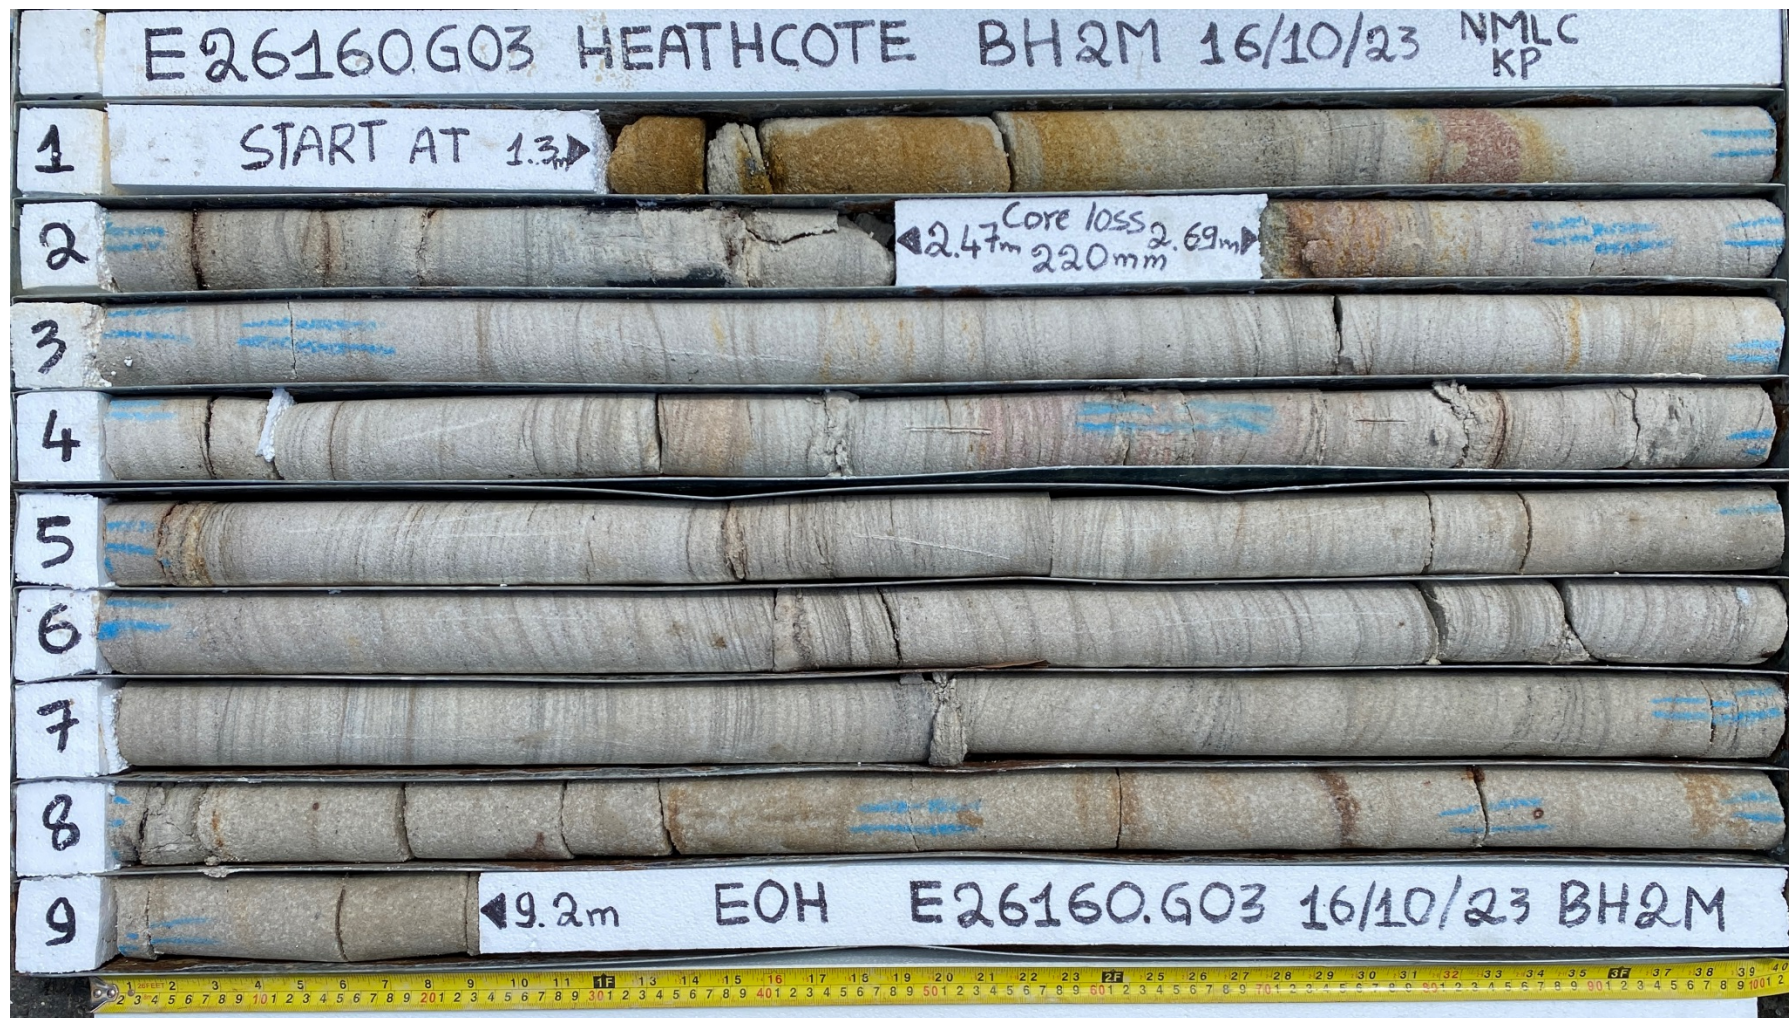
CORE PHOTOGRAPH OF BOREHOLE: BH2M

Project	Proposed Mixed Use Development	East	316311.1692	Depth Range	1.3m to 9.2m BEGL		
Location	1 Veno Street,Heathcote, NSW	North	6226616.1632	Contractor	Geosense Drilling & Engineering Pty Ltd		
Position	See Figure 2	Surface RL	≈ 185.8m	Drill Rig	Comacchio Geo 205		
Job No.	E26160.G03	Inclination	-90°	Logged	KP	Date	16/10/2023
Client	Duffy Kennedy Constructions	Box	1 & 2 of 2	Checked	JS	Date	07/11/2023

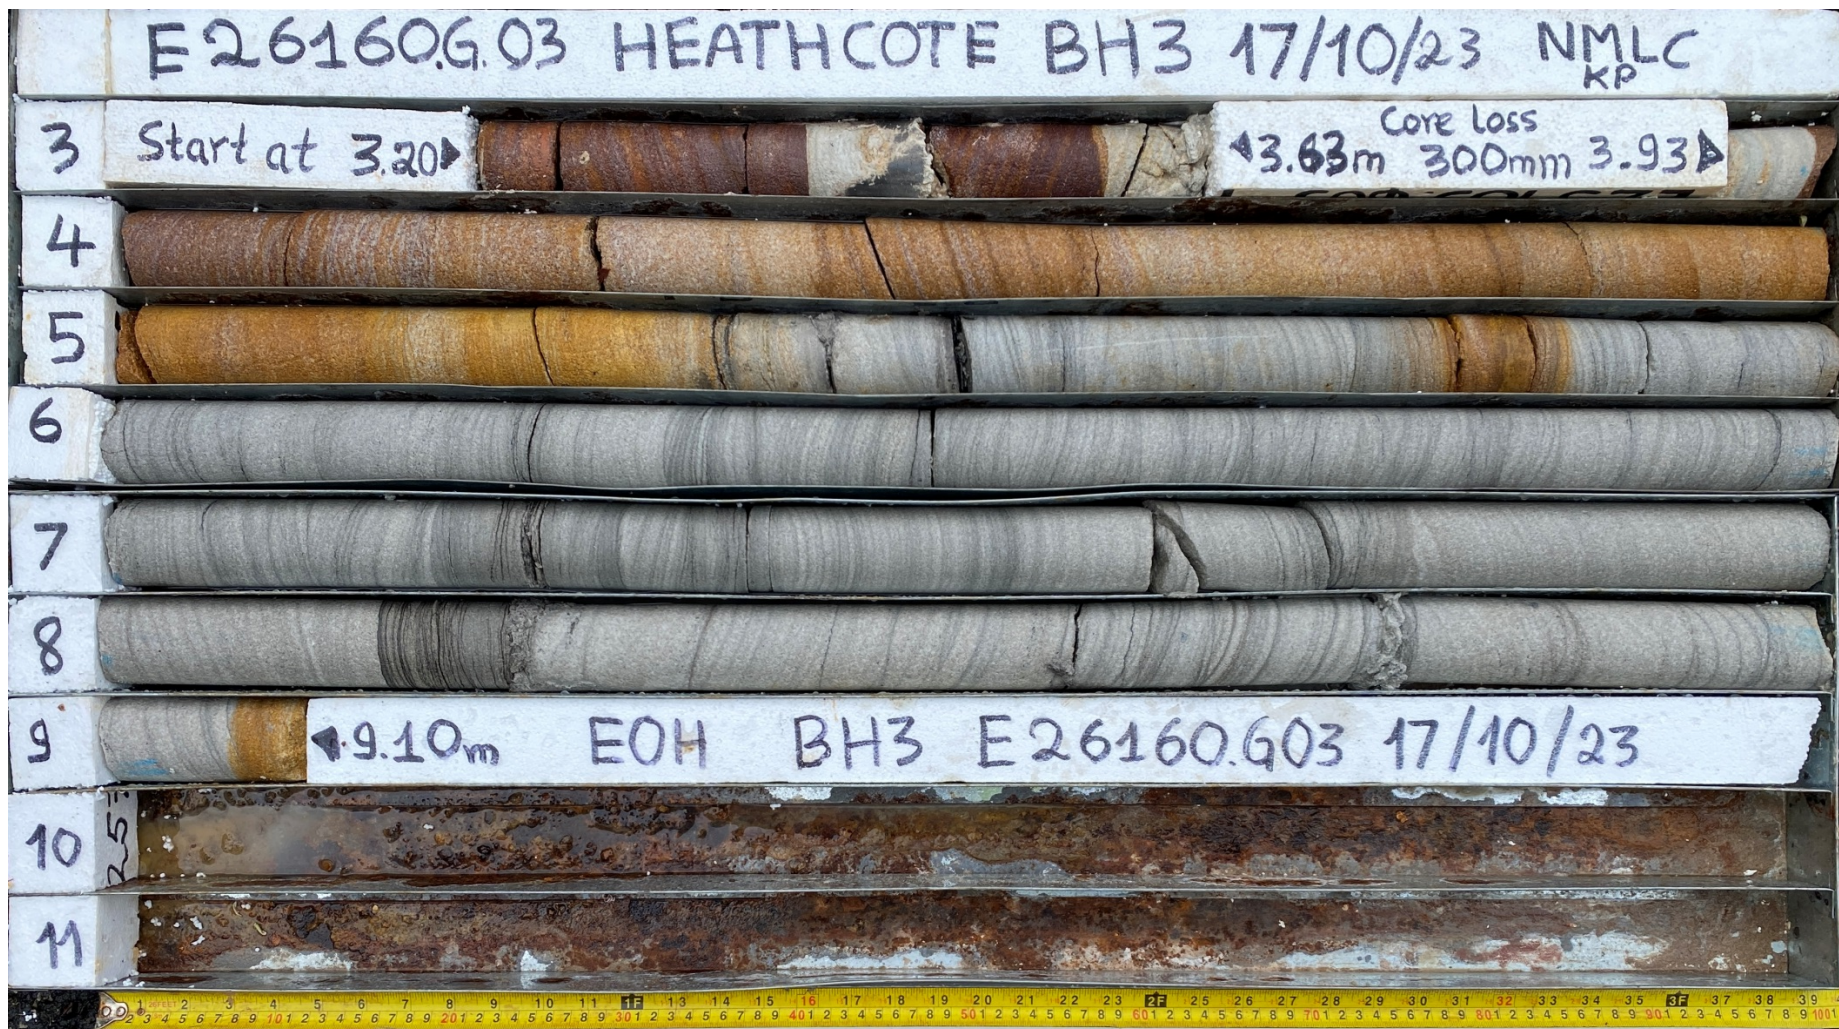
CORE PHOTOGRAPH OF BOREHOLE: BH3

Project	Proposed Mixed Use Development	East	316301.2868	Depth Range	3.2m to 9.1m BEGL		
Location	1 Veno Street,Heathcote, NSW	North	6226591.4992	Contractor	Geosense Drilling & Engineering Pty Ltd		
Position	See Figure 2	Surface RL	≈ 188.00m	Drill Rig	Comacchio Geo 205		
Job No.	E26160.G03	Inclination	-90°	Logged	KP	Date	17/10/2023
Client	Duffy Kennedy Constructions	Box	1 & 2 of 2	Checked	JS	Date	07/11/2023

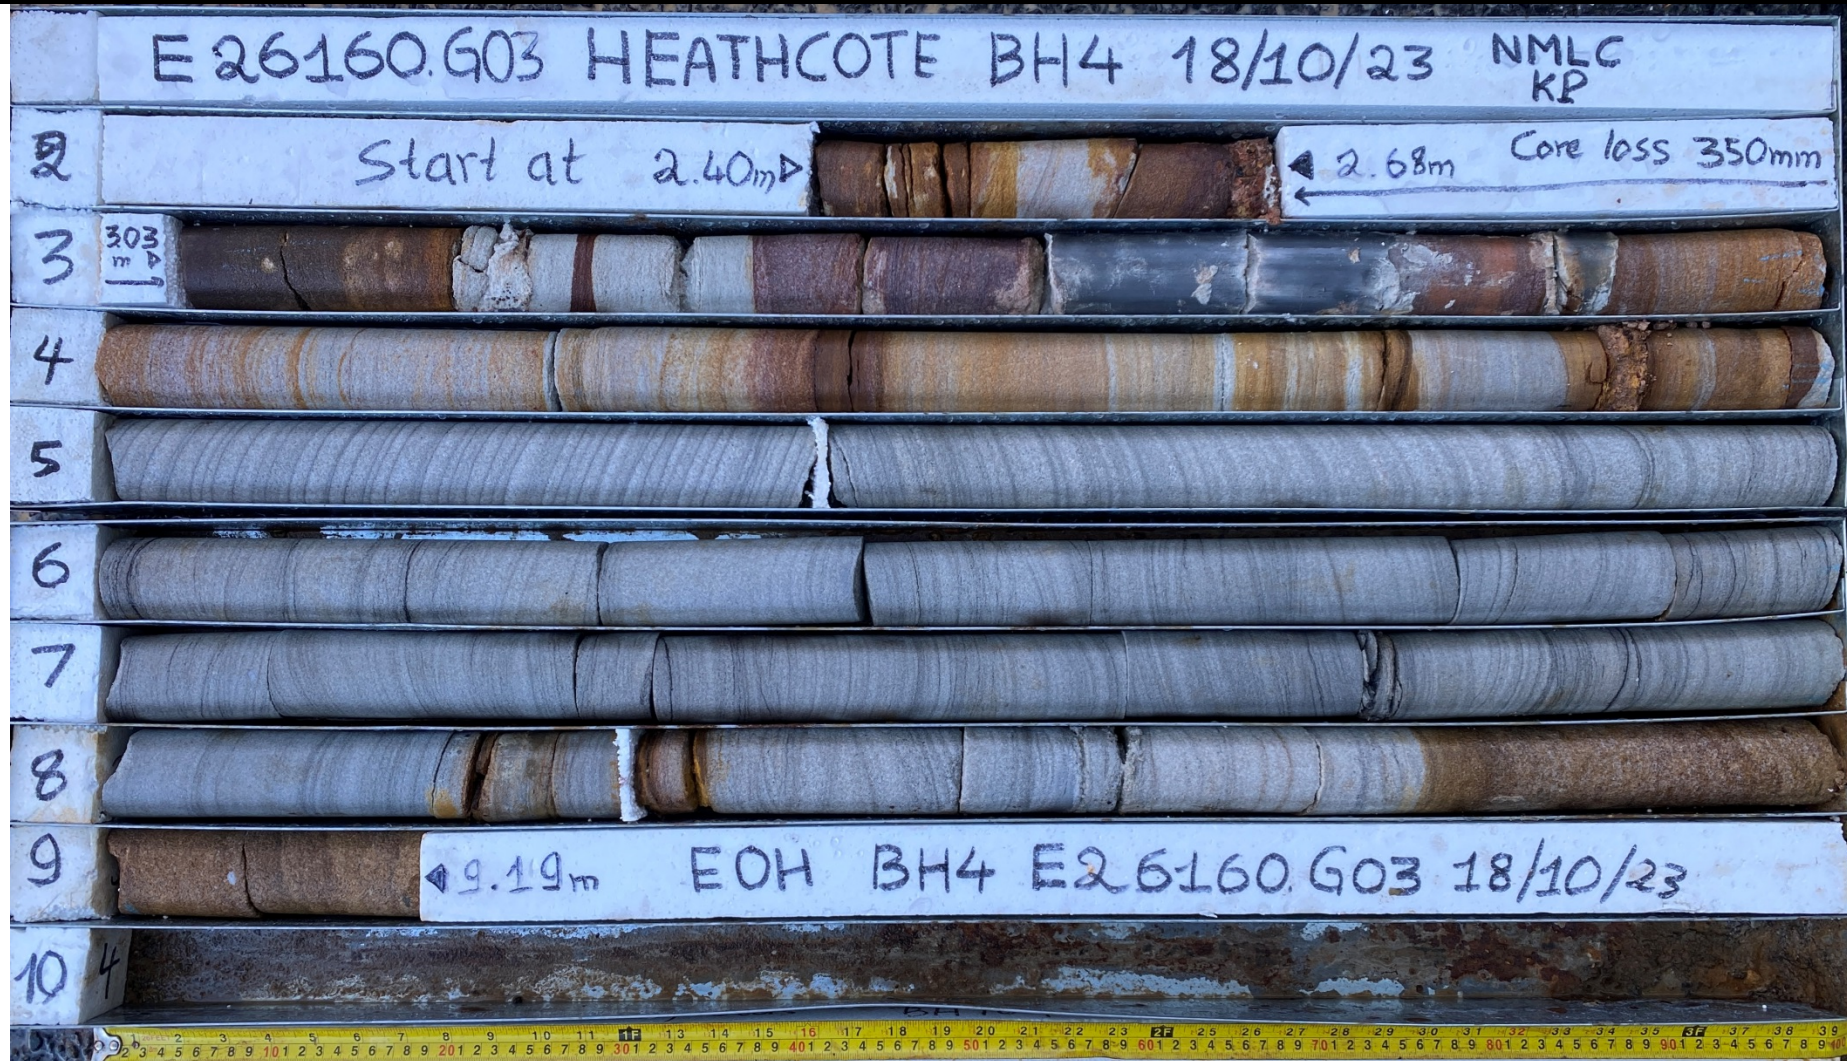
CORE PHOTOGRAPH OF BOREHOLE: BH4

Project	Proposed Mixed Use Development	East	316300.0181	Depth Range	2.4m to 9.19m BEGL	
Location	1 Veno Street, Heathcote, NSW	North	6226561.9038	Contractor	Geosense Drilling & Engineering Pty Ltd	
Position	See Figure 2	Surface RL	≈ 189.7m	Drill Rig	Comacchio Geo 205	
Job No.	E26160.G03	Inclination	-90°	Logged	KP	Date 18/10/2023
Client	Duffy Kennedy Constructions	Box	1 & 2 of 2	Checked	JS	Date 07/11/2023

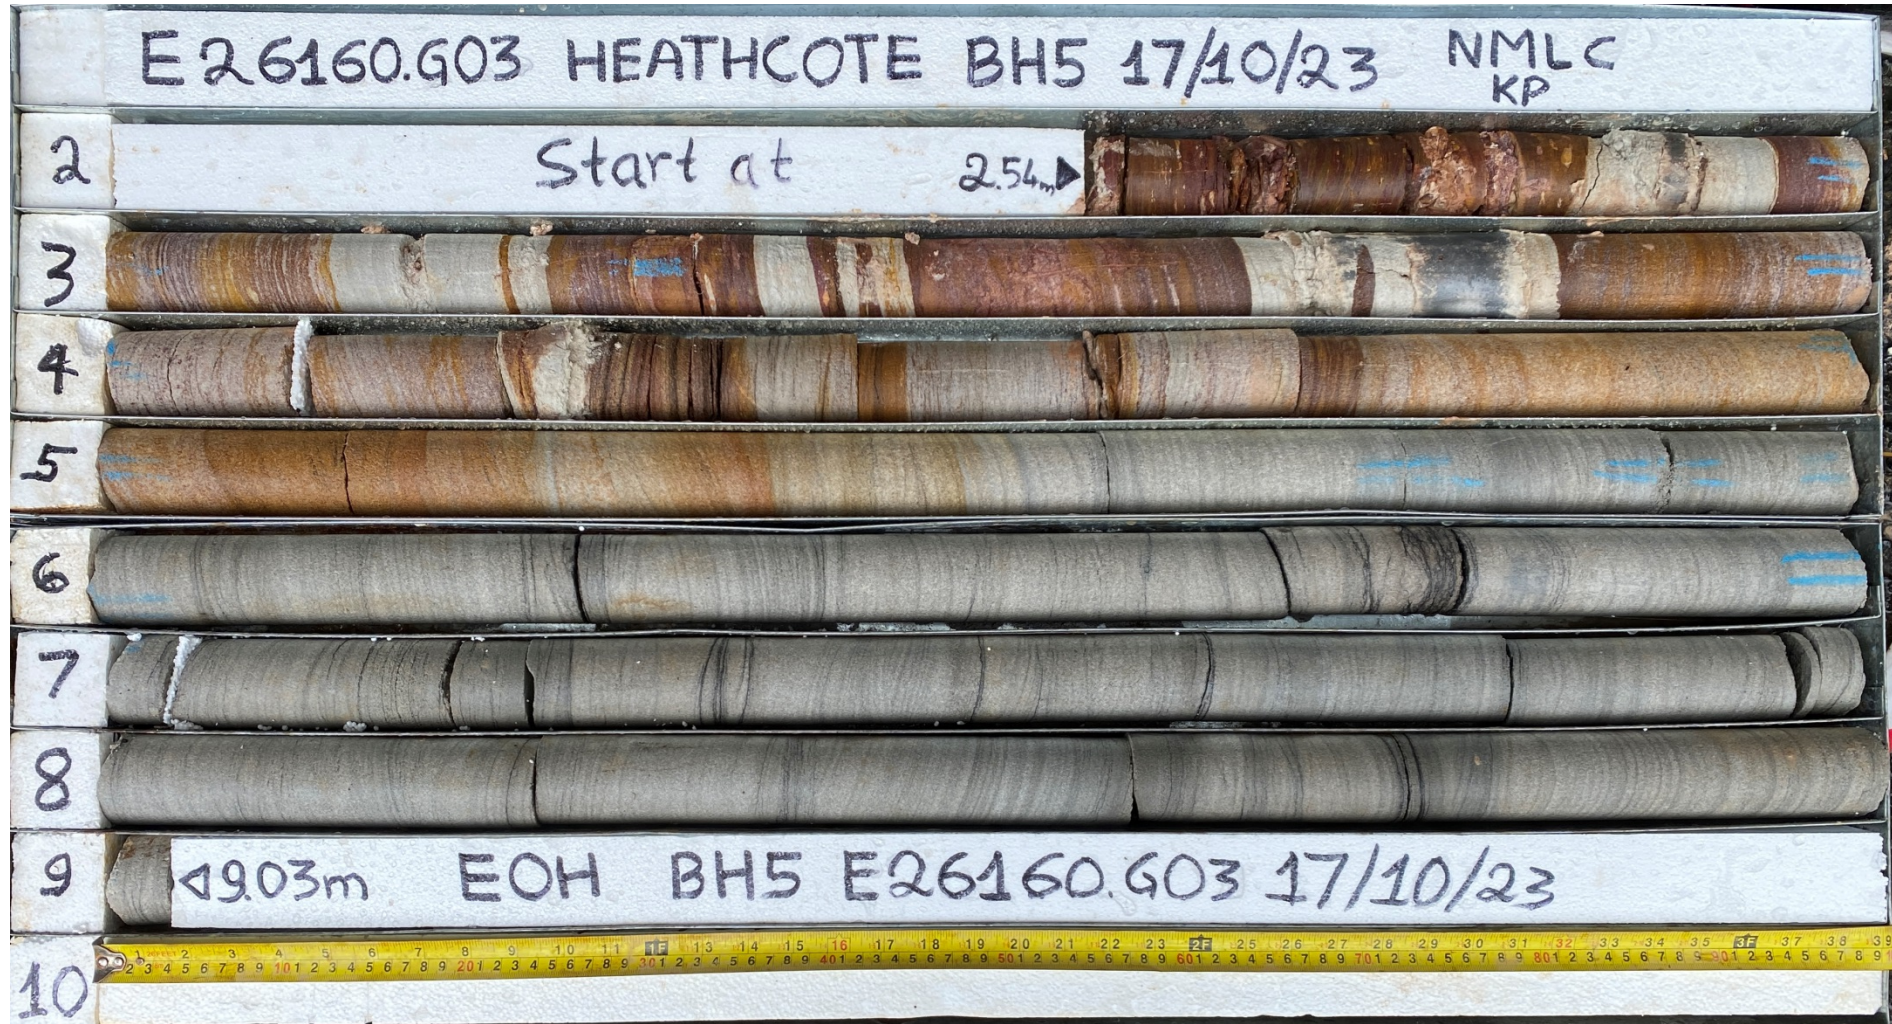
CORE PHOTOGRAPH OF BOREHOLE: BH5

Project	Proposed Mixed Use Development	East	316278.2197	Depth Range	2.54m to 9.03m BEGL		
Location	1 Veno Street,Heathcote, NSW	North	6226559.0172	Contractor	Geosense Drilling & Engineering Pty Ltd		
Position	See Figure 2	Surface RL	≈ 190.4m	Drill Rig	Comacchio Geo 205		
Job No.	E26160.G03	Inclination	-90°	Logged	KP	Date	17/10/2023
Client	Duffy Kennedy Constructions	Box	1 & 2 of 2	Checked	JS	Date	07/11/2023

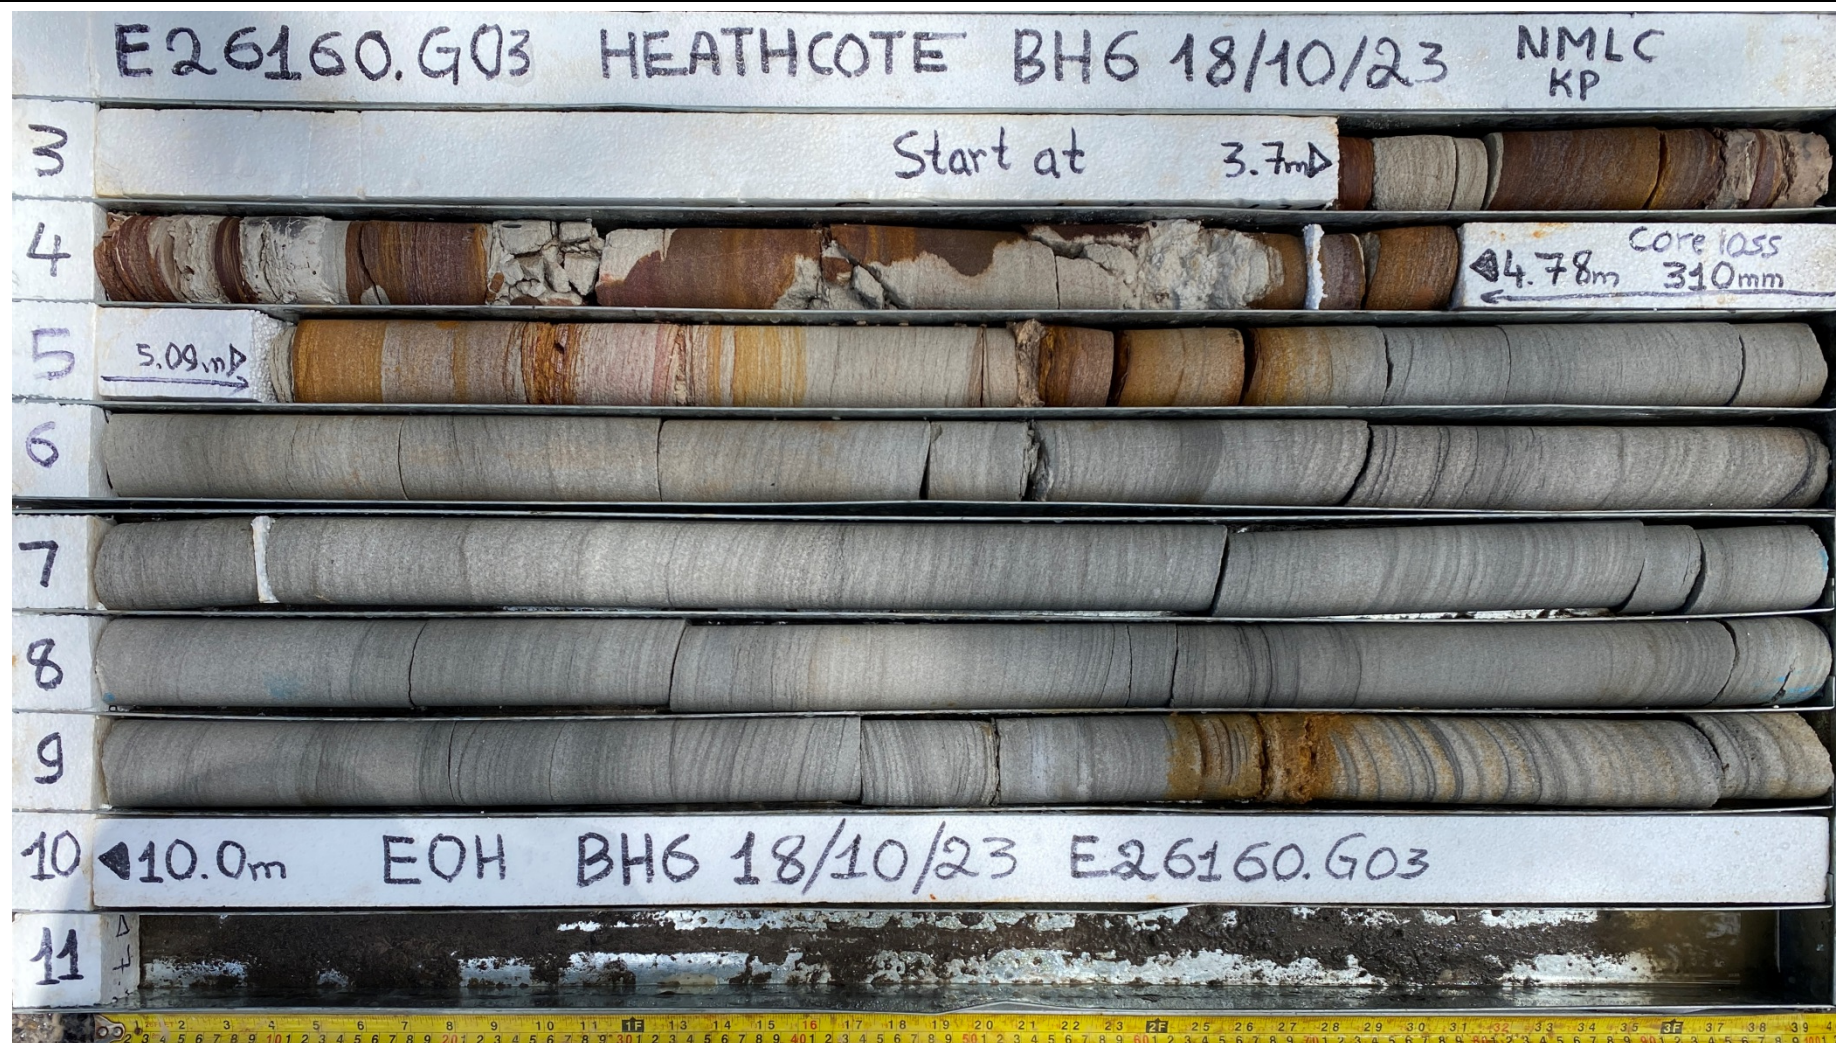
CORE PHOTOGRAPH OF BOREHOLE: BH6

Project	Proposed Mixed Use Development	East	316329.2122	Depth Range	3.70m to 10.00m BEGL		
Location	1 Veno Street, Heathcote, NSW	North	6226546.5107	Contractor	Geosense Drilling & Engineering Pty Ltd		
Position	See Figure 2	Surface RL	≈ 190.00m	Drill Rig	Comacchio Geo 205		
Job No.	E26160.G03	Inclination	-90°	Logged	KP	Date	18/10/2023
Client	Duffy Kennedy Constructions	Box	1 & 2 of 2	Checked	JS	Date	07/11/2023

- Unit 5 material (Class III Sandstone) to be exposed at BEL (RL182.35m AHD) of Building S1,
- Unit 5 material (Class III Sandstone) to be exposed across the majority of the basement footprint of Building S2 / S2-H at BEL (RL182.35m AHD). There is a potential that Class IV Sandstone (Material unit 4) may be encountered at some locations as observed in BH6.

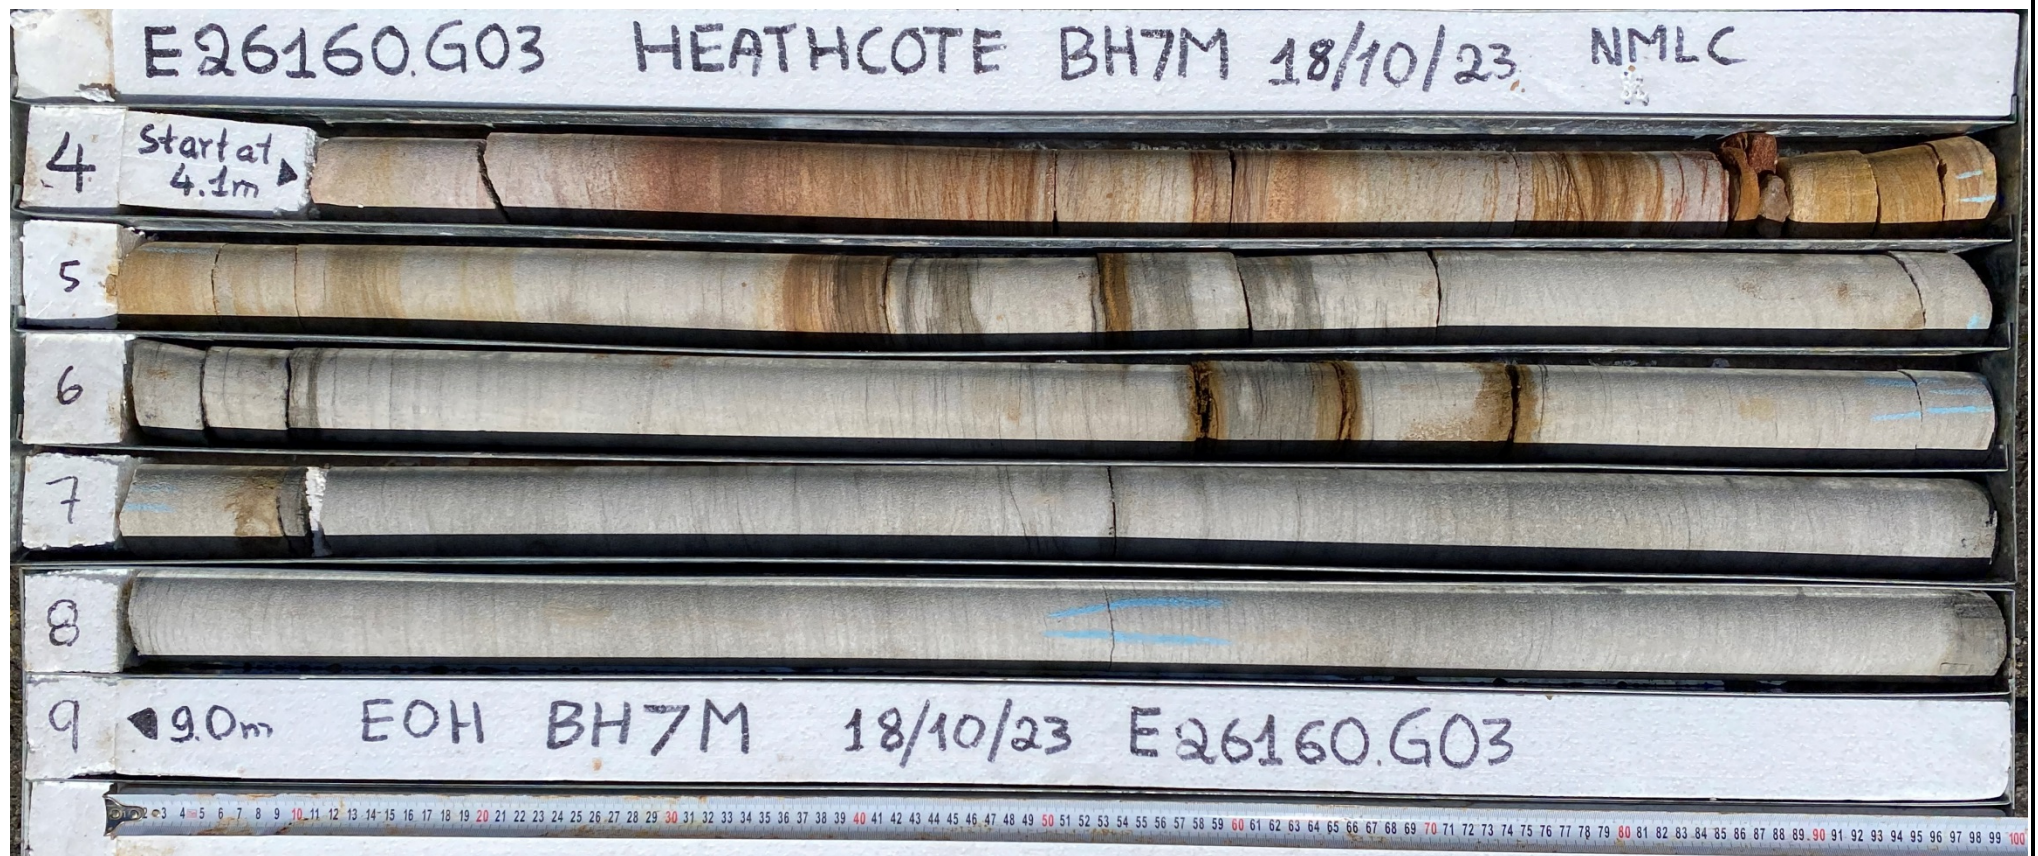
CORE PHOTOGRAPH OF BOREHOLE: BH7M

Project	Proposed Mixed Use Development	East	316351.9833	Depth Range	4.1m to 9.00m BEGL
Location	1 Veno Street, Heathcote, NSW	North	6226529.1240	Contractor	Macquarie Drilling Pty Ltd
Position	See Figure 2	Surface RL	≈ 190.9m	Drill Rig	Edson 100 Series
Job No.	E26160.G03	Inclination	-90°	Logged	KP Date 18/10/2023
Client	Duffy Kennedy Constructions	Box	1 & 2 of 2	Checked	JS Date 07/11/2023

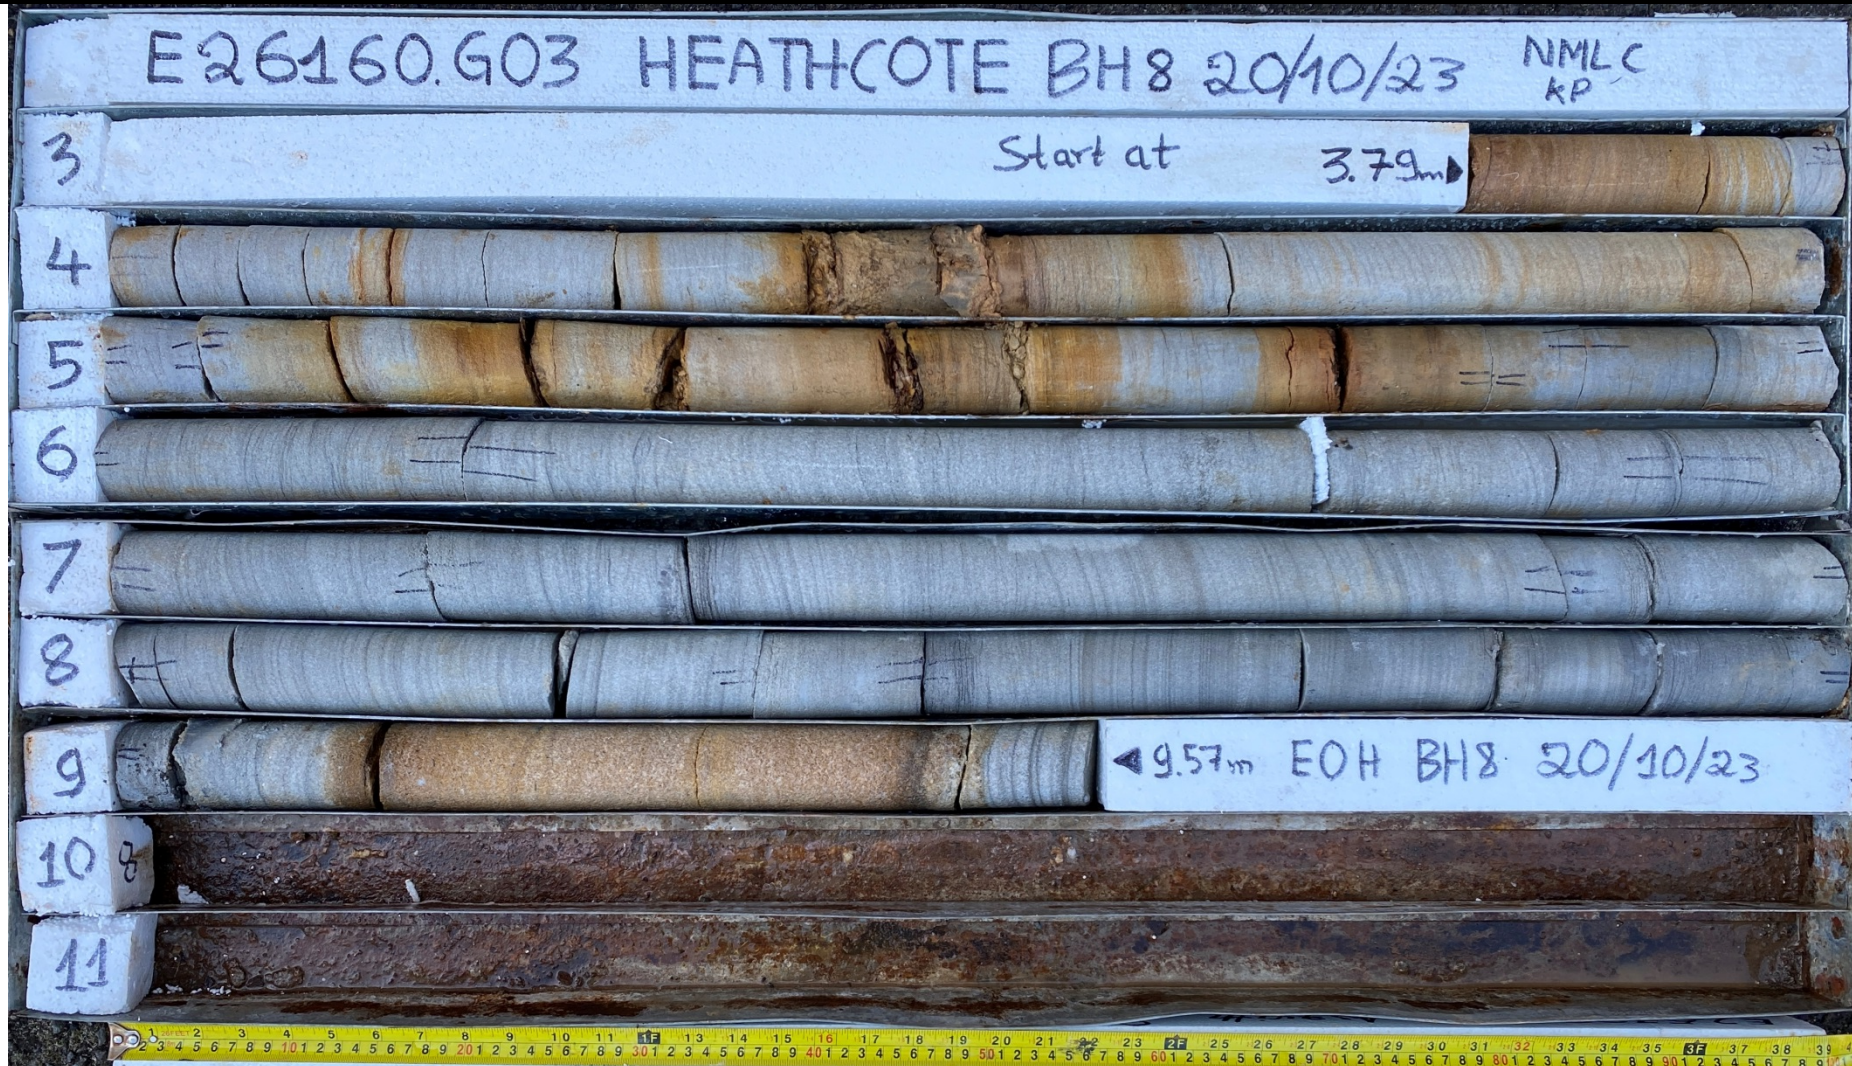
CORE PHOTOGRAPH OF BOREHOLE: BH8

Project	Proposed Mixed Use Development	East	316305.2038	Depth Range	3.79m to 9.57m BEGL		
Location	1 Veno Street, Heathcote, NSW	North	6226518.8532	Contractor	Geosense Drilling & Engineering Pty Ltd		
Position	See Figure 2	Surface RL	≈ 190.9m	Drill Rig	Comacchio Geo 205		
Job No.	E26160.G03	Inclination	-90°	Logged	KP	Date	20/10/2023
Client	Duffy Kennedy Constructions	Box	1 & 2 of 2	Checked	JS	Date	07/11/2023

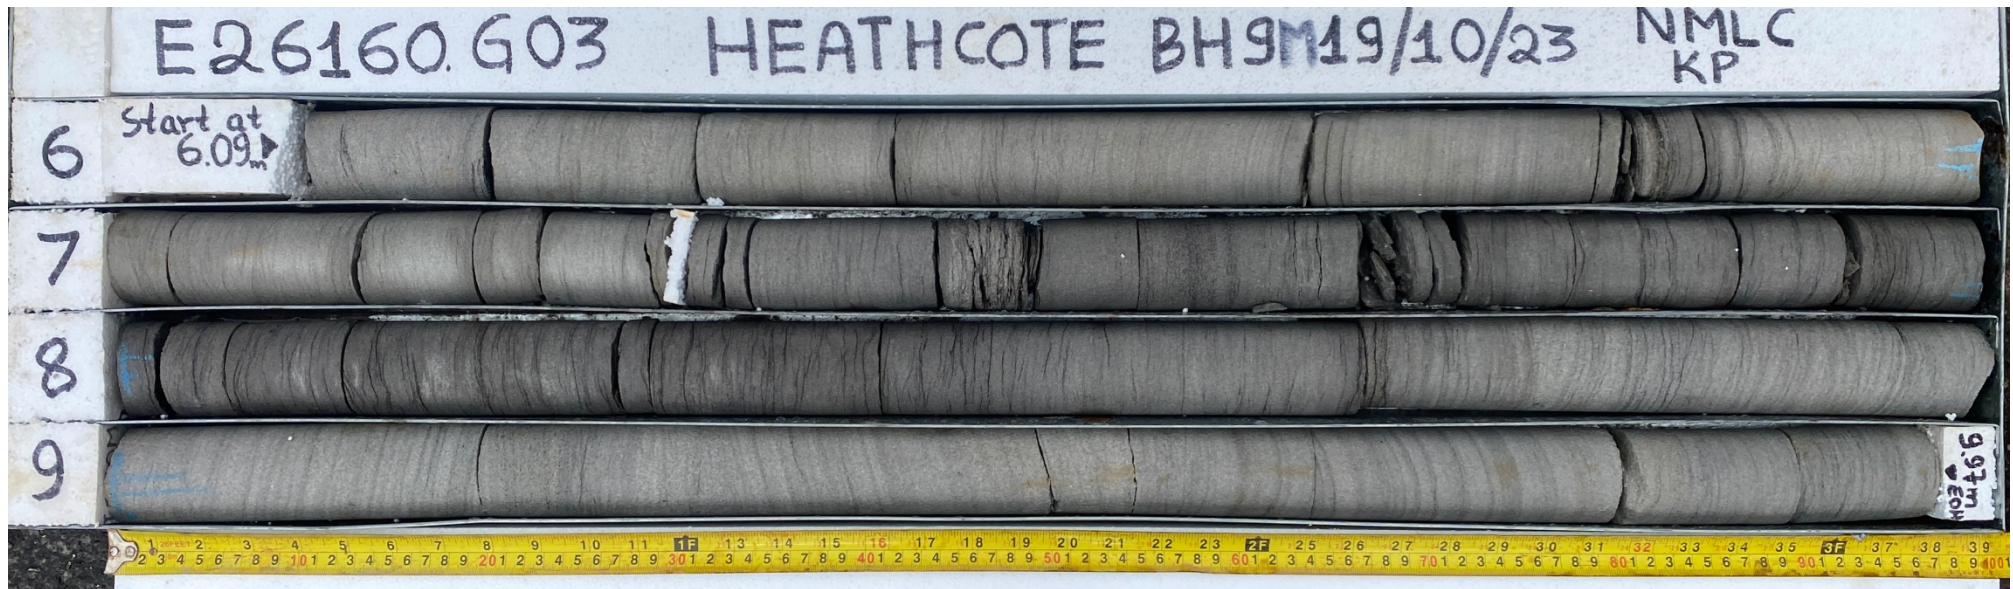
CORE PHOTOGRAPH OF BOREHOLE: BH9M

Project	Proposed Mixed Use Development	East	316331.0335	Depth Range	6.09m to 9.97m BEGL
Location	1 Veno Street, Heathcote, NSW	North	6226511.5868	Contractor	Geosense Drilling & Engineering Pty Ltd
Position	See Figure 2	Surface RL	≈ 191.9m	Drill Rig	Comacchio Geo 205
Job No.	E26160.G03	Inclination	-90°	Logged	KP Date 19/10/2023
Client	Duffy Kennedy Constructions	Box	1 of 1	Checked	JS Date 07/11/2023

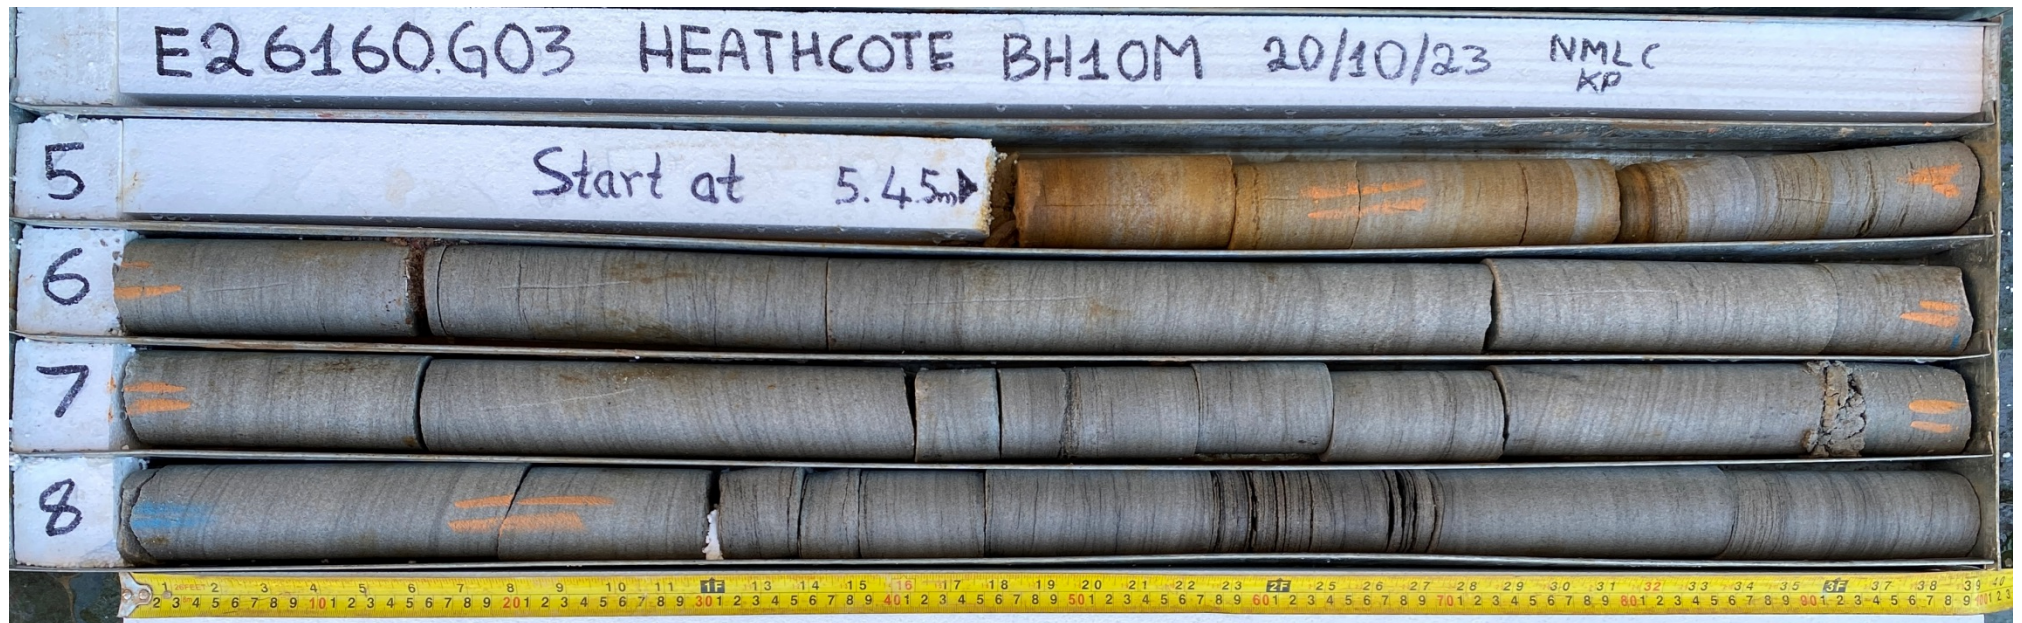
CORE PHOTOGRAPH OF BOREHOLE: BH10M

Project	Proposed Mixed Use Development	East	316278.7709	Depth Range	5.45m to 9.00m BEGL		
Location	1 Veno Street, Heathcote, NSW	North	6226519.3167	Contractor	Geosense Drilling & Engineering Pty Ltd		
Position	See Figure 2	Surface RL	≈ 191.4m	Drill Rig	Comacchio Geo 205		
Job No.	E26160.G03	Inclination	-90°	Logged	KP	Date	20/10/2023
Client	Duffy Kennedy Constructions	Box	1 of 1	Checked	JS	Date	07/11/2023
