Geotechnical Investigation

143A Stoney Creek Road, Beverly Hills, NSW

Report No: E23967.G03_Rev4

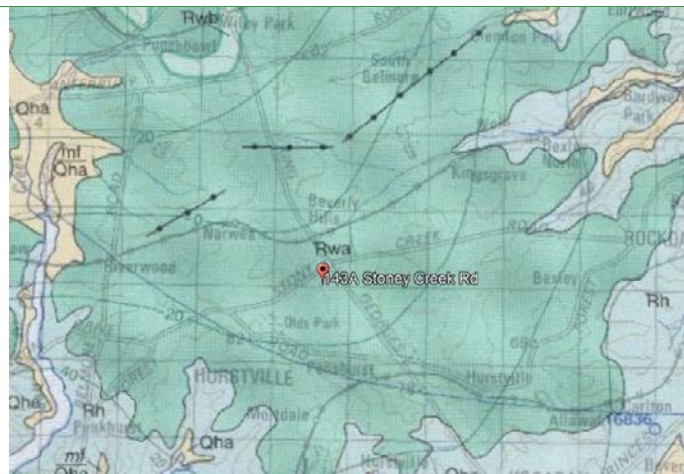
Plate 2: Excerpt of geological map showing location of site.

Attribute	Description
Topography	The site is flat and raised up in relation to the surrounding topography. The site levels are at RL 29.9 to 30.1m whereas the surrounding topography dips gently ($<10^\circ$) towards the north with site levels varying from RL 30.1 at the southern corner to RL 29.4 at the northern corner.
Regional Geology	Information on regional sub-surface conditions, referenced from the Department of Mineral Resources Geological Map Sydney 1:100,000 Geological Series Sheet 9130 (DMR 1983) indicates the site to be underlain by Ashfield Shale, which consists of black to dark grey shale and laminite.

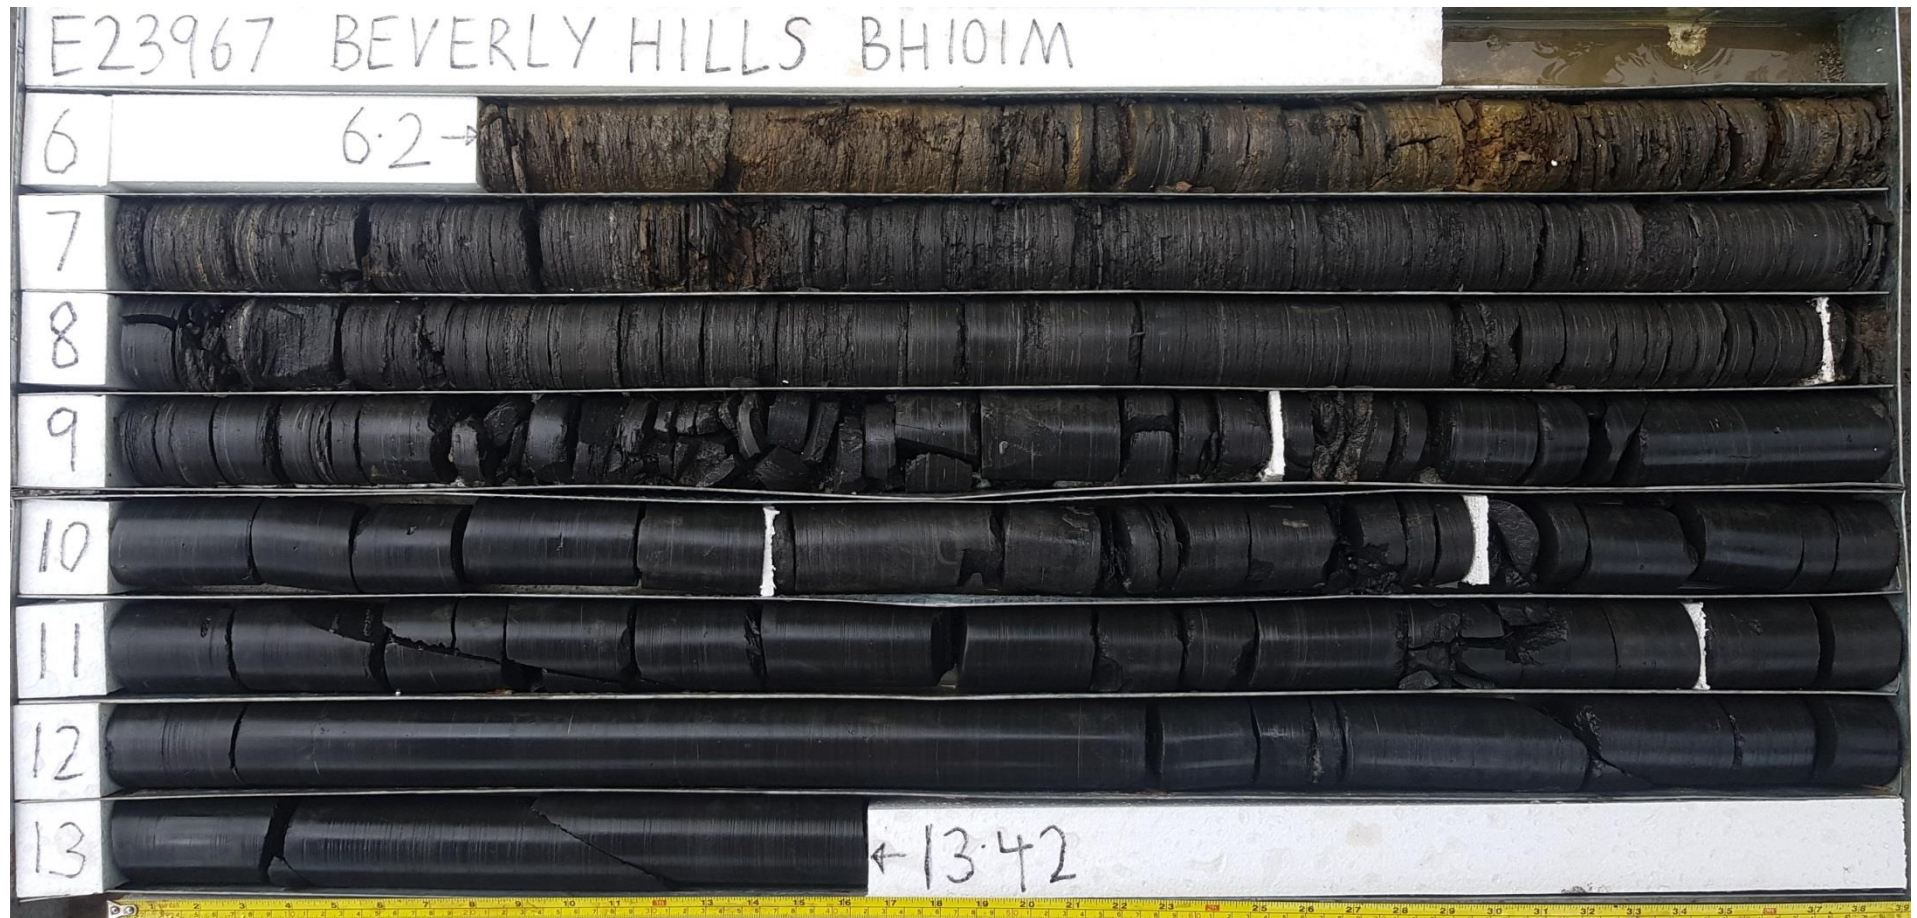
CORE PHOTOGRAPH OF BOREHOLE: BH101M

Project	Proposed Residential Development	Depth Range	6.2m to 13.42m BEGL	
Location	143A Stoney Creek Road, Beverly Hills NSW	Contractor	Geosense Drilling Engineers Pty Ltd	
Position	See Figure 2	Drill Rig	Tight Access Rig	
Job No.	E23967.G03	Logged	DS	Date 17 / 02 / 2020
Client	Cambridge Unit Developments Pty Ltd	Checked	SK	Date 19 / 03 / 2020
		Surface RL	≈ 29.9m	
		Inclination	-90°	
		Box	1-2 of 2

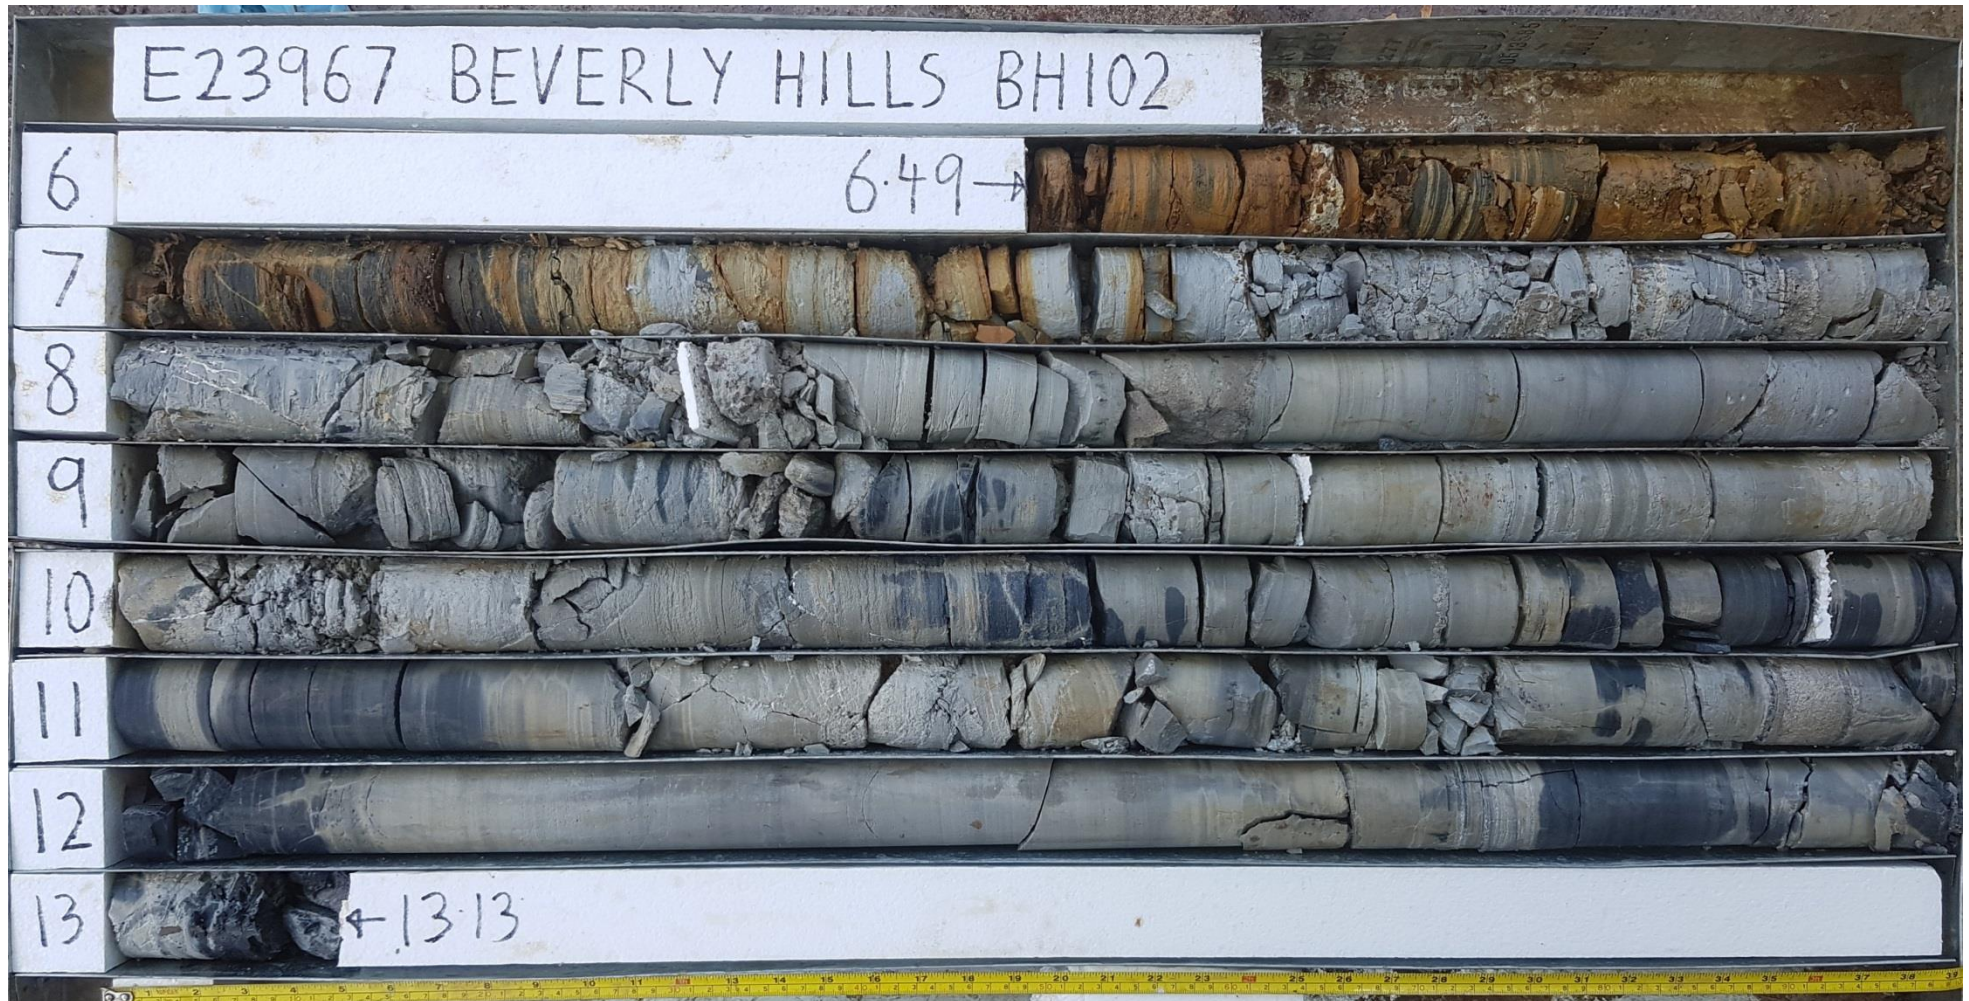
CORE PHOTOGRAPH OF BOREHOLE: BH102

Project	Proposed Residential Development	Depth Range	6.49m to 13.13m BEGL	
Location	143A Stoney Creek Road, Beverly Hills NSW	Contractor	Geosense Drilling Engineers Pty Ltd	
Position	See Figure 2	Drill Rig	Tight Access Rig	
Job No.	E23967.G03	Logged	DS	Date 17 / 02 / 2020
Client	Cambridge Unit Developments Pty Ltd	Box	1-2 of 2	Checked SK Date 19 / 03 / 2020
		Surface RL	≈ 30.1m	
		Inclination	-90°

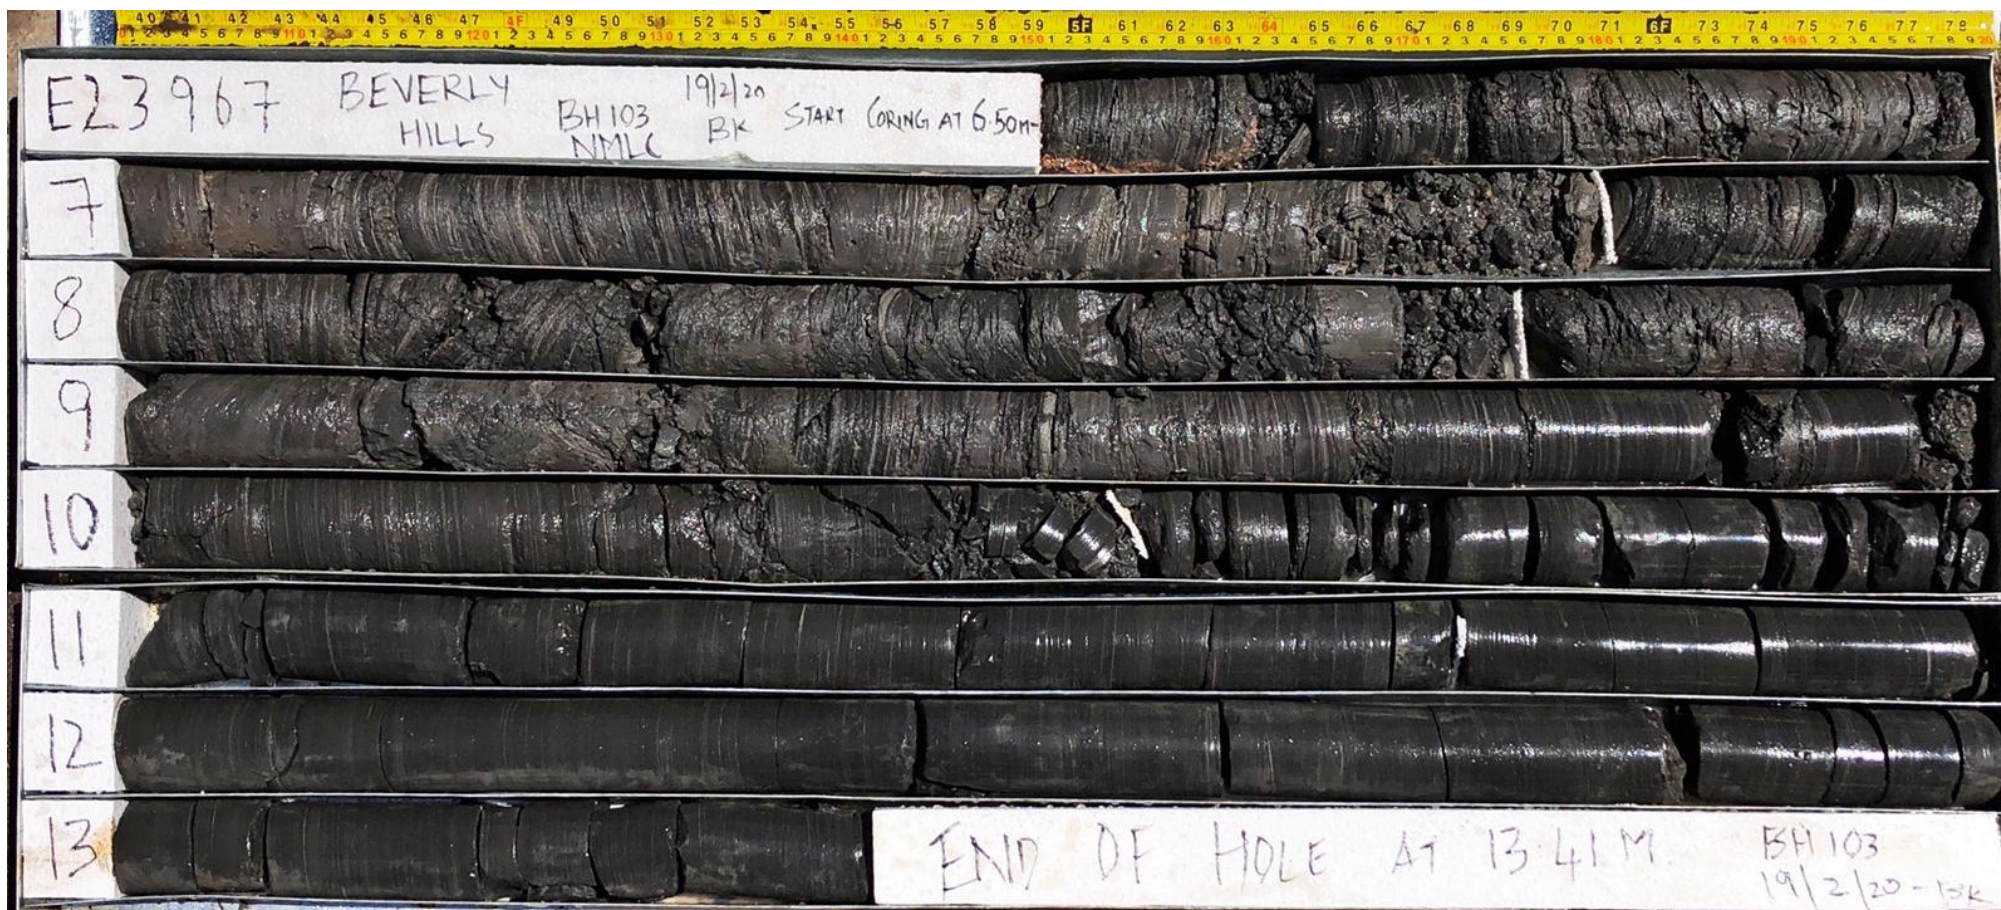
CORE PHOTOGRAPH OF BOREHOLE: BH103

Project	Proposed Residential Development	Depth Range	6.5m to 13.41m BEGL	
Location	143A Stoney Creek Road, Beverly Hills NSW	Contractor	Geosense Drilling Engineers Pty Ltd	
Position	See Figure 2	Drill Rig	Tight Access Rig	
Job No.	E23967.G03	Logged	DS	Date 18 / 02 / 2020
Client	Cambridge Unit Developments Pty Ltd	Box	1-2 of 2	Checked SK Date 19 / 03 / 2020
		Surface RL	≈ 30.0m	
		Inclination	-90°

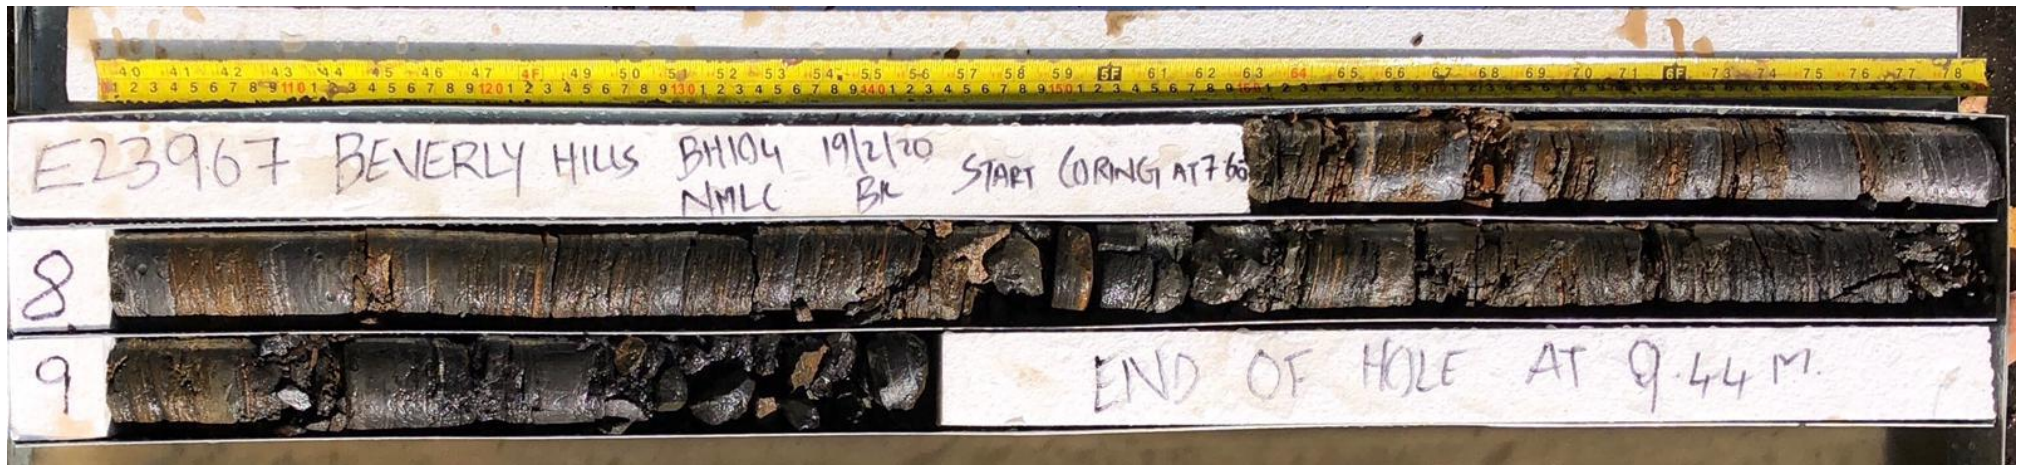
CORE PHOTOGRAPH OF BOREHOLE: BH104

Project	Proposed Residential Development	Depth Range	7.6m to 9.44m BEGL	
Location	143A Stoney Creek Road, Beverly Hills NSW	Contractor	Geosense Drilling Engineers Pty Ltd	
Position	See Figure 2	Drill Rig	Tight Access Rig	
Job No.	E23967.G03	Logged	BK	Date 19 / 02 / 2020
Client	Cambridge Unit Developments Pty Ltd	Checked	SK	Date 19 / 03 / 2020
		Surface RL	≈ 30.0m	
		Inclination	-90°	
		Box	1 of 1
