## Detailed Site Investigation

143A Stoney Creek Rd, Beverly Hills NSW

Report Title: Detailed Site Investigation

Report No: E23967.E02\_Rev2

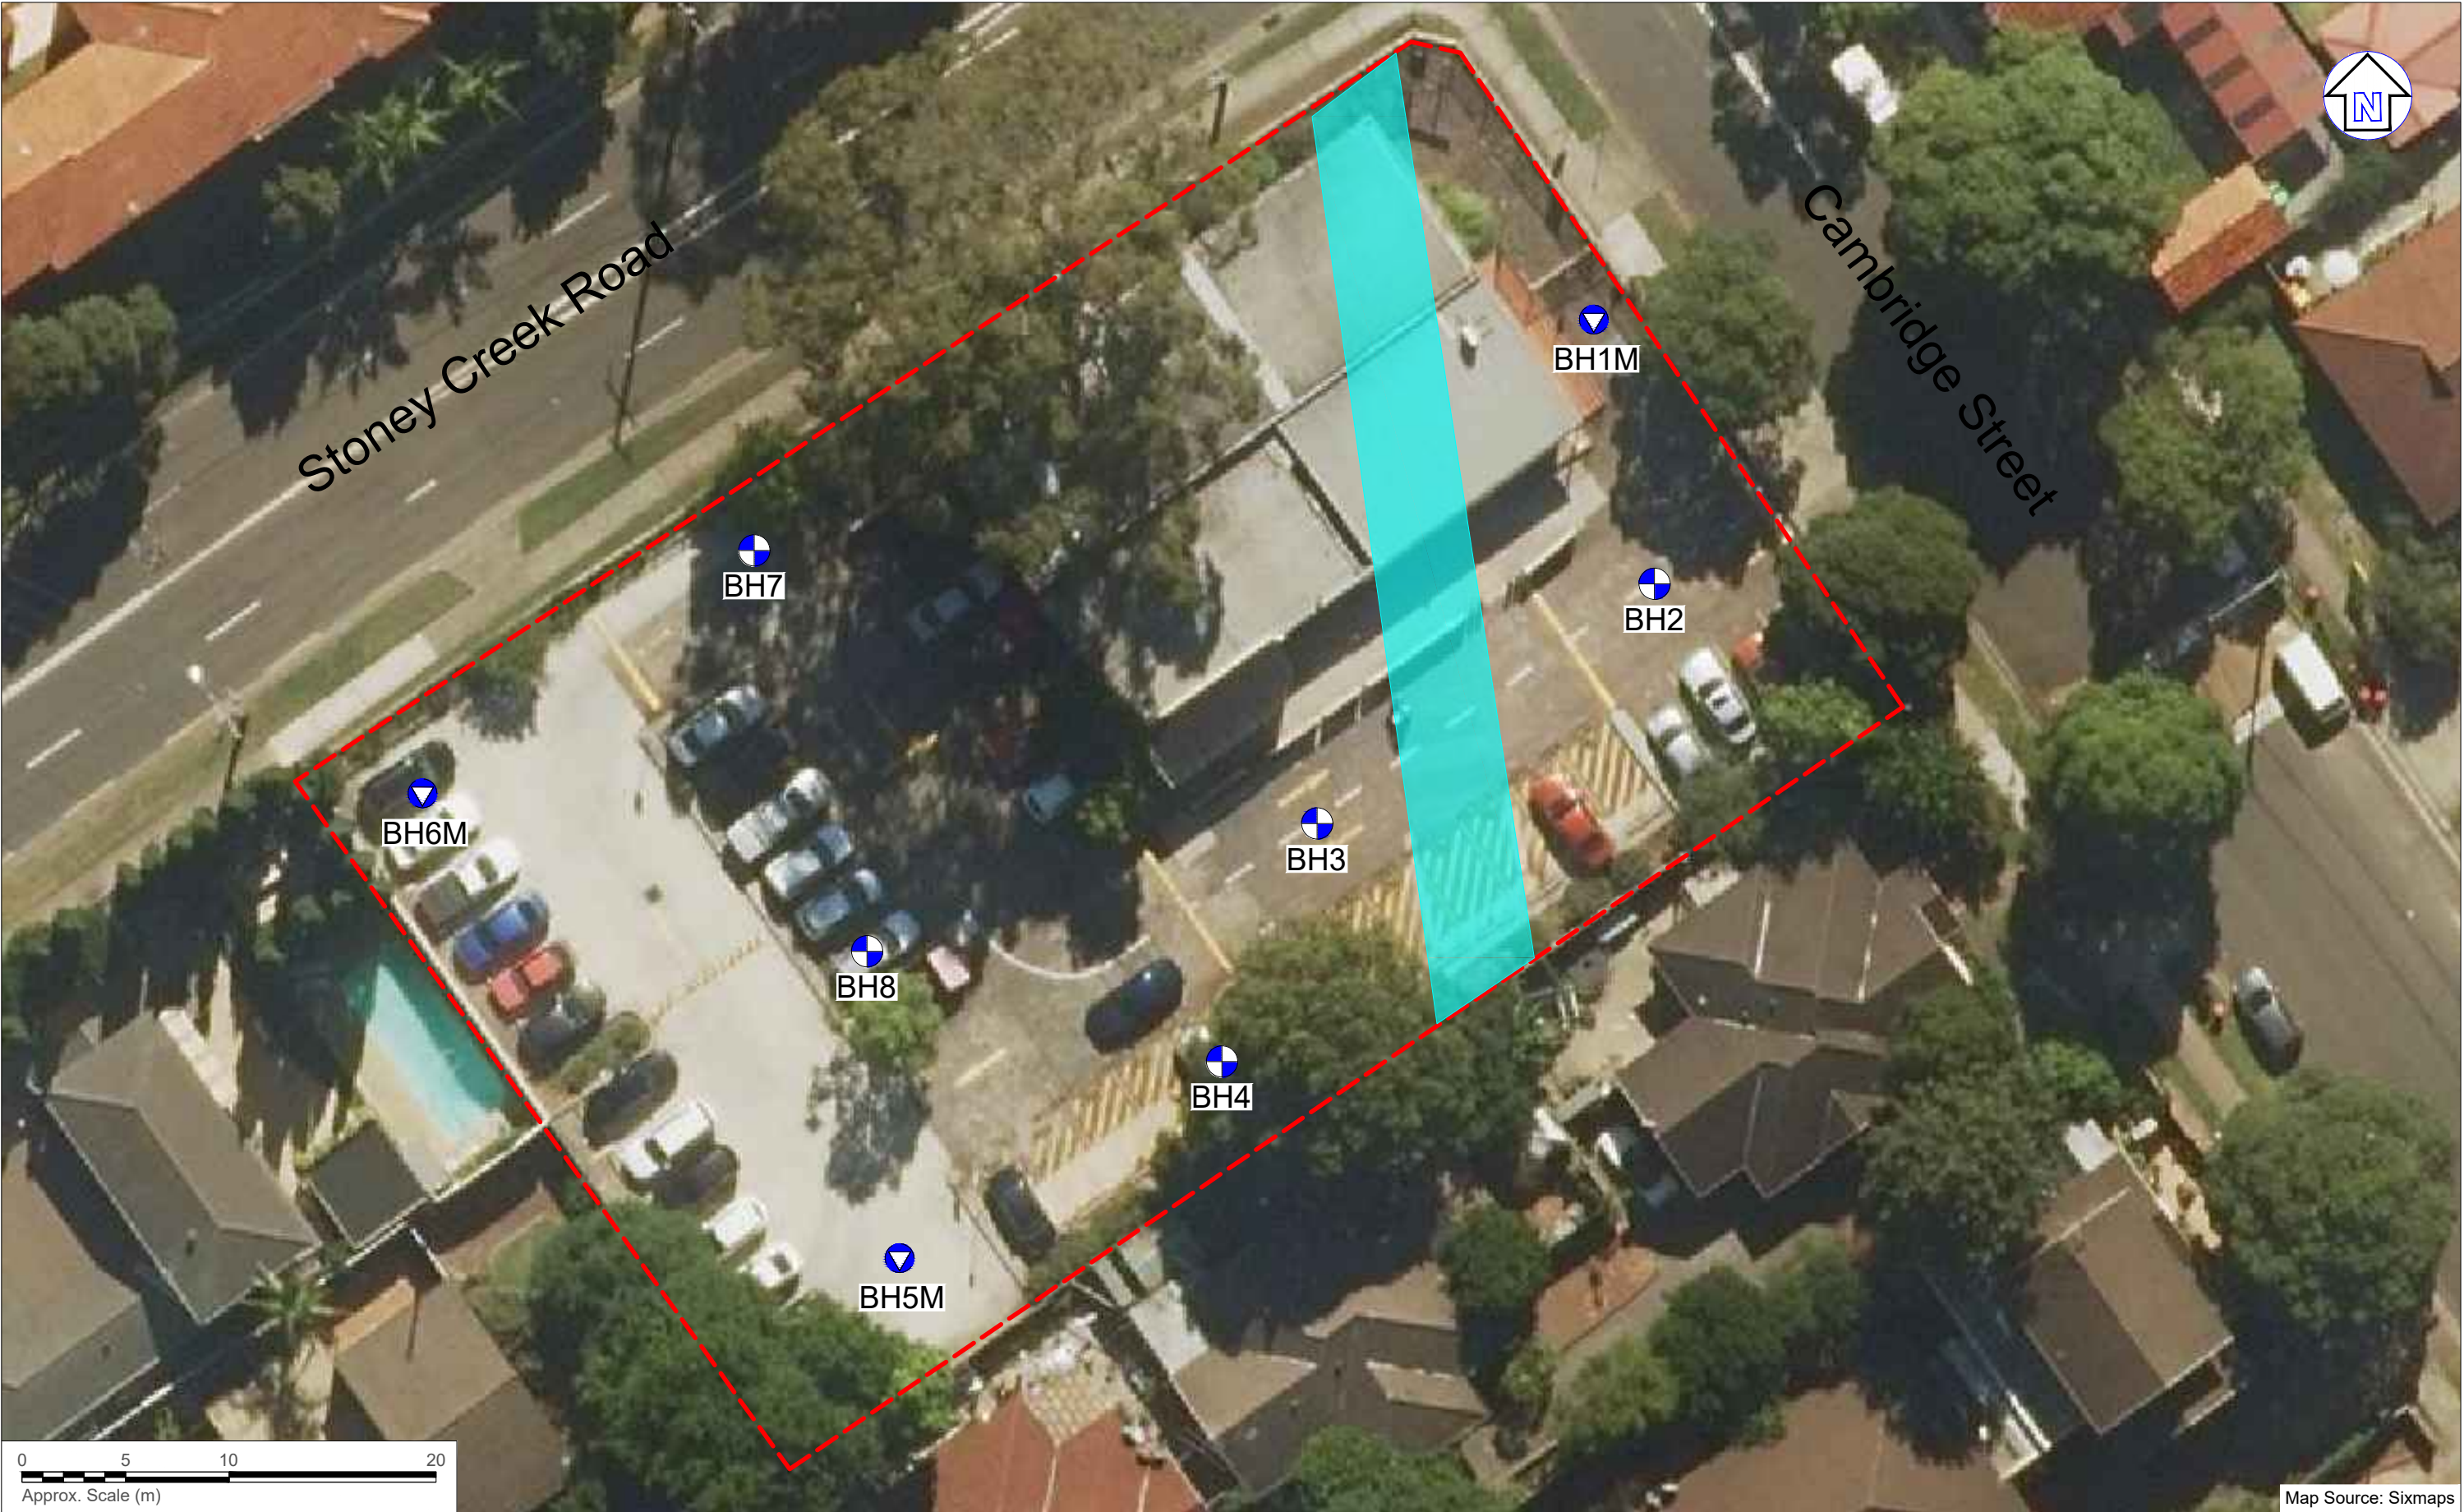
- Approximate site boundary
- ▼ Approximate borehole/monitoring well location
- ⊕ Approximate borehole location
- Approximate location of storm water easement
