ASBESTOS CLEARANCE & SOIL CONTAMINATION ASSESSMENT

January 2020
J160879-01

NSW Land and Housing
Corporation

50 Wellington Road, Chester
Hill NSW

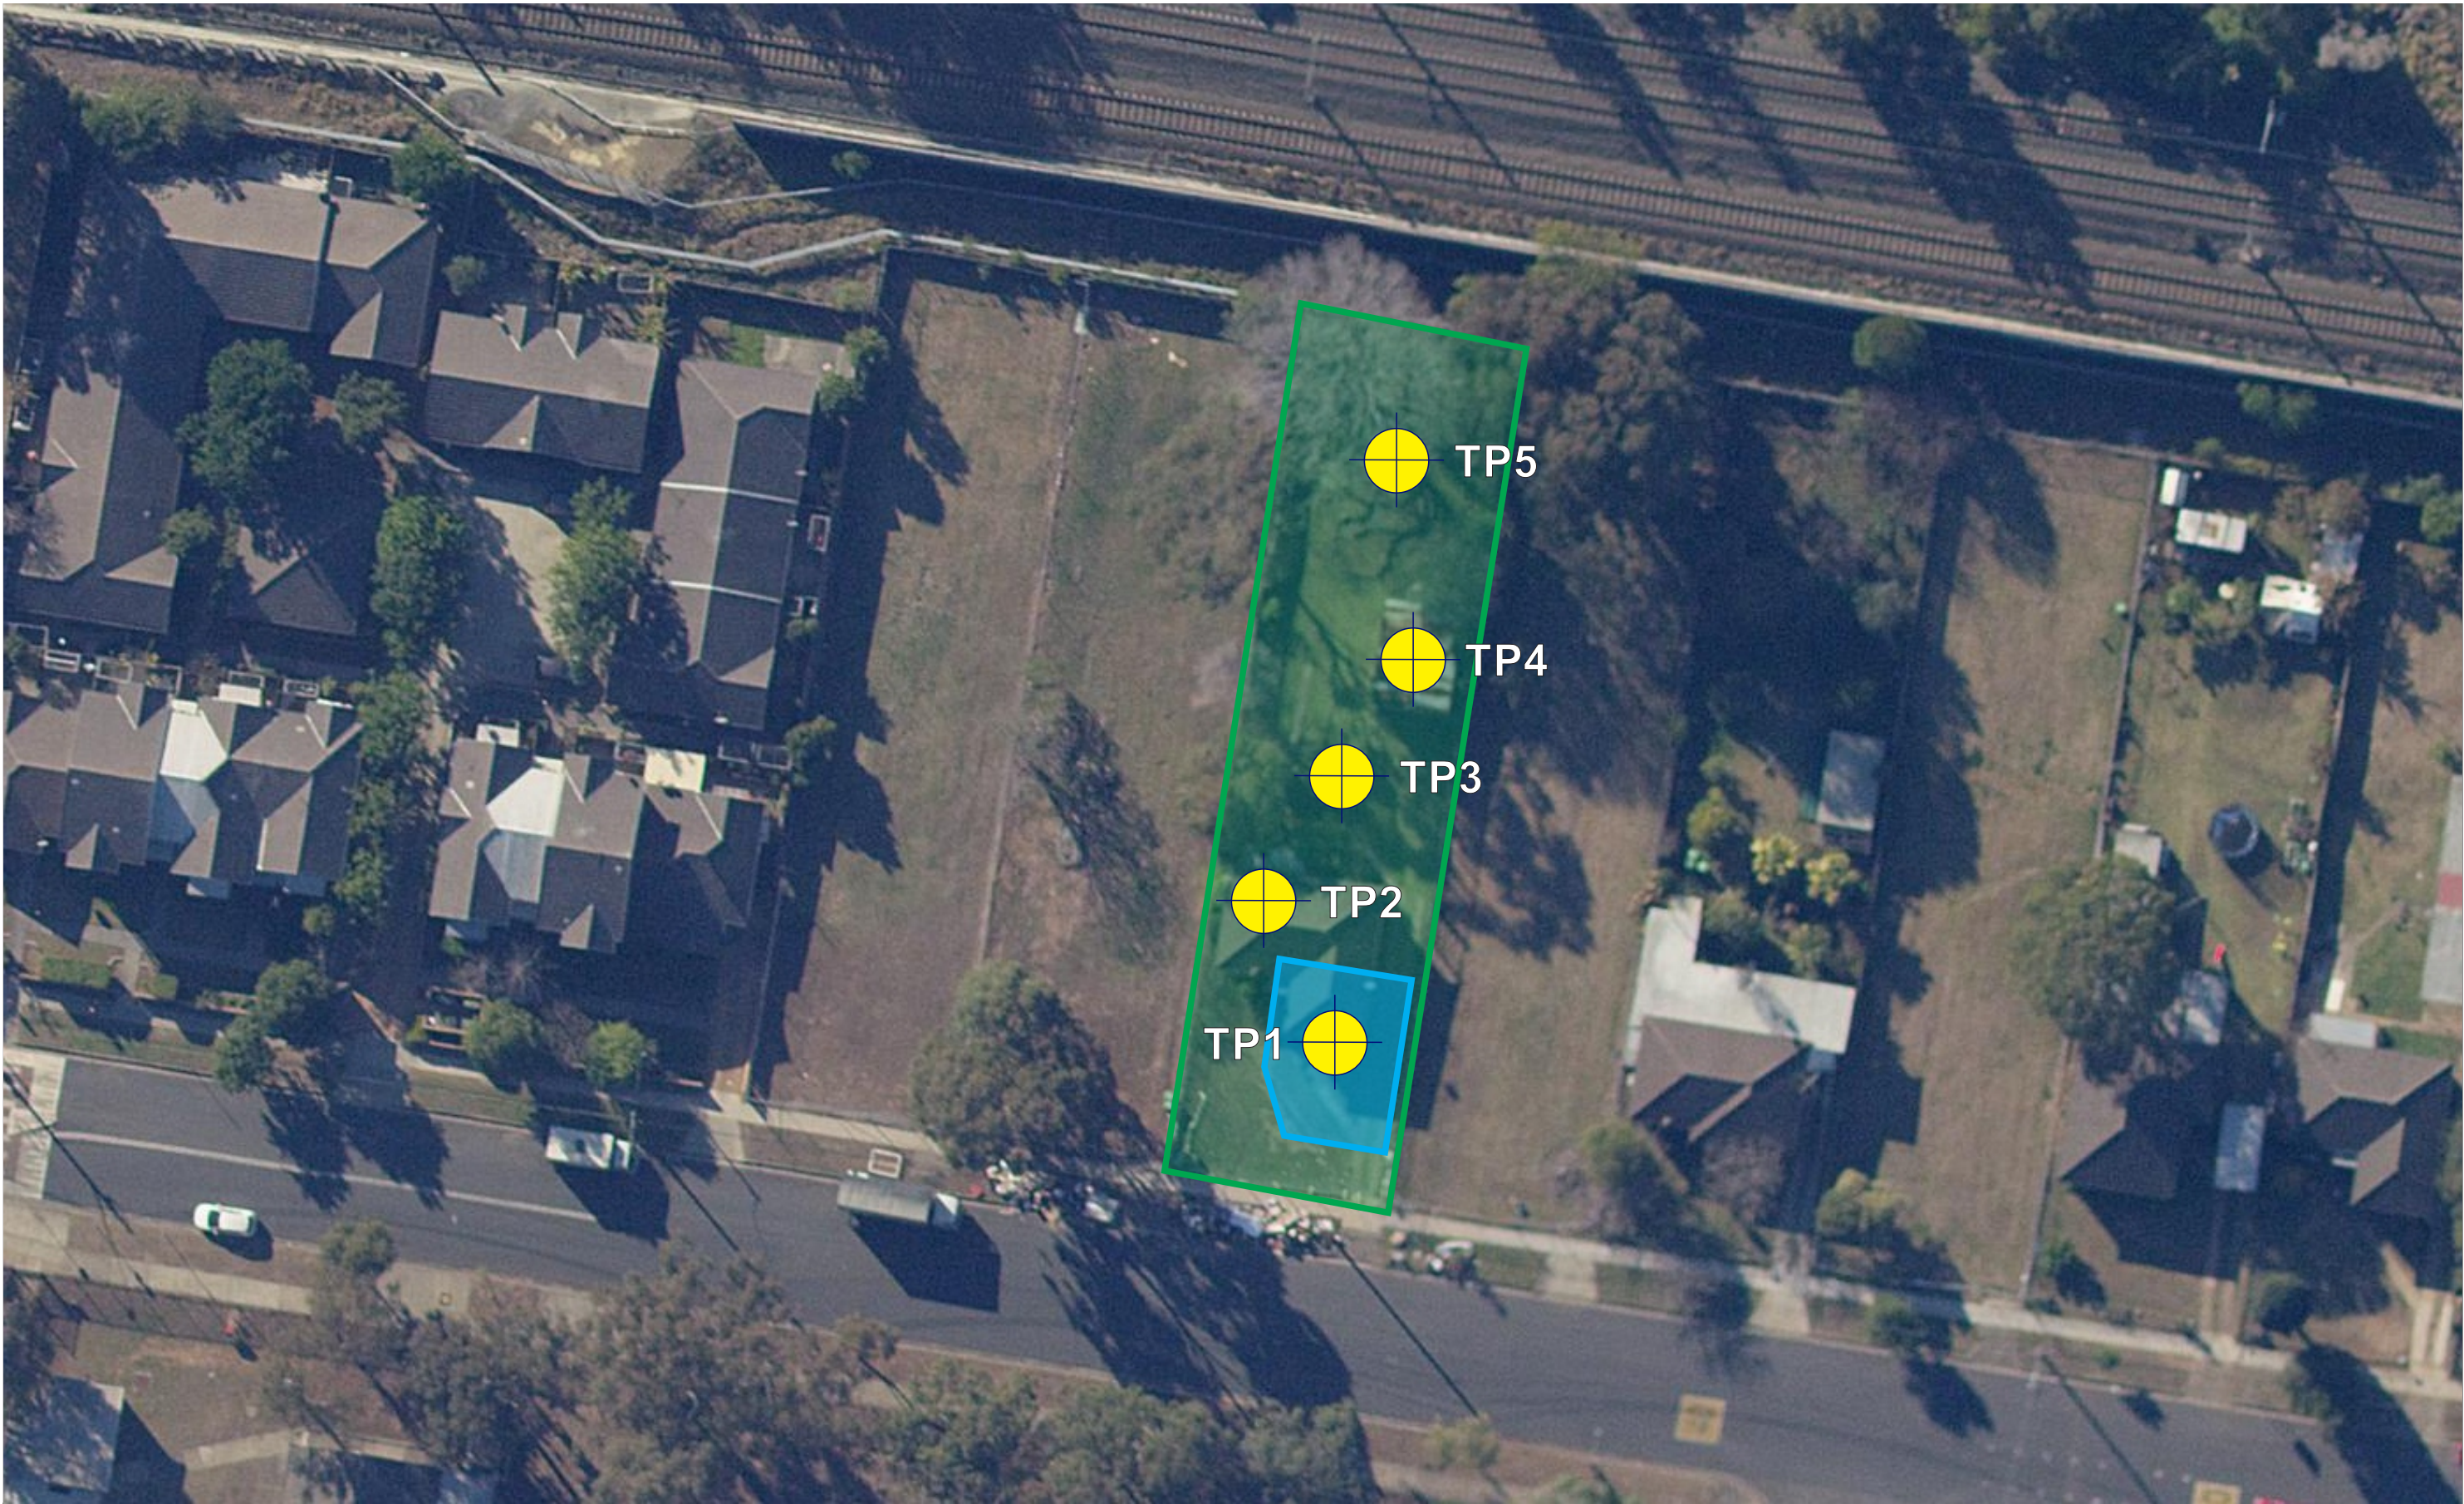
A total of five targeted test pit locations were chosen for the site (refer to *Figure 2* for sampling locations). Sampling targeted the former building footprints.

- Site/Asbestos Clearance Boundary
- Test Pit Location
- Approximate Remediation Boundary

Following receipt of asbestos laboratory results and the identification of asbestos in soil exceeding the adopted criteria surrounding test pit TP1 (*Figure 2*), Greencap undertook an additional walkover inspection upon completion of the remediation works on the 13th January 2020 (refer to *Appendix A - Photographs 5-6*) and collected a composite soil asbestos validation sample from the excavation surface.

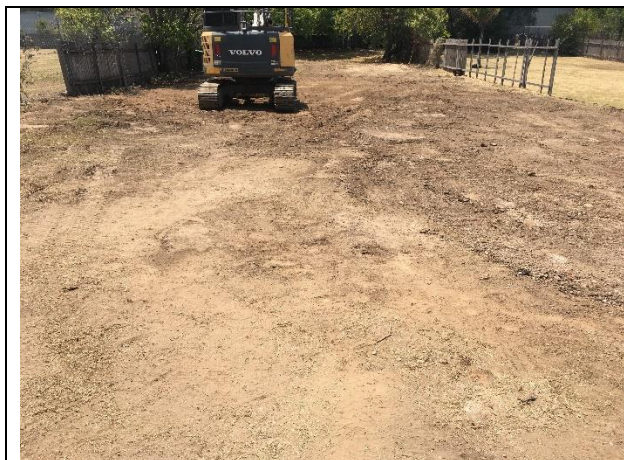
Photograph 1: West facing view of the site.

An initial walkover inspection was undertaken on the 18th December 2019 (refer to *Appendix A - Photographs 1-2*). During this inspection, ACM in the form of a fibre cement sheet fragment was emu picked and removed from the soil surface of the south-eastern portion of the site. No other potential ACM fragments were observed during this inspection.

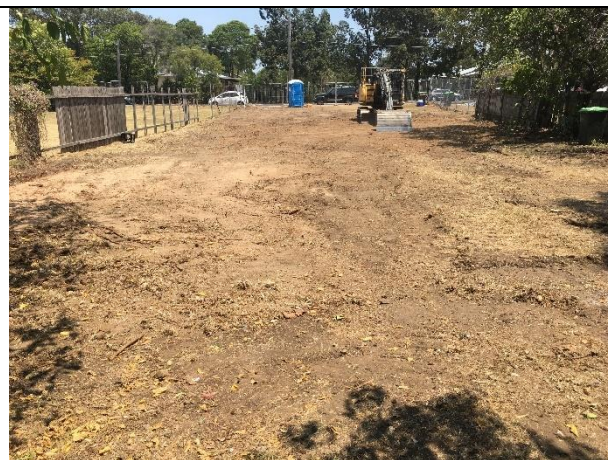
Photograph 2: East facing view of the site.

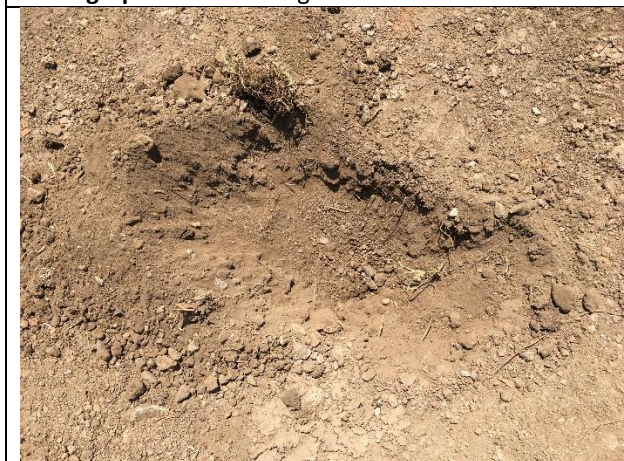
Soil profiles encountered across the site consisted of fill material. The majority of fill material encountered across the site comprised brown sandy topsoil and orange/brown reworked clays, with minor amounts of aggregate (refer *Appendix A – Photographs 1 to 4*).

Asbestos in the form of a fibre cement fragment (ACM) was identified above the reporting limit in sample TP1. Asbestos in the form of a fibre cement fragment was identified in samples TP2 and TP4, however this result was observed below the reporting limit - returns a negative result.

Photograph 3: Test pit TP1 - Example of material encountered.

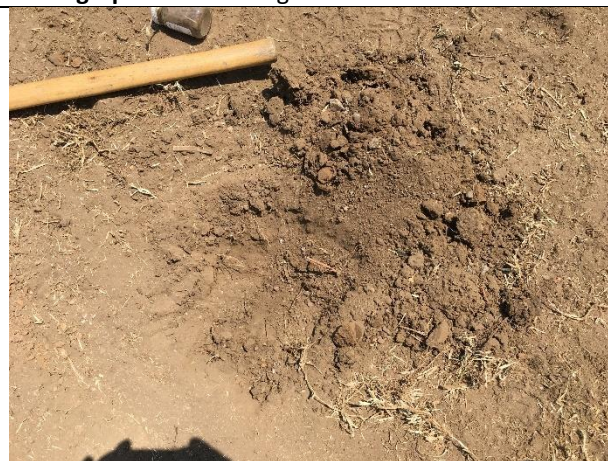
Photograph 4: Test pit TP5 - Example of material encountered.

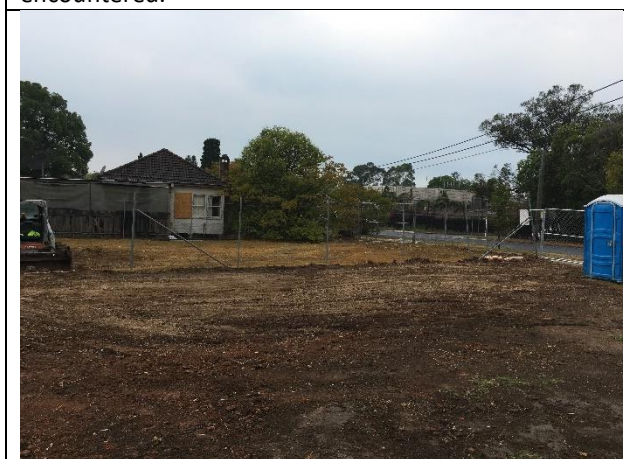
Photograph 5: Remediation area - Following removal.

Greencap then attended site on the 16th January 2020 to supervise remediation works undertaken by Sydney City Civil. During which, fill soils on the site were excavated to reworked clays, a depth of approximately 150mm. These works surrounded the area (TP1) which was identified to have contained asbestos exceeding the site criteria (refer to *Appendix A – Photographs 5-6*). Greencap inspected excavation works during remediation and a total of approximately 2.42 tonnes of additional contaminated topsoil was removed from the site (refer to *Appendix E* for tipping dockets). An additional round of air monitoring was undertaken during the remediation works (refer to *Appendix D*).

Following these works on the 16th January 2020, Greencap undertook a surface clearance of the excavation footprint and collected a validation composite sample for asbestos (ACM and AF/FA NEPM) analysis.

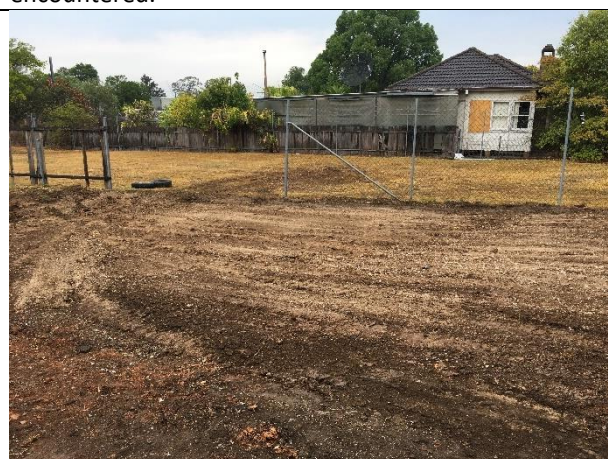
Photograph 6: Remediation area - Following removal.
