Geotechnical Investigation

149-163 Milton Street, Ashbury, NSW

Report No: E22851 GA_Rev2

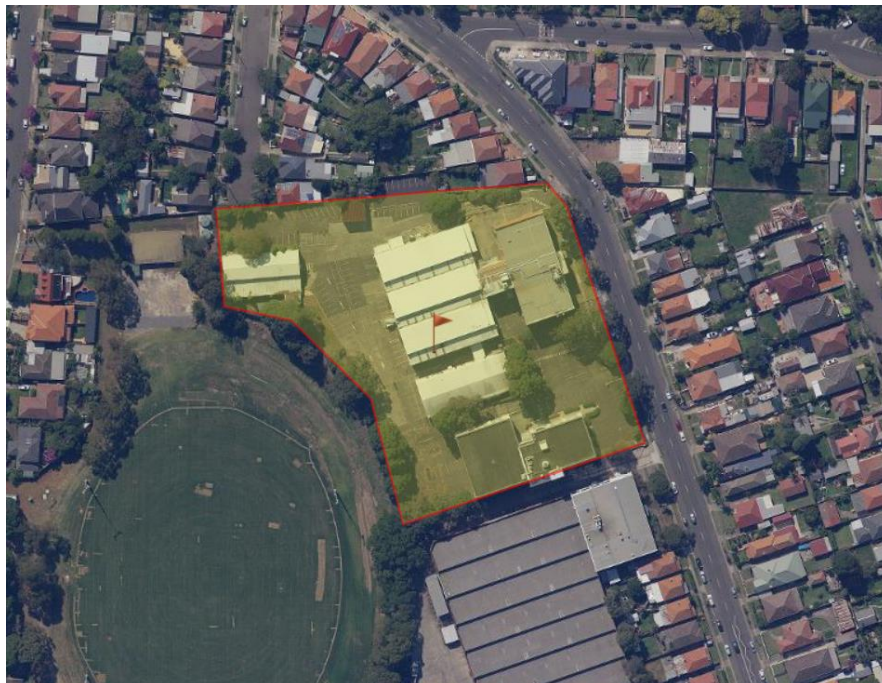
Plate 1: Aerial photograph of the site (source: Sixmap, accessed 28/7/19)

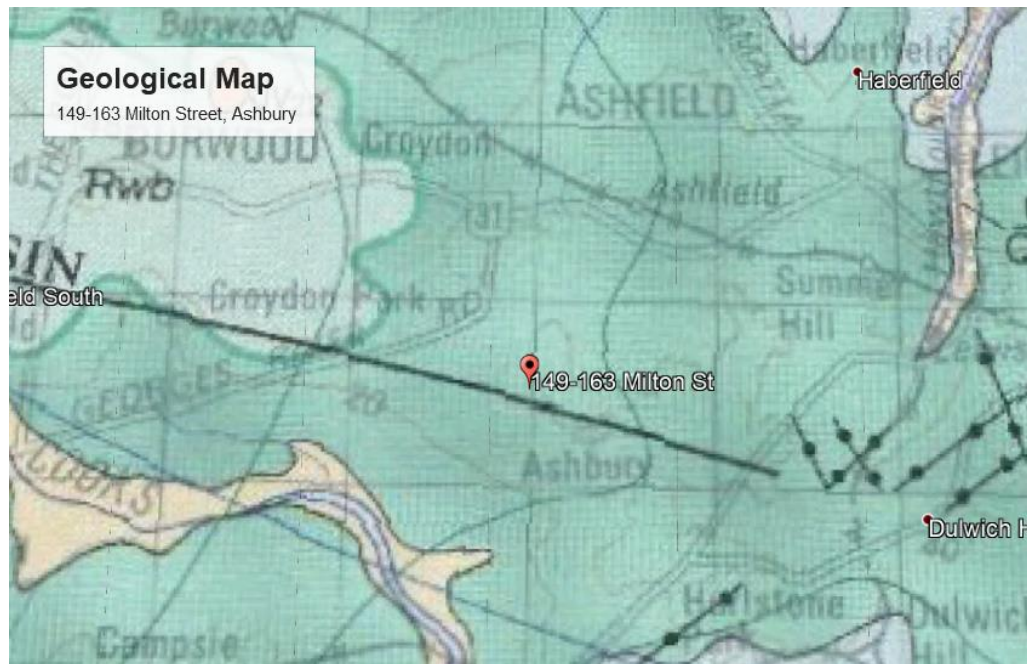
Plate 2: Excerpt of geological map showing location of site.

Attribute	Description
Topography	The regional topography typically comprises a north-northwest trending spur line running along the alignment of Milton Street. Site topography slopes down from east to west, from an RL of approximately 40.8m AHD at the eastern side of the site, to approximately 33.2m AHD at the north-west corner of the site
Regional Geology	Information on regional sub-surface conditions, referenced from the Department of Mineral Resources Geological Map Sydney 1:100,000 Geological Series Sheet 9130 (DMR 1991) indicates the site to be underlain by Ashfield Shale of the Wianamatta Group, which typically comprises black to dark grey shale and laminite. Ashfield Shale generally weathers into silty clay of medium to high plasticity. An excerpt of the geological map is shown in Plate 2 below. The site is located approximately 100m to the north of the Fairfield Basin anticline.

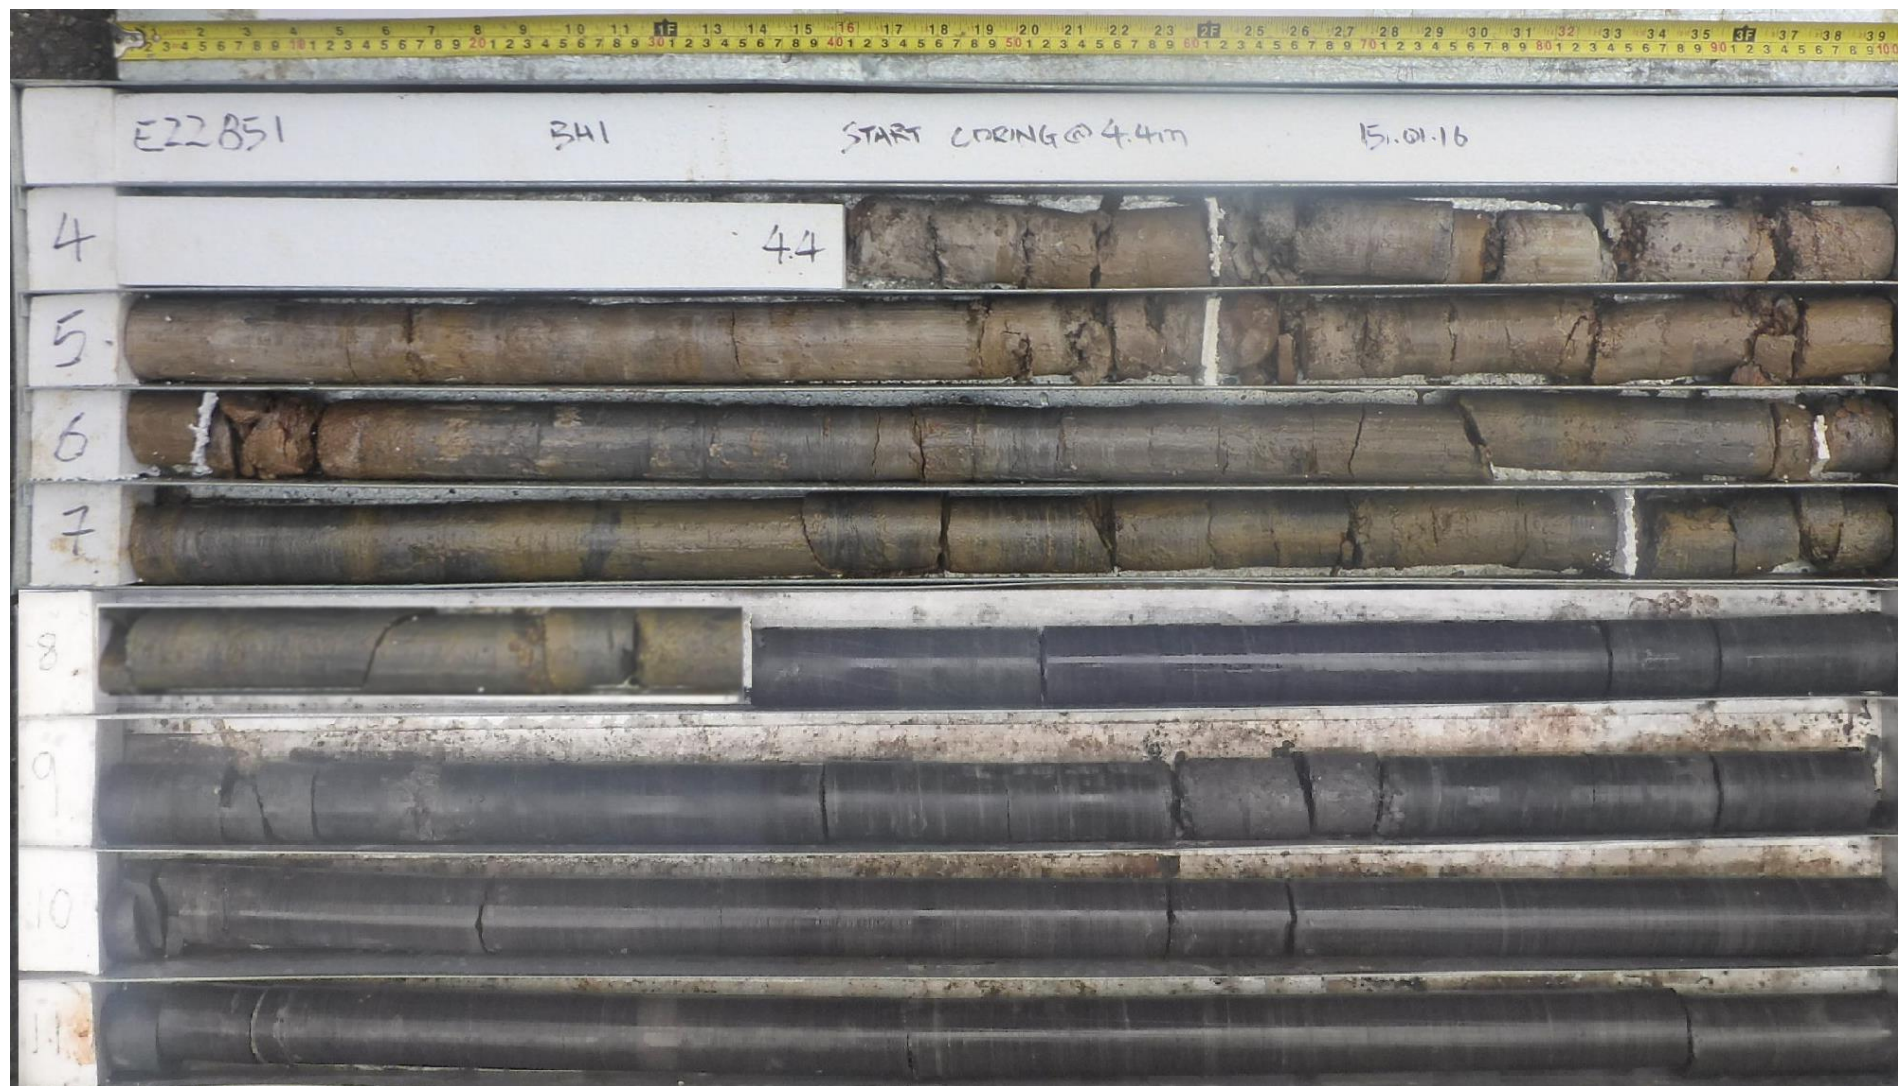
BH1M

Surface RL: 33.60 m AHD
Inclination: -90°
Box: 1-2 of 2
Hole Depth: 12.00 m

Depth Range: 4.40 m to 12.00 m
Contractor: Chadwick Geotechnics Pty Ltd
Drill Rig: Hanjin DB8
LOGGED: SY DATE: 15/1/16
CHECKED: JC DATE: 24/2/16

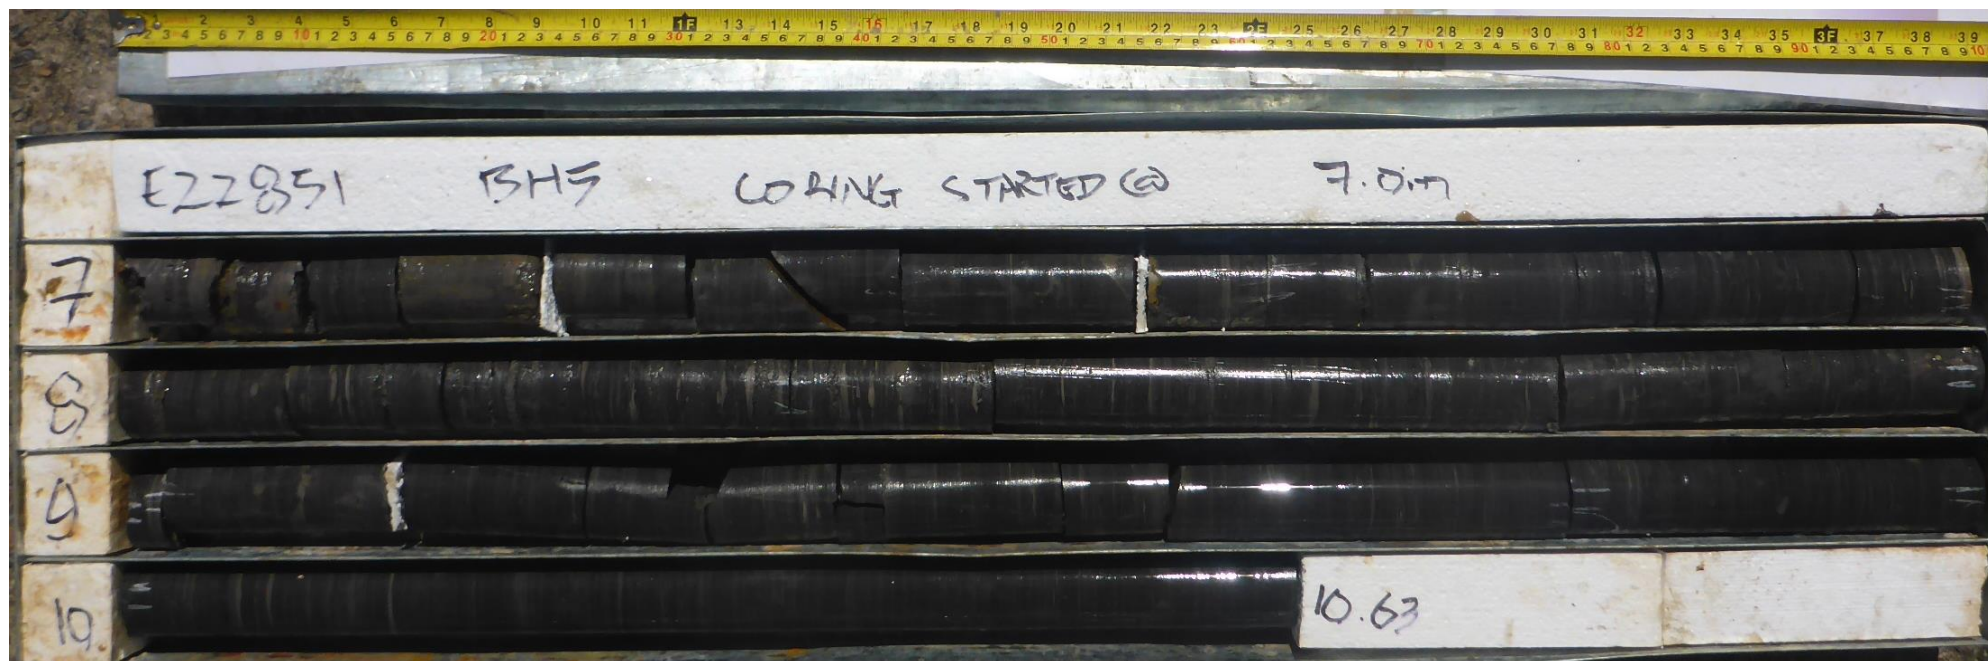
Surface RL: 37.40 m AHD
Inclination: -90°
Box: 1 of 1
Hole Depth: 10.63 m

Depth Range: 7.00 m to 10.63 m
Contractor: Chadwick Geotechnics Pty Ltd
Drill Rig: Hanjin DB8
LOGGED: SY DATE: 20/1/16
CHECKED: JC DATE: 24/2/16

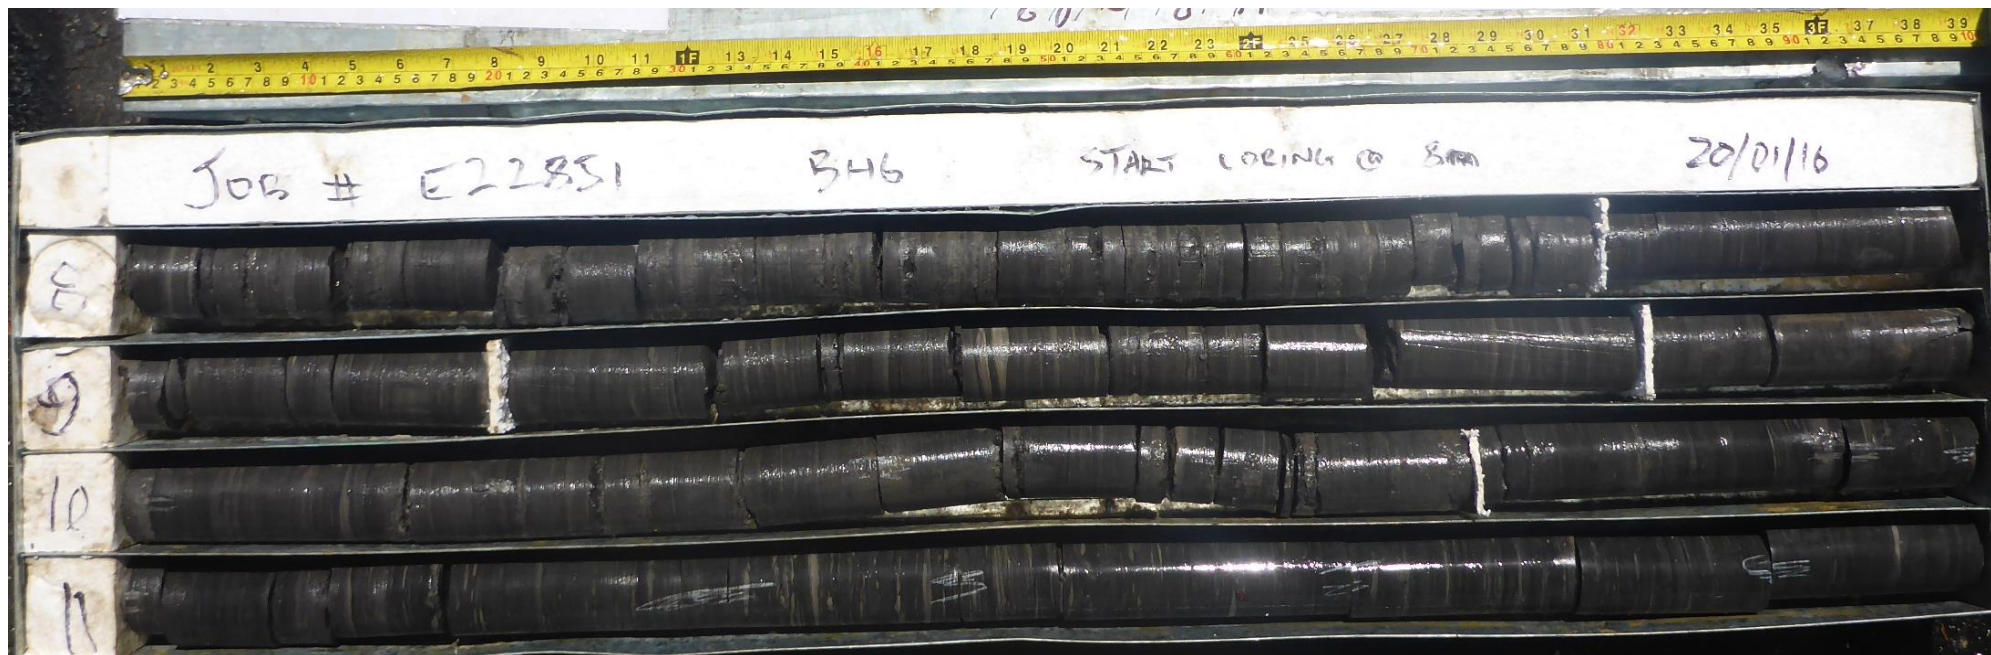
Surface RL: 40.40 m AHD
Inclination: -90°
Box: 1 of 1
Hole Depth: 12.00 m

Depth Range: 8.00 m to 12.00 m
Contractor: Chadwick Geotechnics Pty Ltd
Drill Rig: Hanjin DB8
LOGGED: SY DATE: 20/1/16
CHECKED: JC DATE: 24/2/16

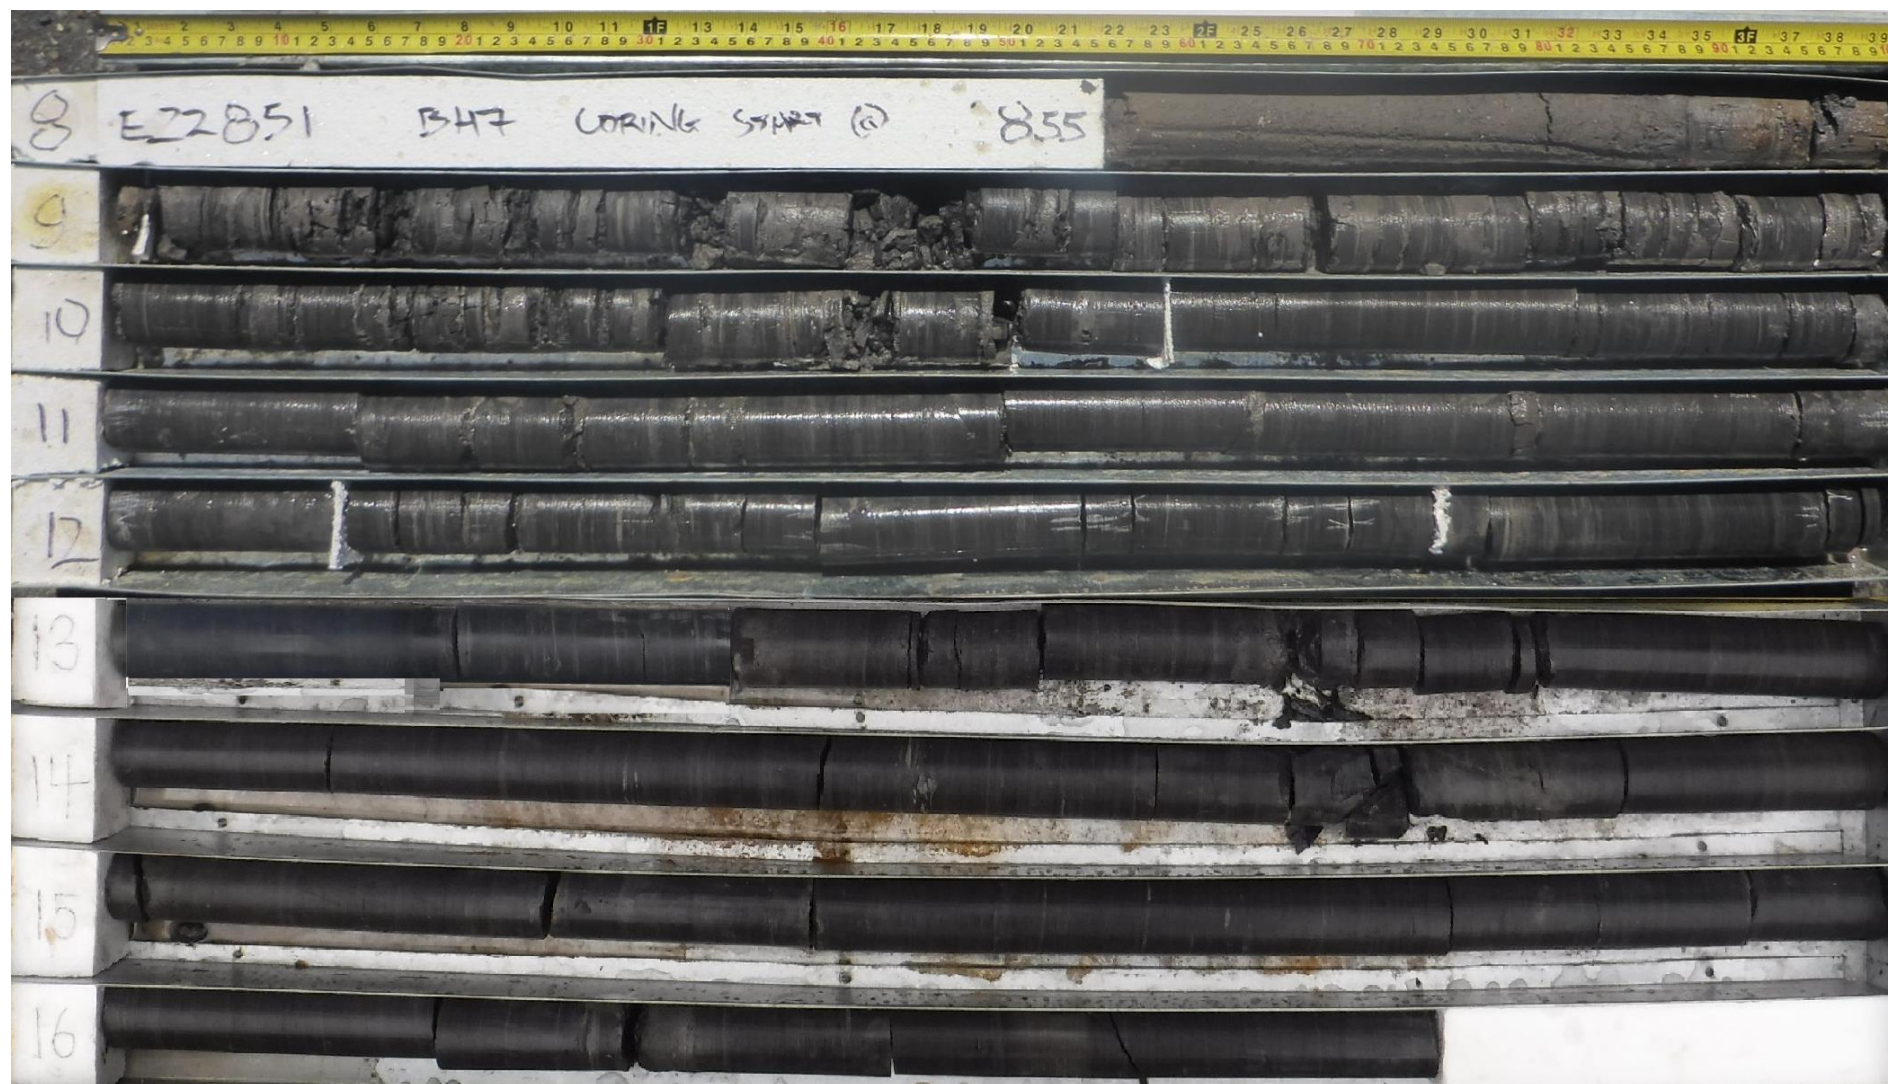
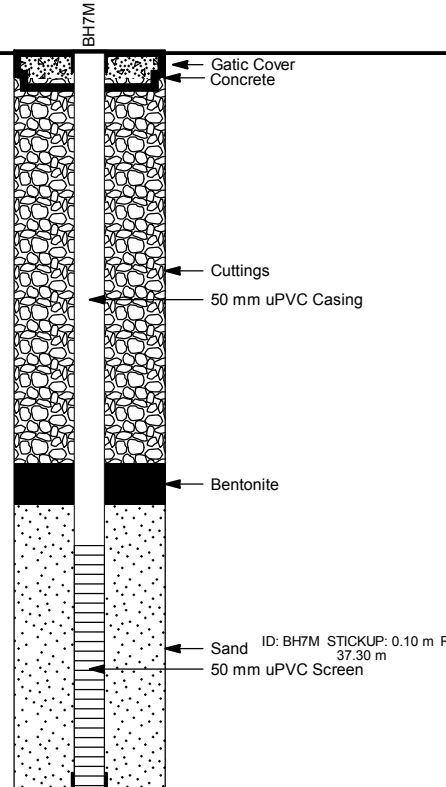
PIEZOMETER CONSTRUCTION DETAILS					
Method	Drilling Water	Depth (m)	Elevation (m AHD)	Graphic Log	Soil / Rock Description	ID BH7M	Type Standpipe	Stick Up & RL 0.10 m 37.10 m	Tip Depth & RL 9.00 m 28.20 m	Installation Date 20/01/2016	Static Water Level 7.58m
AD/T	GWNE on completion of augering				Asphaltic-concrete: 100mm thick.

36		FILL: Sandy GRAVEL; fine to coarse, sub-angular sandstone gravel, orange-brown, sand is fine to medium grained, no odour.							
		34		From 3.4m, with some brick fragments.							
		32		FILL: Silty SAND; fine grained, brown, with some brick fragments, no odour.							
		6			SHALE; pale brown, extremely low to very low strength, extremely to distinctly weathered, with iron indurated bands, no odour.			5.50 m

6.00 m			
		30									
		8									
NQ	80-90% RETURN				SHALE; bedding dipping 0-10 degrees, <1mm thick, grey brown with orange iron staining.			9.00 m			
		28		From 9.02m; dark grey with grey laminations, 1-2mm thick, 10-20mm spacing.			9.00 m				
		10		SHALE; bedding dipping 0-5 degrees, dark grey with grey laminations, 1-2mm thick, 10-30mm spacing.							
		26									
		12									
		24									
		14									
		22									
		16									
		20			Hole Terminated at 16.75 m Backfilled with drilling spoil and concrete capped.						
		18

- The presence of deep fill encountered in BH7. Bored piers may not be adequate and CFA piles may be required within the vicinity of BH7. Due to this granular fill, a contiguous/secant pile wall may be required within the vicinity of BH7. Investigation of the extent of this fill material using test pits/boreholes is recommended.
- Groundwater considerations.
- Basement excavation retention to prevent potential lateral deflections and ground loss as a result of excavations, resulting in damage to nearby structures;
- Potential vibration risks; and
- Foundation design for building loads.

The use of a more closely spaced shoring system (such as contiguous) is preferred adjacent to neighbouring buildings/infrastructures so as to reduce the lateral movements and the risk of potential damage. This is recommended in the western portion of the southern retaining wall due to the presence of sandy gravelly fill and silty sand fill to 5.40m depth BEGL.

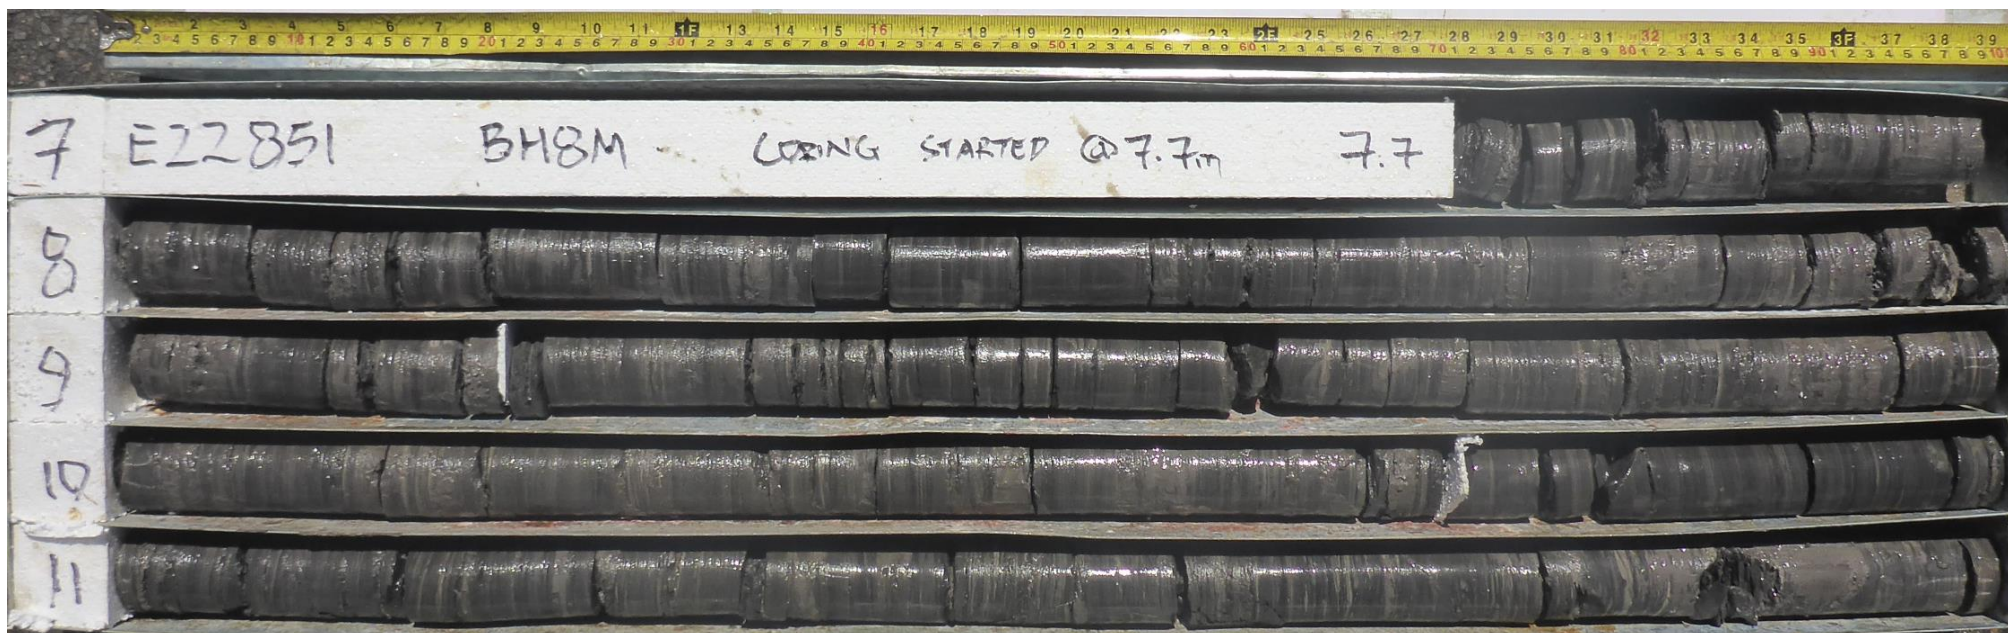
BH8M

Surface RL: 40.40 m AHD
Inclination: -90°
Box: 1 of 1
Hole Depth: 12.00 m

Depth Range: 7.70 m to 12.00 m
Contractor: Chadwick Geotechnics Pty Ltd
Drill Rig: Hanjin DB8
LOGGED: SY DATE: 21/1/16
CHECKED: JC DATE: 24/2/16
