# CONTAMINATED SITE AUDIT

165 Milton Street, Ashbury, NSW

# ASHBURY DEVELOPMENTS CONTAMINATED SITE AUDIT REPORT

Site Audit Report to support Site Audit Statement TNC118

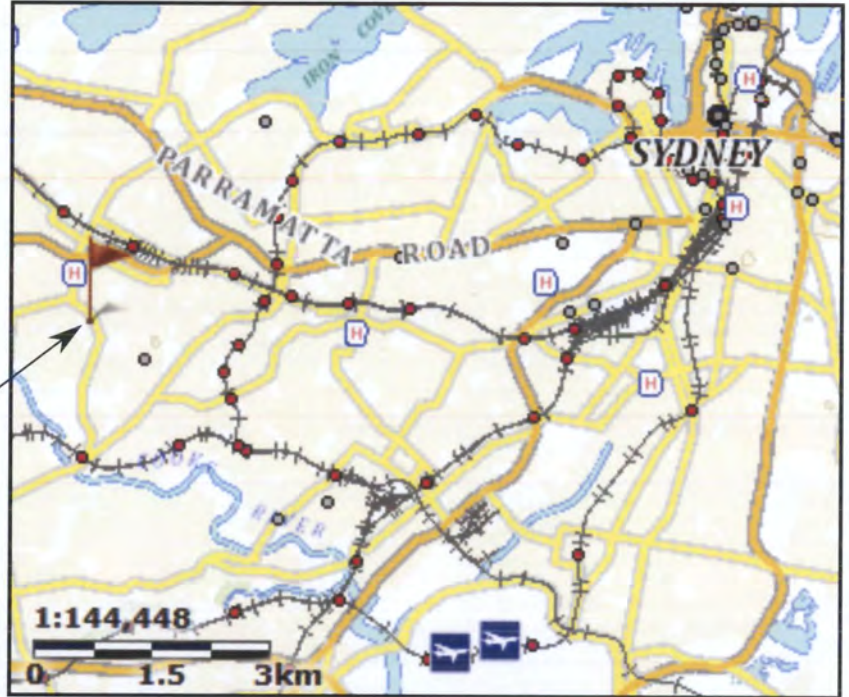
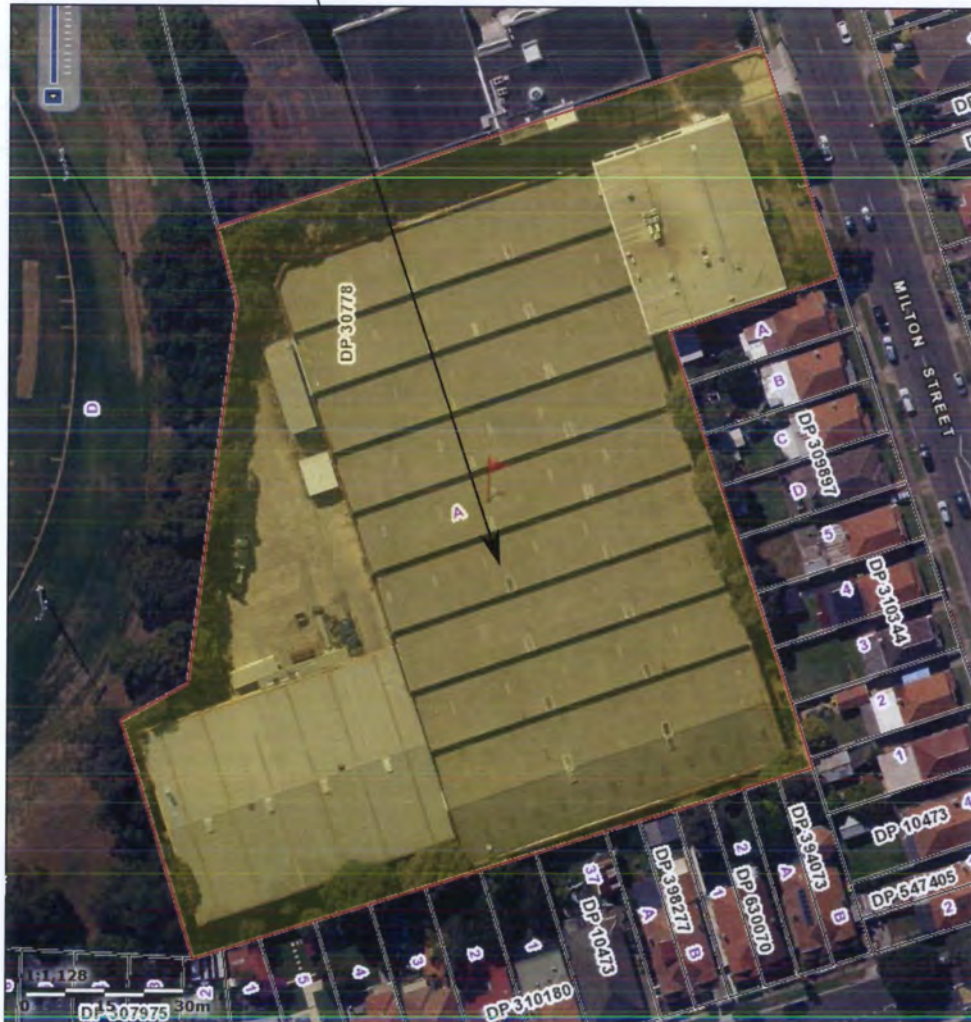
UST area and electrical substation area marked based on Auditor's site observations and consultant's reports, particularly EI, May 2019.

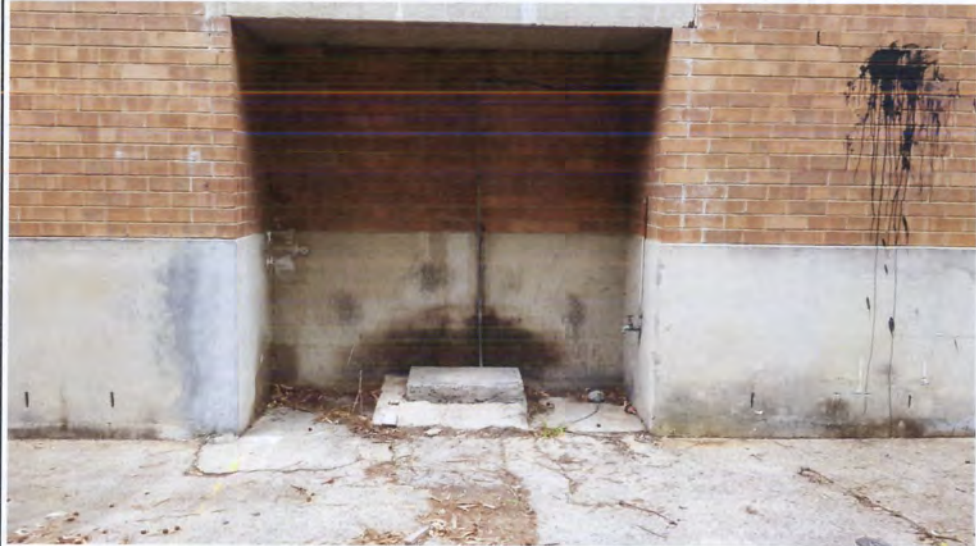
**Photograph 1**

The former bowser stand remains adjacent to the access road along the northern site boundary and shows some staining (See photograph 1 in Appendix D)

Former bowser location along northern driveway. Some staining evident.

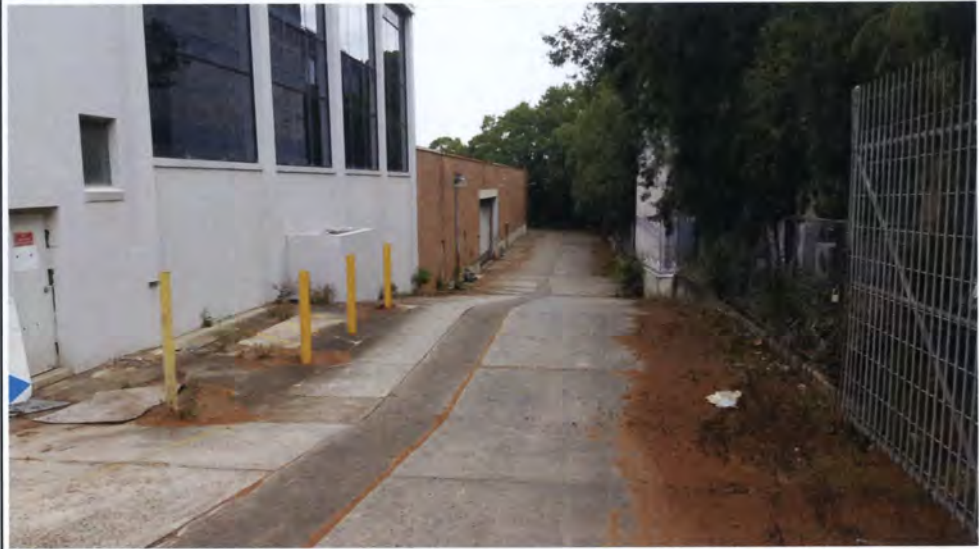
**Photograph 3**

Driveway on northern boundary, facing west.

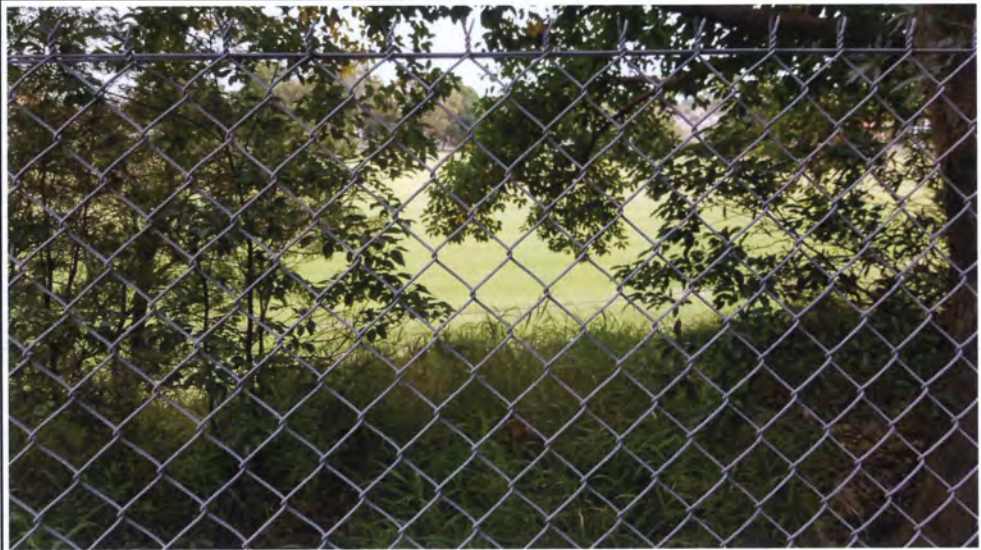
**Photograph 4**

The sports field adjacent to the west (W.H. Wagener Oval) is known to be a former putrescible waste landfill and may pose a hazardous ground gas risk to site development, as well as potentially adversely influencing groundwater quality.

View across the western boundary, illustrating topographic drop to the adjacent playing field/former landfill.

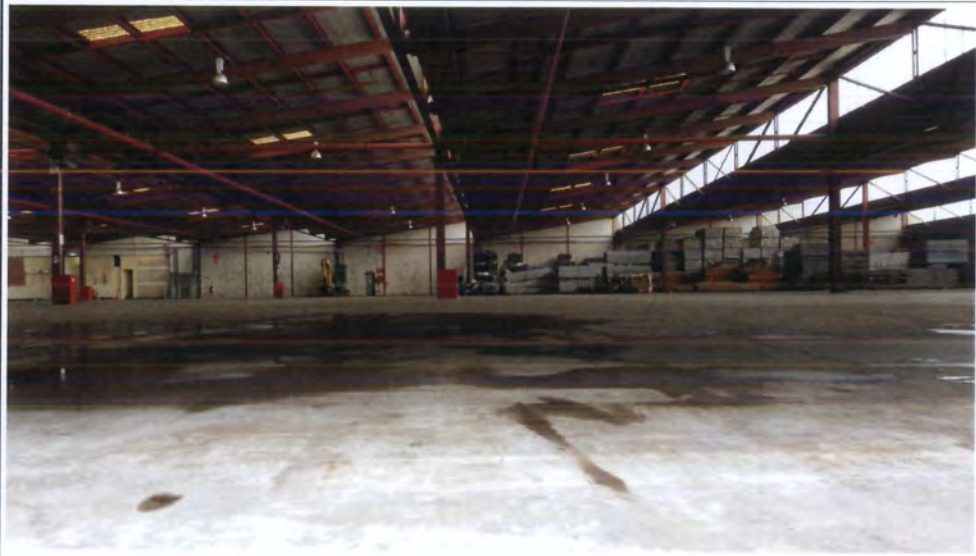
**Photograph 5**

No visual indication of contamination (filming, ACM fragments, or similar) was apparent although EIS noted staining on concrete within the warehouse. No odours were noted during site assessment.

Interior of warehouse. Concrete appears in good condition.

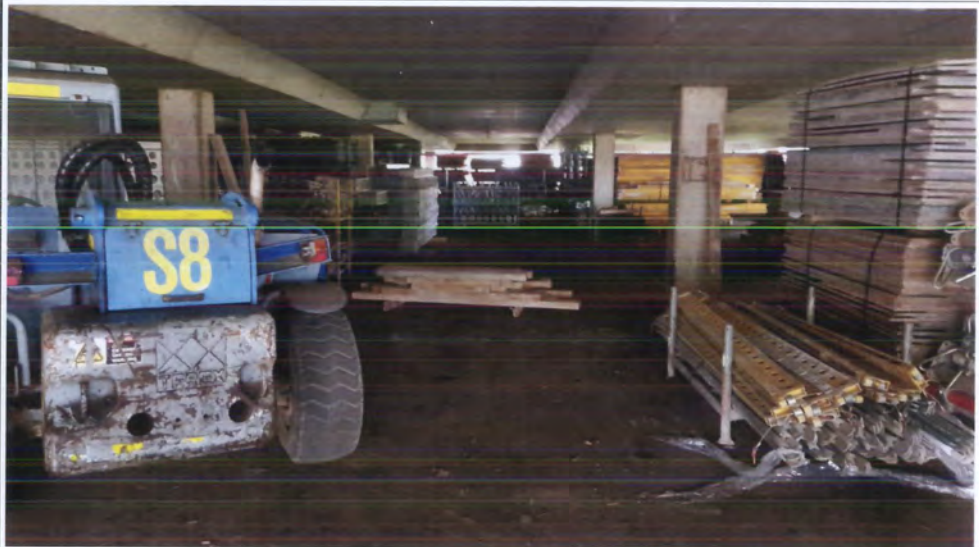
**Photograph 6**

Miscellaneous storage in the undercroft of the southwestern building. Used to store building materials and scaffolding.
