## Remediation Action Plan

Proposed Pool and Park Redevelopment  
Kogarah War Memorial Pool,  
78 Carwar Avenue  
Carss Park

Prepared for  
SJB Architects c/- SJB Planning

Project 99751.00  
February 2021

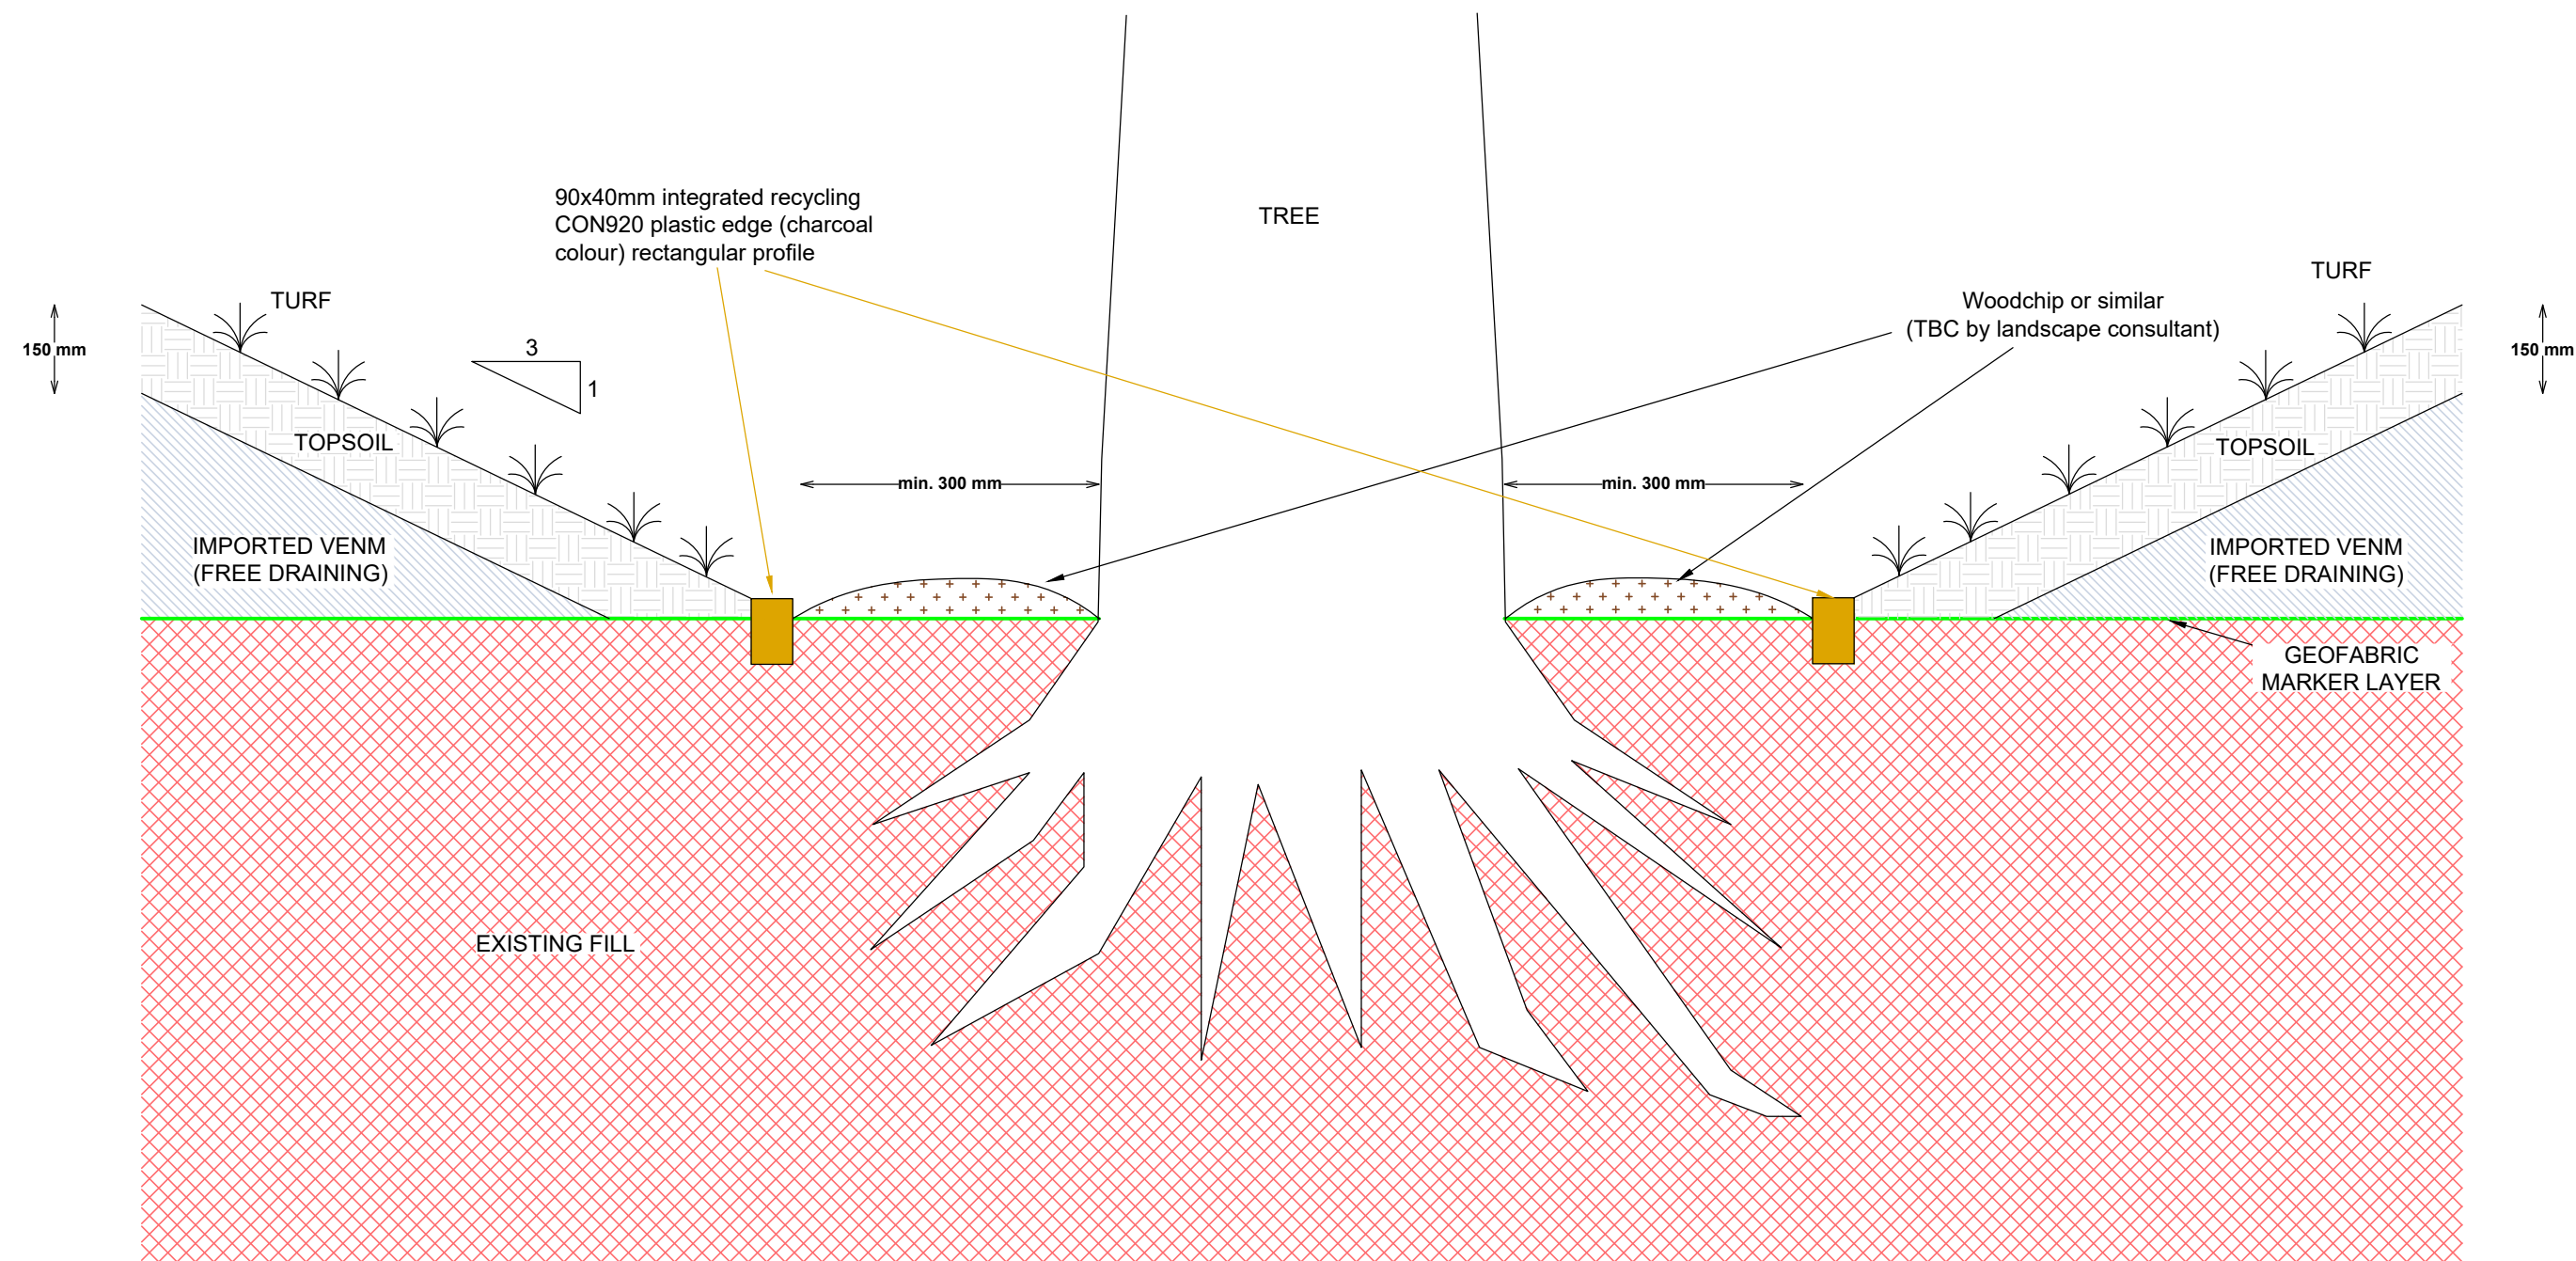
NOTE: - Works to be confirmed with arborist and landscape consultant prior to commencing  
 - If required, existing fill greater than 1 m from the trunk may be removed using hand tools to 100-150 mm deep.  
 This is to be undertaken in consultation with the arborist.  
 - Refer to civil drawings for final capping thickness in Tree Protection Zones.

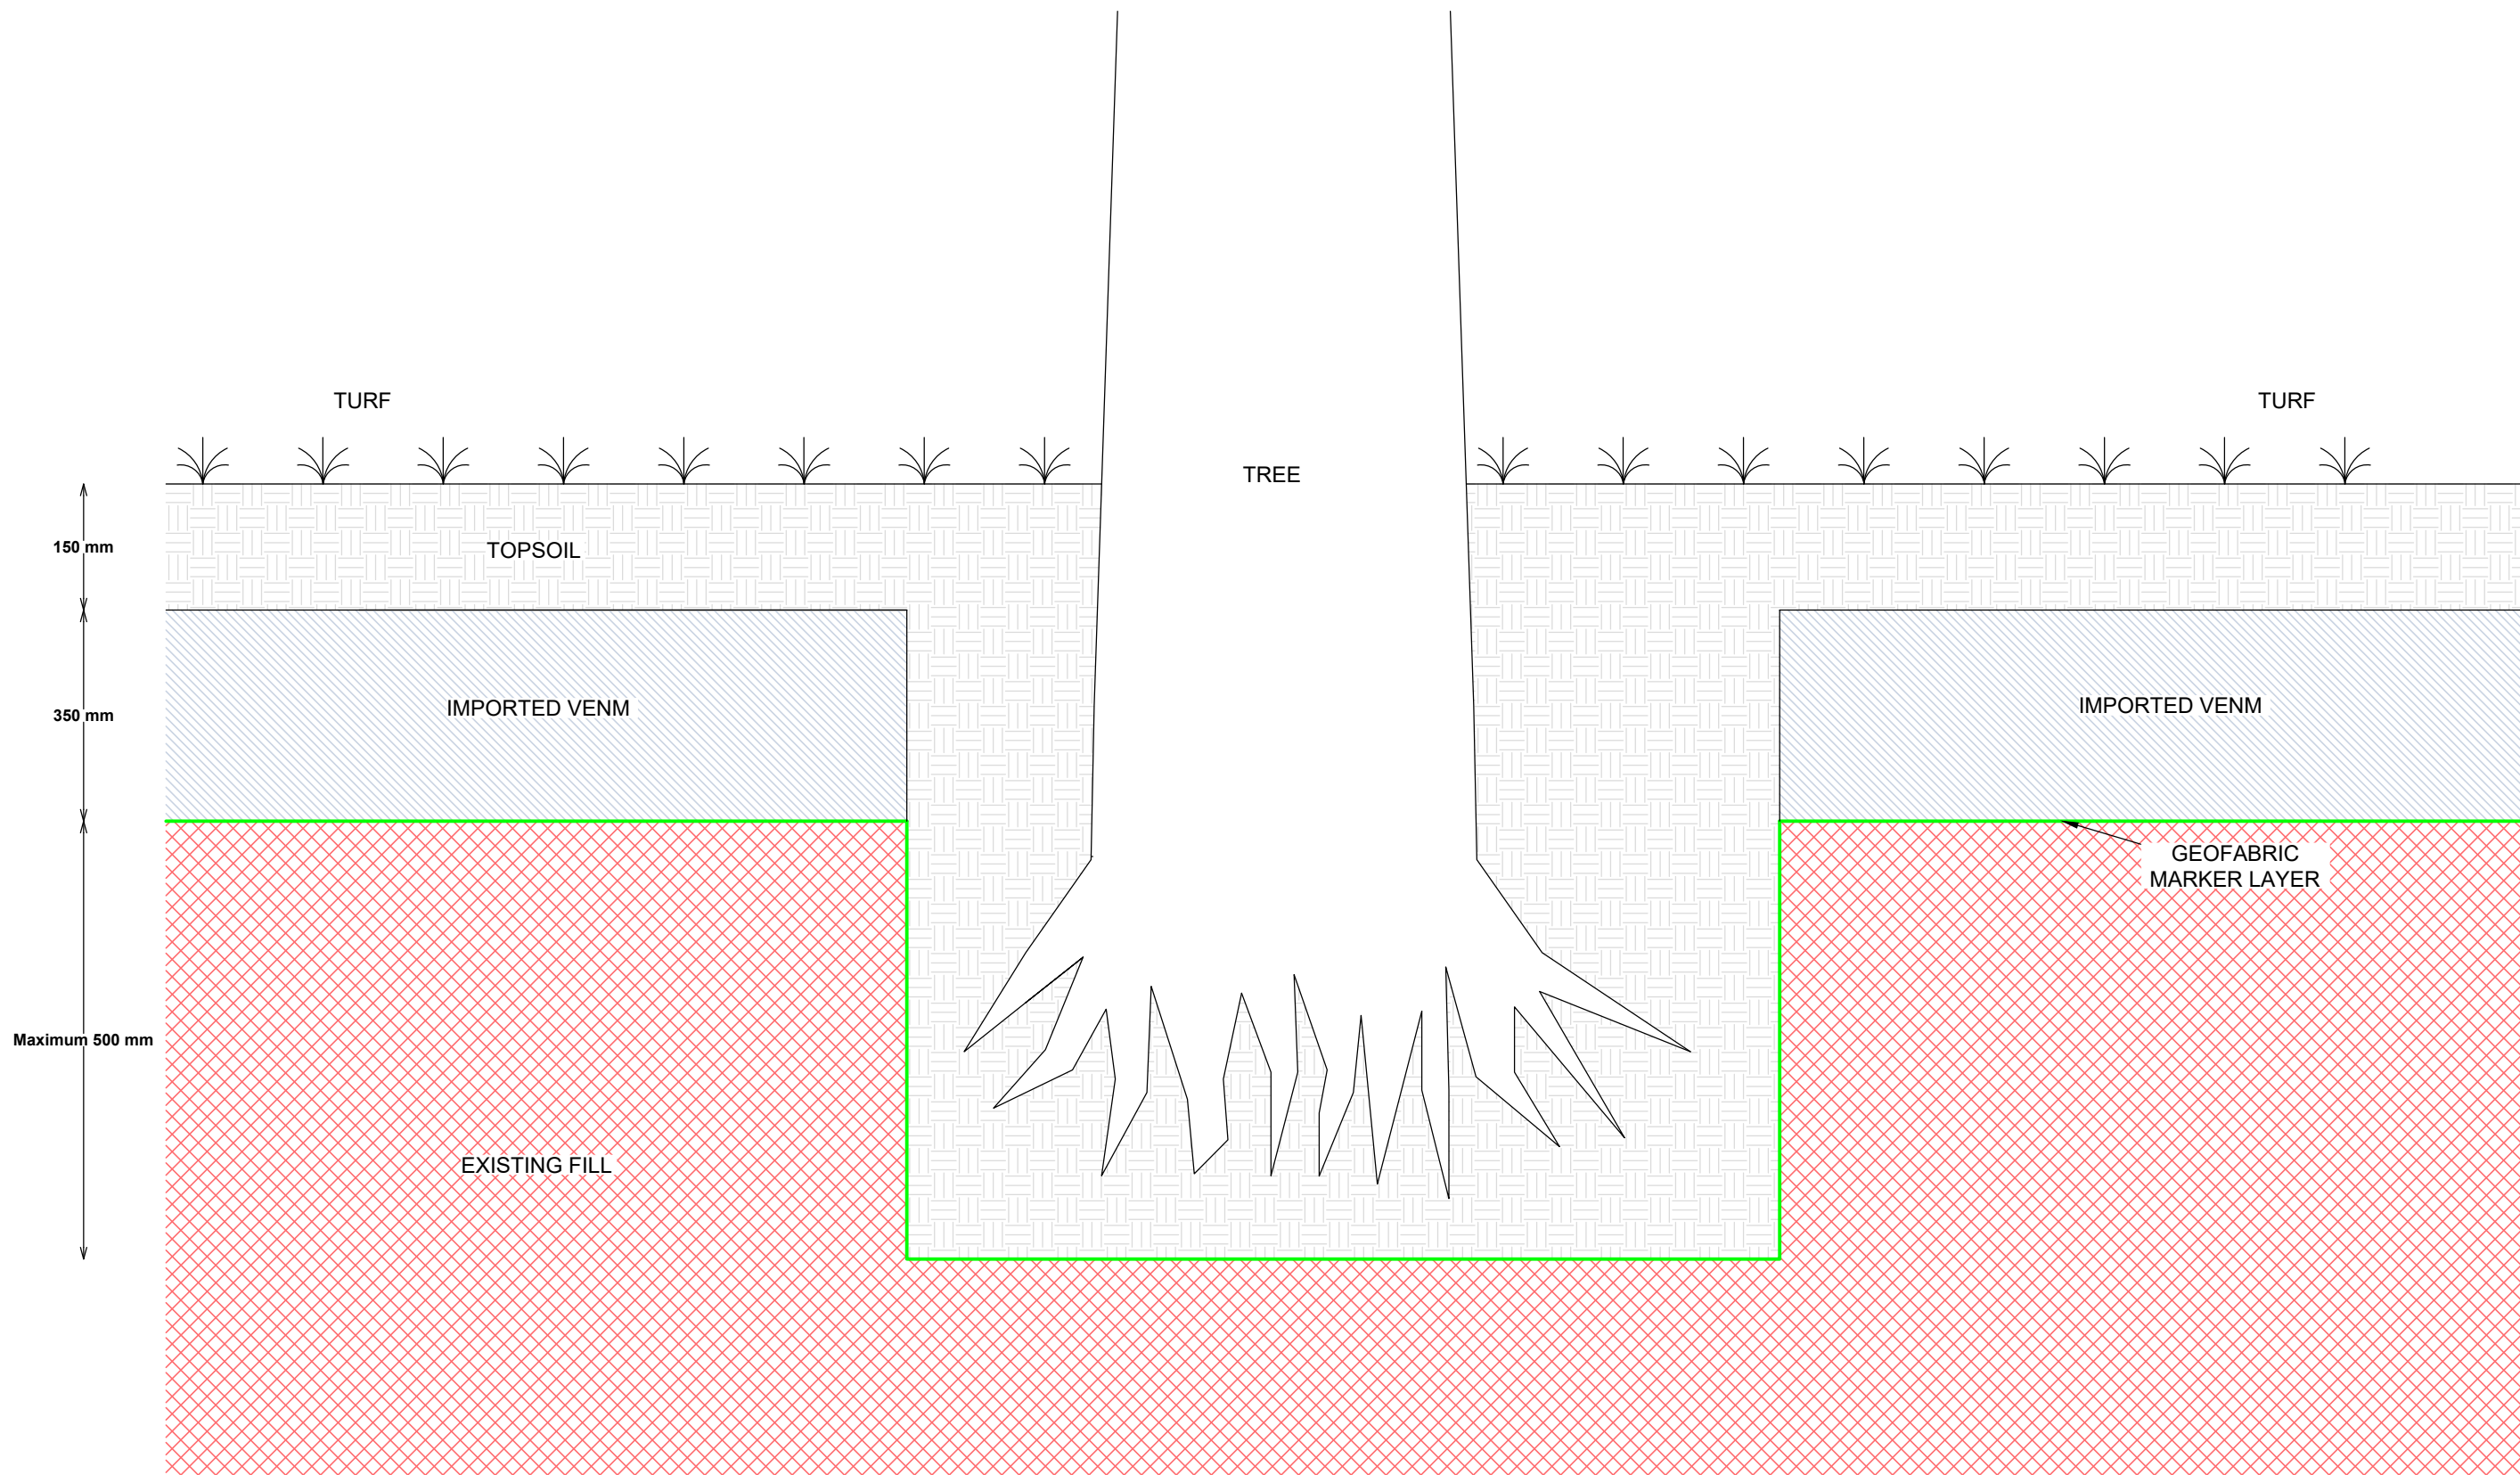
NOTE: Width and length of deeper topsoil area to be confirmed with arborist and landscape consultant

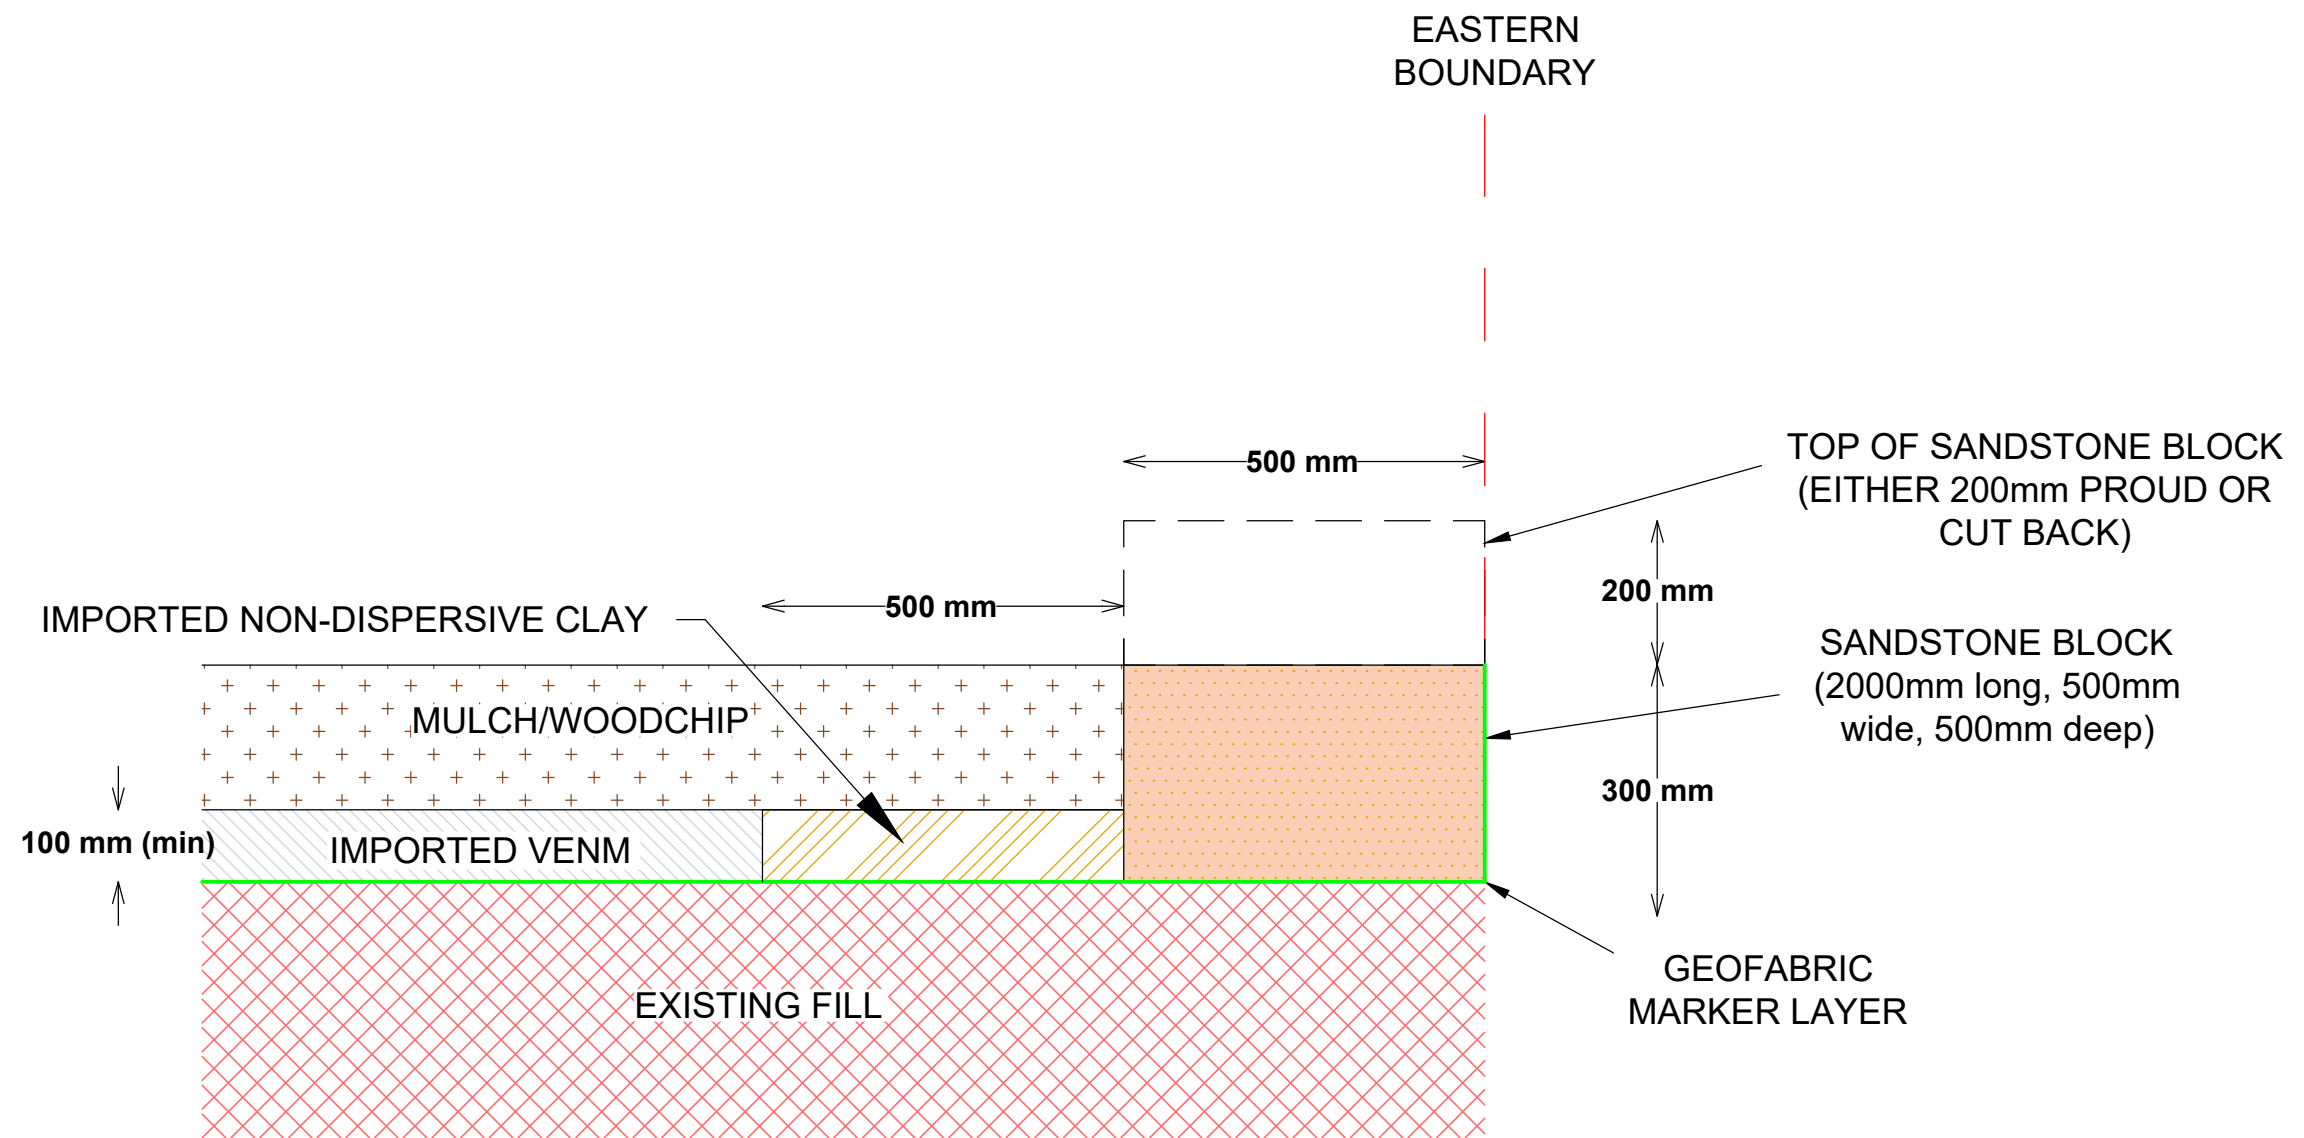
NOTE: Sketch for general information only. Surface and ground conditions vary along eastern boundary

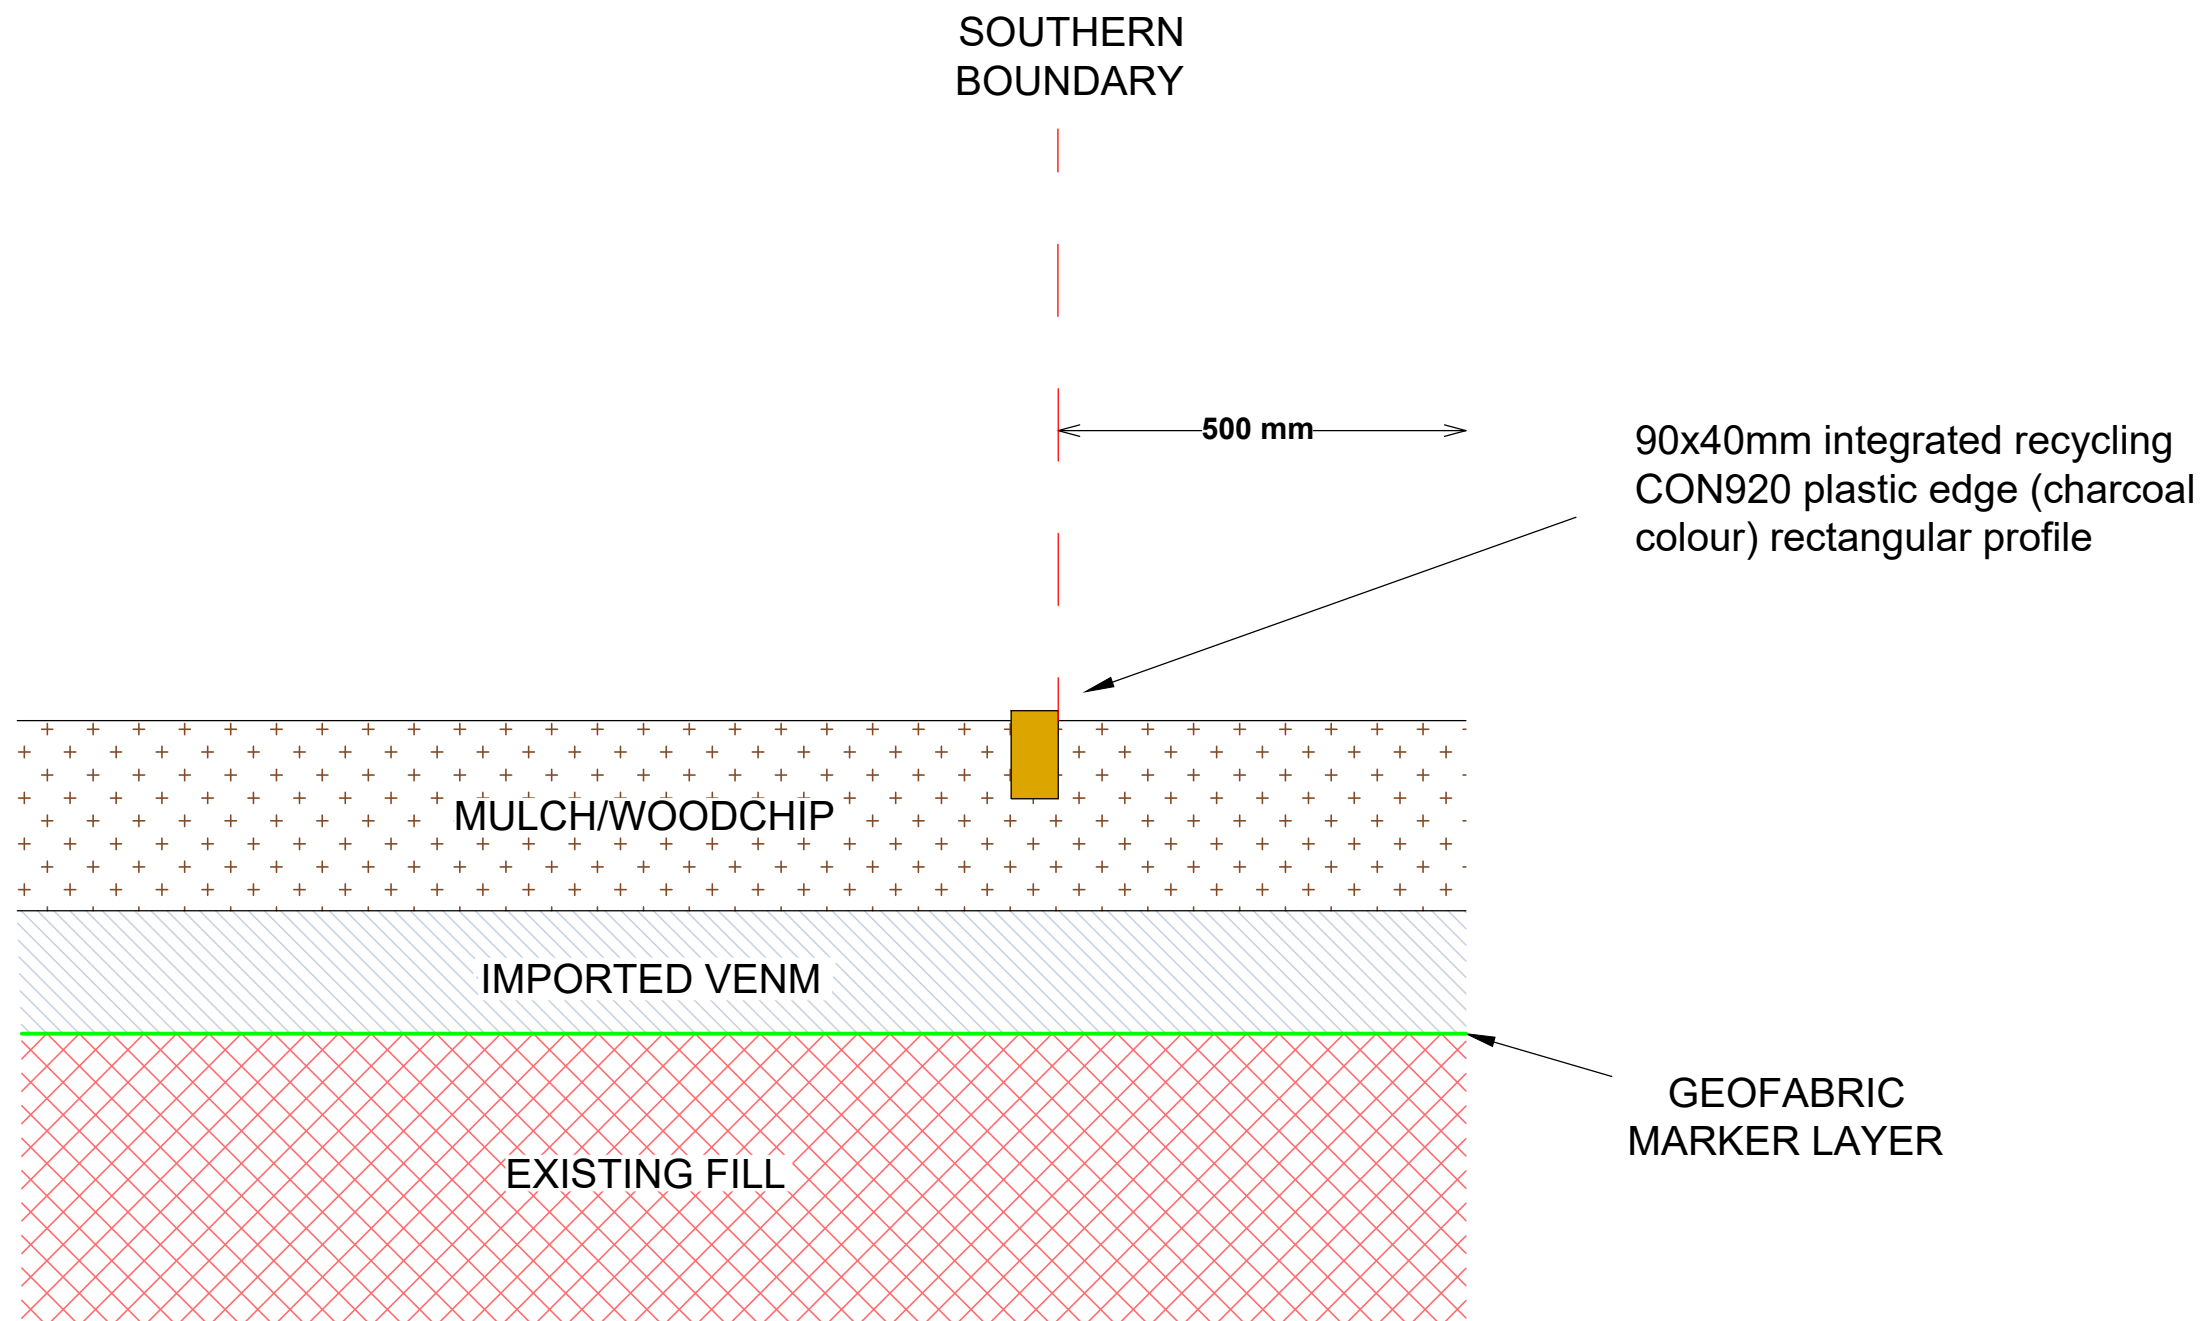
| | OFFICE: Sydney | DRAWN BY: JDB | | DRAWING No: R.002 - 12 |

NOTE: Works not to extend into Carss Cottage state heritage listing curtilage

| | CLIENT: SJB Architects | | TITLE: <b>Capping Approach - Southern Boundary within TPZ (Type 2)</b><br><b>Kogarah War Memorial Pool</b><br><b>Carss Park</b> | PROJECT No: 99751.00 |

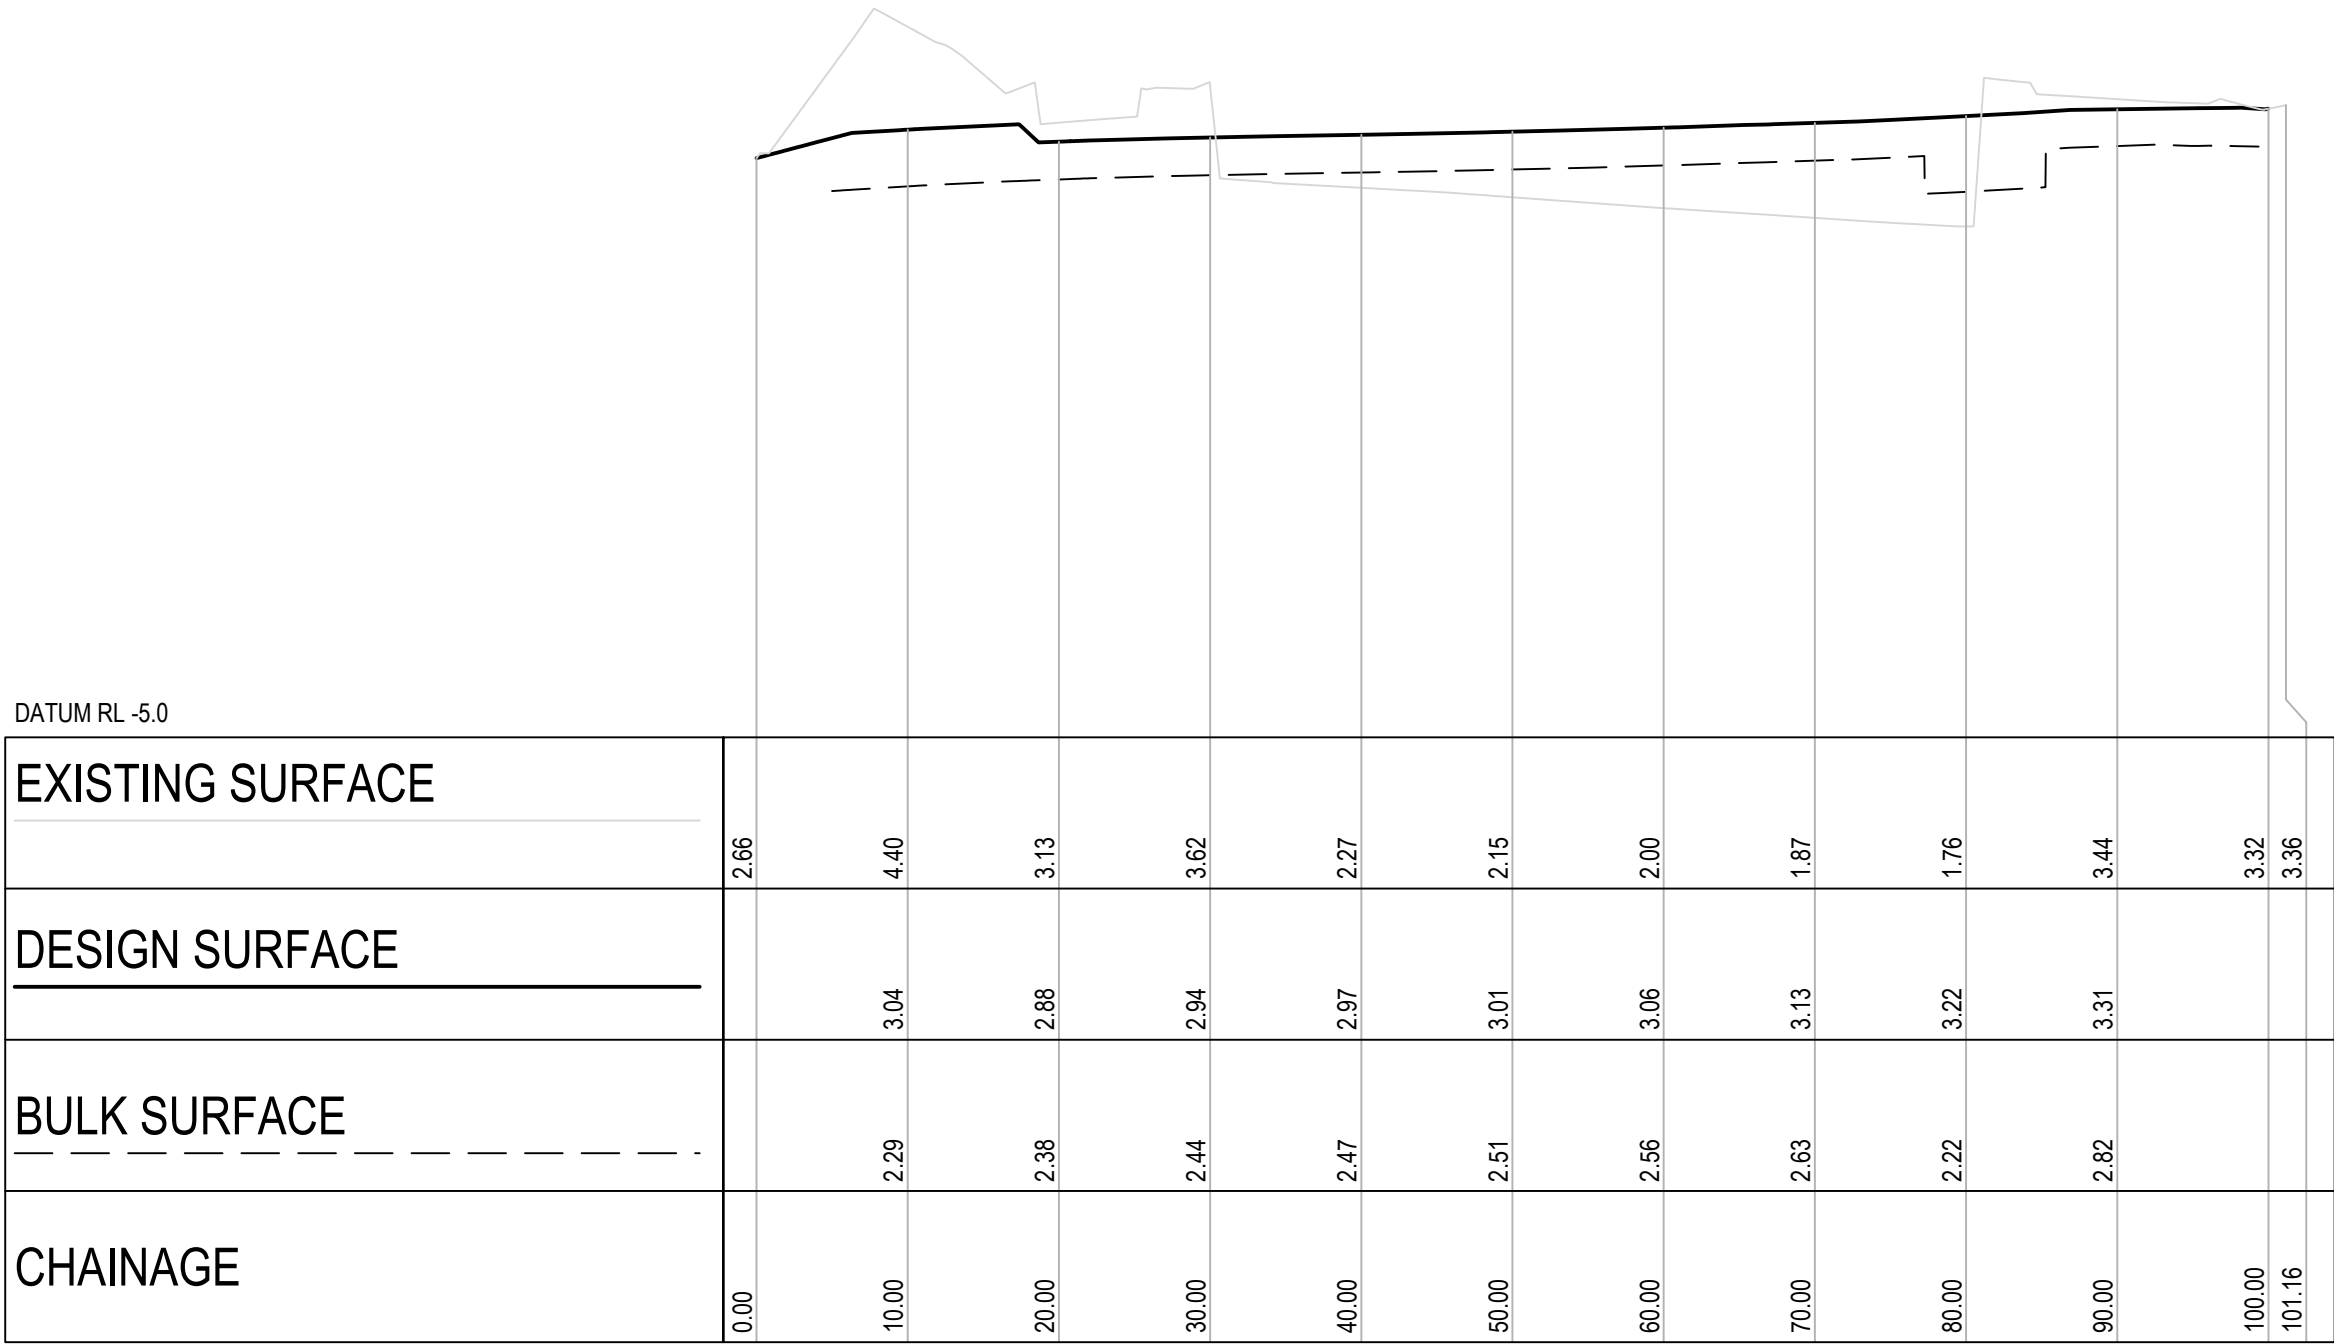
SECTION 1  
SCALE 1:500 (H)  
SCALE 1:100 (V)  
C05.01

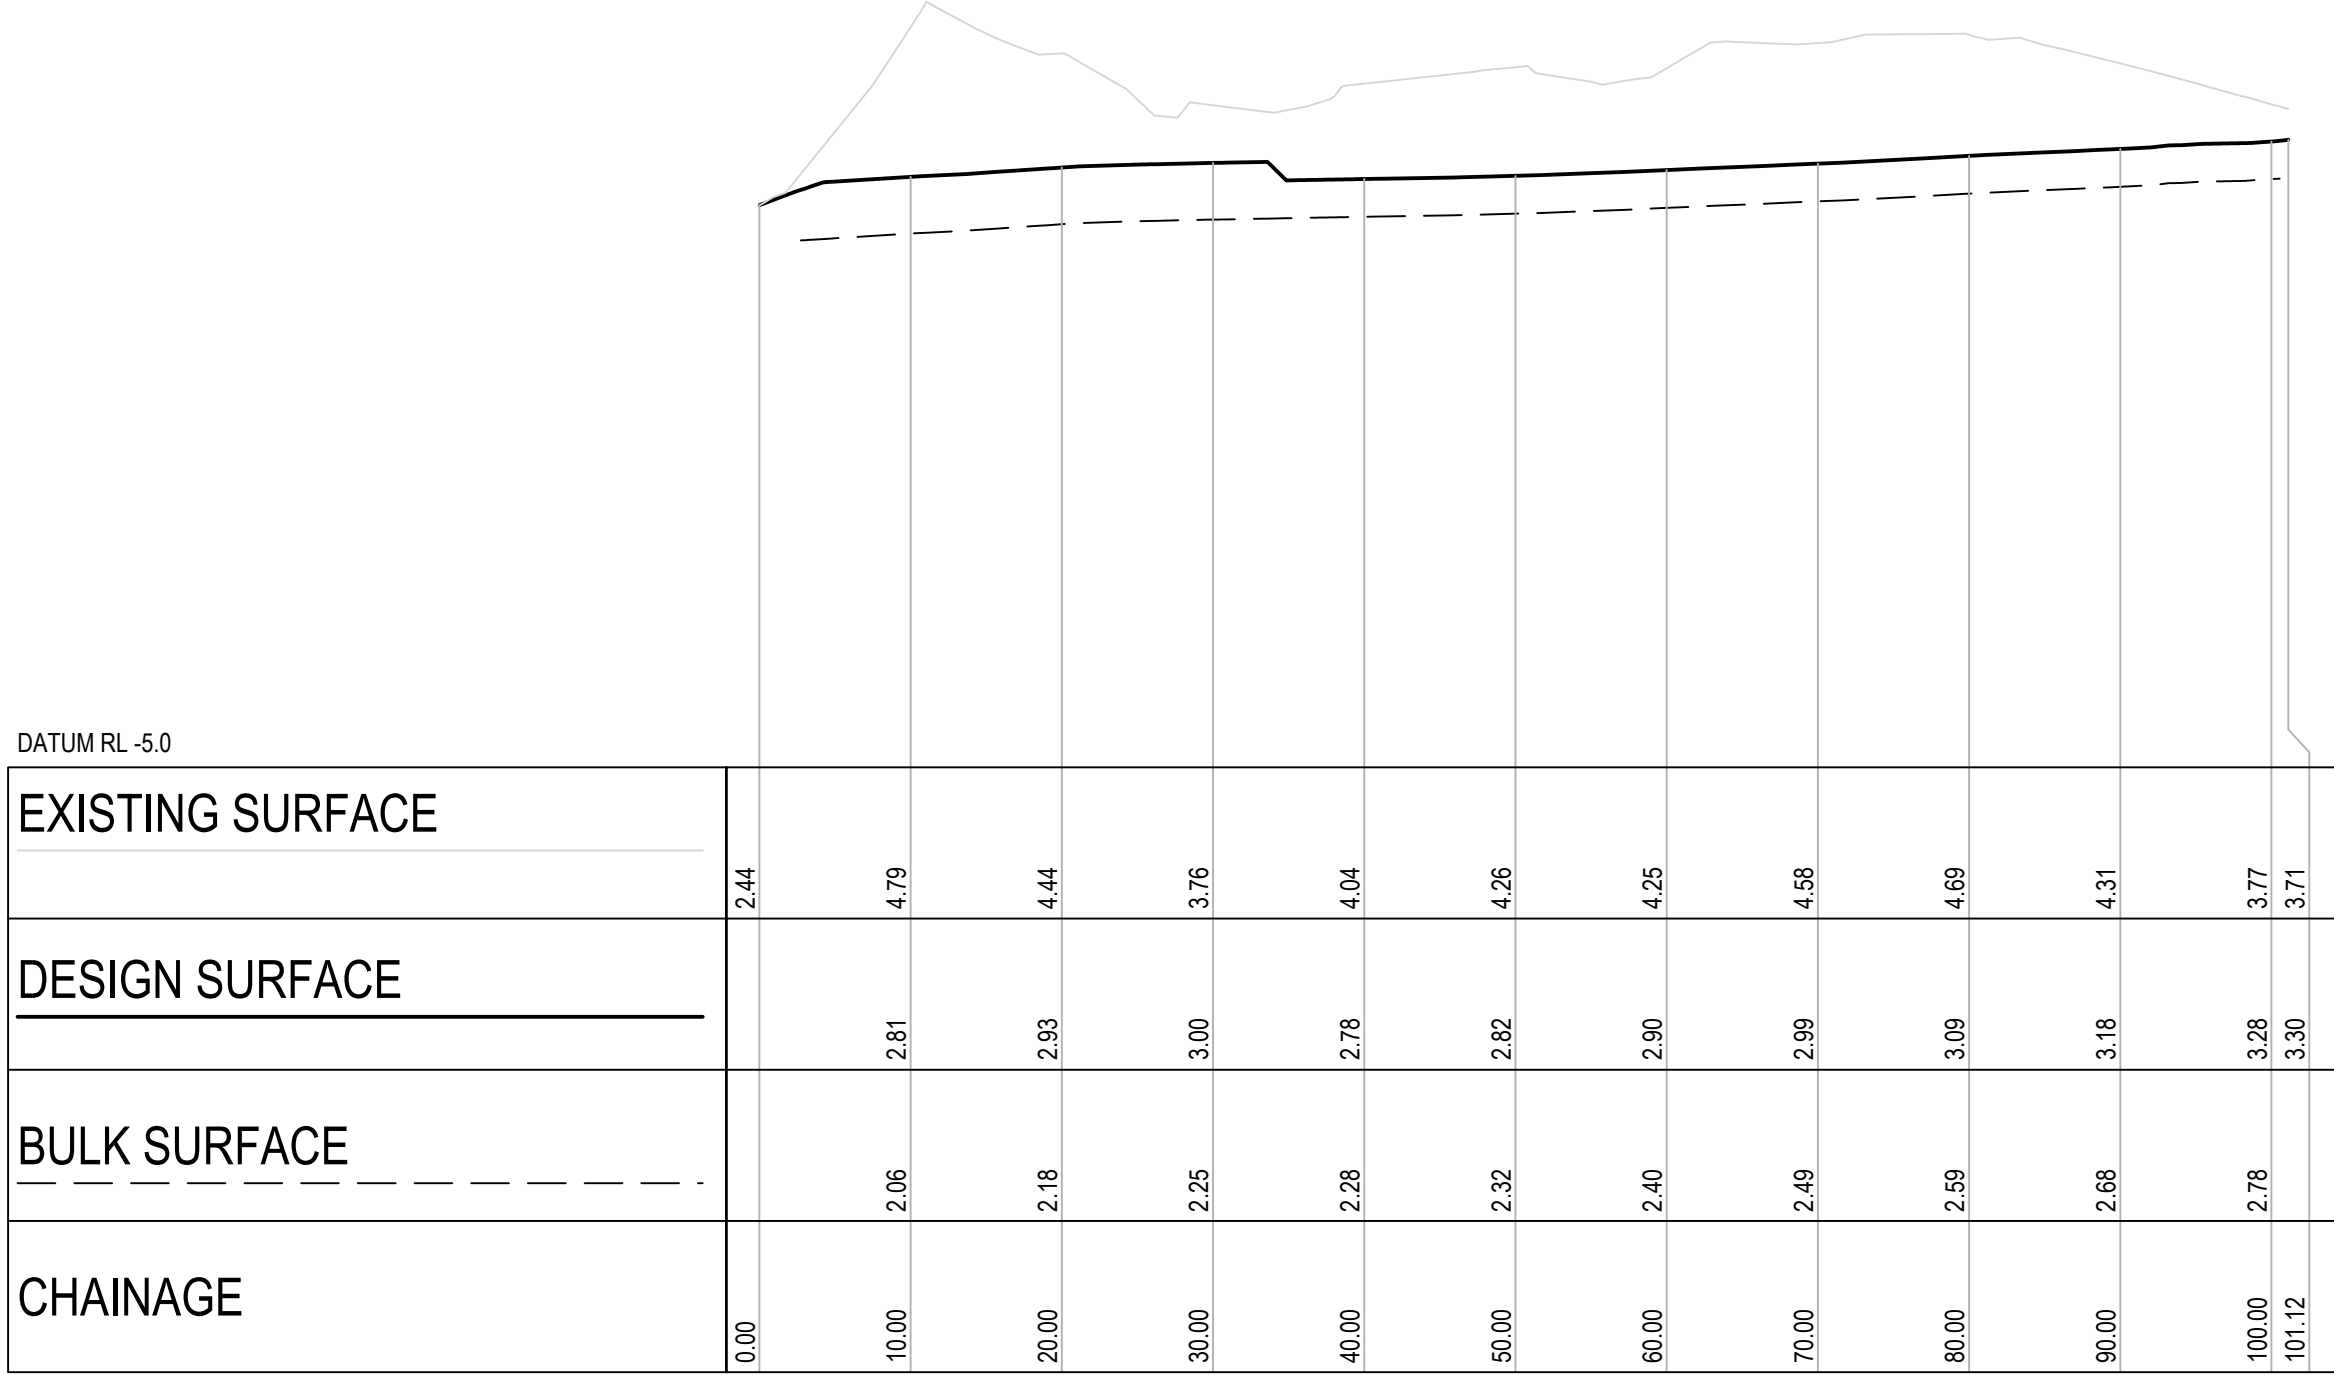
SECTION 2  
SCALE 1:500 (H)  
SCALE 1:100 (V)  
C05.01

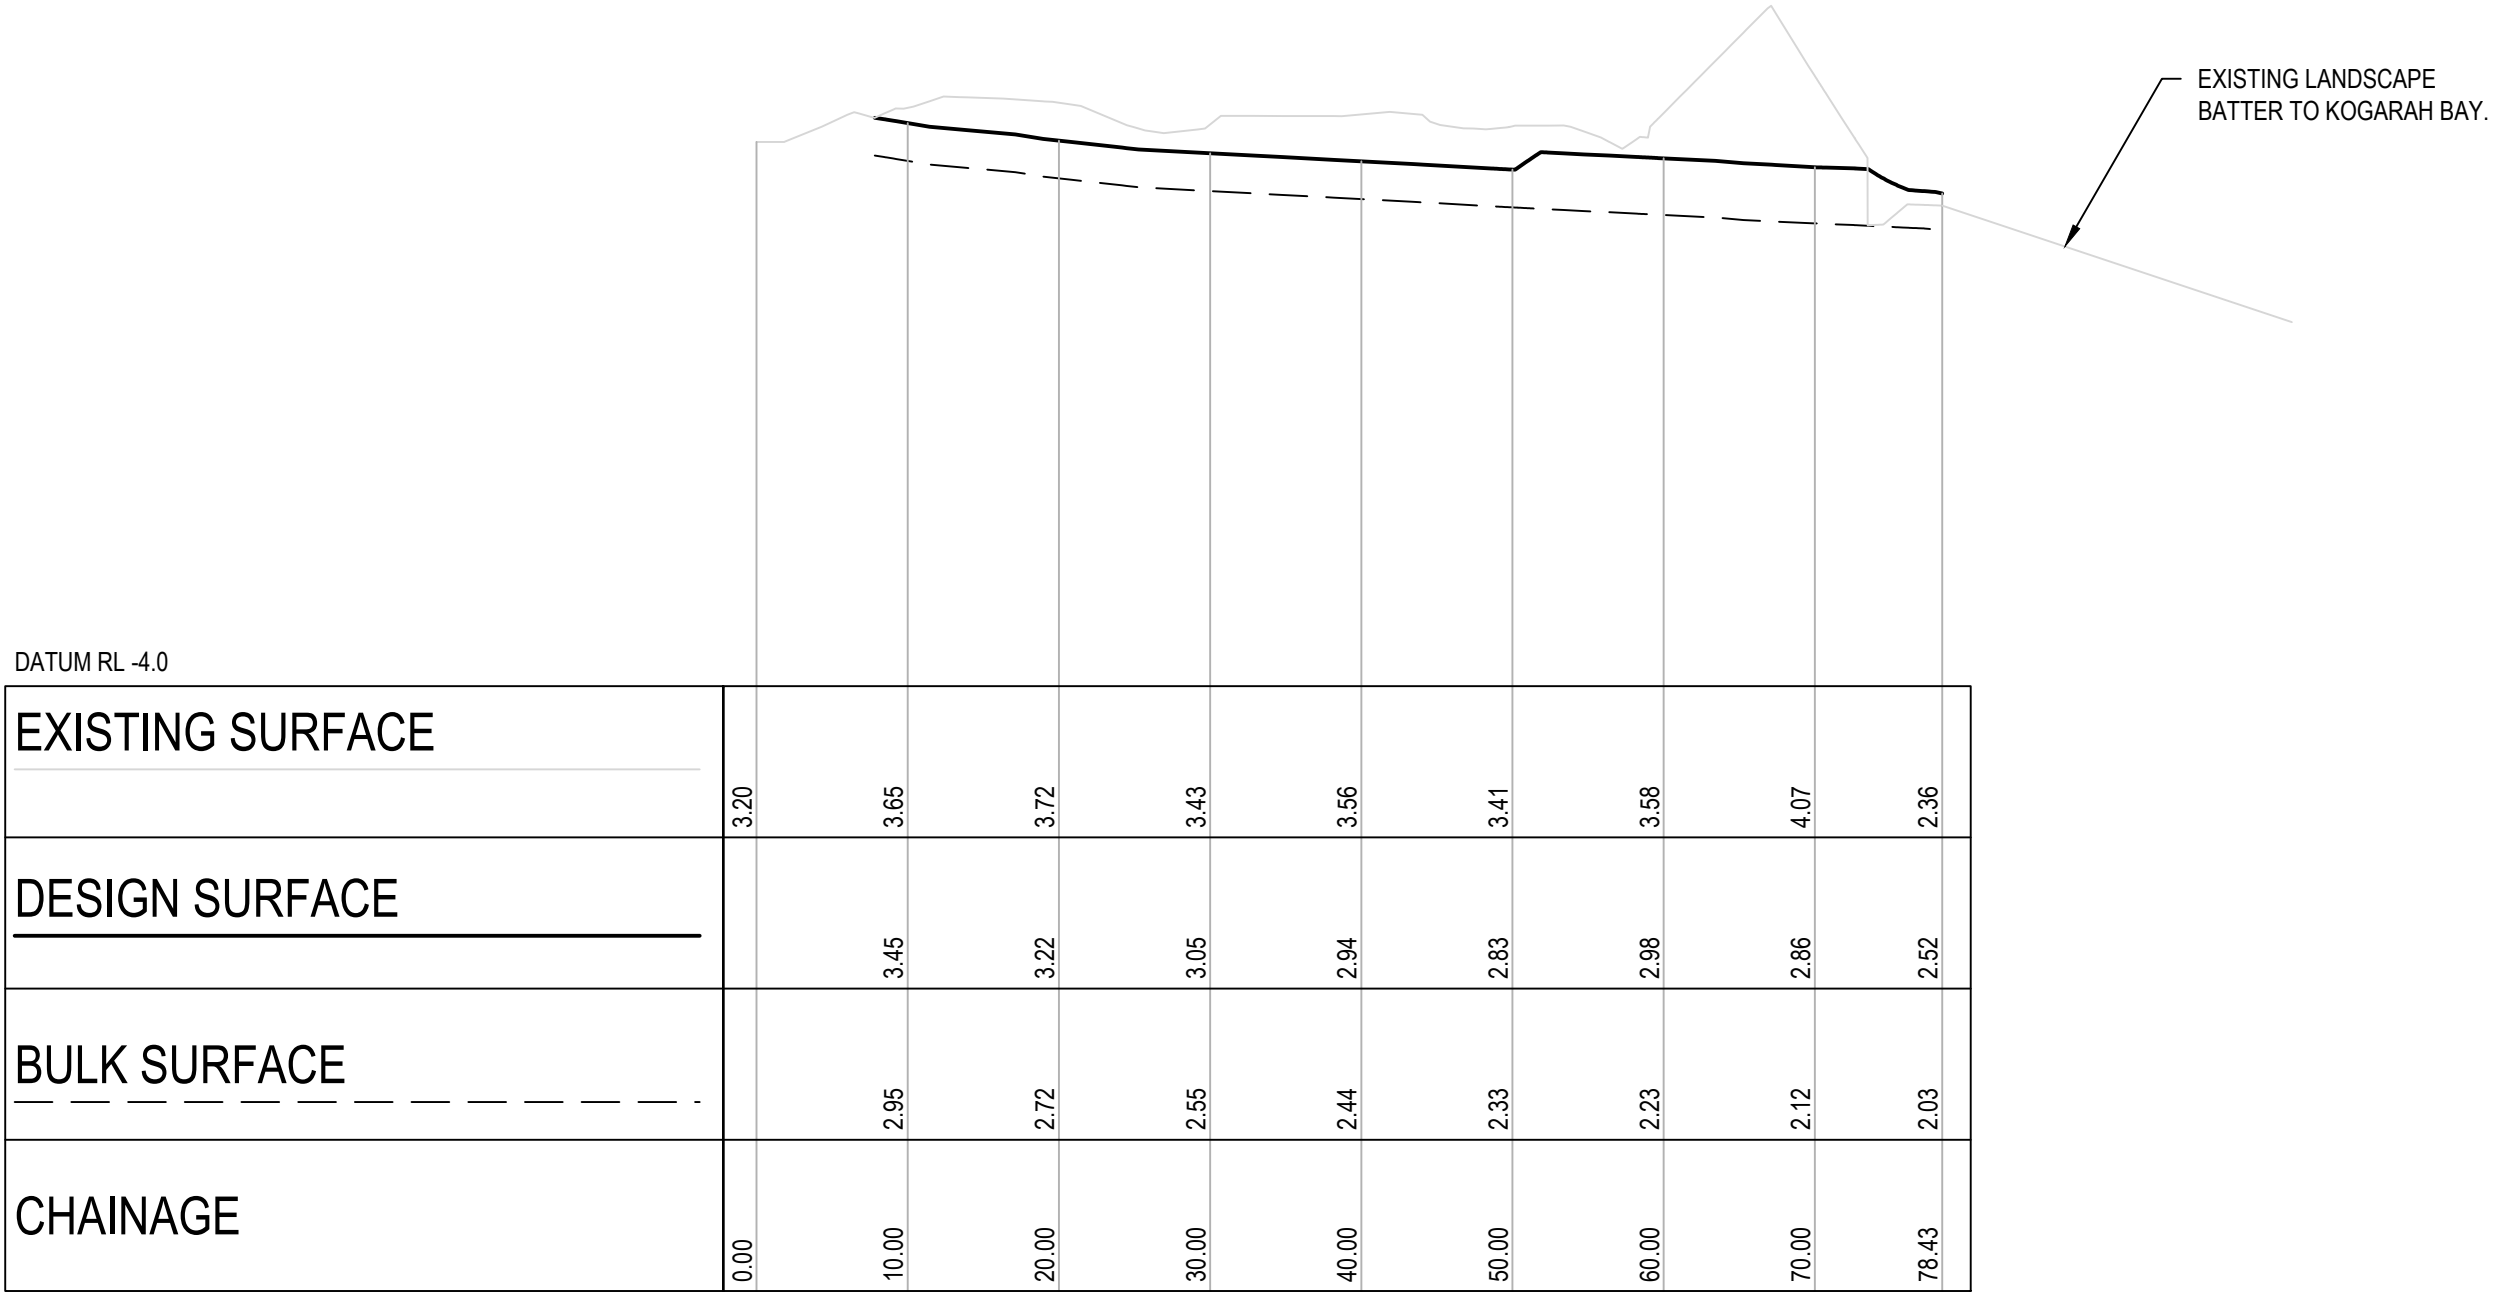
SECTION 3  
SCALE 1:500 (H)  
SCALE 1:100 (V)  
C05.01
