## Remediation Action Plan

Proposed Pool and Park Redevelopment  
Kogarah War Memorial Pool,  
78 Carwar Avenue  
Carss Park

Prepared for  
SJB Architects c/- SJB Planning

Project 99751.00  
February 2021

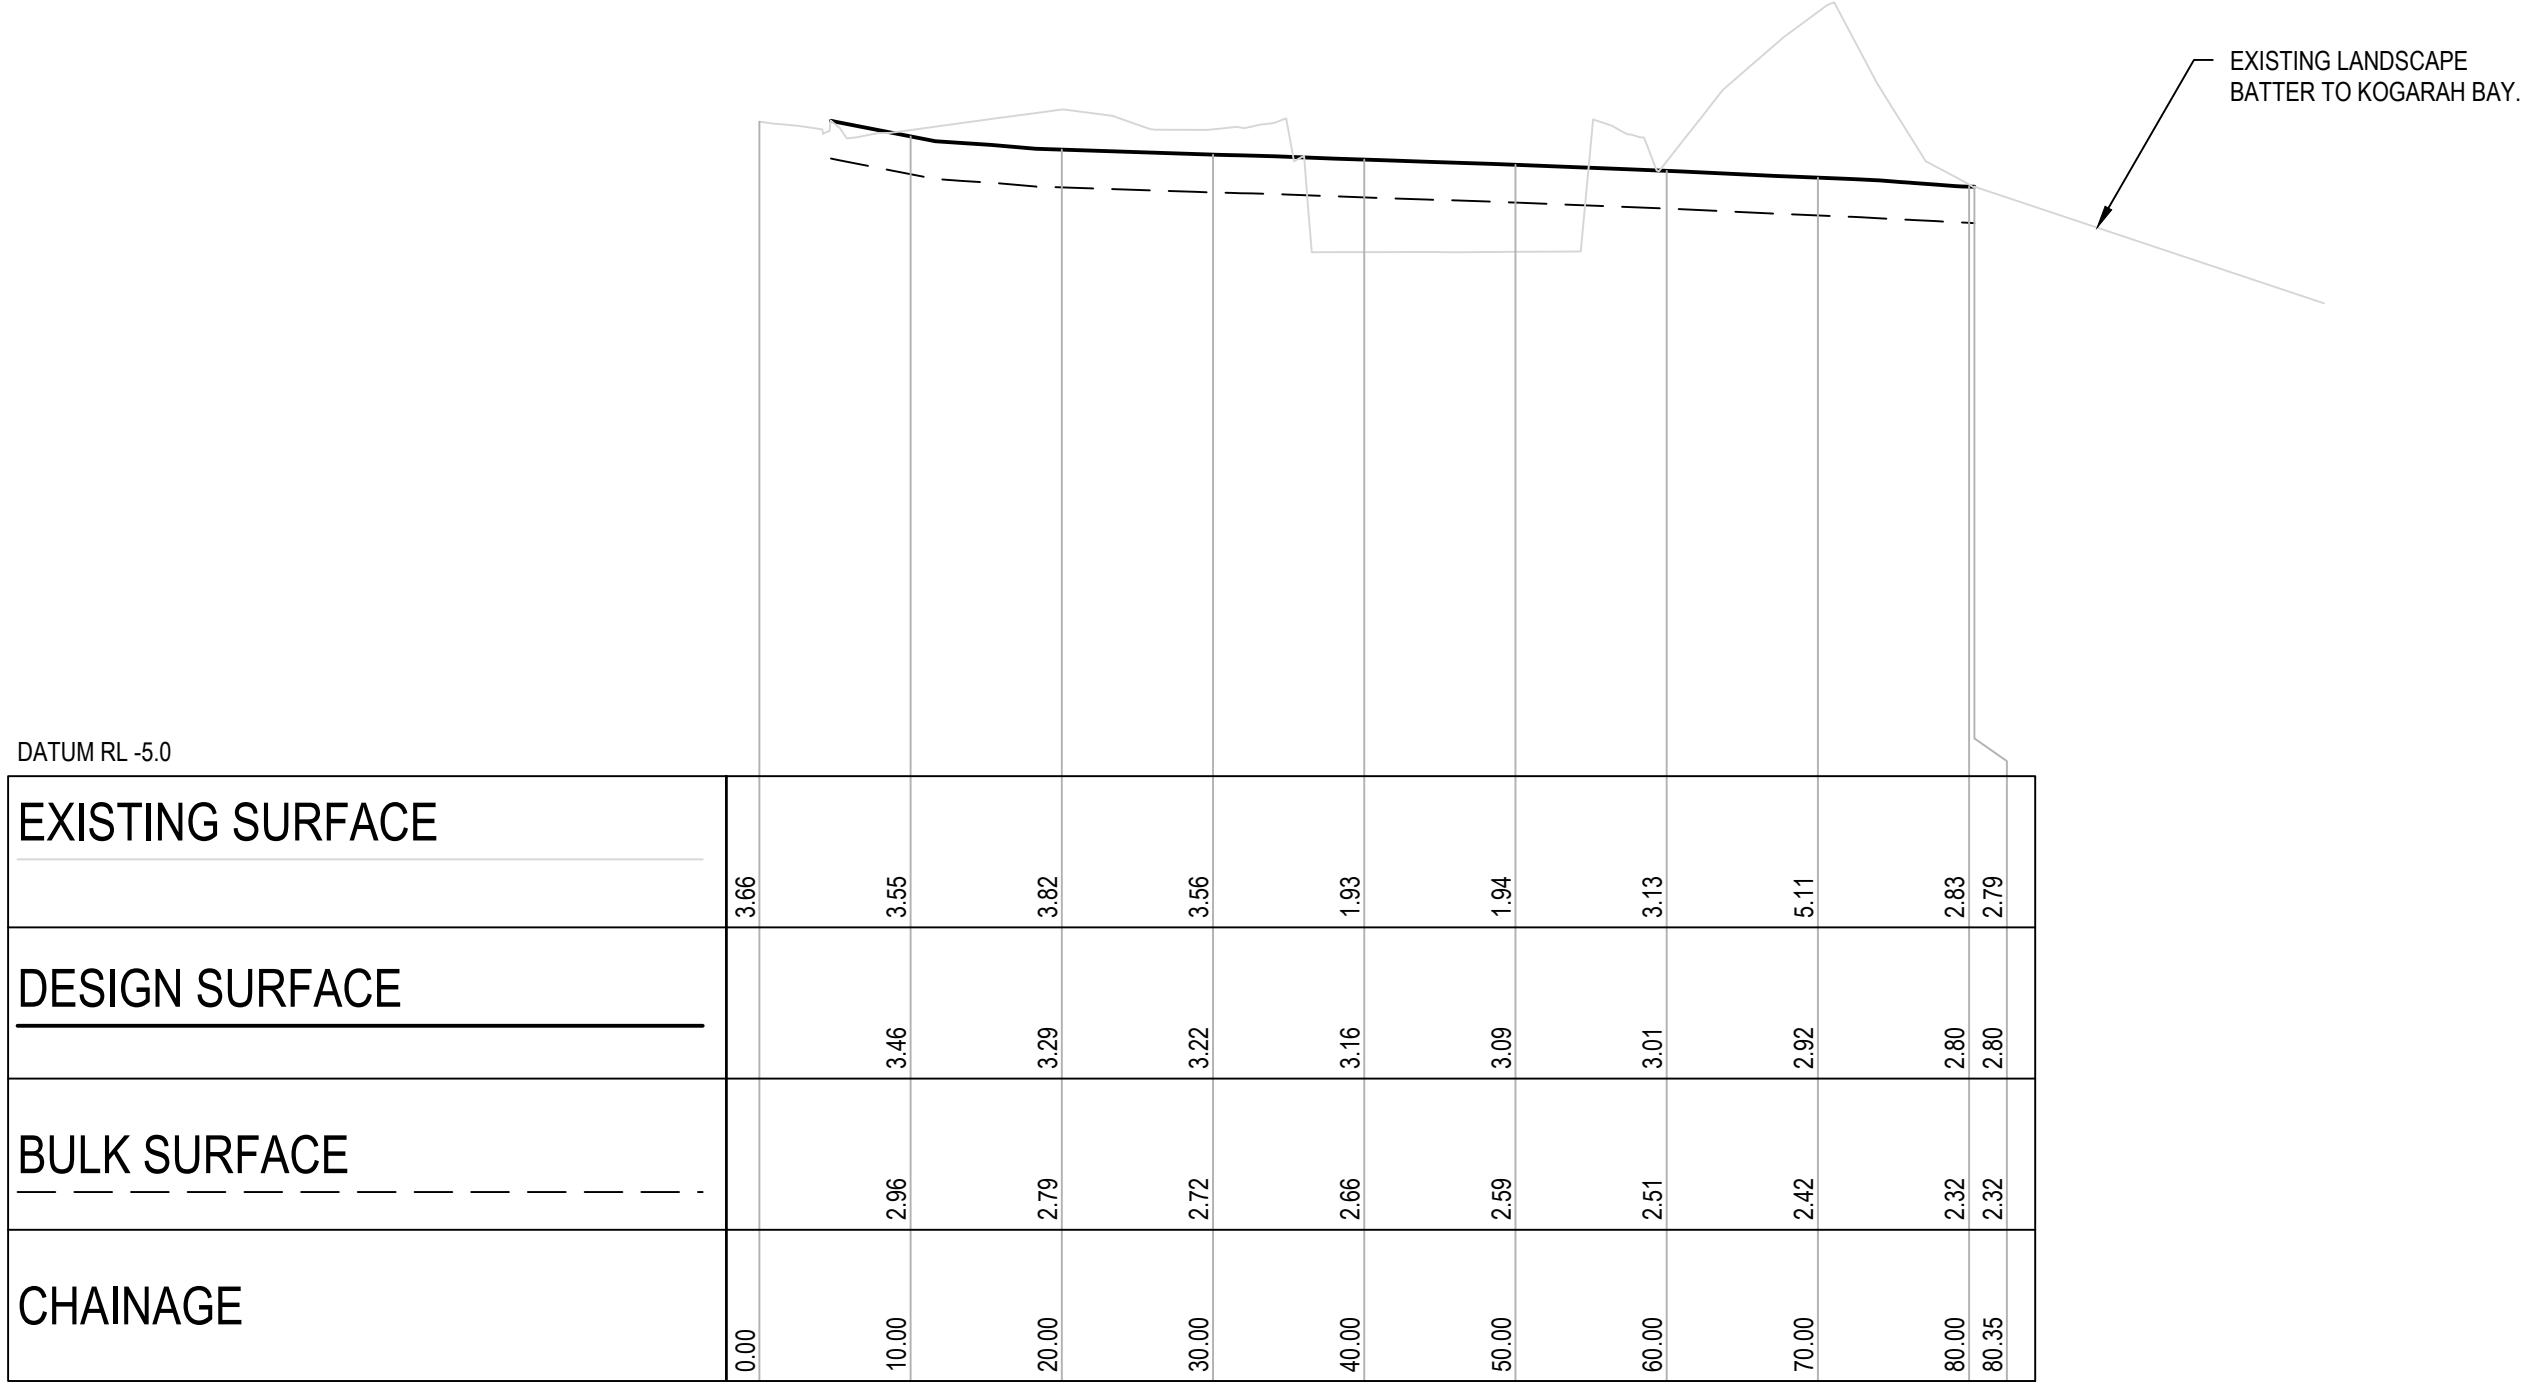
SECTION 4  
SCALE 1:500 (H)  
SCALE 1:100 (V)  
C05.01

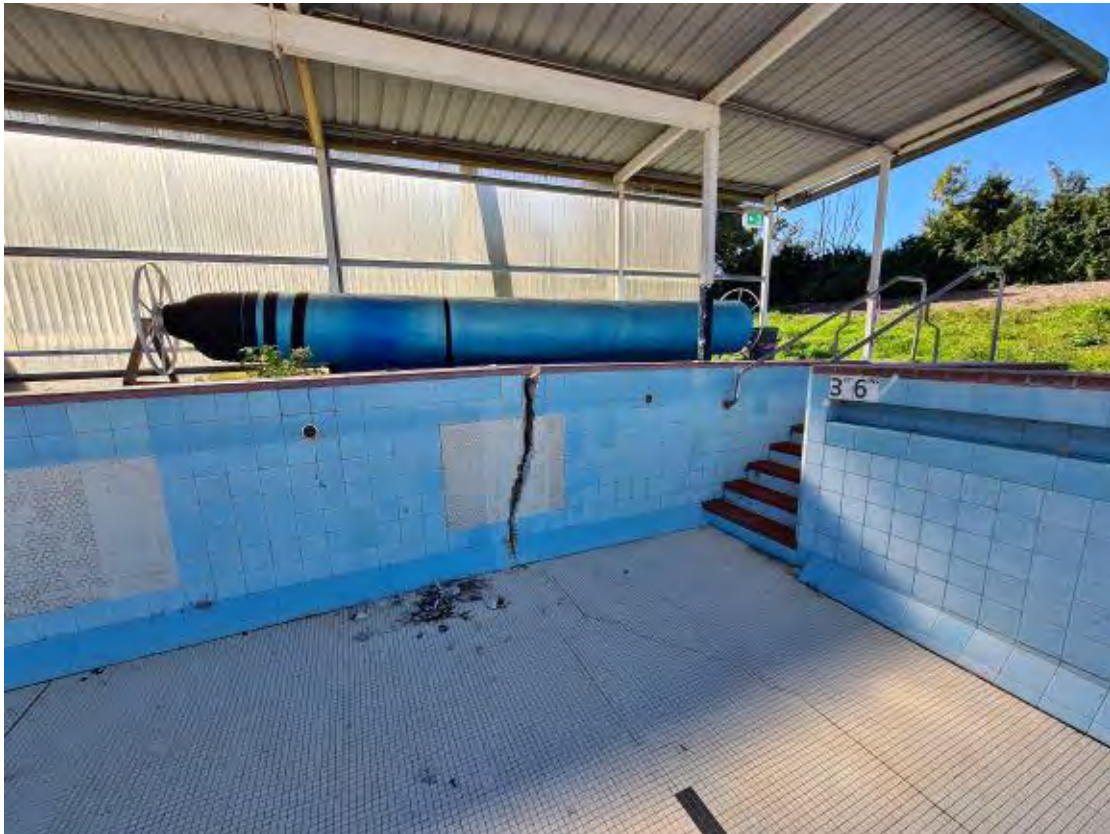
Photo 1: Looking north showing a large crack in the pool wall

- The site was occupied by a swimming pool with associated single-storey buildings. The swimming pool was observed to have significant cracking in the walls;
- Central and western parts of the site were concrete paved or hardstand and there was some cracking evident;
- The eastern, northern and southern portions of the site were predominantly vegetated;
- No general storage of chemicals on site was observed, however, there was evidence of previous chemical storage associated with the operation of the swimming pool, including chlorine;
- Stormwater pits were visible throughout the site;
- Potential hazardous building materials such as fibre cement sheet and Synthetic Mineral Fibres (SMF) were present (including associated with in-ground pipes); and
- A large berm on the eastern boundary of the site indicated a significant amount of earthworks had occurred on the site.

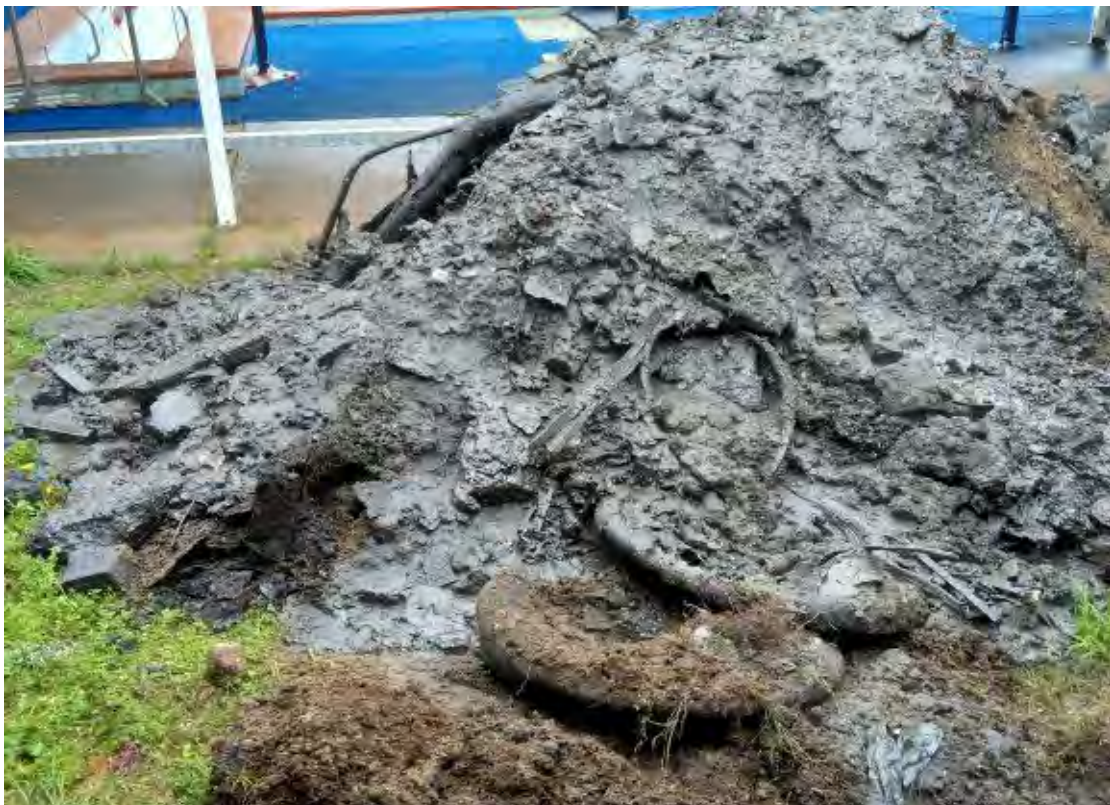
Photo 2: TP121 looking east showing fill material from beneath water table

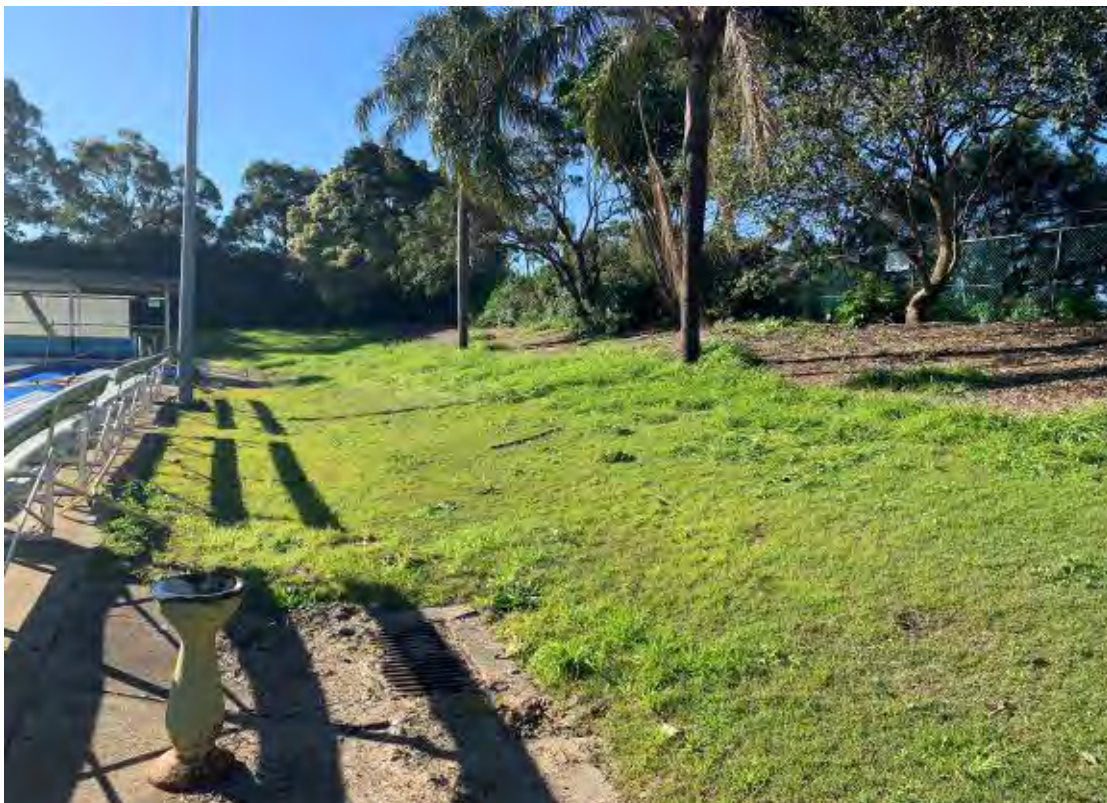
Photo 8: Looking north from the vicinity of BH109 showing the eastern site boundary and the berm
