Remediation Action Plan

Proposed Pool and Park Redevelopment
Kogarah War Memorial Pool,
78 Carwar Avenue
Carss Park

Prepared for
SJB Architects c/- SJB Planning

Project 99751.00
February 2021

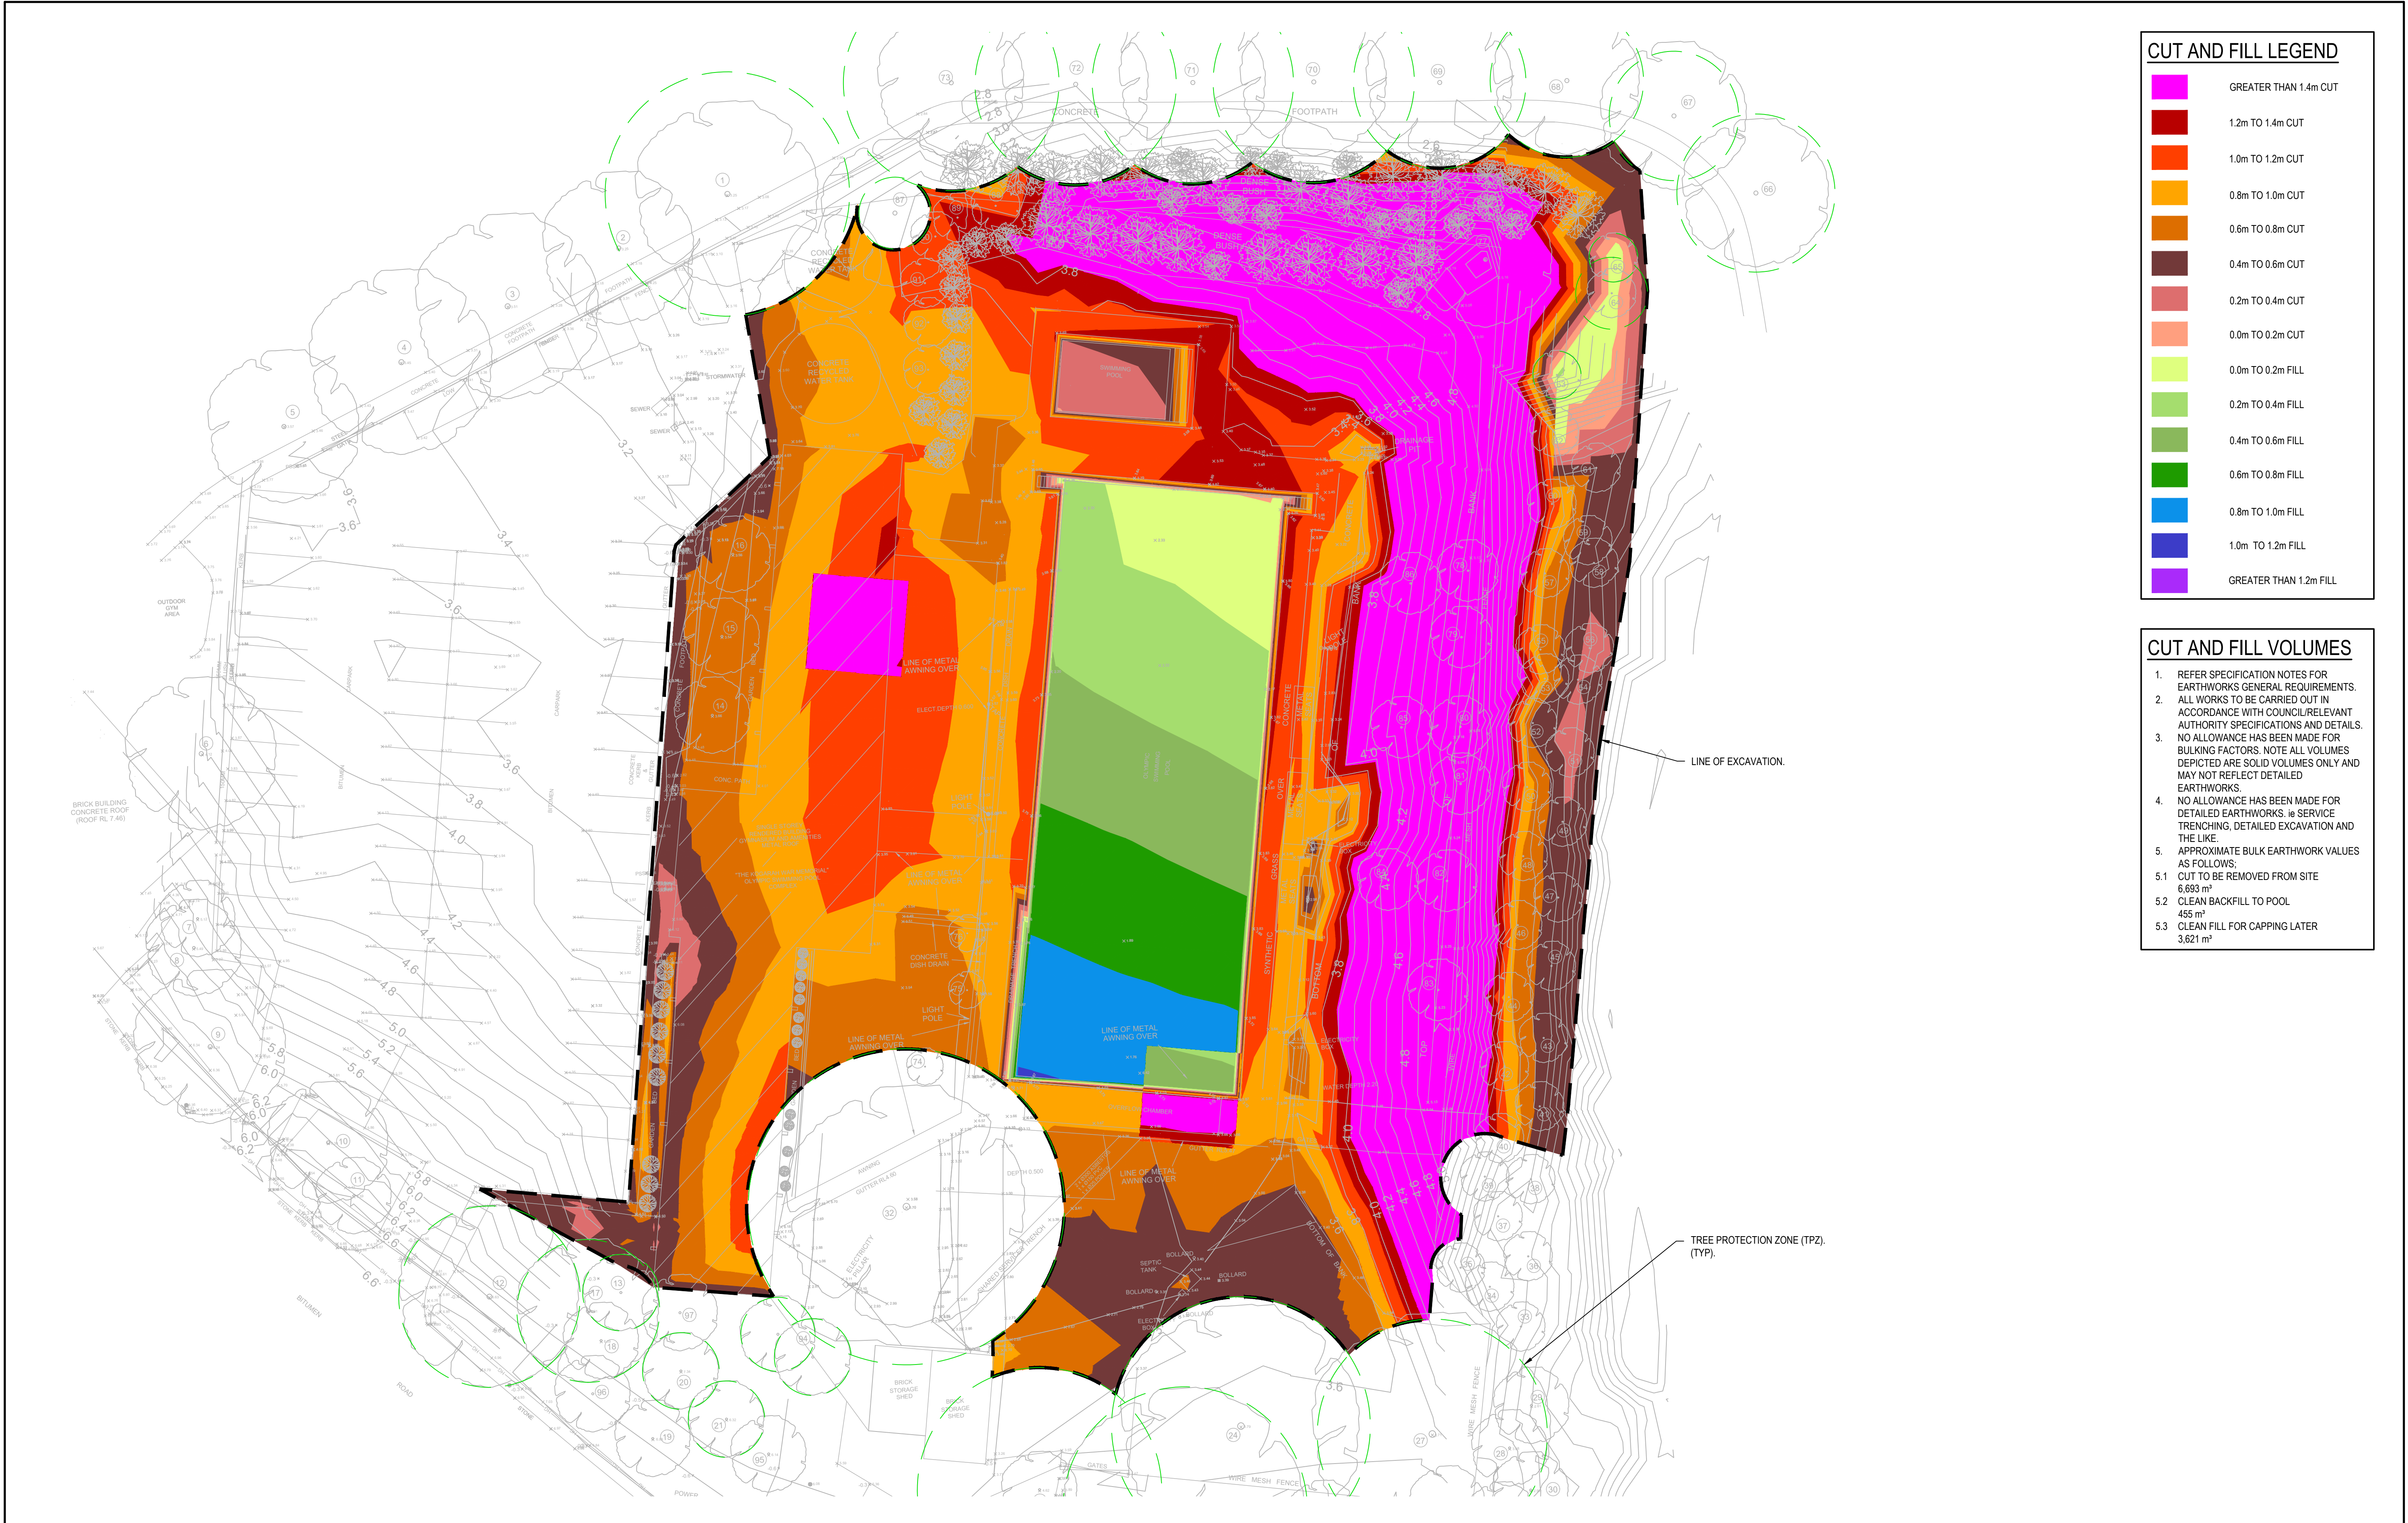
Project Number/Drawing Number
200060-DA-C03.21

GREATER THAN 1.4m CUT
	1.2m TO 1.4m CUT
	1.0m TO 1.2m CUT
	0.8m TO 1.0m CUT
	0.6m TO 0.8m CUT
	0.4m TO 0.6m CUT
	0.2m TO 0.4m CUT
	0.0m TO 0.2m CUT
	0.0m TO 0.2m FILL
	0.2m TO 0.4m FILL
	0.4m TO 0.6m FILL
	0.6m TO 0.8m FILL
	0.8m TO 1.0m FILL
	1.0m TO 1.2m FILL
	GREATER THAN 1.2m FILL

1. REFER GEOTECHNICAL REPORT
PREPARED BY DOUGLAS PARTNERS
FOR REMEDIATION REQUIREMENTS.

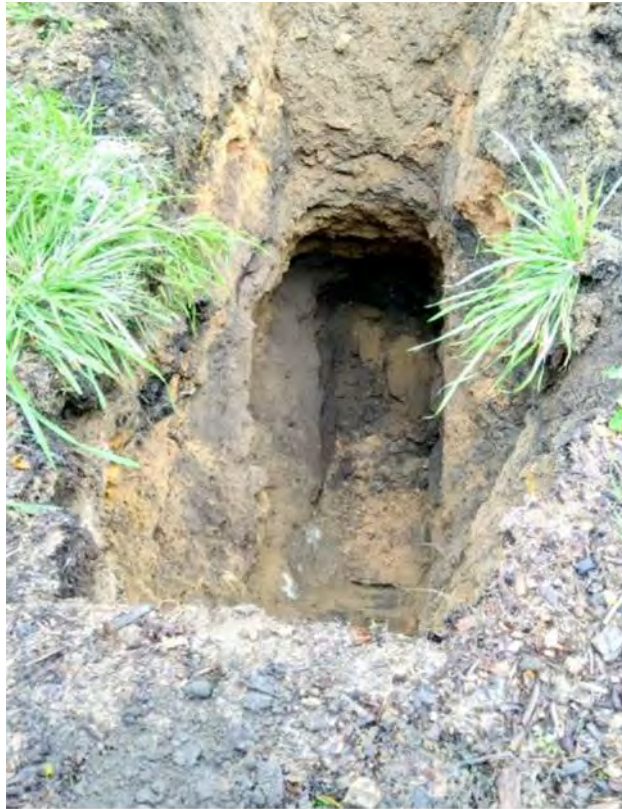
Photo 3: TP126 looking west showing the soil profile

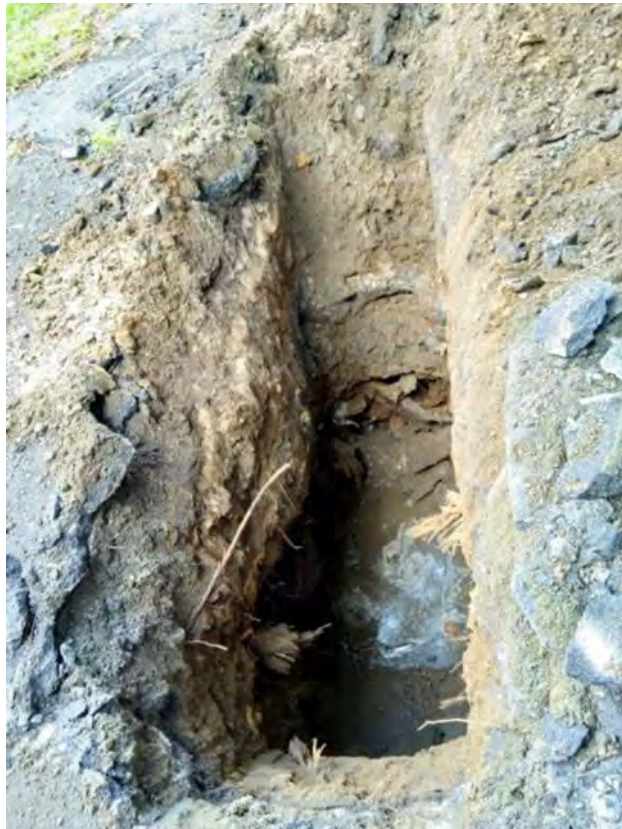
Photo 4: P128 looking east showing soil profile and groundwater at base of test pit

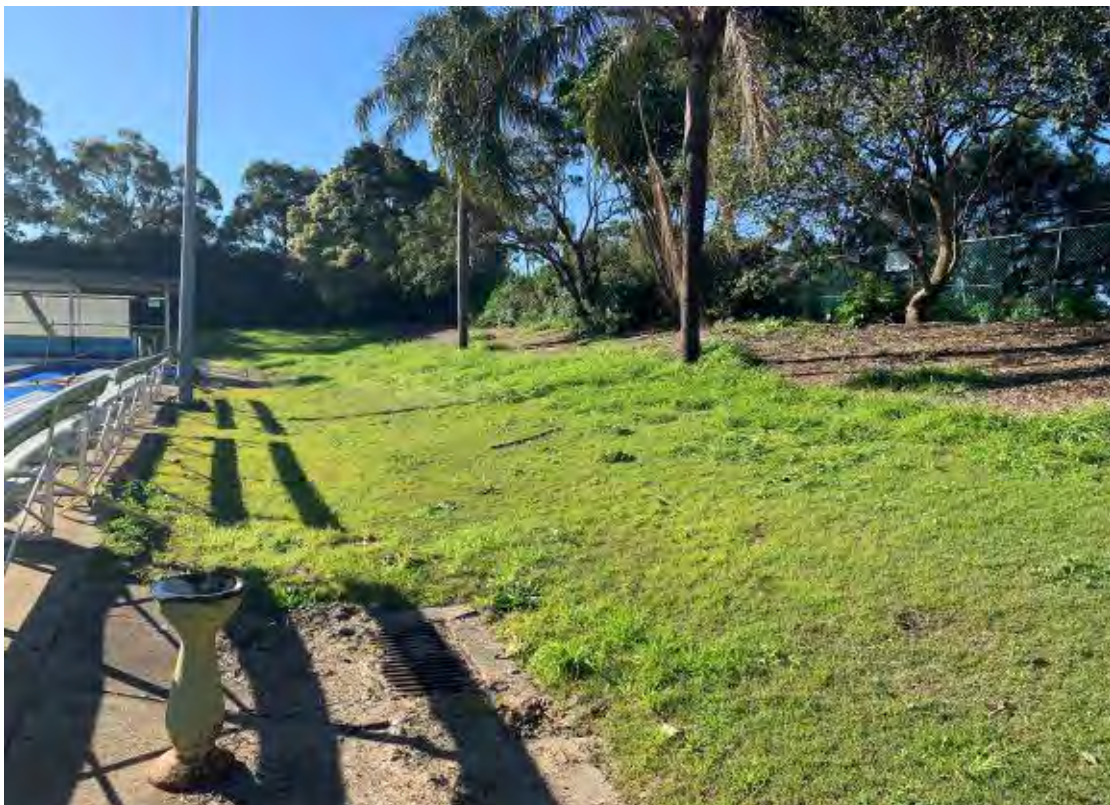
Photo 8: Looking north from the vicinity of BH109 showing the eastern site boundary and the berm

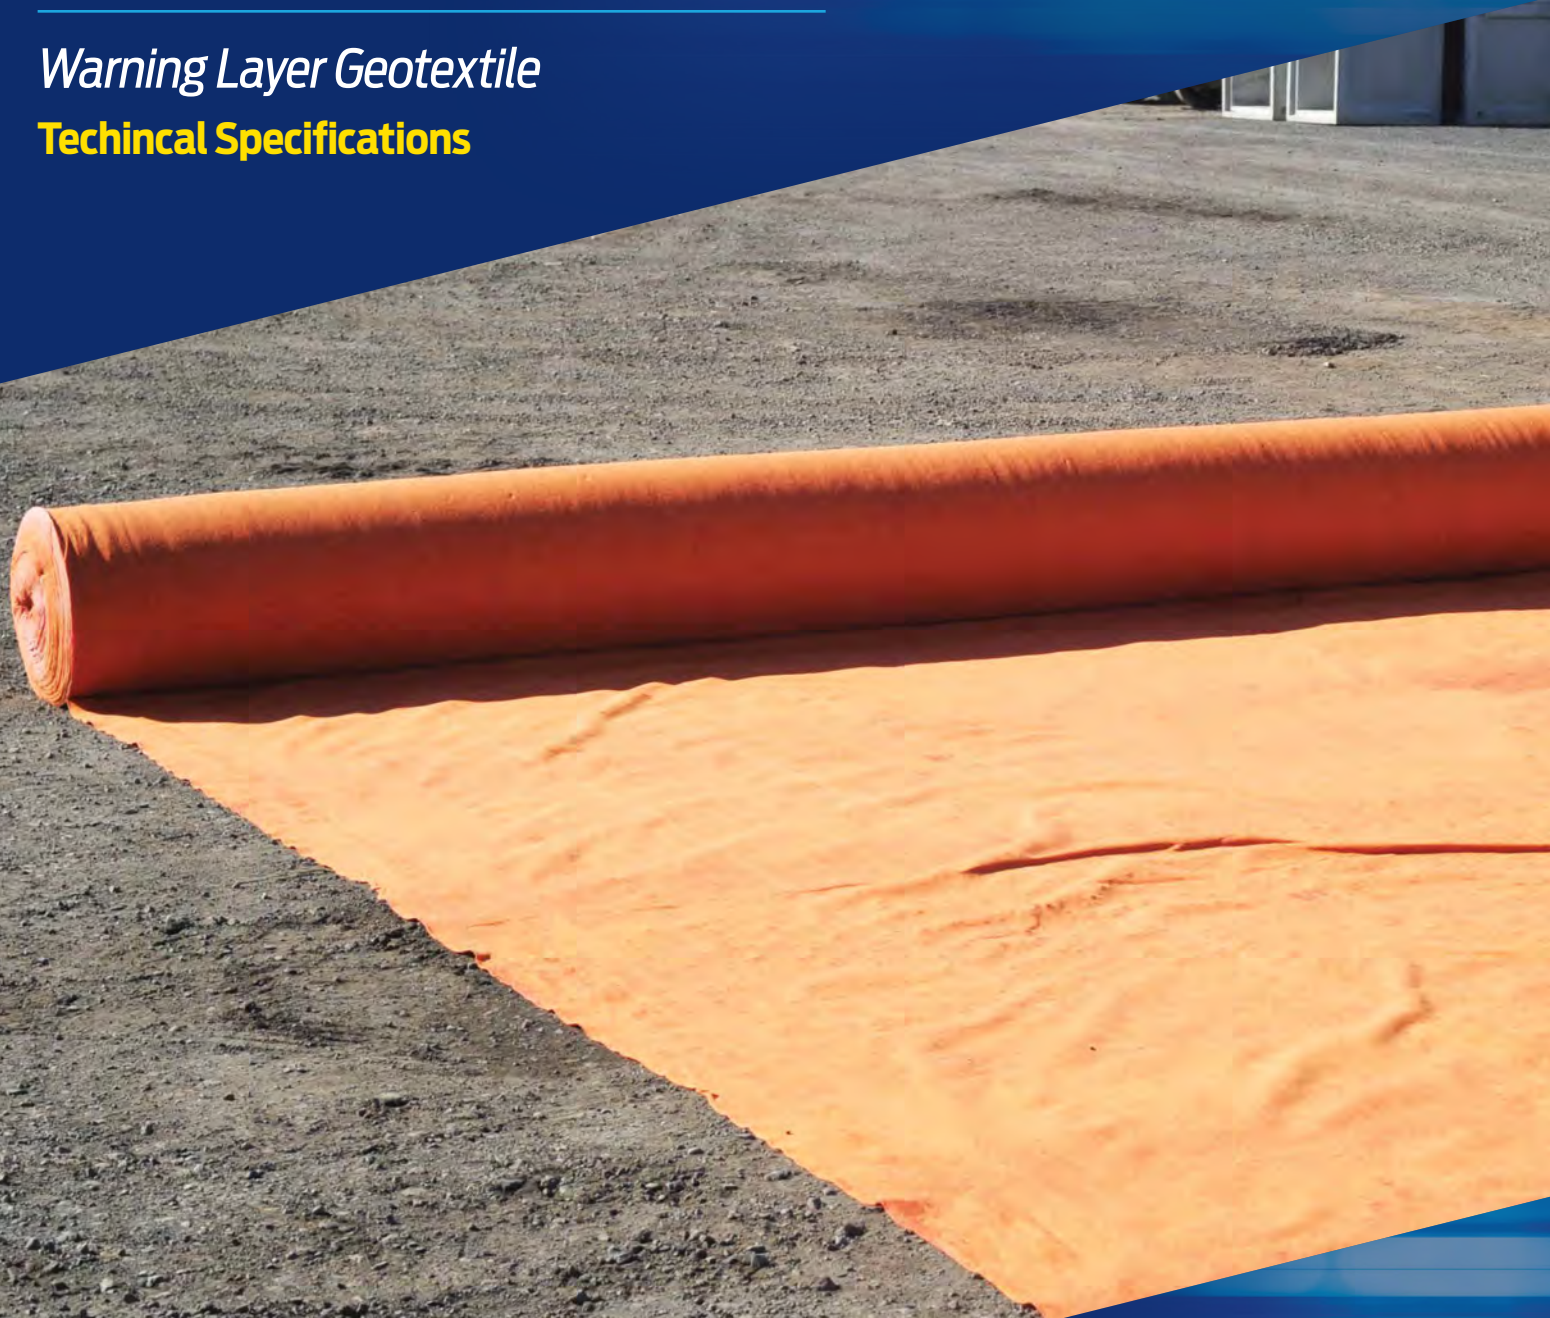
GEO MASTA™

- ✓ Segregation of contaminated soil
- ✓ Filtration
- ✓ Warning Layer

TEST METHOD	UNIT	VALUES
INDEX PROPERTIES			
Material			Polyester (PET)
Grab Tensile Strength	AS 3706.2B	N	500
Wide Strip Tensile Strength	AS3706.2A	kN/m	8.1
Mass	AS 3760.1	gsm	140
TYPICAL HYDRAULIC PROPERTIES MEAN			
Pore Size	AS 3706.7	µm (Microns)	120
Nominal Flow Rate	AS 3706.9	l/m ² /s	240
DIMENSIONS			
Width		m	6
Length		m	150
Roll Diameter		m	400
