**REPORT  
TO  
ABM BUILT  
ON  
GEOTECHNICAL INVESTIGATION  
FOR  
PROPOSED MIXED USE DEVELOPMENT  
AT  
62 – 70 KING GEORGES ROAD &  
280 – 292 LAKEMBA STREET, WILEY PARK NSW**

**22 June 2017  
Ref: 30501Srpt**

**JK Geotechnics**  
GEOTECHNICAL & ENVIRONMENTAL ENGINEERS

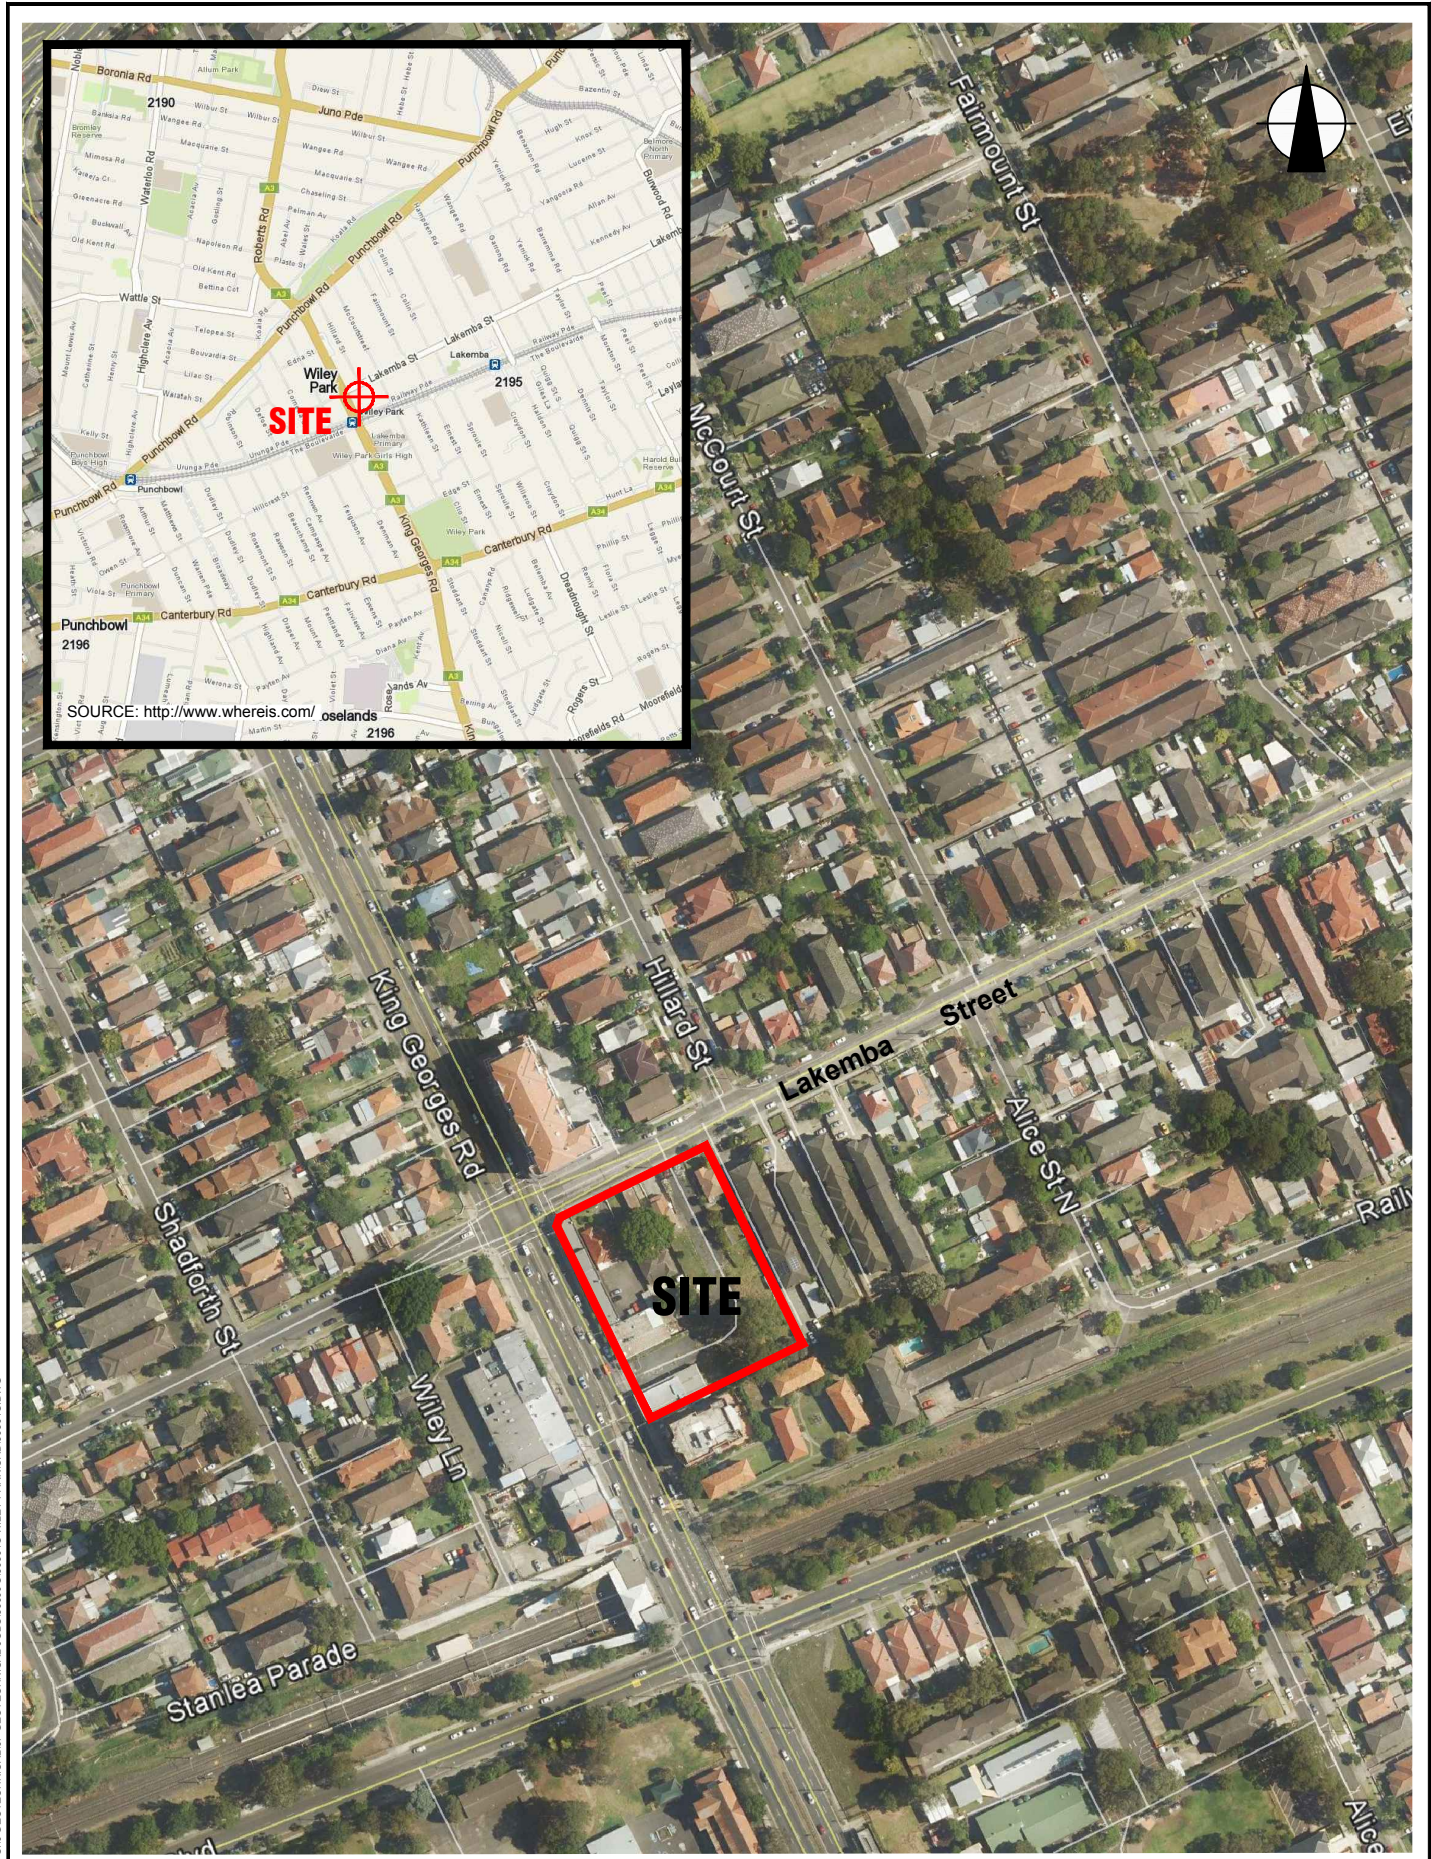
AERIAL IMAGE SOURCE: GOOGLE EARTH PRO 7.1.5.1557  
AERIAL IMAGE ©: 2015 GOOGLE INC.

This plan should be read in conjunction with the JK Geotechnics report.

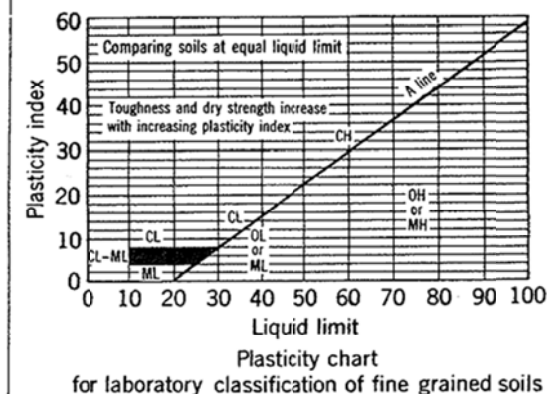
Determine percentages of gravel and sand from grain size curve  
Depending on percentage of fines (fraction smaller than 75 µm sieve size) coarse grained soils are classified as follows:  
Less than 5% GW, GP, SW, SP  
More than 5% GM, GC, SM, SC  
Borderline cases requiring use of dual symbols

Use grain size curve in identifying the fractions as given under field identification

- Note: 1 Soils possessing characteristics of two groups are designated by combinations of group symbols (eg. GW-GC, well graded gravel-sand mixture with clay fines).  
2 Soils with liquid limits of the order of 35 to 50 may be visually classified as being of medium plasticity.
