30 June 2022
Our ref: JM/C12708.2

**PROPOSED MASTERPLAN DEVELOPMENT
ST PETER'S ANGLICAN COLLEGE – 61 TRAIN STREET, BROULEE, NSW**

PRELIMINARY ENVIRONMENTAL SITE ASSESSMENT REPORT

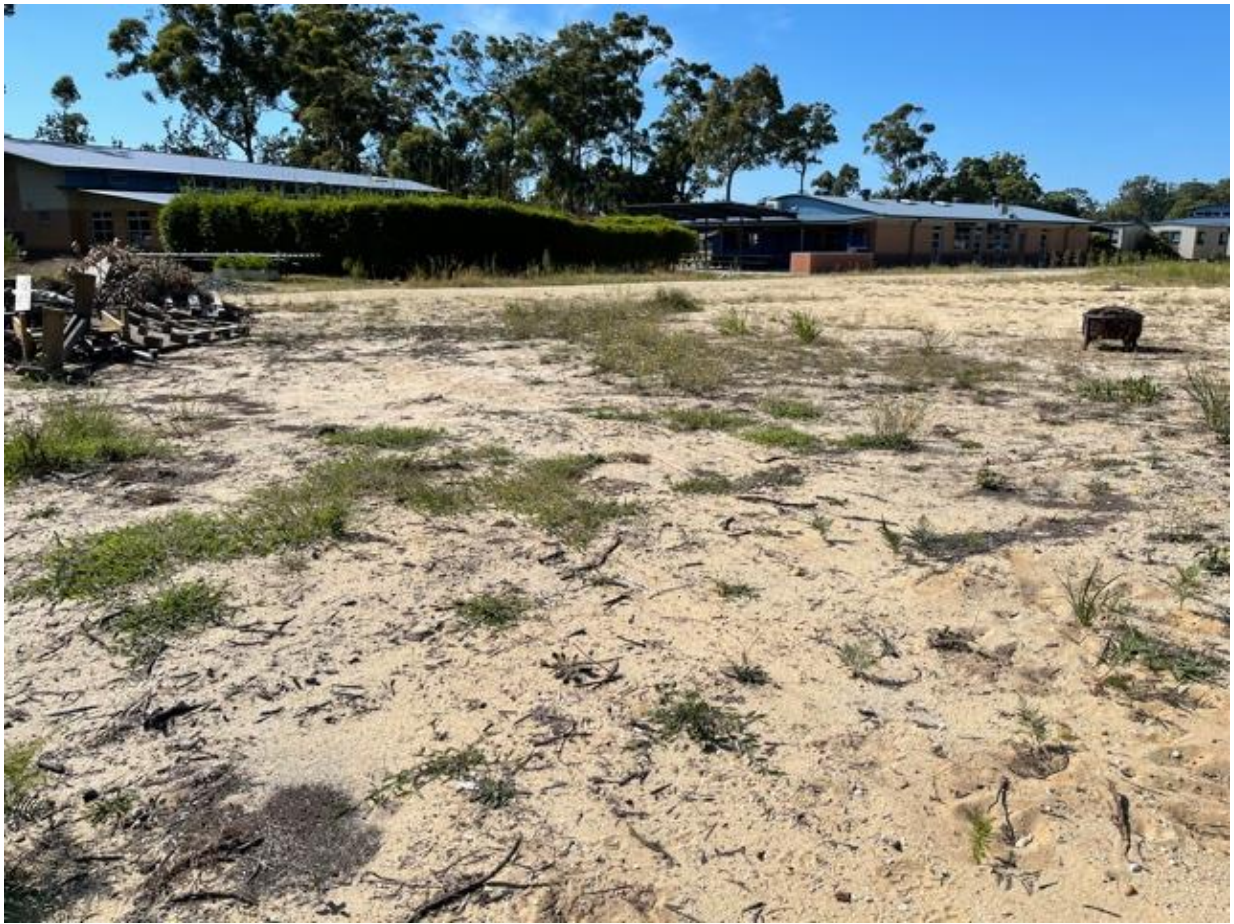
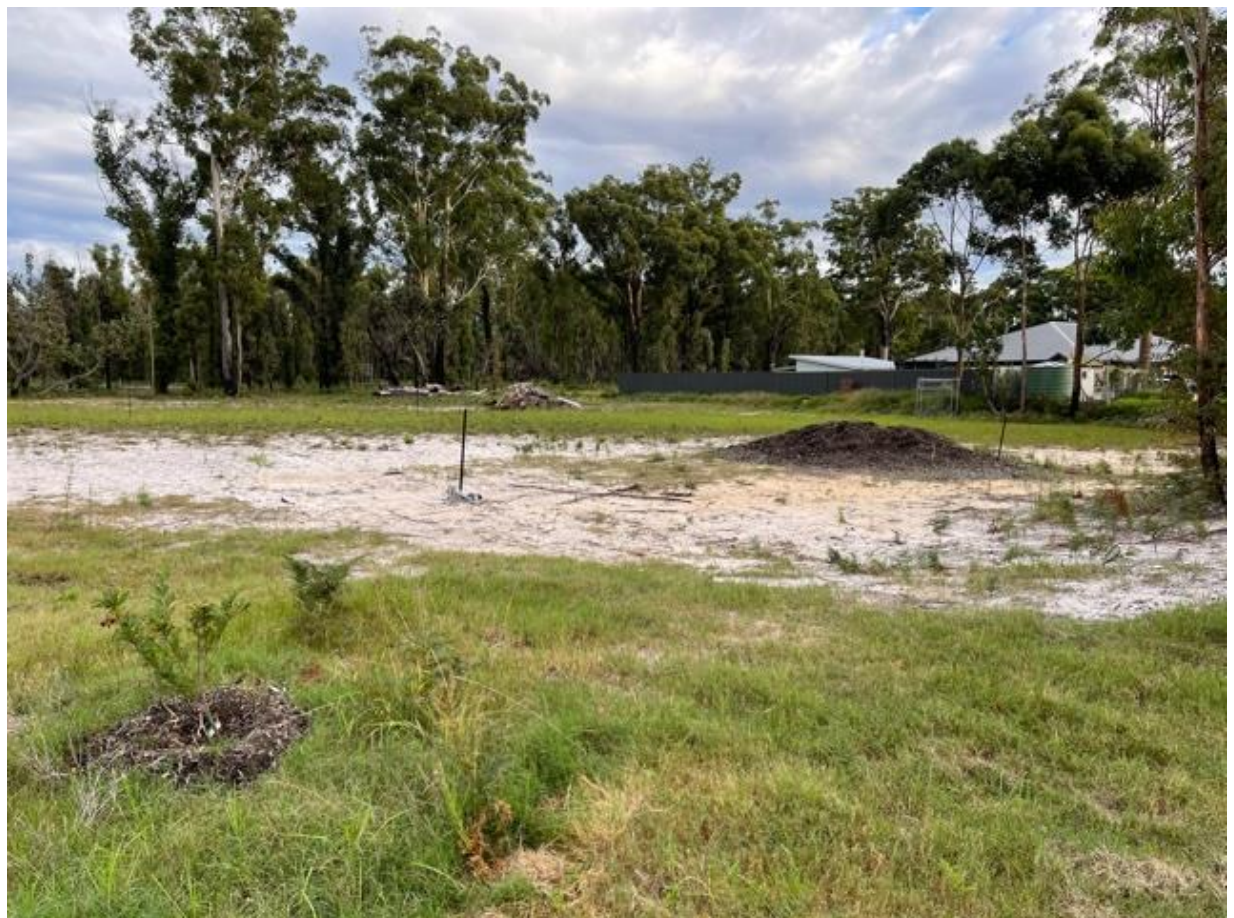
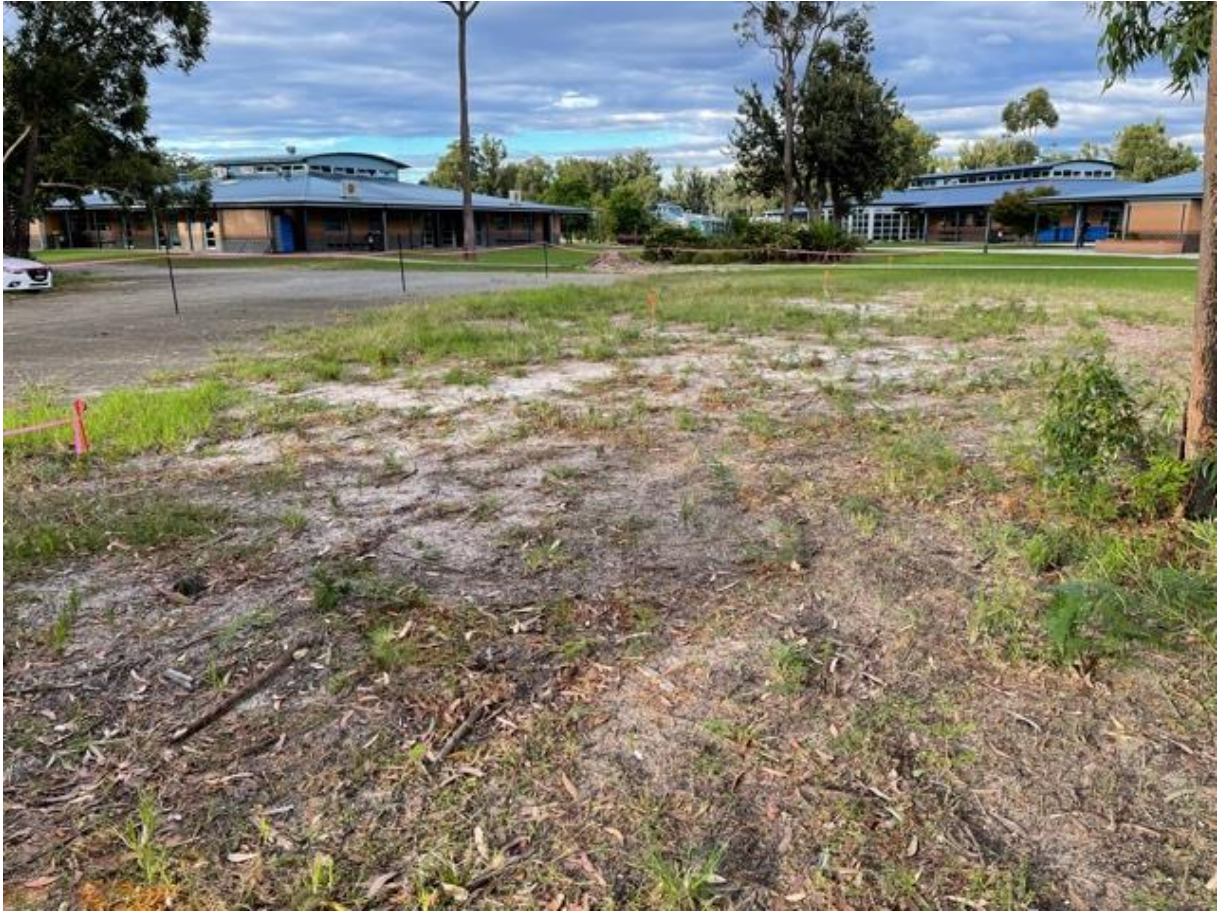
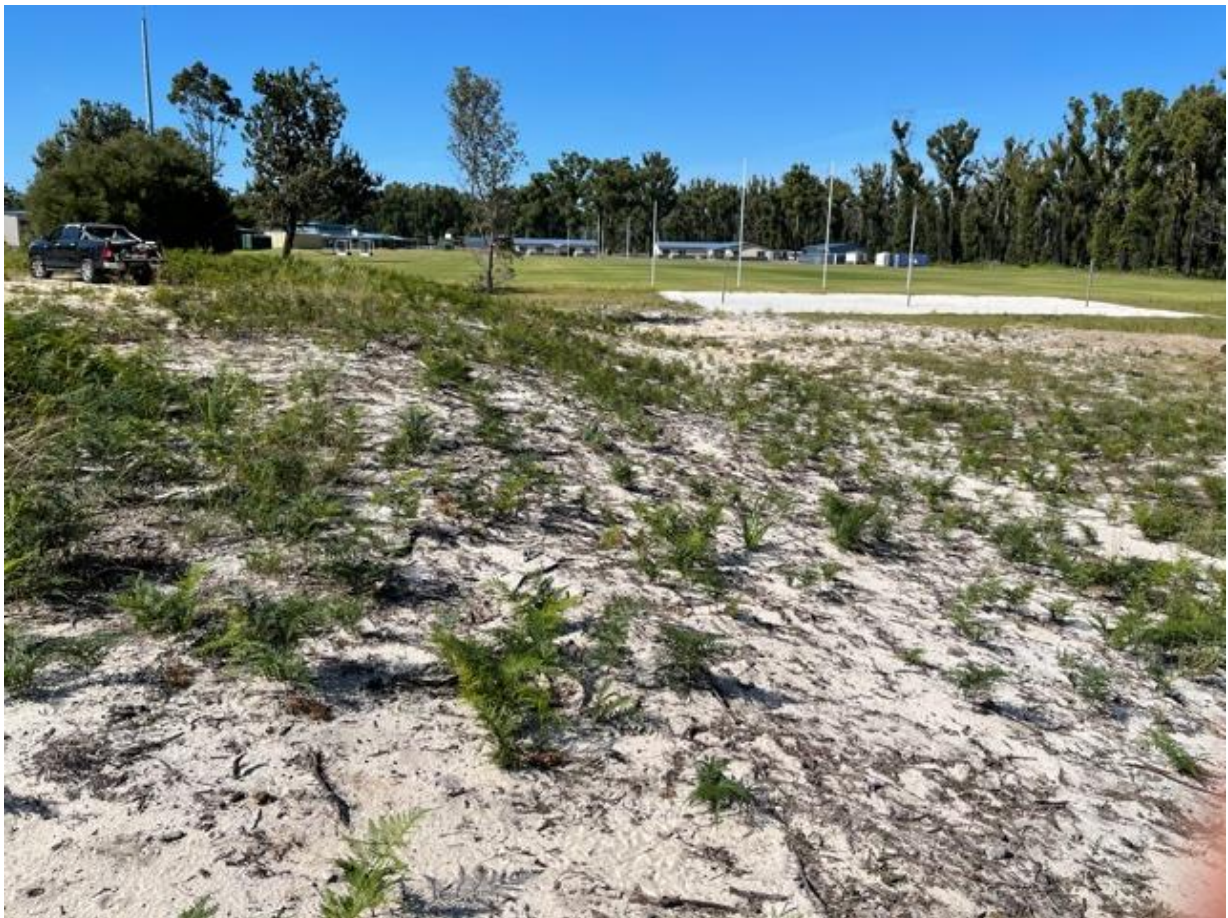
APPENDIX A
Photographs of the Site

No olfactory or visual indicators of contamination or anthropogenic materials were noted during the site visit across the site.

There were no visual surface staining and odours noted during walkover survey in the proposed investigation area.

While it is unlikely that contamination may be encountered during future construction works, it is recommended that an unexpected finds protocol (UFP), with management procedures for asbestos, is implemented prior to construction works commencing. The UFP will assist the construction contractor with identifying and managing any unexpected occurrences of contaminated material.
