## **GEOTECHNICAL INVESTIGATION**

**RFS COOMA, 9 POLO FLAT ROAD, POLO  
FLAT**

**REPORT GG10926.001  
14 MARCH 2023**

# **Geotechnical Investigation for a proposed RFS Control Centre at RFS Cooma, 9 Polo Flat Drive, Polo Flat**

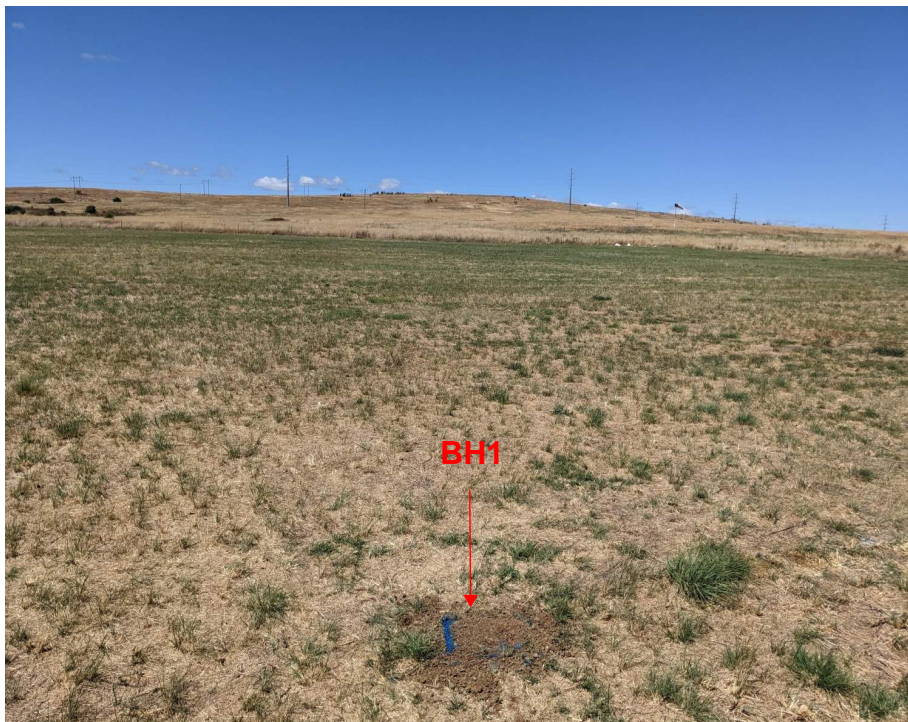
Position of BH1

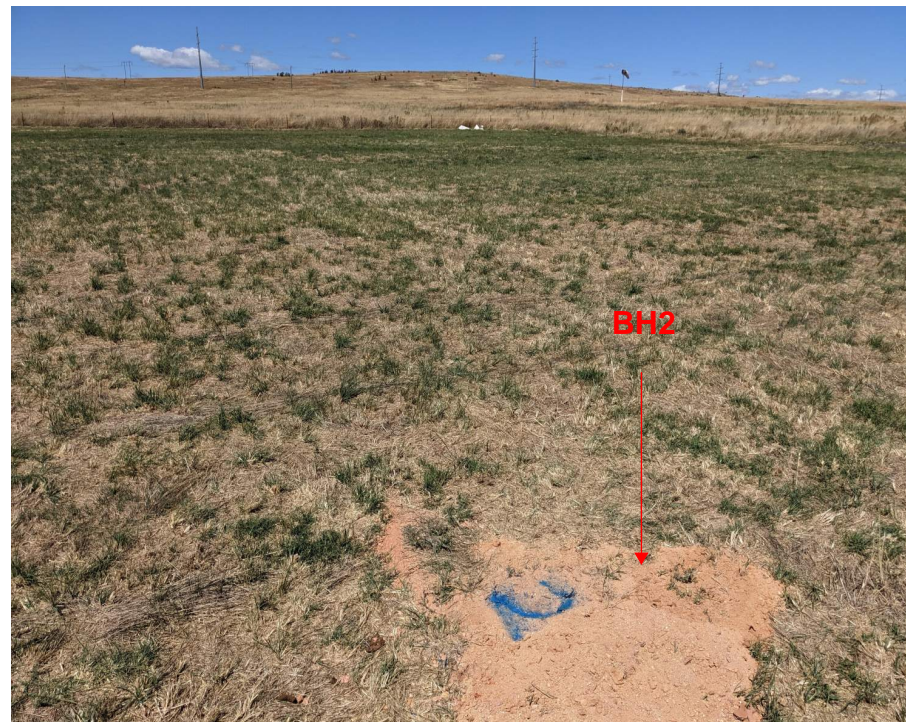
Position of BH2

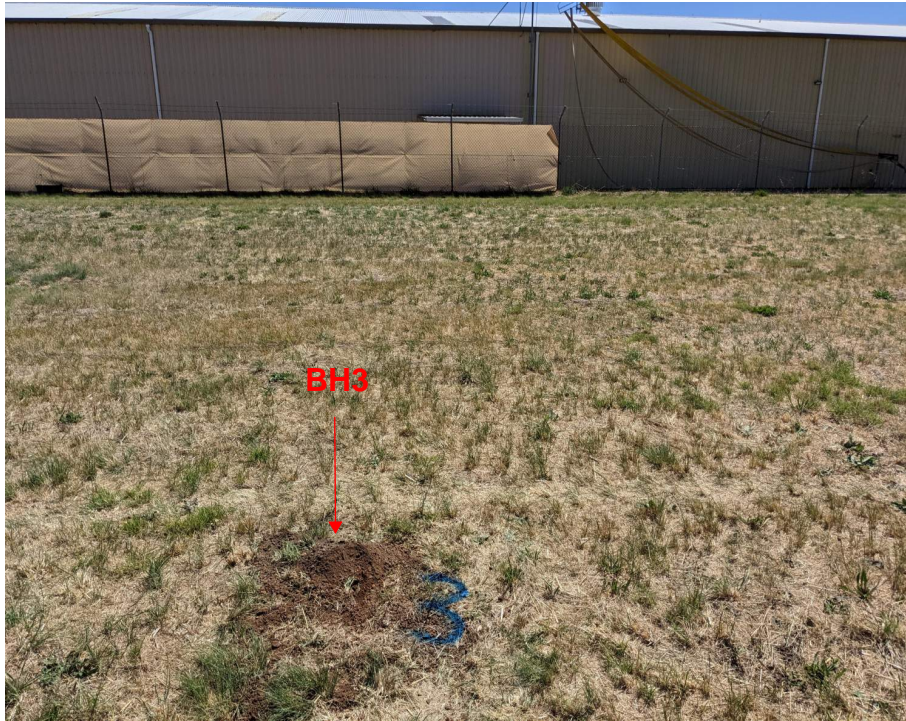
Position of BH3

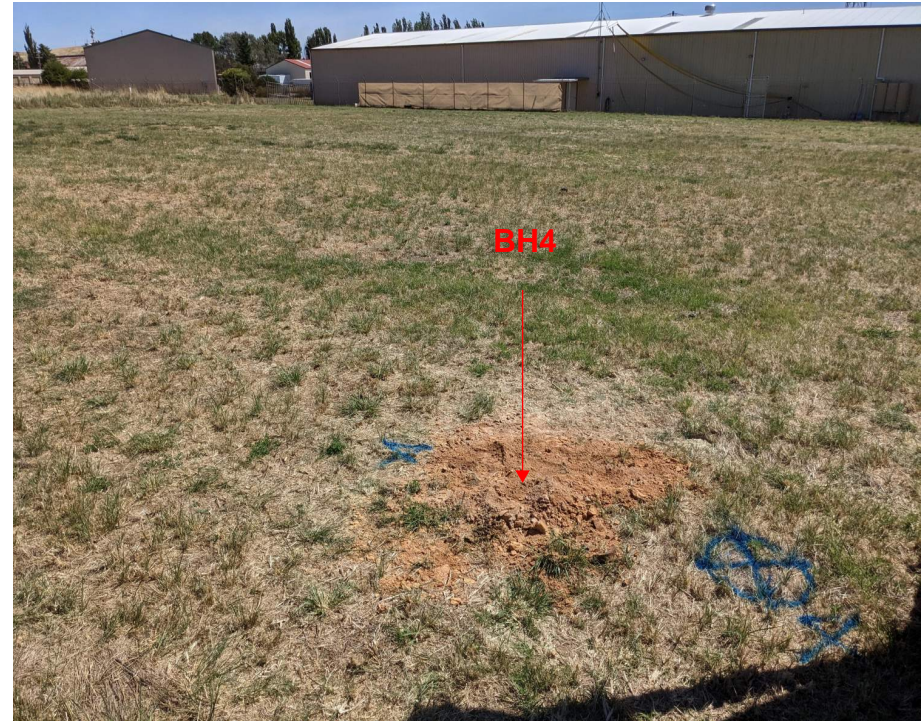
Position of BH4

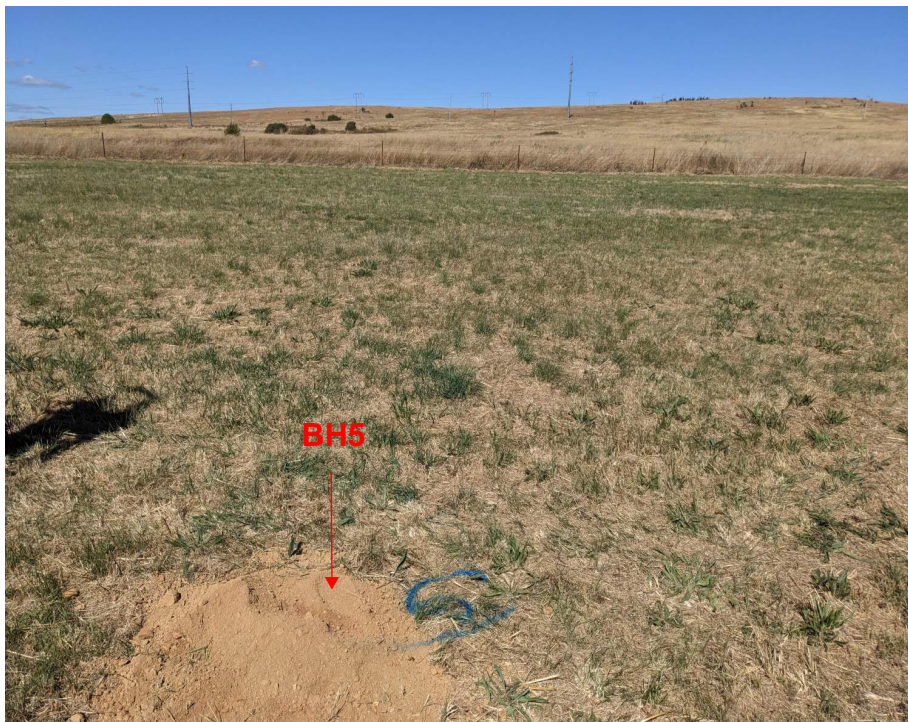
Position of BH5

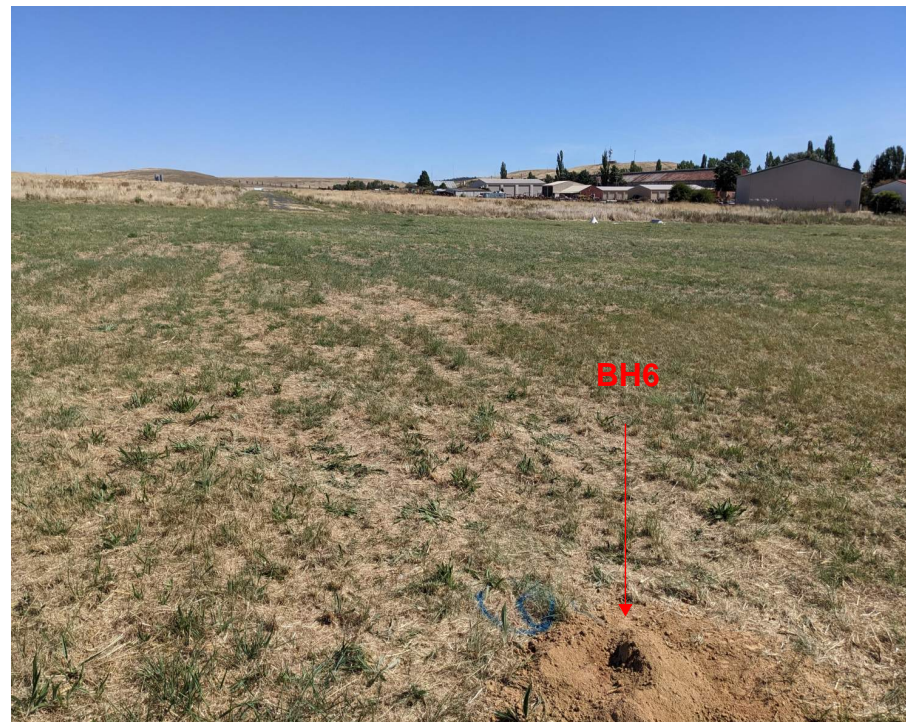
Position of BH6

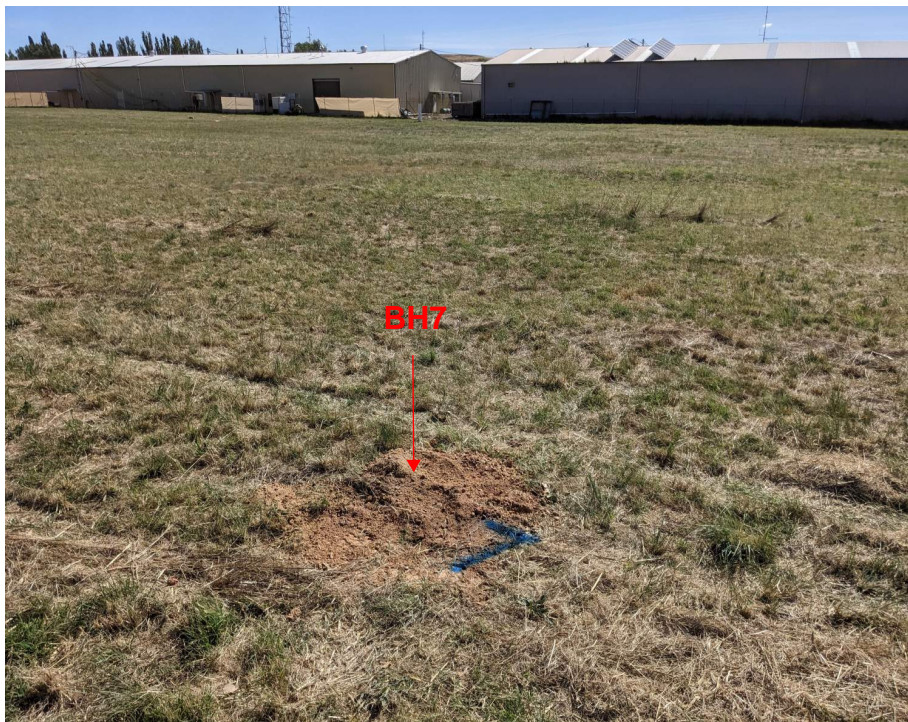
Position of BH7

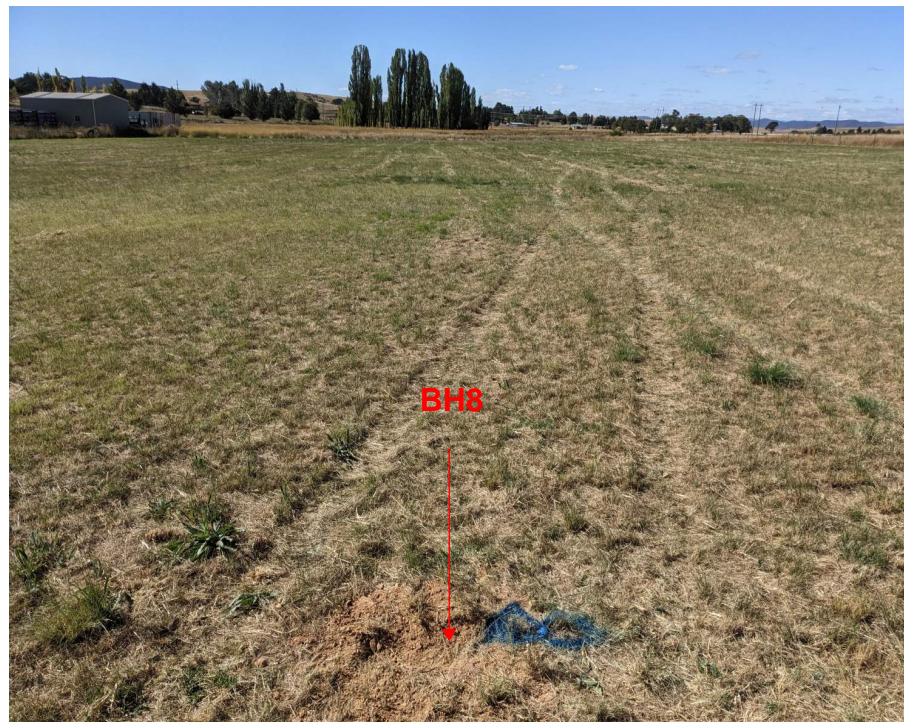
Position of BH8

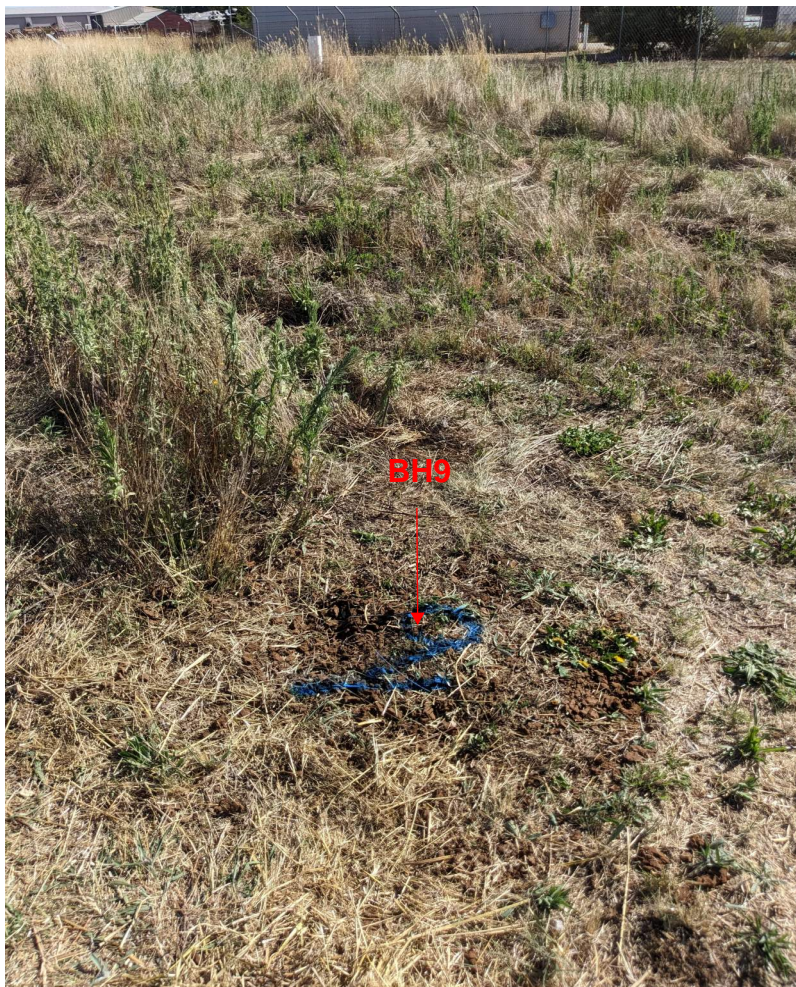
Position of BH9

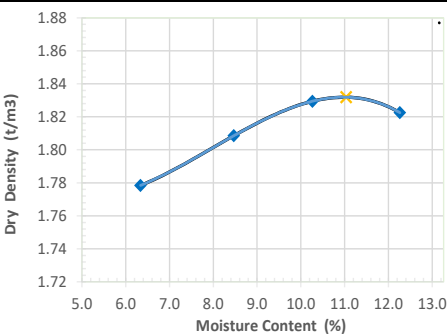
**Dry Density Vs Moisture Content**

Parameters	Units	Test Results	Information
Pretreatment Regime	--	No Pretreatment	
Portion Retained on AS Sieve	%	2% on 19mm	Retained material excluded from CBR
Material Plasticity (Liquid Limit)	--	Sand / Granular	By Technician's Assessment
Sample Curing Time	hrs	MDD = 2 hrs	CBR = 145 hrs
Soil Particle Density	t/m <sup>3</sup>	2.67	Estimated value only**
Maximum Dry Density (MDD)	t/m <sup>3</sup>	1.832	Standard compactive effort
Optimum Moisture Content (OMC)	%	11.0	
Field/Prep Moisture Content	%	Field %	Prep 10.5 %
Compaction Moisture Content	%	Achieved 10.7 %	LMR = 96.5%
Compaction Dry Density	t/m <sup>3</sup>	Achieved 1.84 t/m <sup>3</sup>	LDR = 100.5%
Surcharge Load	kg	4.5	
Period of Soaking	Days	Soaked - 4 Days	Dry Density (after soaking) = 1.78 t/m <sup>3</sup> .
Specimen Swell	%	3.0	
Moisture Content - Top 30mm	%	19.3	After Penetration
Moisture Content - Remaining	%	17.3	After Penetration

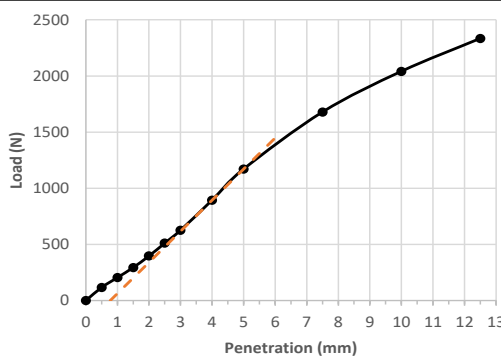
**Load-Penetration Curve**

**Material CBR Value (%)**
**7**
**California Bearing Ratios**
**CBR<sub>2.5</sub> = 5.0**
**CBR<sub>5.0</sub> = 7**

Including an Applied Correction of 0.8 mm

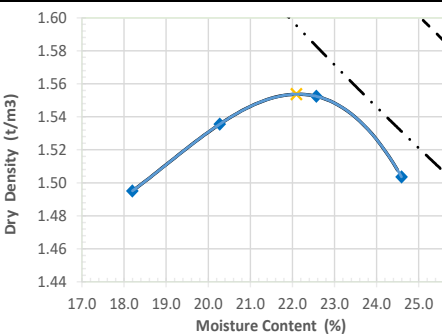
**Dry Density Vs Moisture Content**

Parameters	Units	Test Results	Information
Pretreatment Regime	--	No Pretreatment	
Portion Retained on AS Sieve	%	0% on 19mm	Retained material excluded from CBR
Material Plasticity (Liquid Limit)	--	Low (Less than 35%)	By Technician's Assessment
Sample Curing Time	hrs	MDD = 126 hrs	CBR = 172 hrs
Soil Particle Density	t/m <sup>3</sup>	2.67	Estimated value only**
Maximum Dry Density (MDD)	t/m <sup>3</sup>	1.554	Standard compactive effort
Optimum Moisture Content (OMC)	%	22.1	
Field/Prep Moisture Content	%	Field %	Prep 16.7 %
Compaction Moisture Content	%	Achieved 22.5 %	LMR = 102.0%
Compaction Dry Density	t/m <sup>3</sup>	Achieved 1.55 t/m <sup>3</sup>	LDR = 99.5%
Surcharge Load	kg	4.5	
Period of Soaking	Days	Soaked - 4 Days	Dry Density (after soaking) = 1.52 t/m <sup>3</sup> .
Specimen Swell	%	2.0	
Moisture Content - Top 30mm	%	33.8	After Penetration
Moisture Content - Remaining	%	29.2	After Penetration

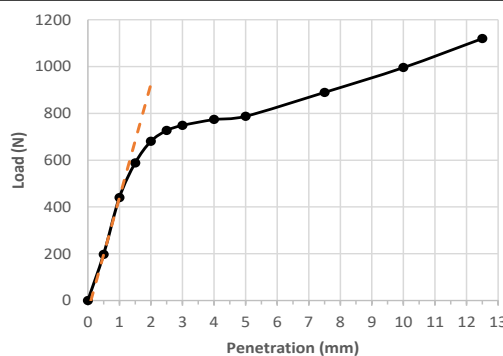
**Load-Penetration Curve**

**Material CBR Value (%)**

# 6

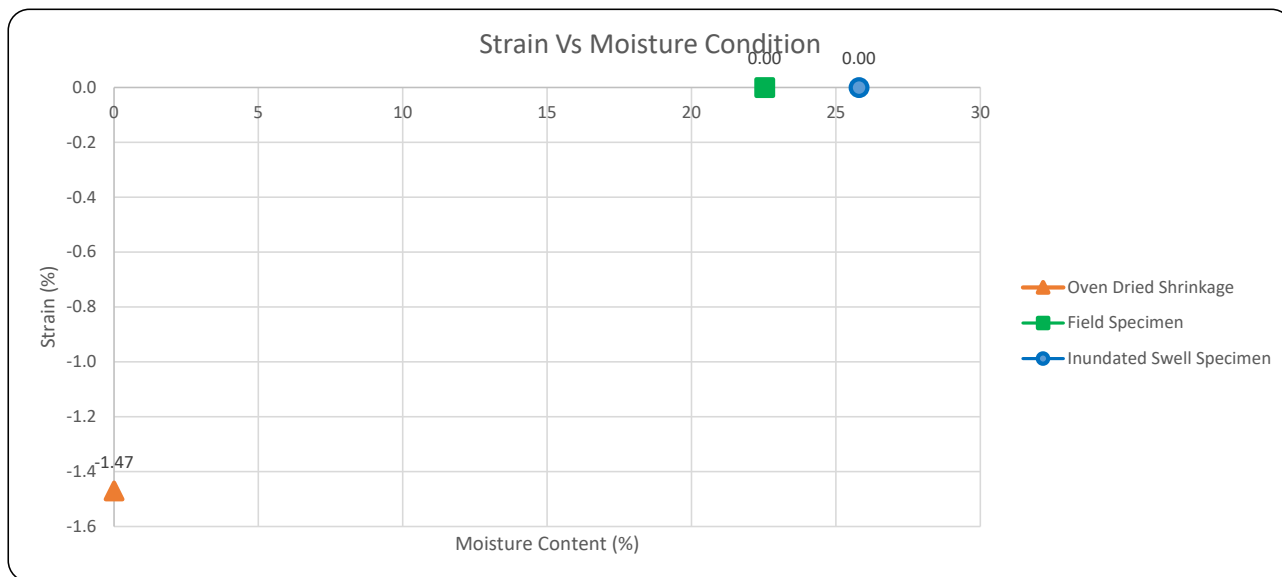
Sample Number	Sample Date	Chainage/Location	Offset	Level of Test	Test Depth
6938	27/02/2023	-	-	BH02	0.4-0.7

Parameters	Units	Test Results	Soil Description
Shrinkage - Field Moisture Content	%	22.2	CI, Silty CLAY
Swell - Field Moisture Content	%	22.8	
Swell - Inundated Moisture Content	%	25.8	
Inert Inclusions in the soil	%	0	
Extent of Soil Crumbling	-	None	
Extent of Soil Cracking	-	Minor	
<b>Shrink-Swell Index</b>	%	<b>0.8</b>

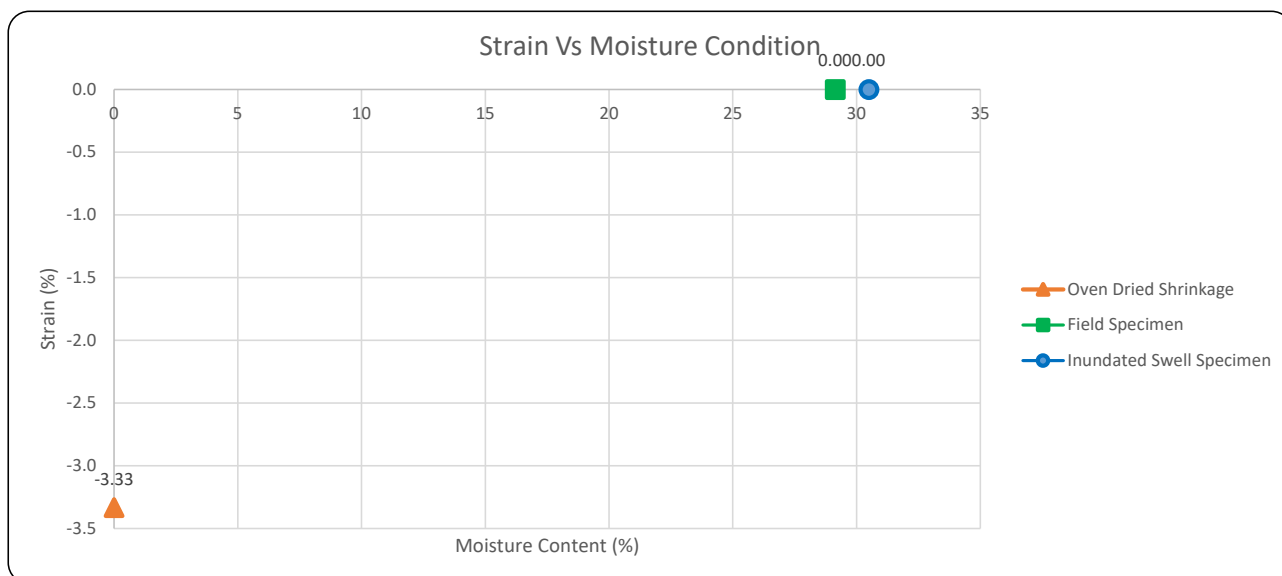
Sample Number	Sample Date	Chainage/Location	Offset	Level of Test	Test Depth
6939	27/02/2023	-	-	BH05	0.6-0.85

Parameters	Units	Test Results	Soil Description
Shrinkage - Field Moisture Content	%	29.2	CH, Silty CLAY
Swell - Field Moisture Content	%	29.1	
Swell - Inundated Moisture Content	%	30.5	
Inert Inclusions in the soil	%	0	
Extent of Soil Crumbling	-	None	
Extent of Soil Cracking	-	Minor	
<b>Shrink-Swell Index</b>	%	<b>1.9</b>
