*Proposed Queanbeyan Headquarters Administration Building*

# **Preliminary Site Investigation**

**For Queanbeyan-Palerang Regional Council**

Date: 31 July 2017  
Reference: T-C0294.00  
Status: Client Draft

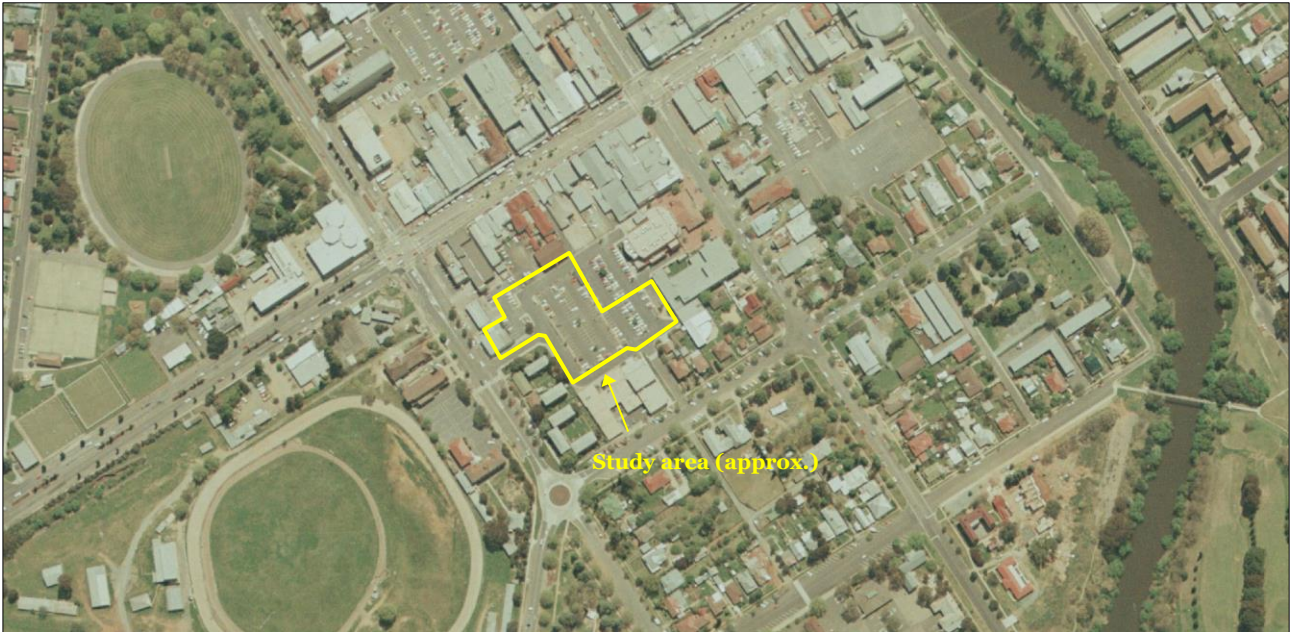
**1992**

| Date | Description |
|---|---|
| 1992 | <p>Site and adjoining land use appears very similar to that observed currently, minus the performing arts centre which is used for car parking at this time.</p> <p>Site features shown in the aerial photo are consistent with observations made during site inspection (28 June – 3 July 2017).</p> |

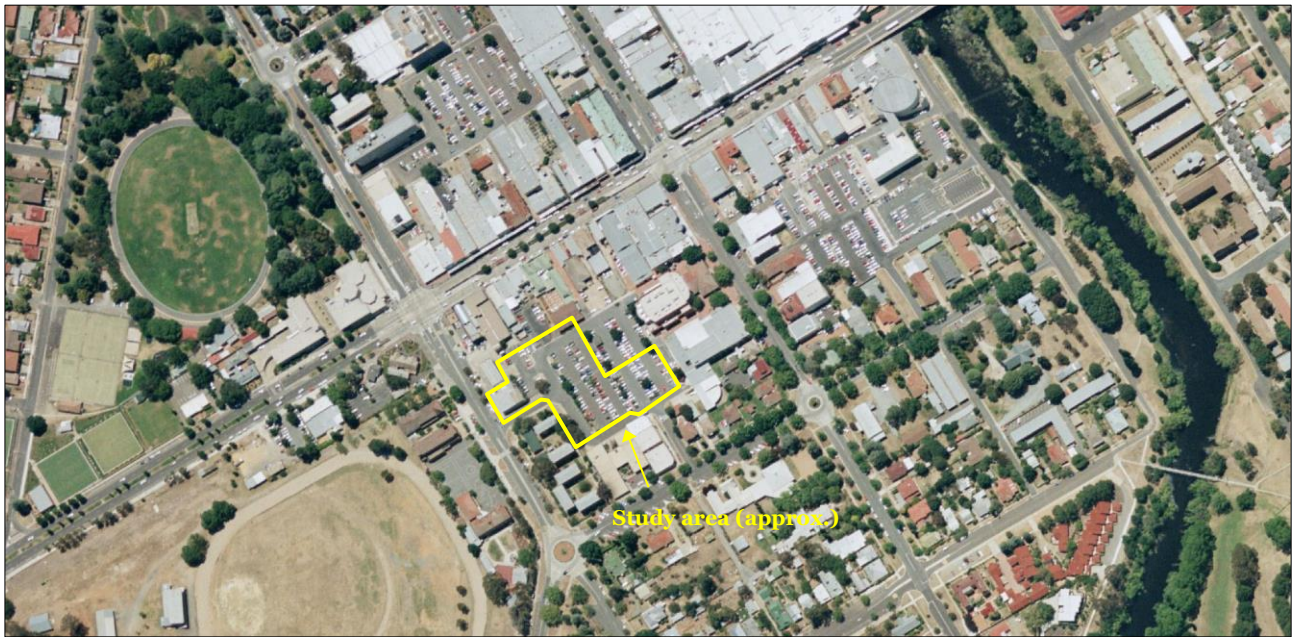
| Date | Description |
|---|---|
| 2005 | <p>Site and adjoining land use appears very similar to that observed currently, minus the performing arts centre which is used for car parking at this time.</p> <p>Site features shown in the aerial photo are consistent with observations made during site inspection (28 June – 3 July 2017).</p> |
